RE: Firdale Farms Ltd – Existing Pond Structural Review - (Revision 1)

RJHall and Associates Ltd, have been engaged by Dairy Green Ltd, to review the Firdale Farms effluent pond at Dobbie Road, Seaward Downs, Southland (Auth. 204751).

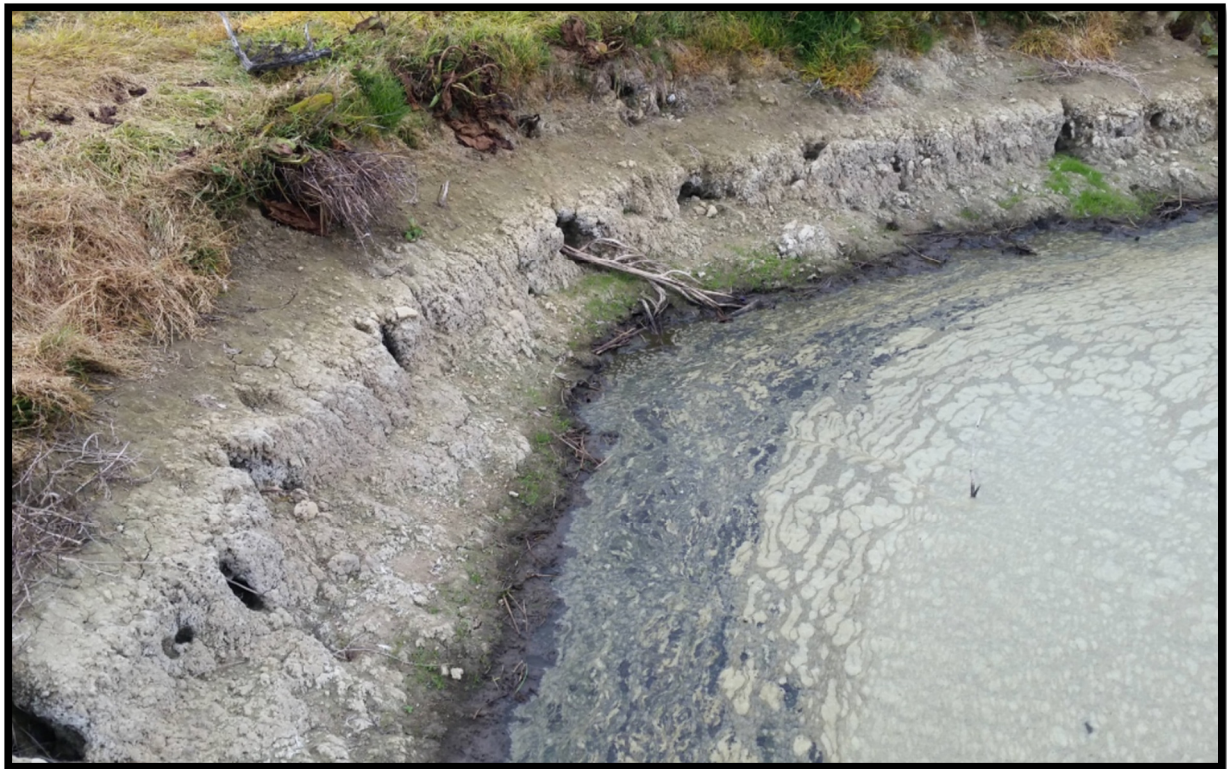
During the site walk over by Dairy Green Ltd holes in the embankment were observed. These holes were caused by rats burrowing into the banks, they are presented in Figure 1. The damage to the embankment caused by the rats needs to be repaired as part of the pond maintenance schedule.

Figure 1: Holes in the internal embankment of the pond

Damage has been caused to the embankment by rat warrens and could lead to minor slumping of the banks and effluent leakage. The damage to the embankment need to be remediated as part of the pond maintenance schedule.

The site investigation and site walkover showed no signs of slumping or cracking on the embankment or internal batters or leakage from the embankment. Rat warrens were present in the freeboard zone of the pond. This damage needs immediate attention. Repair procedures are outlined in Section 4 of this report and shall be carried out with supervision by Dairy Green Ltd.

The basic recommended remediation strategy outlined is:

1. Draw down pond, Dairy Green to inspect banks during draw down;
2. Scrape back and set aside top soil;
3. Scrape back silt soil until all damage from rats has been removed;
4. Reinststate silt soil and compact. Perform a nuclear densometer test to confirm suitable compaction has been achieved (min 95% MDD for that material); and,
5. Replace top soil (min 300 mm overlay) to seal embankment, prevent cracking and protect against wave action.
6. Install rat traps and bait regularly

The construction should be overseen by Dairy Green Ltd to provide quality control of the proposed works.
