WAIANIWA-OPORO RD CULVERT – RESPONSE TO REQUEST FOR FURTHER INFORMATION

Assessment of Fish Passage at Waianiwa Oporo Road Culvert, Southland

REPORT NUMBER: 70-2018

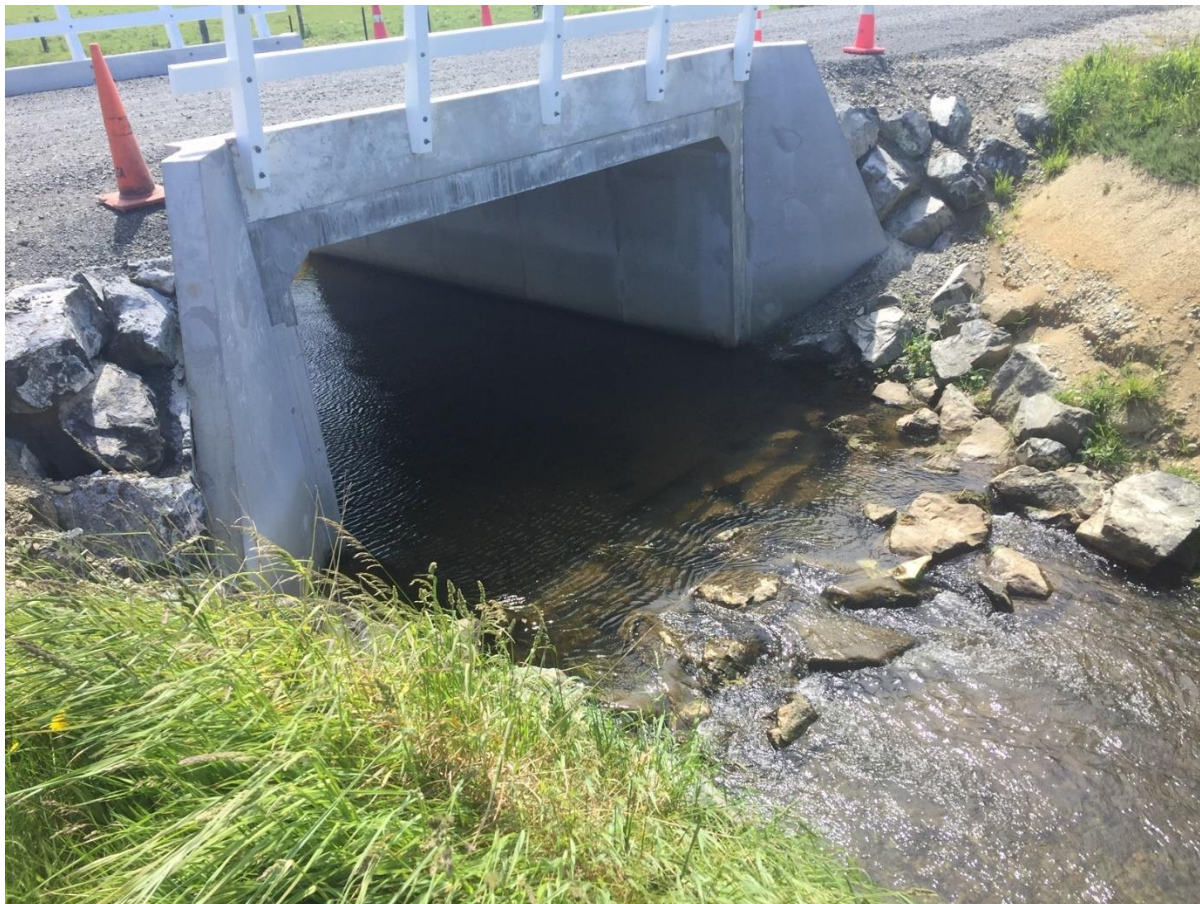
Figure 2: Waianiwa Oporo Road culvert downstream end.

At present the culvert has rock placed downstream and upstream of the concrete culvert floor (Figure 2). The downstream boulders help raise the water level of the stream immediately downstream of the culvert and provide an upstream fish passage pathway

Within the culvert the flat bed of the culvert provides for fish passage. Due to the gentle gradient of Hubbers Stream there is no high water velocity issue that can restrict fish passage in the culvert. For downstream migrating fish passage will be available through the culvert at all times unless the stream stops flowing. Therefore, the key issue is maintaining upstream fish passage especially when flows are low and the culvert lip maybe exposed despite the placement of boulders downstream of the culvert.

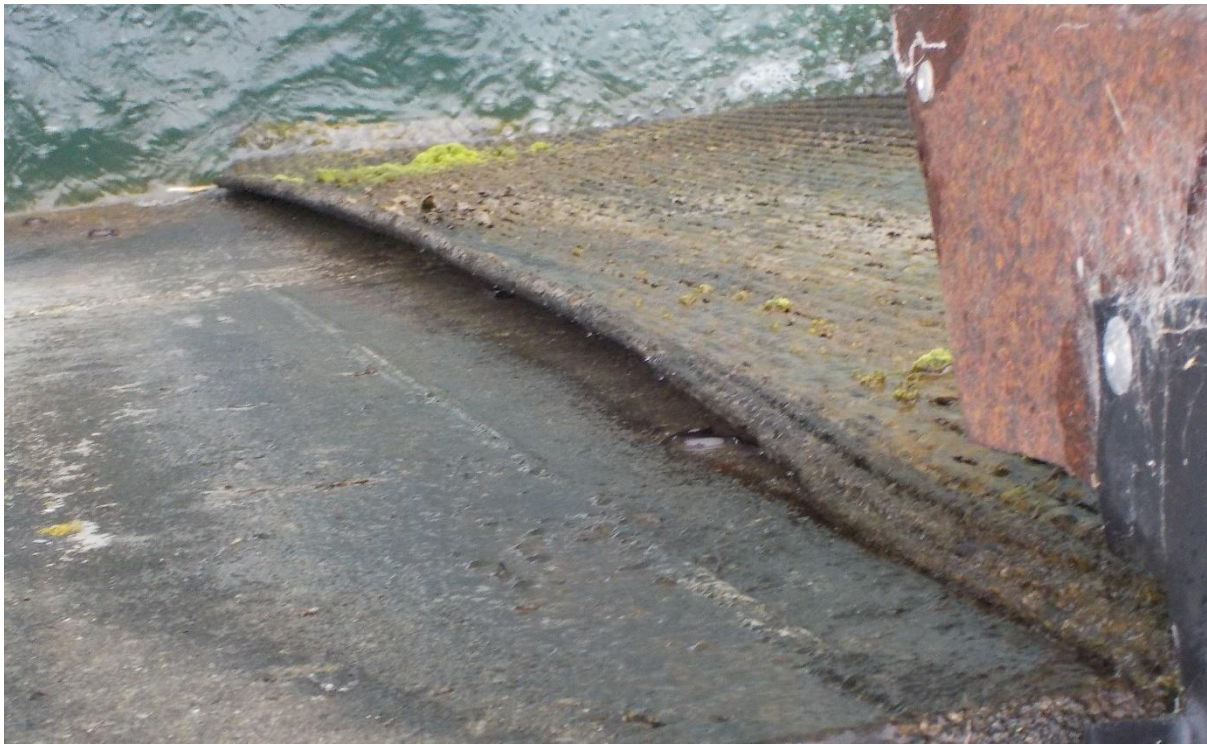
Figure 4: Elver climbing a wetted concrete face at hydroelectric power station.

Shortfin and longfin elvers (juvenile eels) migrate upstream between December and March when water temperatures are warmest. However, elvers are both well known for their climbing ability and readily climb vertical faces several metres high (e.g., Figure 4). Free fall water drops such as occurs at some barrel culverts (Figure 5) are fish passage barriers to elvers as there is no pathway to climb up into the culvert. The culvert at Waianiwa Oporo Road will only be a fish passage barrier to upstream moving elvers if a freefall drop forms at the culvert outflow. This is extremely unlikely when splash zones and water flowing down the concrete face will provide a wetted pathway for elvers.

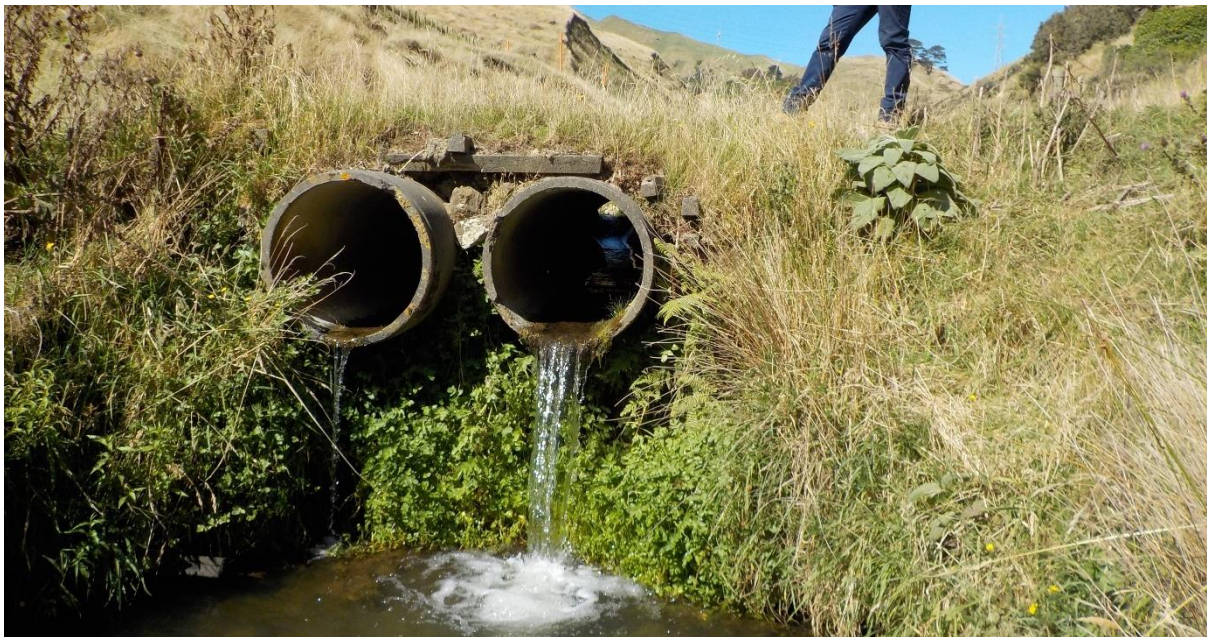
Figure 5: An example of a culvert fish passage barrier to all fish species.

Fish surveys can attempt to detect fish passage barriers. For the culverts such as in Figure 5 this is simple as accumulations of fish will be present immediately downstream of the culvert as fish passage is never available. However, it can be expected that the Waianiwa Oporo Road will only limit fish passage for bully species and only during low flow periods. Therefore, assessment of fish passage should only occur after a period of low flow during the migration period for the fish of interest. However, accumulations of fish immediately downstream of the culvert can be expected even if fish passage is available through the culvert as the boulder pile has created habitat that will provide good cover for fish and will be readily occupied. Therefore, the occurrence of fish in a higher density immediately downstream of the culvert does not prove fish passage is prevented.

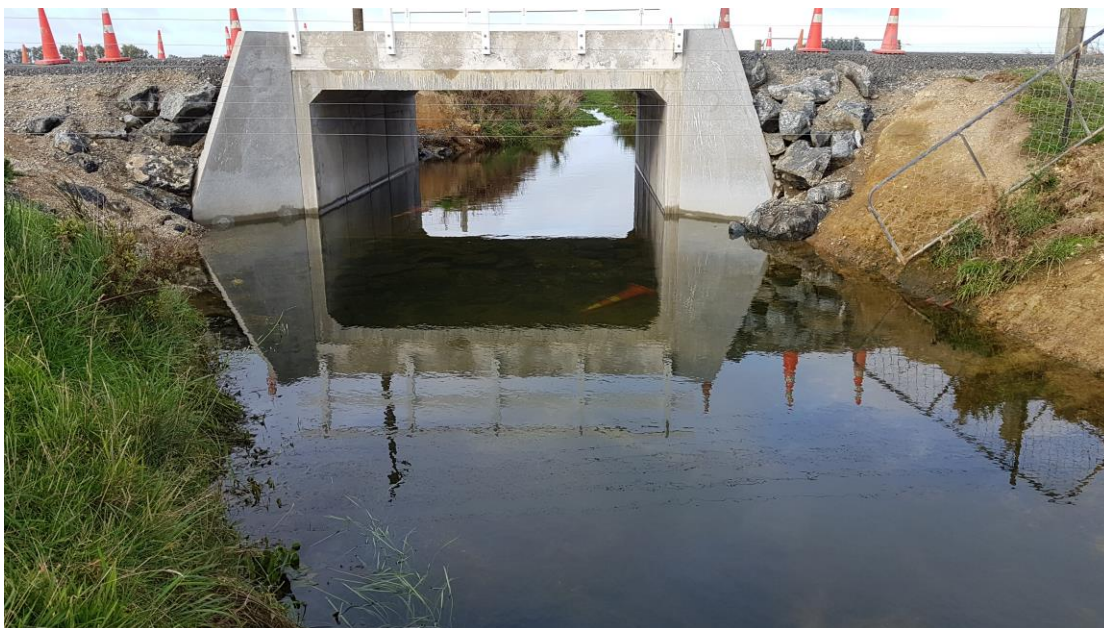
Photo 1: Looking downstream through culvert following installation

There also appears to be some concern that local bed scour may leave the culvert outlet perched above the downstream channel bed, thus potentially impeding fish passage at low flows. This situation can be monitored, and if observed to develop, it can be simply remediated with rock or concrete works which can be engineered to facilitate fish passage while protecting the bed against scour. Any such measures will need minimal maintenance owing to the relatively low ambient velocities and minor local velocity increase.

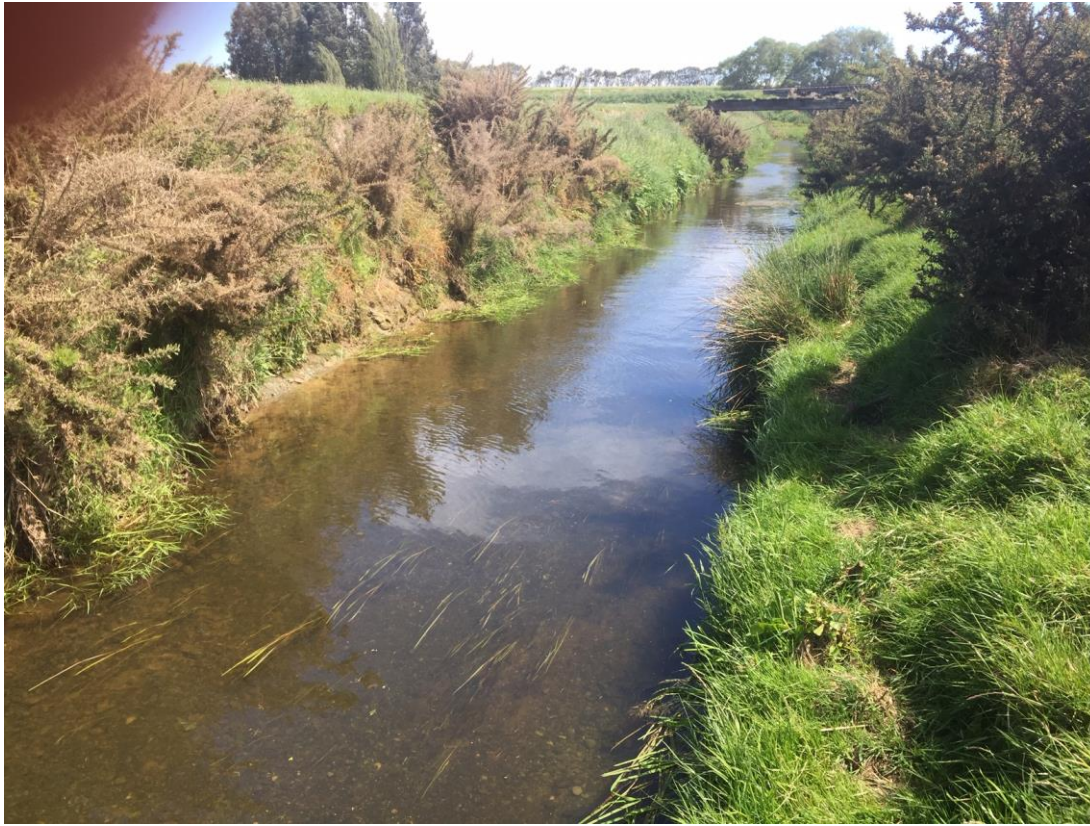
Photo 2: Heavy vegetation on adjacent stream banks.

This is not unexpected, given the flat bed gradient (less than 0.2% over 100 m downstream) and relatively high hydraulic roughness due to heavy vegetation on the stream banks (see Photo 2). These effects will be combining to control upstream water levels to the extent that any effect of the raised culvert invert is insignificant even at moderate flows, and under flood conditions any effect will be even less.

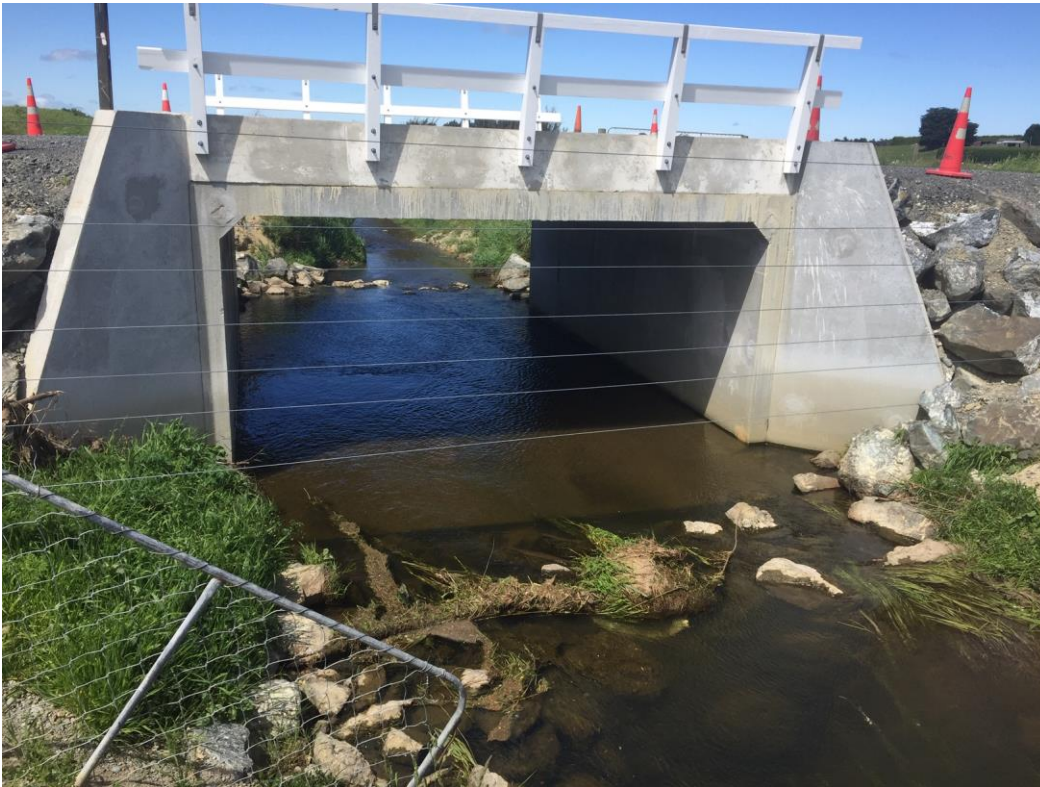
Photo 3: Showing rocks placed at each end of culvert.

Subsequent to construction, rocks appear to have been placed across the channel bed at both sides of the culvert (Photo 3). These appear to be trapping vegetative debris and may be having a significant influence on local upstream water levels, particularly at lower flows. Any such influence is likely to be confined to a small upstream area in the near vicinity of the rocks. Consideration should be given to removing these rocks.

Overall, the hydrological effects of the elevated culvert are considered to be less than minor. However, these effects could be further reduced by removing some of the rock upstream of the culvert to prevent vegetation becoming trapped.
