GeoSolve Ref: J190531
2 September 2019

Hydrology Review Fiordland Trails Trust Lake 2 Lake Leg 6

Resource Consent Application Reference: APP-20191150

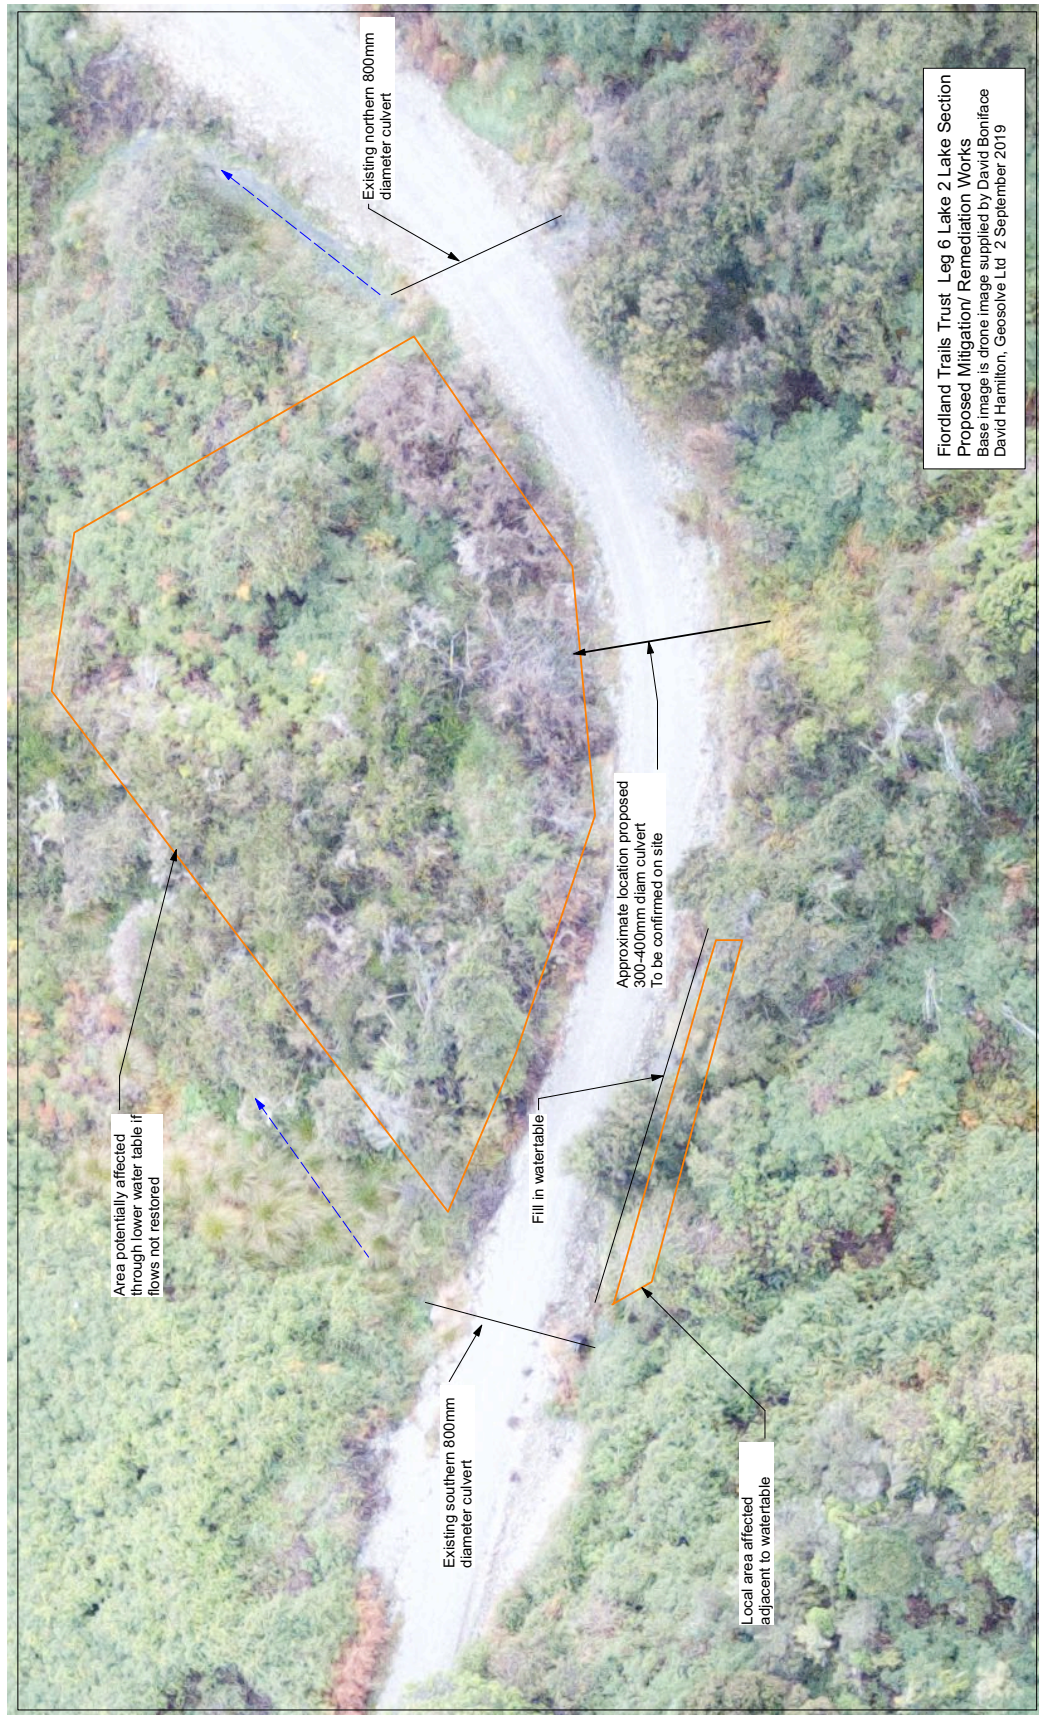
The areas potentially affected by the track construction on upstream and downstream sides of the track are shown on the attached Figure 1.

It is concluded that the construction of the trail between the northern and southern culverts has reduced the interflow from upstream to downstream of the trail through the higher ground between the two 800mm culverts. A small area adjacent to the watertable that feeds to the southern culvert would also have been affected.

Figure 1: Drone image of section of trail showing proposed remediation work

The proposed remediation by way of filling in the upstream watertable is supported as a part solution. A small diameter pipe, nominal size 300mm to 400mm diameter, to pass the higher elevation water between the 800mm culverts would return water to the area of higher ground below the track, and ensure this area does not dry out. This should be placed approximately halfway between the two larger culverts., with the actual location to be confirmed on site. It is considered that a culvert with the ability to pass 20 l/s should be sufficient. This could be provided by a 200mm diameter culvert. Smaller culverts can have a tendency to get root bound and cleaning out is easier with a culvert in the 300 to 400mm diameter size and should be used. See Figure 1 attached for details.

- (a) through filling in of the watertable as previously proposed by Opus in letter 27 March 2019, and
- (b) placing a 300-400mm diameter culvert through the high ground approximately halfway between the two larger culverts. The actual location should be confirmed on site.
