RE: Woldwide Drop Test, August 2018

Abe De Wolde
Woldwide Four Ltd
104 Shaws Trees Road
RD 3
Winton 9783

Drop Test Results: Woldwide Four Ltd Effluent Pond, 10 - 12 August 2018.

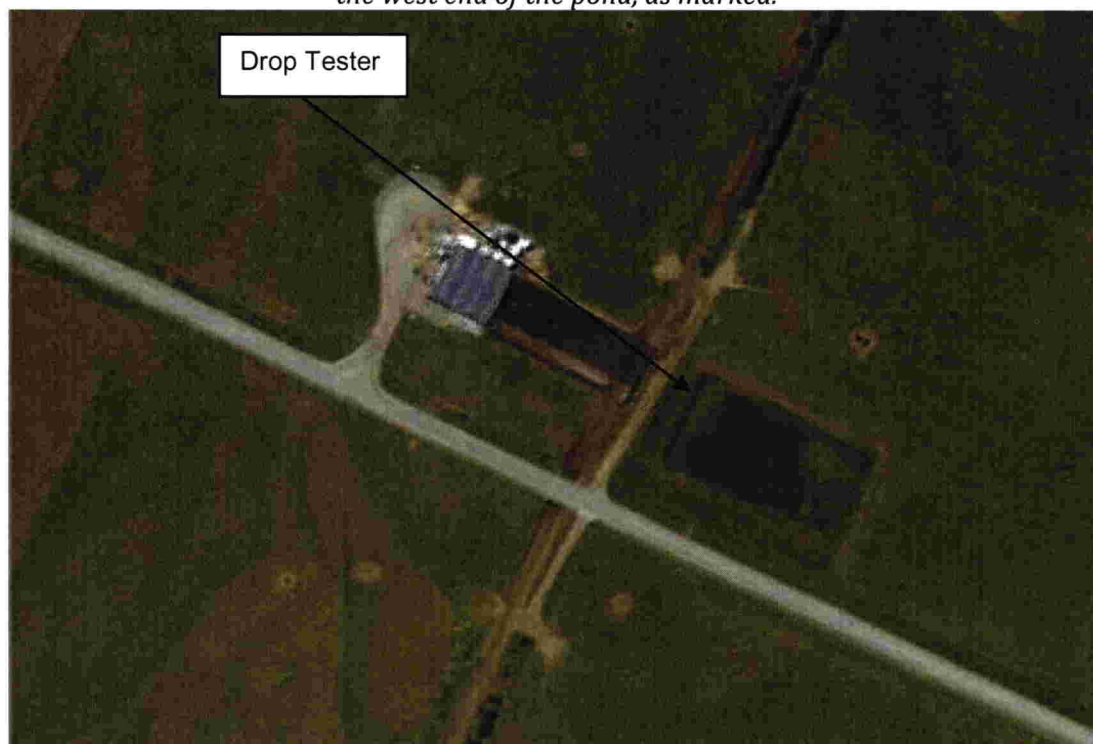
Below is an aerial photo that shows the pond and dairy shed. The laser drop test unit was installed at the west end of the pond, as marked.

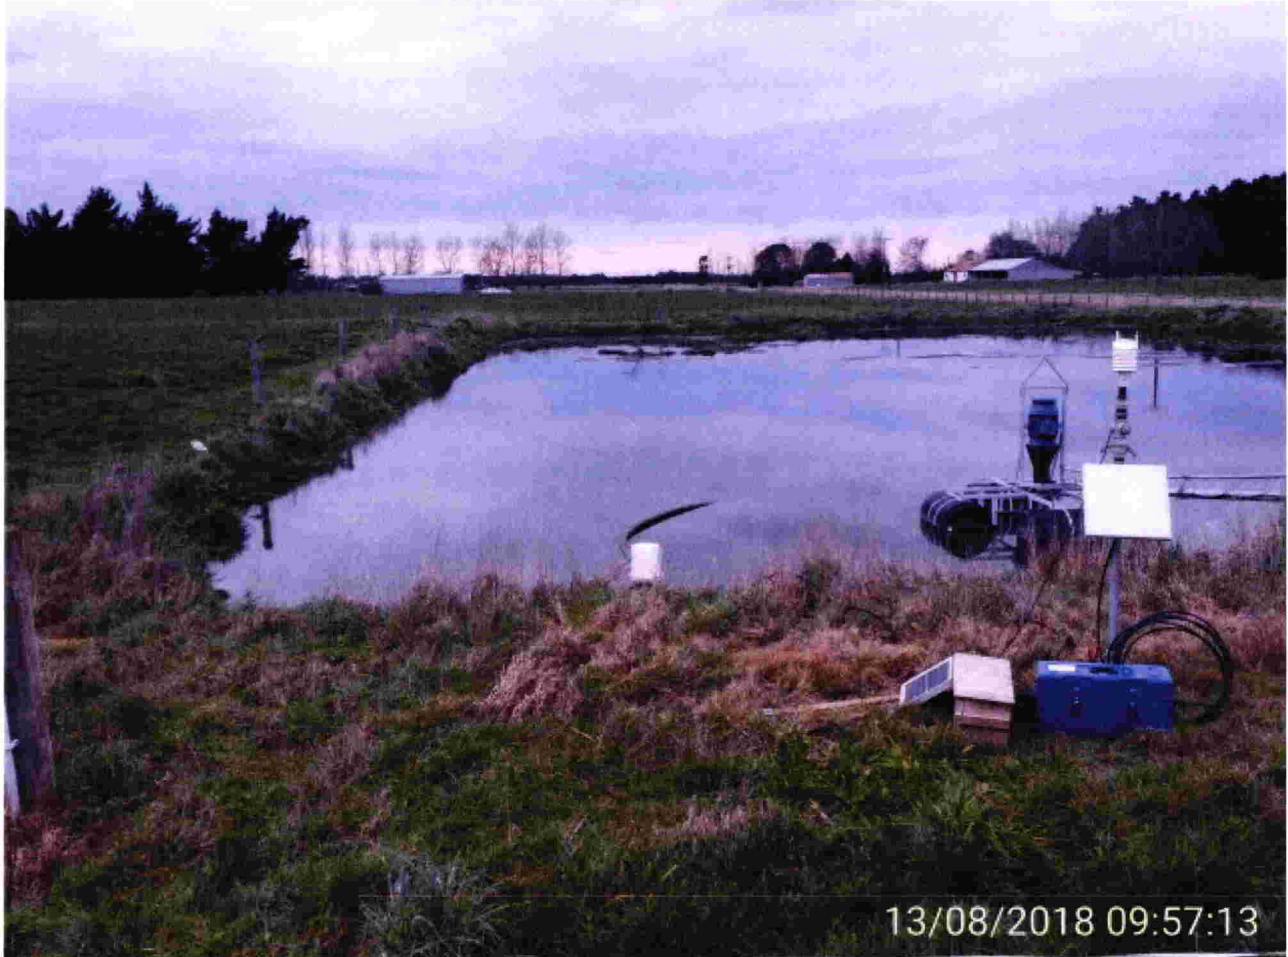
- When a period of 48 hours or more has elapsed the information is down loaded and the results interpreted.
- The GPS location of the pond and equipment set up is recorded. For this test the equipment was located at E1221882, N4883618, at the west end of the pond.

Laser at the west side of the pond.
