WW1&2 consent application

Appendix A

Drop Test Results: Effluent Pond, 17 – 19 November 2017

**Effluent Pond Drop Test – A De Wolde
Woldwide Two, 1915 Winton-Wreys Bush Hwy**

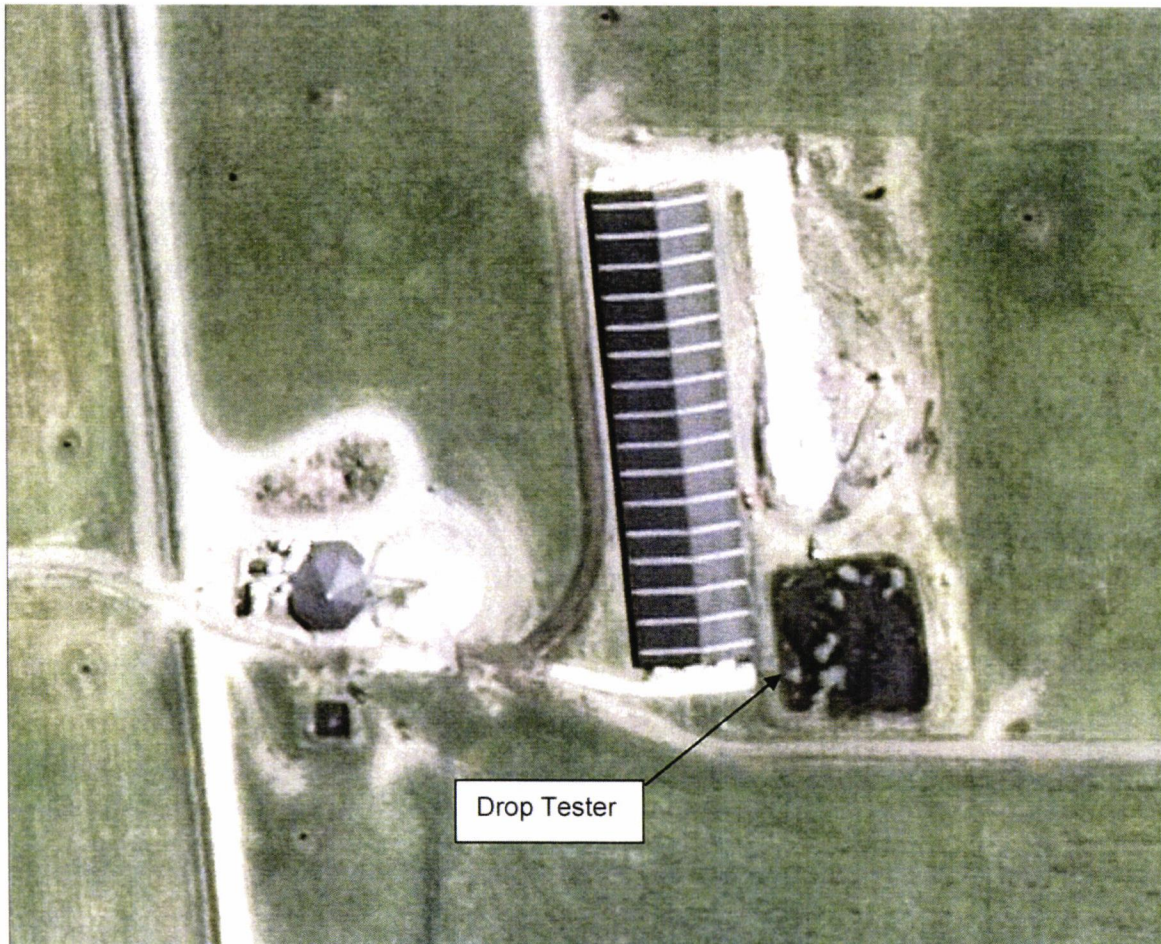
Below is an aerial photo that shows the pond and dairy shed. The laser drop test unit was installed at the west side of the pond, as marked.

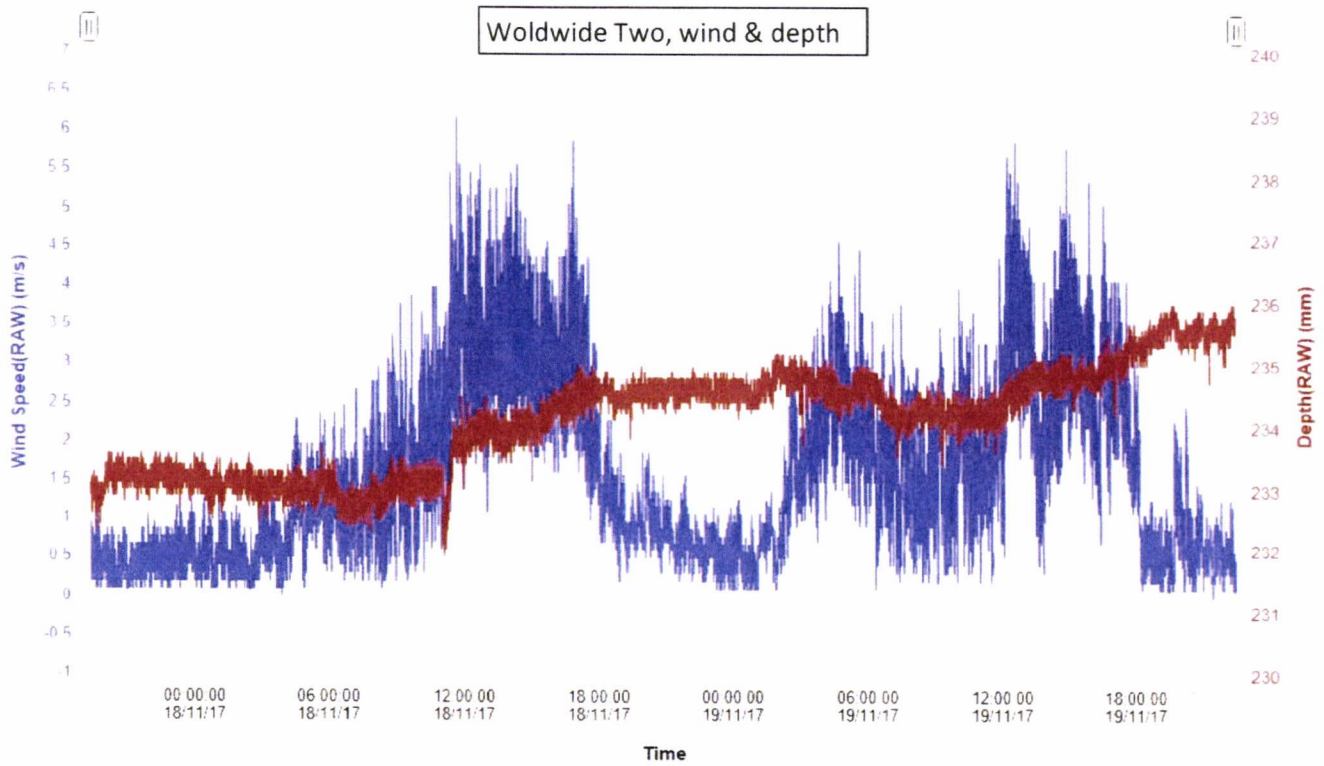
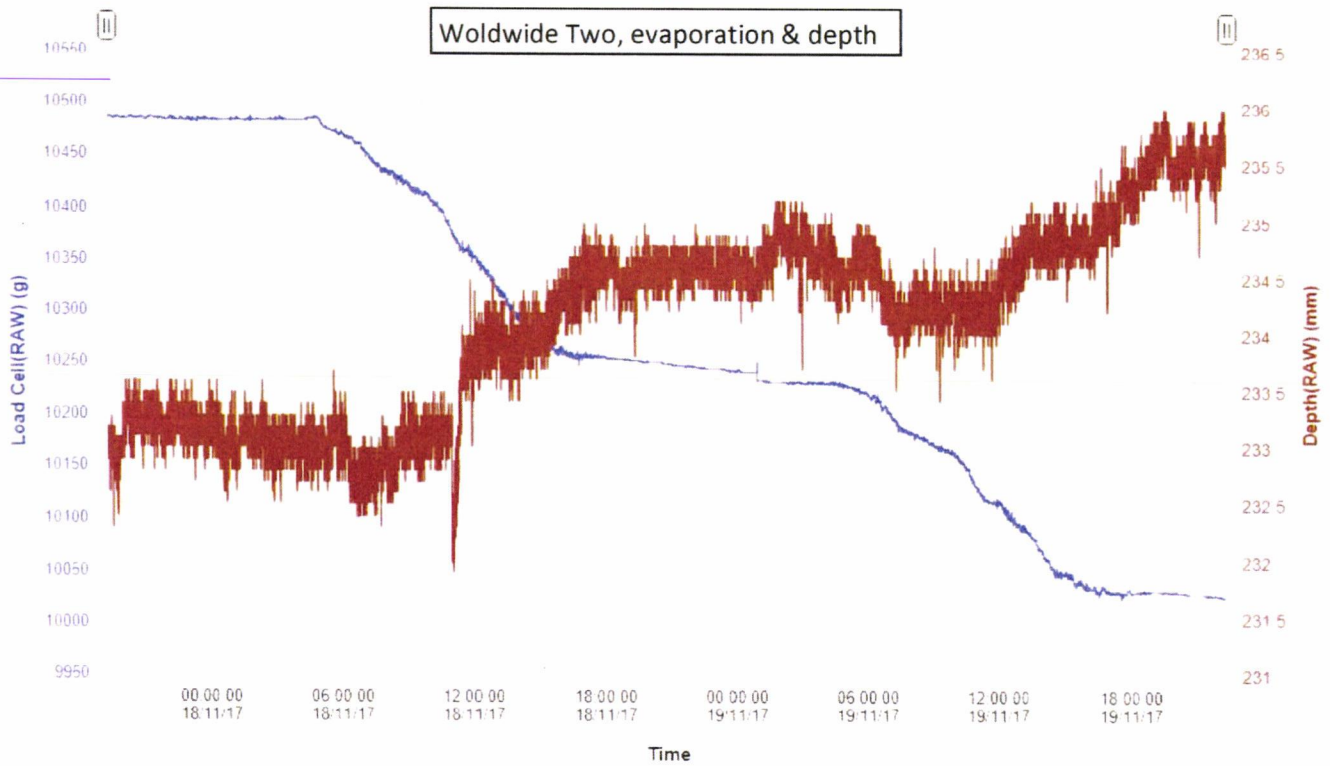
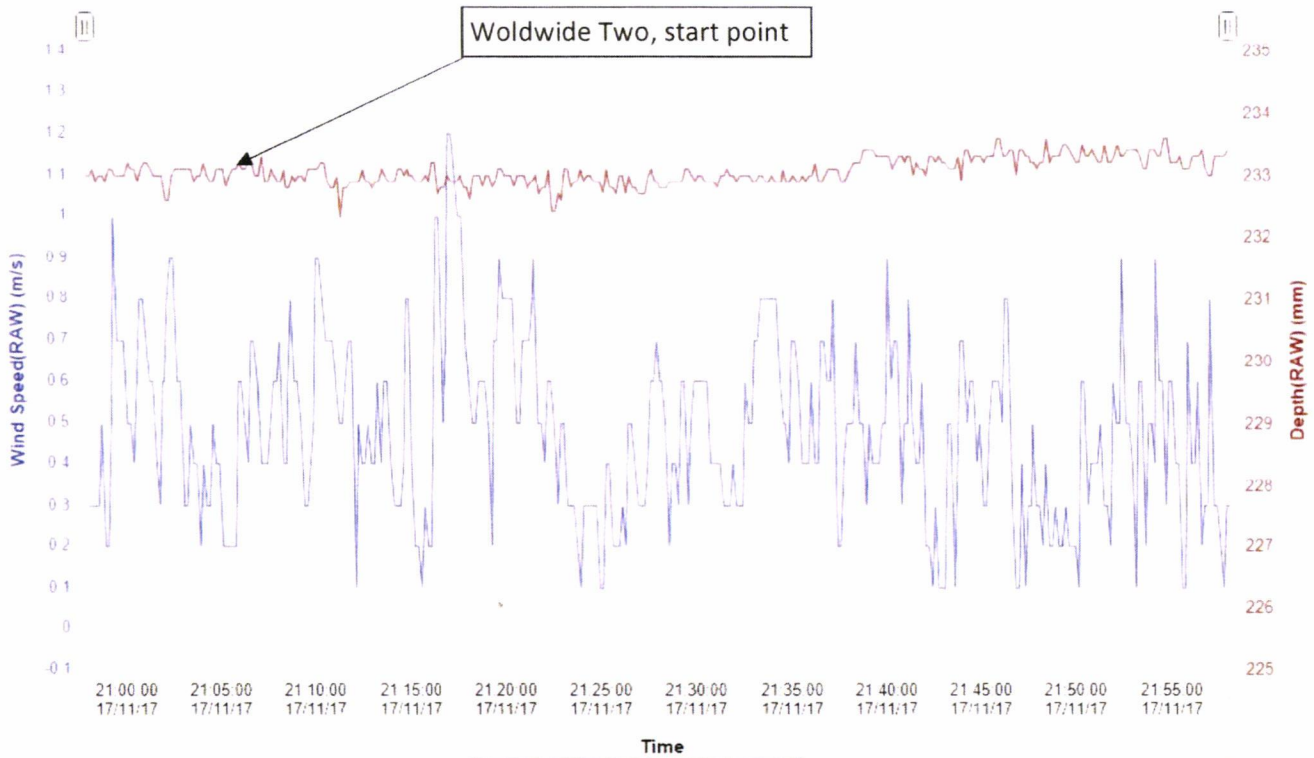
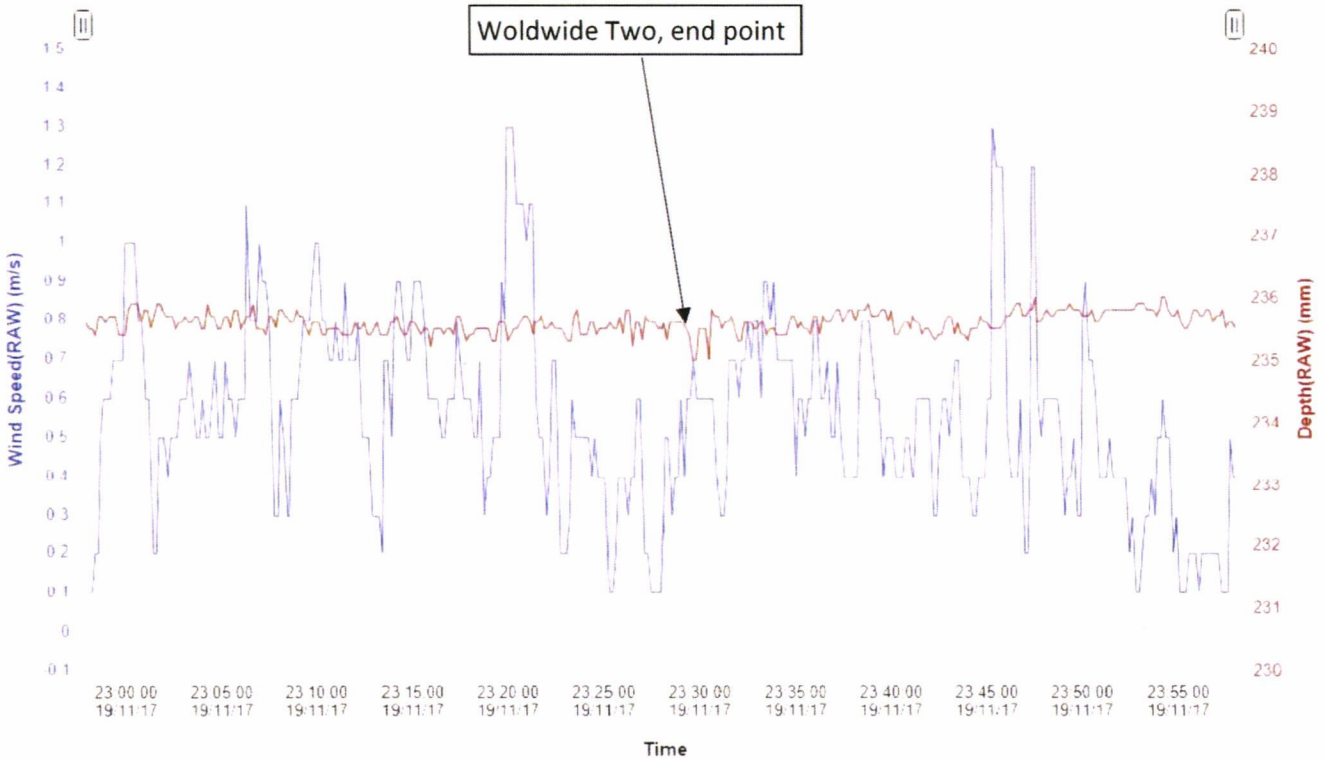
The plot of wind speed and pond height shows that at times wind caused waves on the pond surface, particularly during the day time of the 18th and again during the day time of 19th November.

Depth and wind speed for the start of the test period.

Depth and wind speed for the end of the test period.

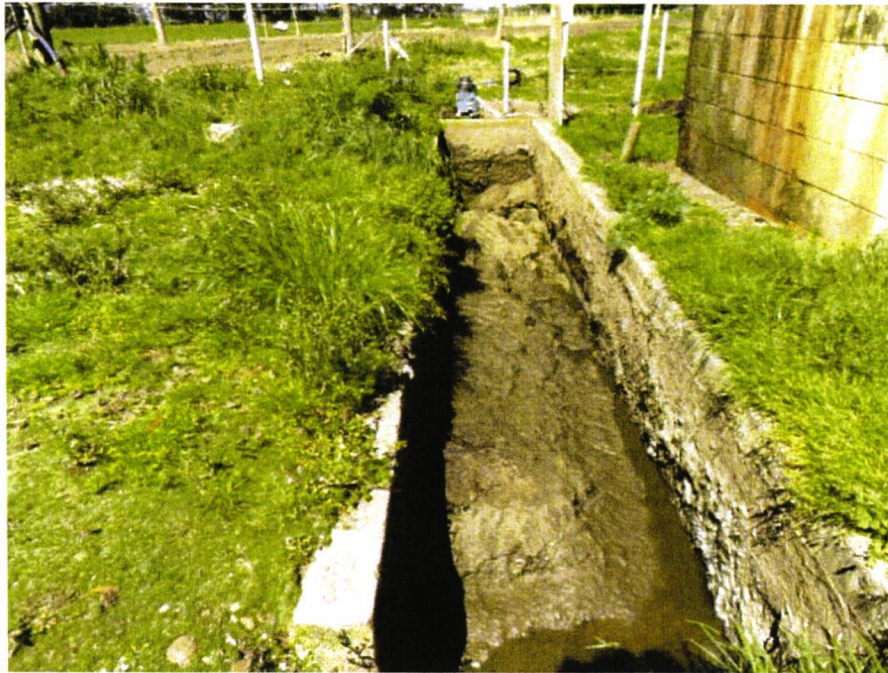
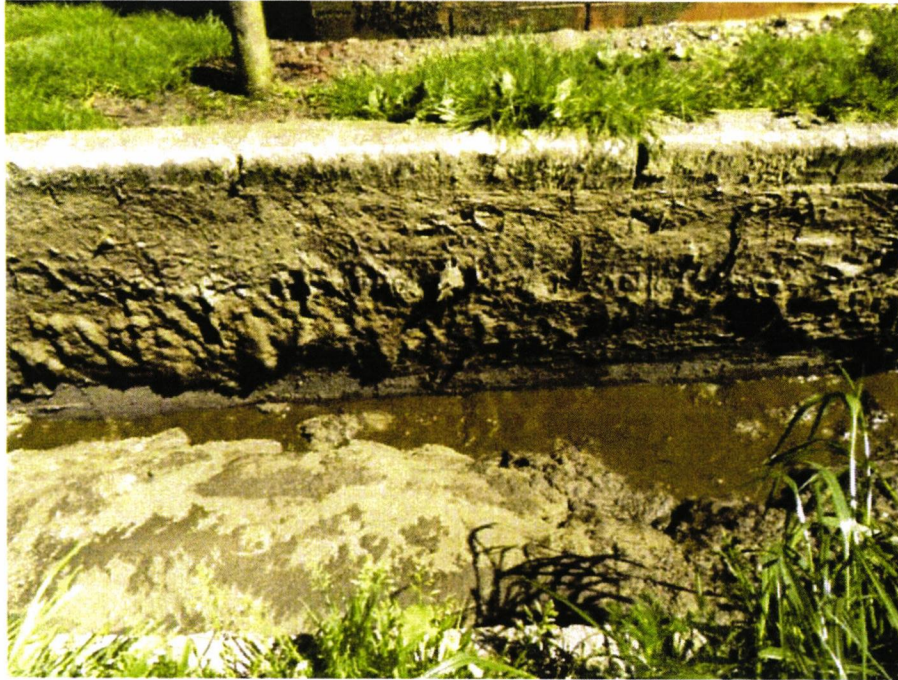
There was no sign of settlement or differential settlement or cracking. Grouted joints that could be observed appeared to be sound although there was one join in the top course of blocks that had lost some material. This was above the maximum operating height; the surrounding ground would be flooded for this join to be flooded.

The sand trap appeared to meet the criteria of not causing defects that would allow leakage.

Below are photos showing the sand trap lengthwise and looking at the internal concrete block wall.

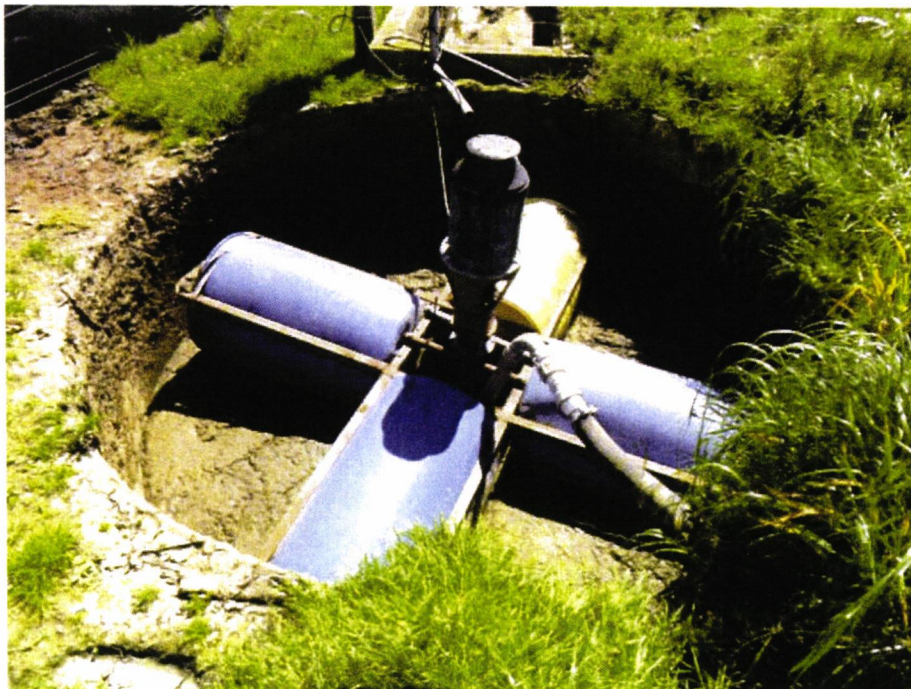
The pump sump at the end of the sand trap is formed from a precast 22.5m³ concrete tank. It has an inlet from the sand trap and one from a pipe crossing a race at a higher level. There were no obvious cracks in the concrete. A small area of concrete had been removed to facilitate the placement of the discharge pipe in a conduit under the race.

The sump appeared to meet the criteria of not causing defects that would allow leakage. It is pictured below with the end of the stone trap in the background.

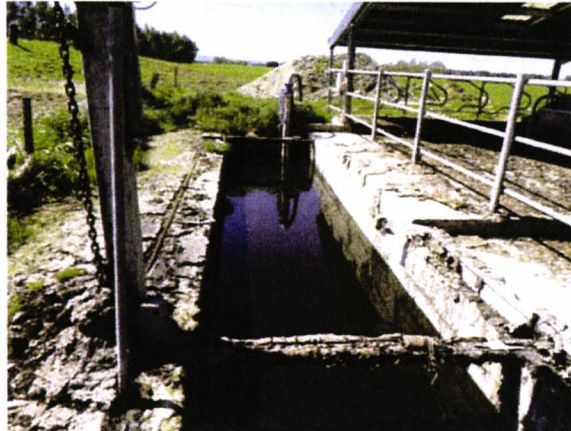
Wintering Barn

The wintering barn has a collection sump at the north end where scraped effluent is deposited prior to being pumped into the storage pond. The sump is 1.9m wide and 26m long. It appeared to be in sound order with no obvious corrosion of concrete.

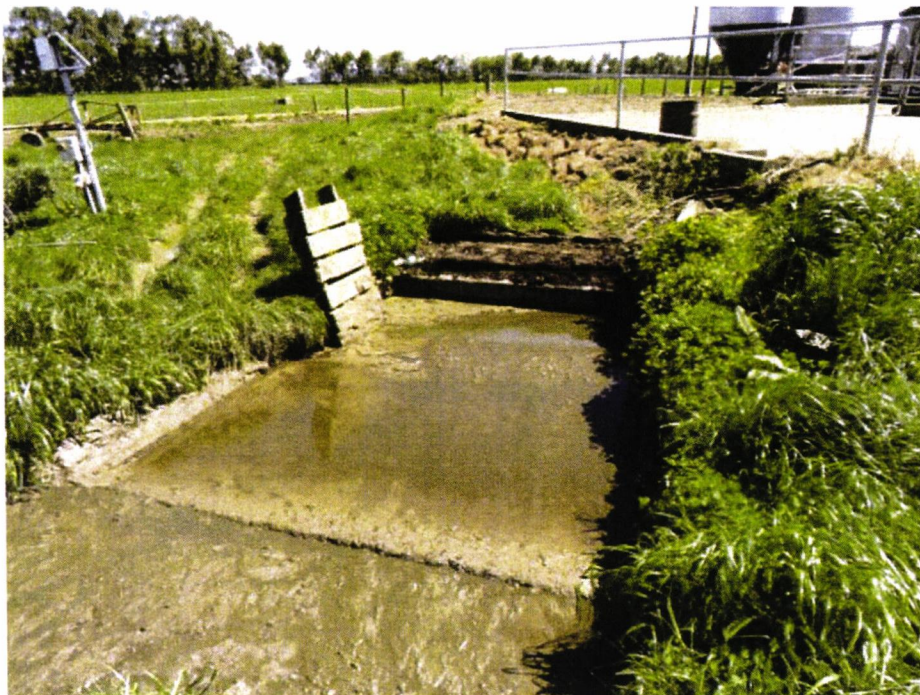
Effluent from the dairy shed and yard flows to a conventional sand trap on the south side of the dairy shed. It is emptied by front end loader. The structure didn't show any visible signs of settling or cracking. There was no cracking of the concrete where tractor tyres enter the trap or along the back wall where the front-end loader bucket may contact the wall.

The sand trap appeared to meet the criteria of not causing defects that would allow leakage.

Below is a photograph of the sand trap.

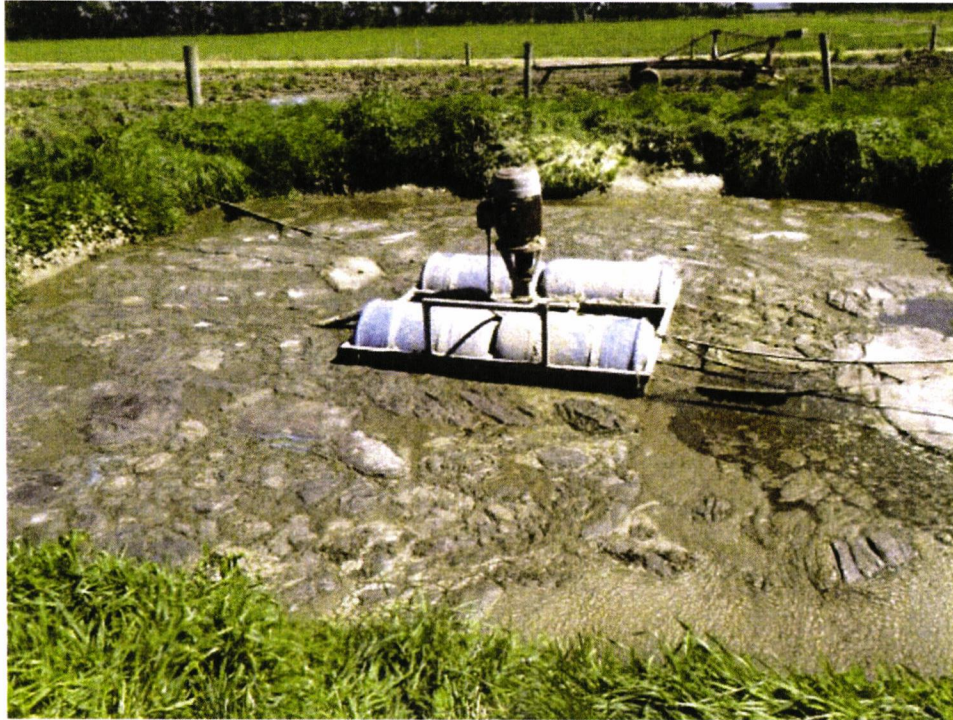
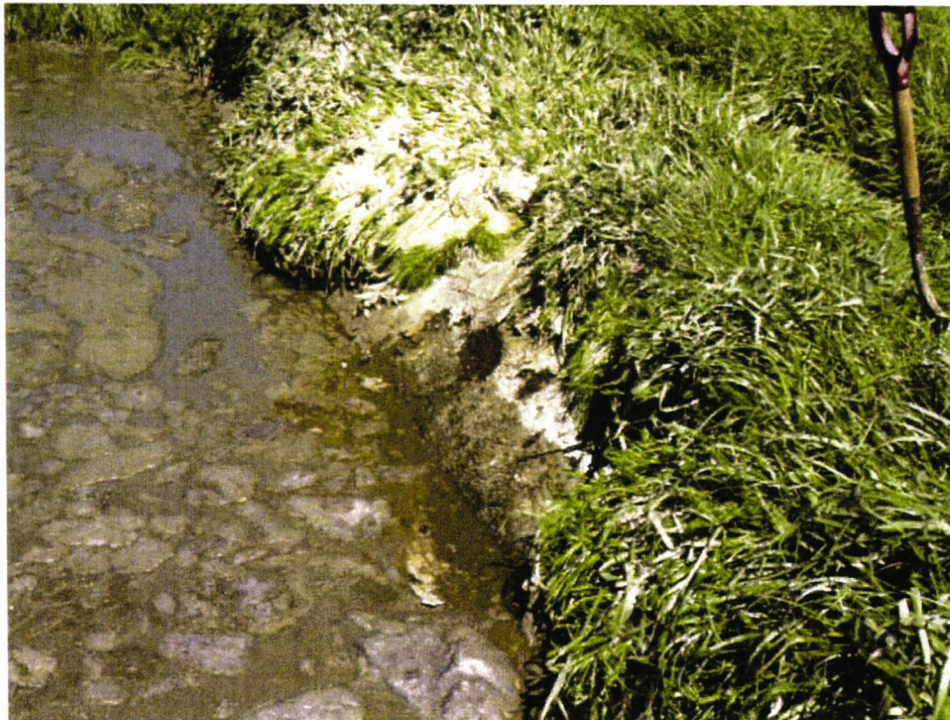
The pump sump adjacent to the sand trap is formed from a shotcrete concrete tank in the order of 9.2 m x 9.2 m. It has an inlet from the sand trap. There were no obvious cracks in the concrete for the area of concrete that was visible.

The pump sump appeared to meet the criteria of not having defects that would allow leakage. It is pictured below with a section of the freeboard batter slope exposed in the background and then close up.

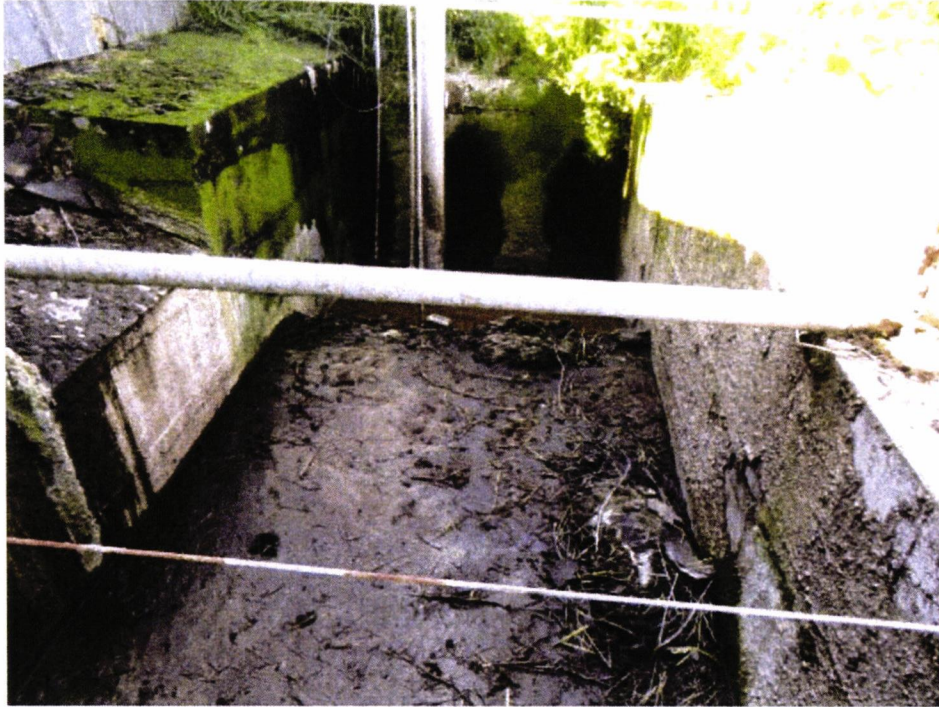
Wintering Barn

The wintering barn has a collection sump at the south end where scraped effluent is deposited prior to being pumped into the storage pond. The sump is 1.9 m wide and 30 m long. It had been poured in situ. It appeared to be in sound order with no obvious corrosion of concrete.
