Woldwide Two

Effluent Pond Supplementary Information

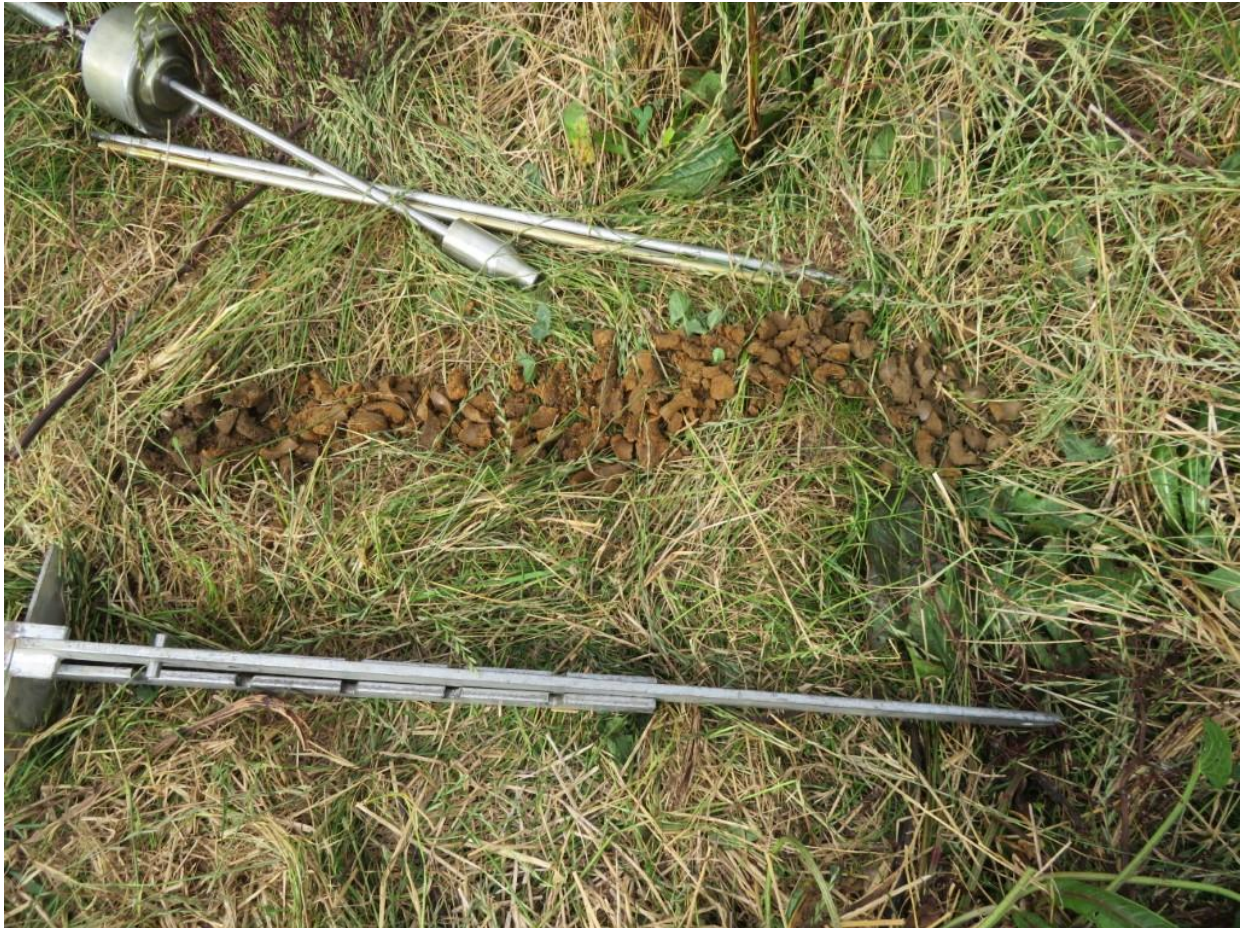
Figure 1. Photograph of Scala Penetrometer and material from auger hole.

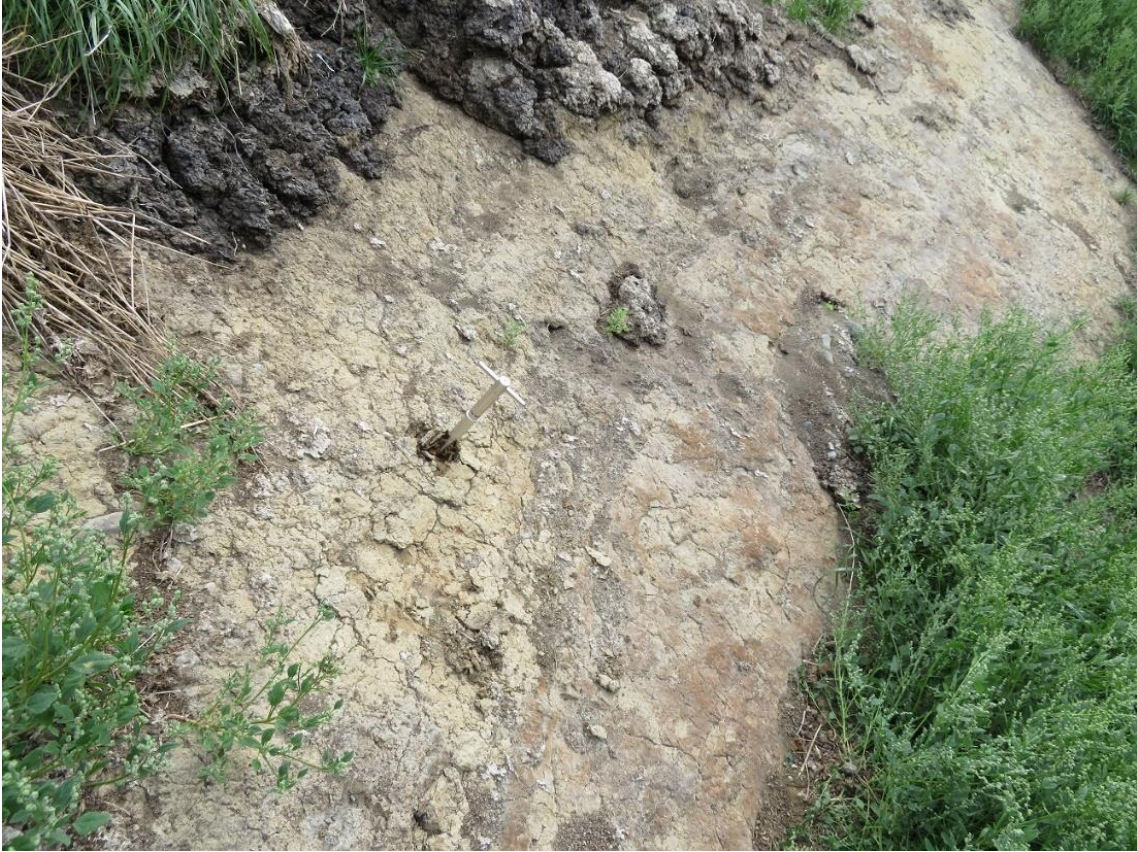
Figure 2. Internal batter with shear vane.
