**Nitrate Hotspots
Survey of Wells with
Excessive Nitrate**

**Report by
Southland Regional Council
Keith Hamill**

Southland Regional Council Publication No. 1999-6

June 1999

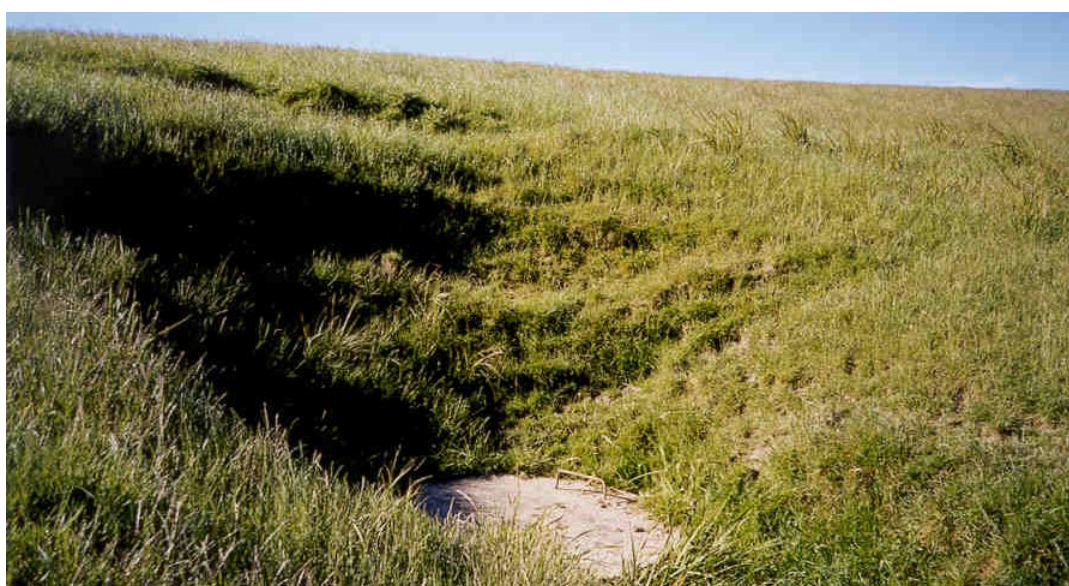
Photo 1: Stock camp on McNab well

High nitrate in the McNab well (see Table 2.1) was probably caused by stock camping on the wellhead. The well is dug into the hillside to tap a seep. It is located in a hollow that provides a sheltered stock camp (for sheep) and allows surface runoff to enter the well (see photo 1). The water level is very shallow (0.1 metres below ground level) and the wellhead is poorly protected so urine and faeces would easily leach into the well. The presence of stock and poor wellhead protection also explains the microbial contamination of the groundwater.

No other wells were located in the same aquifer but the contamination is almost certainly localised and caused by stock camping near the well, the location in a depression and the poor wellhead protection.

Surface runoff can easily enter this well and sheep had been camping above the wellhead

The water quality from this well would improve if the wellhead were protected. Stock should be excluded from the area surrounding the wellhead and the wellhead better sealed against the intrusion of surface water. It is more important to exclude stock up-gradient of the well than down-gradient of the well. Further work is needed to provide defensible exclusion distances for this site; at the very least stock need to be excluded for a distance to prevent runoff carrying faecal material to the well.

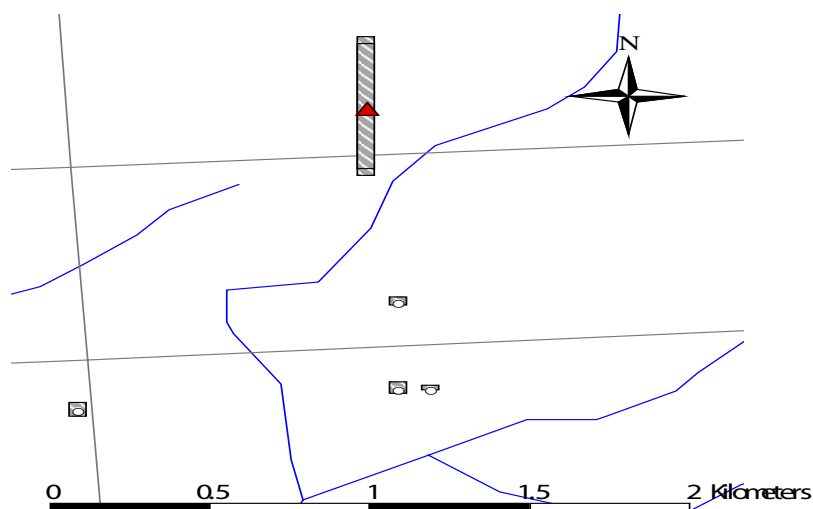
Figure 2.3 Spatial distribution of nitrate in the wells sampled near Timpany

High nitrate in the Timpanys well (Table 2.3) was probably localised. It may have resulted from stockyards 40 metres up-gradient³, but further work would be needed to confirm this.

High groundwater nitrate is not widespread in the Timpanys area. Sampling in the area found most wells to have very little nitrate (see fig 2.3). Although in one case the low nitrate probably resulted from the high iron concentration in the groundwater⁴.

Further investigation into the source of nitrate in this well is needed before reliable guidance can be given for improving the groundwater quality at this site. It is likely that another well may need to be drilled up-gradient of contaminants, alternatively the water could be treated to reduce the nitrate concentration.

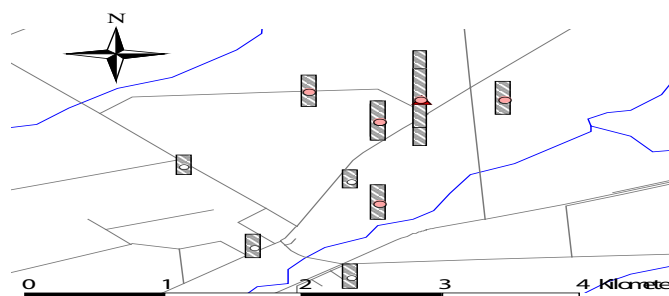
Figure 2.4 Spatial distribution of nitrate in the wells sampled near Woodlands

High nitrate in the Woodlands well (Table 2.4) was probably caused by leaching and surface run-off from a nearby sheep yards. The yards were covered (with open sides) which would reduce the potential for leaching, but the well was only 5 metres from the yards and the congregation of sheep in this area has probably impacted on the well water quality.

The contamination appeared to be localised near the well. All other wells sampled near the high nitrate well were within the nitrate MAV (see Fig 2.4). However wells in the Woodlands area had nitrate concentrations above Southland's median of 3.2 gm⁻³.

The water quality from this well would improve by improving wellhead protection and reducing the potential for leaching from the sheep yards. The wellhead would be better protected from direct contamination (especially from faecal coliforms) if the wellhead was raised above ground level and sealed.

Water that enters the yards is likely to leach contaminants to groundwater near the well. Thus nitrate contamination would be minimised by ensuring no water enters the yards (from for example rain or a leaking pump). Ideally the well should be located away from the yards.

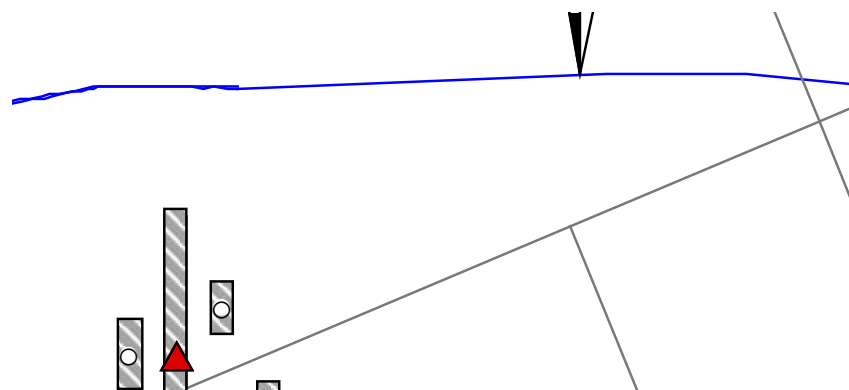
Figure 2.5: Spatial distribution of nitrate in wells sampled near Oteramika Road

There was no obvious reason why nitrate should be high in the Oteramika Road well (Table 2.5). The well was located in a grass paddock where a few sheep and horses were grazed, but was distant from sources of contamination like septic tank disposal areas and offal pits. Although the wellhead was flush with the ground it appeared protected from surface runoff.

The contamination appeared to be very localised; since all other wells sampled along Oteramika Road were within the nitrate MAV (see Fig 2.5).

The source of contaminants needs to be identified before actions can be taken to reduce nitrate in this well.

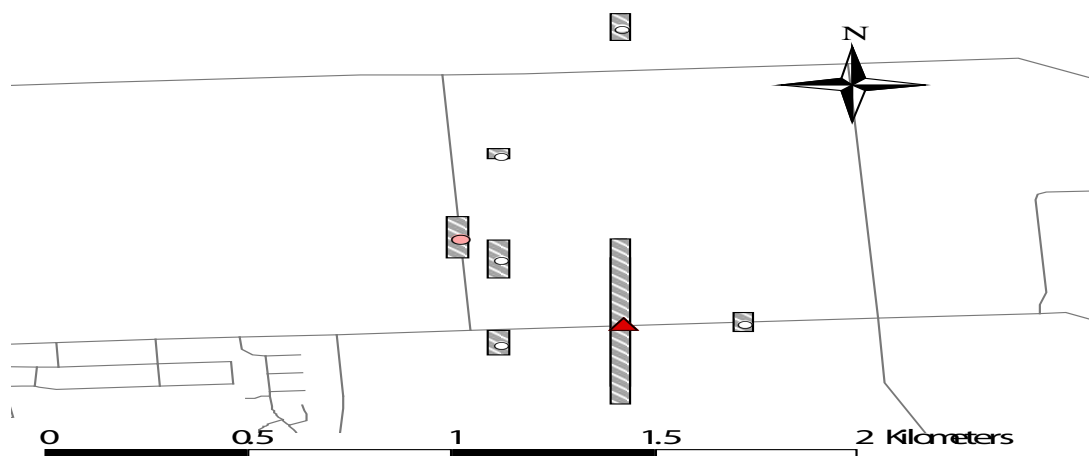
Figure 2.6: Spatial distribution of nitrate in wells sampled near Bainfield Road

High nitrate in the Bainfield Road well (Table 2.6) may be caused by nitrate leaching from a nearby shearing shed or from a septic tank outfall. The well was only a few metres from a shearing shed and less than 40 metres from a septic tank disposal area; one or both of these sources may be responsible for elevated nitrate in the well water.

Nitrate contamination is not widespread in the Bainfield Road area (see Table 2.6 and Fig 2.6). Elevated nitrate is likely to be limited to areas close to sources of contamination.

Nitrate is likely to remain high in this well while it is located near two potential sources of contamination.

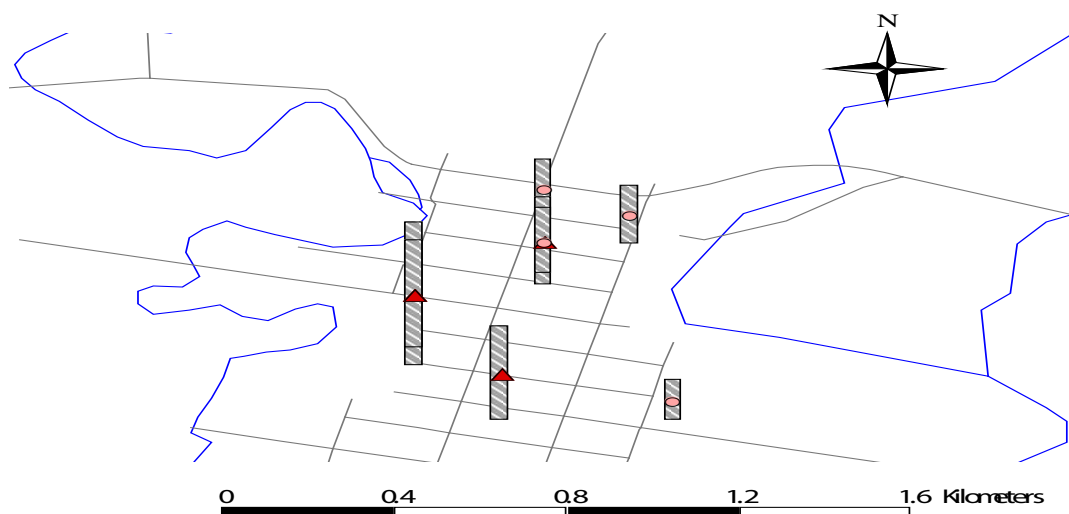
Figure 2.7: Spatial distribution of nitrate in wells sampled at Wallacetown

Two wells were found to have elevated nitrate in Wallacetown and further sampling in 1998 found a third well with groundwater nitrate exceeding the MAV (Table 2.7). In each case elevated nitrate has probably resulted for close proximity to septic tank disposal fields.

Nitrate contamination is widespread in the shallow aquifer below Wallacetown (see Table 2.7 and Fig 2.7). Elevated nitrate was found in three of the four wells sampled in the town. The contamination probably derives from the high density of septic tank disposal fields in the township.

The shallow groundwater aquifer below Wallacetown will probably continue to have elevated nitrate while the household effluent is sent to existing septic tanks.

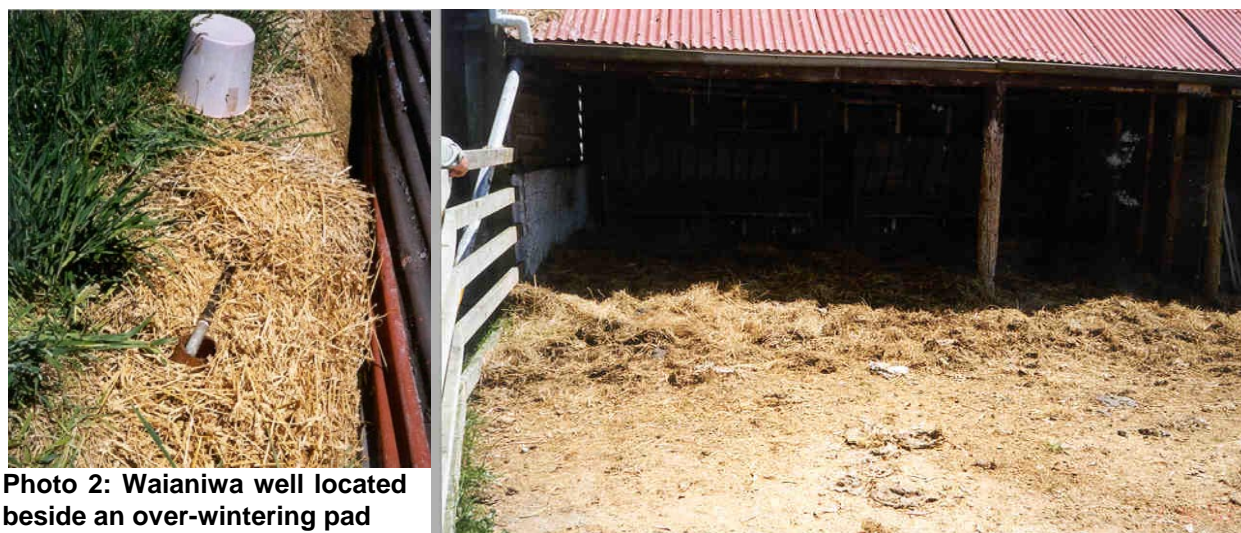
Photo 2: Waianiwa well located beside an over-wintering pad

High nitrate in the Waianiwa well (Table 2.8) was probably a result of nitrate leaching from an over-wintering pad. The well was located approximately 6 metres from cattle over-wintering pad. Most of this pad was open to the weather and cracks in the concrete would allow leaching of nitrate to the groundwater (see photo 2).

Water quality in this well may improve if the over-wintering pad was shifted away from the well. However an improvement would not occur immediately because of residual high nitrate in the surrounding land.

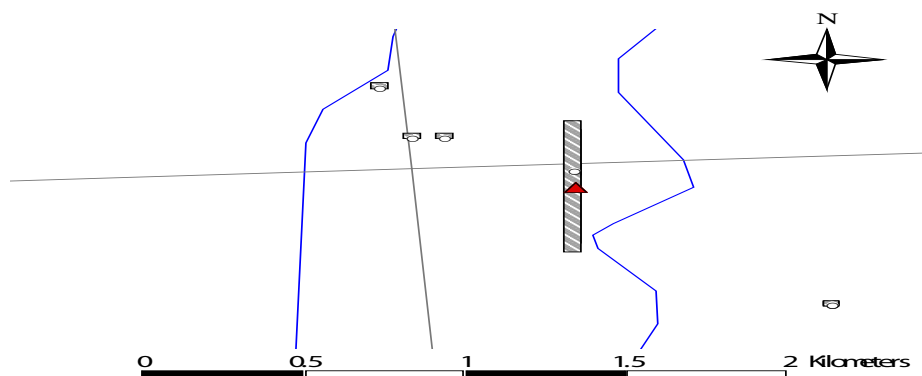
Figure 2.9: Spatial distribution of nitrate in wells sampled around Gap Road

High nitrate in the Gap Road well (Table 2.9) was probably caused by local contamination from a shearing shed. The well was less than 5 metres from the shed and yards, and rain could leach nitrate from these areas to the shallow groundwater (< 2 metres deep).

The wellhead was also poorly protected. Sheep faeces covered the wellhead and the concrete lid did not prevent water entering the well.

Elevated nitrate of the Gap Road well is probably localised. Other wells on Gap Road (and even within 100 metres of the contaminated well) had very low nitrate concentrations (see Table 2.9 and Fig 2.9). However, the low nitrate in this area probably reflects the high iron levels rather than a lack of contamination.

The water quality from this well may improve by protecting the wellhead. However leaching from the sheep yards has probably elevated groundwater nitrate locally. The well is poorly located in respect to this source of contamination.

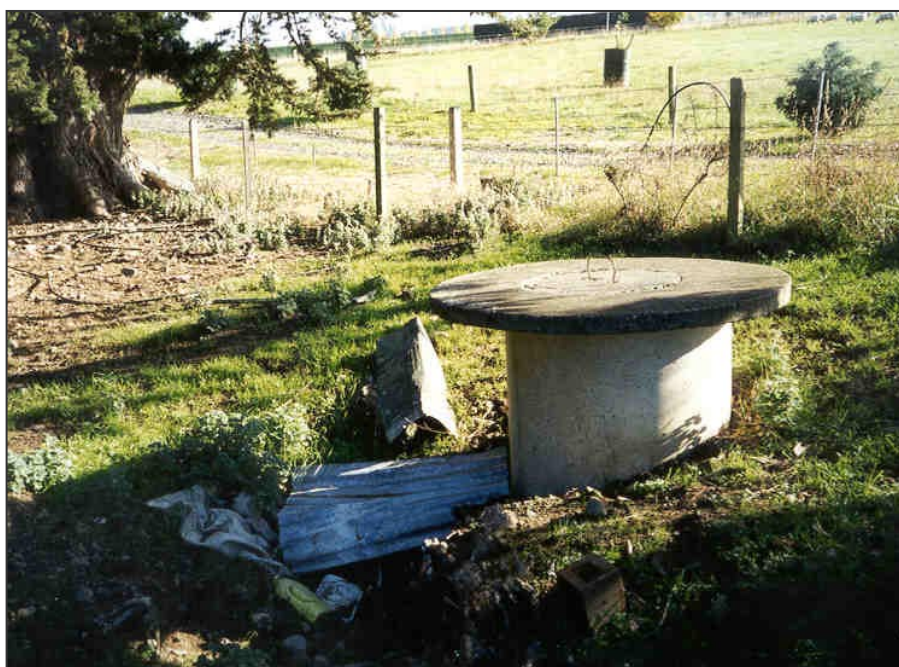
Photo 3: A well at Aparima where high nitrate has been recorded

Re-sampling of the Aparima well in 1999 found that the nitrate no longer exceeded the MAV (Table 2.11). The well has relatively poor wellhead protection, which may have resulted in temporary high nitrate levels in 1998.

This aquifer has an average nitrate concentration. However, poor wellhead protection and septic tank disposal areas appear to have contaminated some wells in the area (see Photo 3).

Better wellhead protection and fencing stock away from the well would help ensure a consistently good groundwater supply.
