Investigation of cracking soils: Heddon Bush, January 2018.
Michael Killick, Technical Specialist (Soils and Groundwater Quantity)

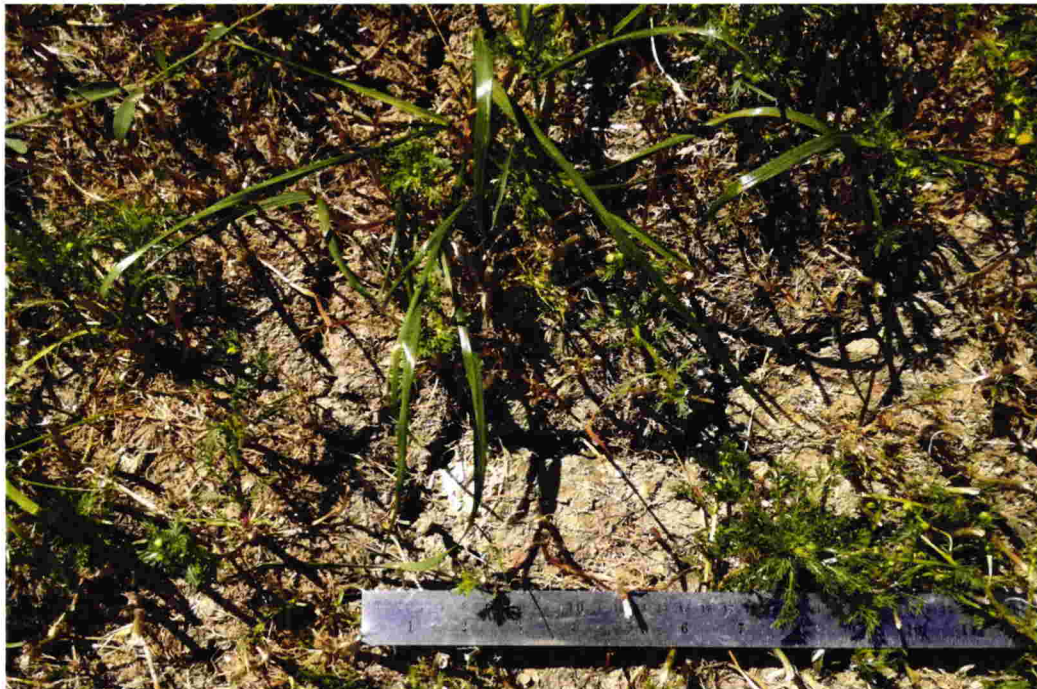
On January 30, 2018, I visited dairy farms of the Woldwide group with the owner, Abe de Wolde, in the area of Heddon Bush, to see if we could observe soil cracking as is described for the Central Plains physiographic unit. We looked at a paddock ('Site 1') on the corner of Hundred Line Road and Drummond Heddon Bush Road which in the Topoclimate survey is mapped as Braxton + Pukemutu soils. There were noticeable cracks in the soil at this site, 3-10mm wide, less than 150mm long, 5-10m apart. It was not clear how many cracks might be hidden by pasture, but there were areas of sparse pasture which had no cracks.

Figure 1. Cracked soil at Site 1.

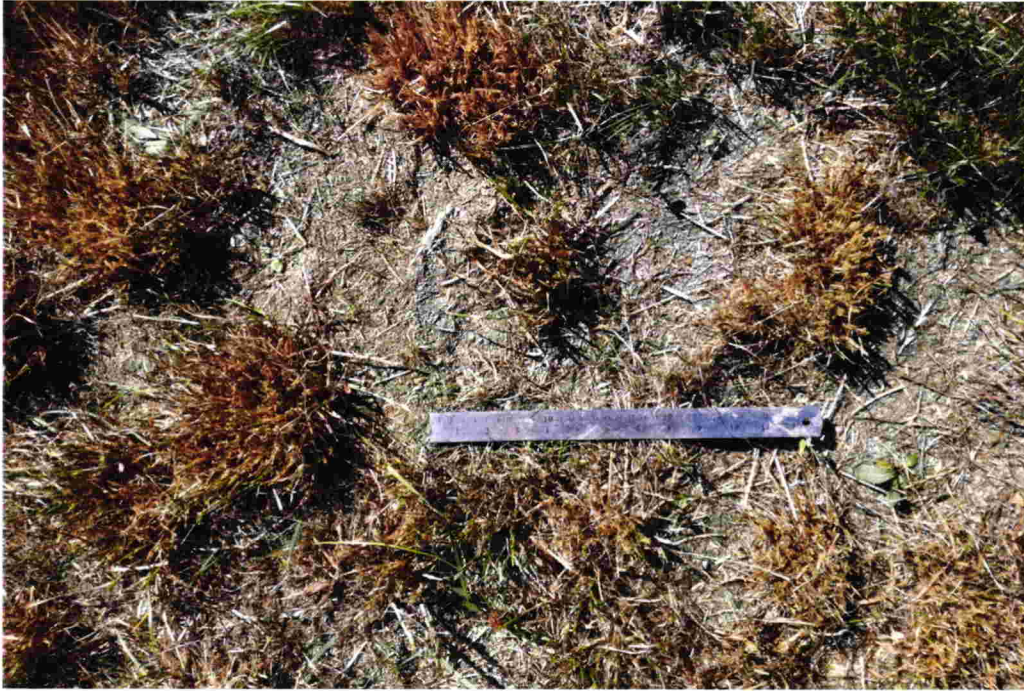
Figure 2. Uncracked soil at Site 1.

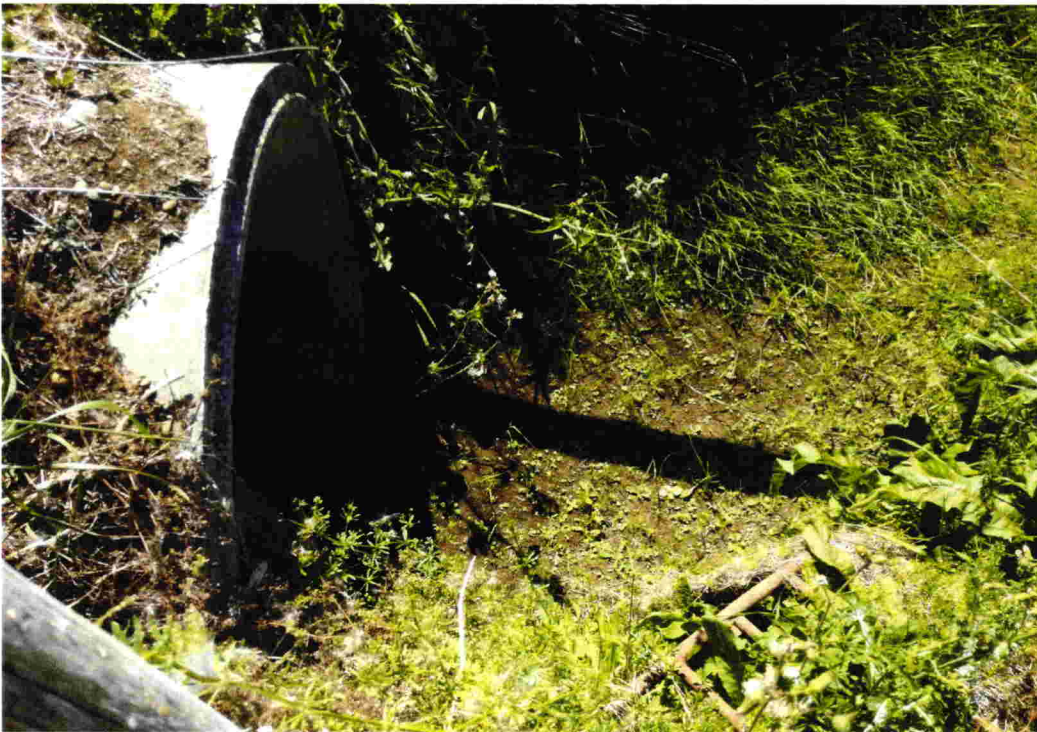
A shallow hole (~15cm deep) at the site showed the soil was friable with many small to medium well-formed peds. A creek on the west side of the paddock which is a small tributary of Middle Creek was dry at the culvert where the bed was a metre or so below ground level. Site 1 was described by Abe as wet in winter with areas of standing water, the effects of which could still be observed in the dry conditions of our visit (re-sowing with new pasture had been prevented in one place due to previous muddy conditions). See figures 1-5.

Figure 3. Creek bed at Site 1.

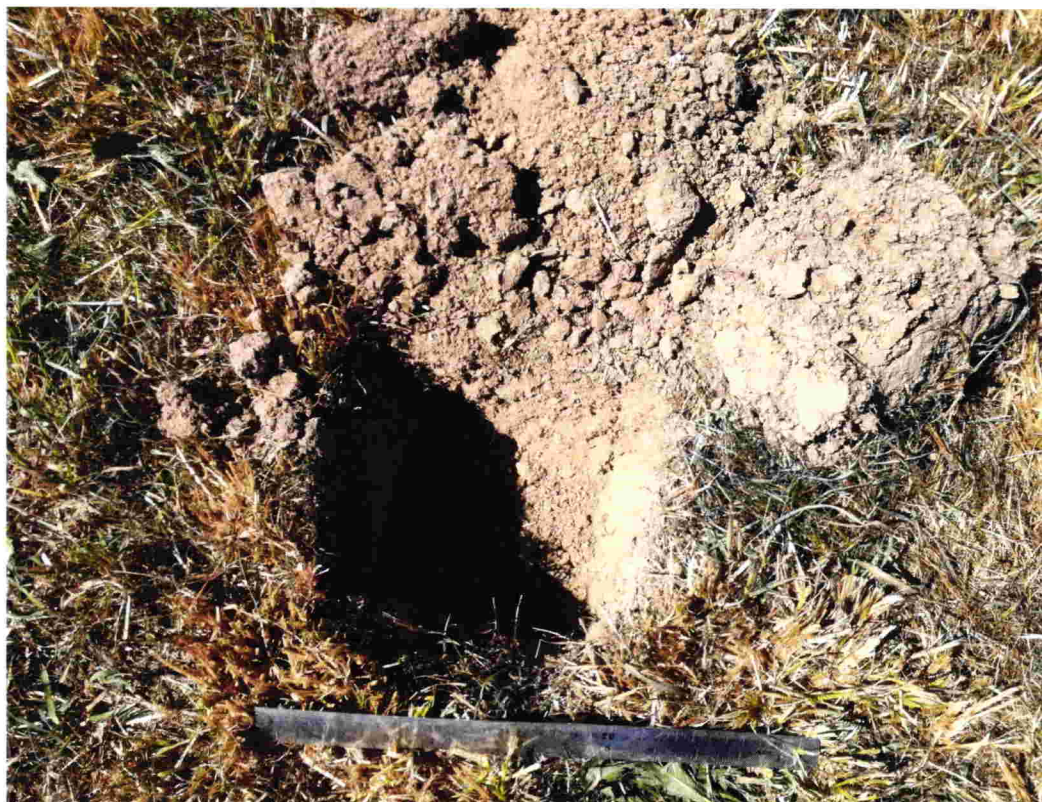
Figure 5. Soil at Site 1.

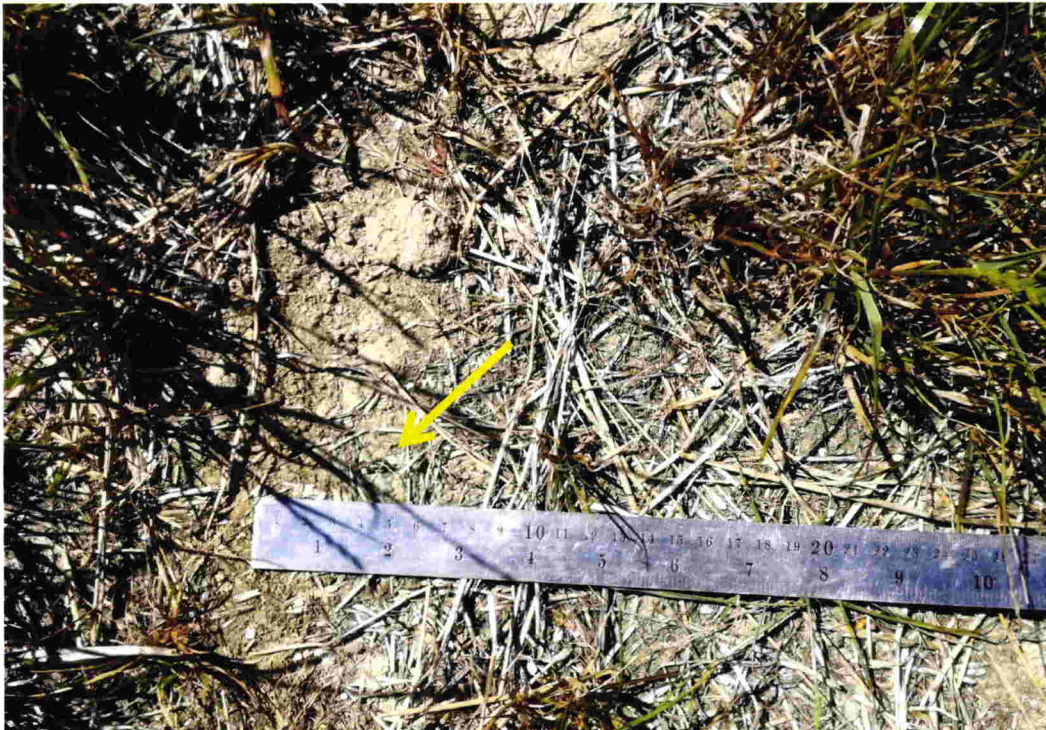
We walked a transect of approximately 50m at a third site ('Site 3', Figure 7) mapped as Glenelg + Drummond soils (close to the boundary of Braxton + Pukemutu soils). Cracks in this soil were observed at a density of at least one in the region of each stride i.e. $1/m^2$. The cracks were smaller than at Site 1, 2-4mm wide and less than 100mm long (see Figure 6). A hole dug to about 15cm depth at this site brought up two large stones (~90mm) and a number of small stones. A steel ruler was inserted easily into a crack to a depth of ~20cm, but could be inserted with similar ease to similar depth in soil without cracks at the site. (The depth of the cracks could not otherwise be ascertained as it was not visible from the surface and the soil structure and cracks collapsed easily with digging.)

Figure 6. Cracking at Site 3. These cracks do not show up well in the photo because of their smaller size and the high contrast shadows but were easily visible at the time.

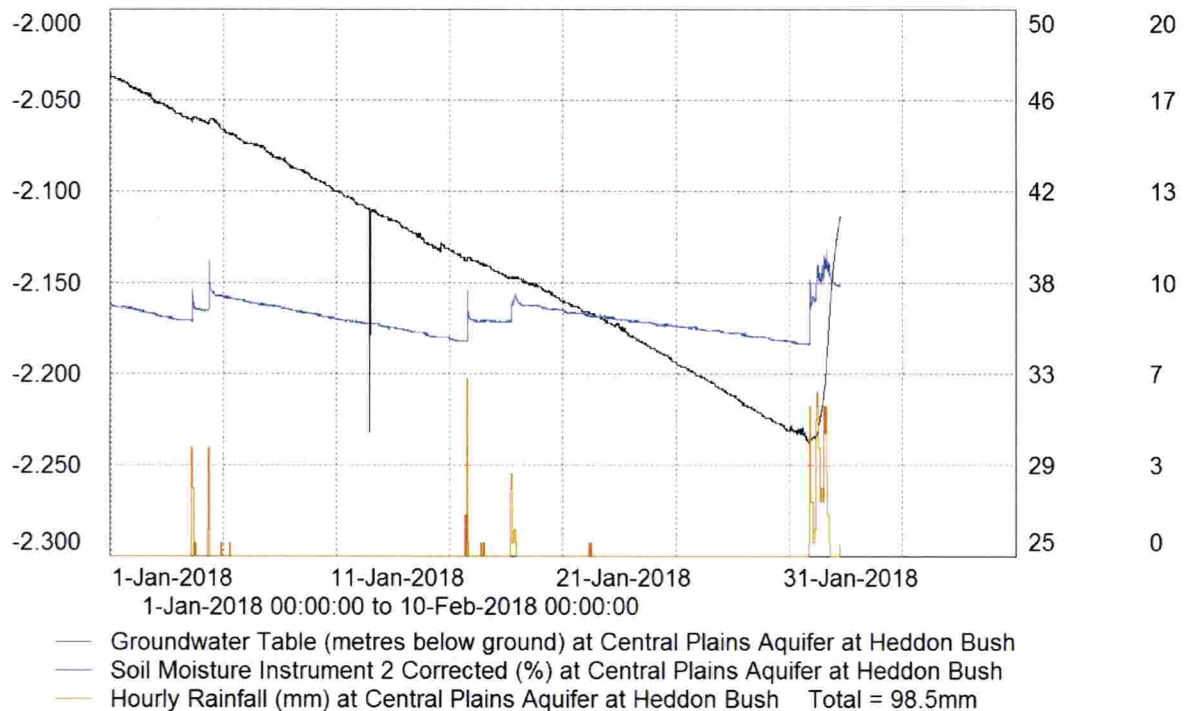
At the Environment Southland site, Central Plains Aquifer at Heddon Bush, about 2.7 km from Site 1, rise in the groundwater level in the 6m deep bore occurred within 12 hours of the onset of rainfall. The location of this site is mapped as Braxton and Puke mutu soils but it was found at installation to be stony, so the site description was changed to Glenelg soils. Earlier, lesser rainfall events in January had little effect on groundwater level. See Figure 8.

Figure 8. Groundwater level, soil moisture and rainfall at the Environment Southland Heddon Bush monitoring site.

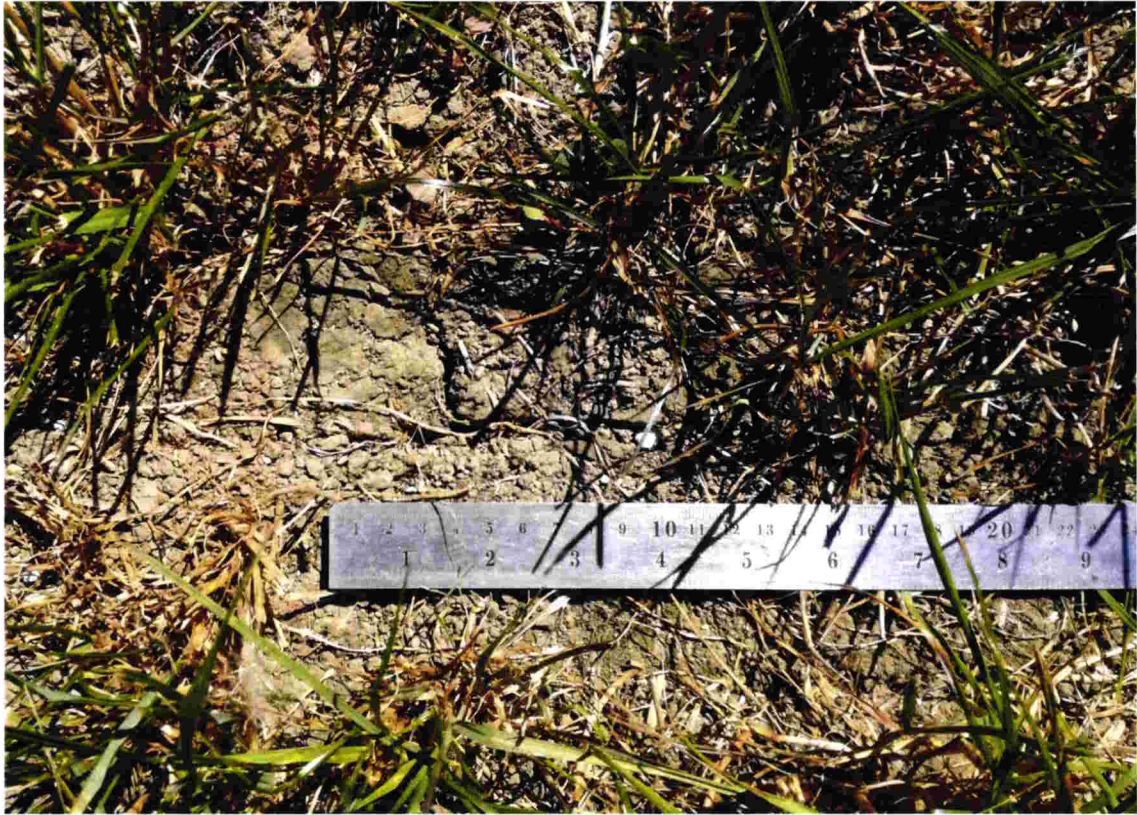
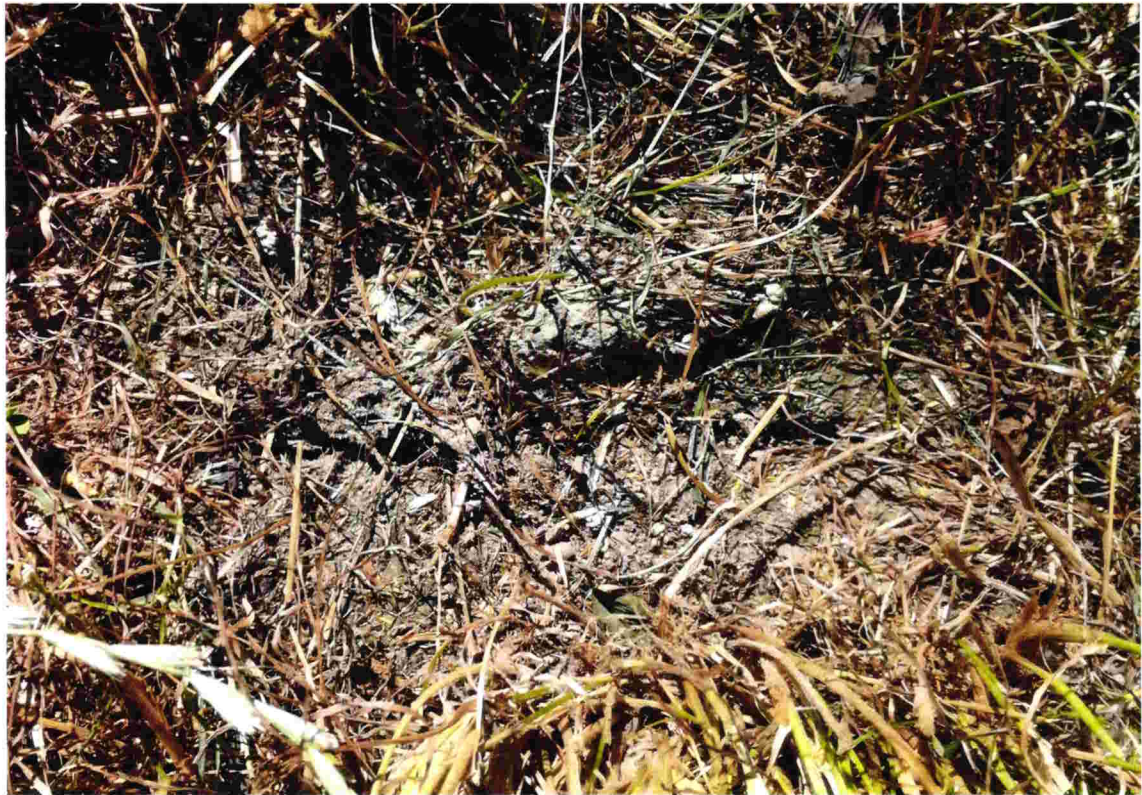
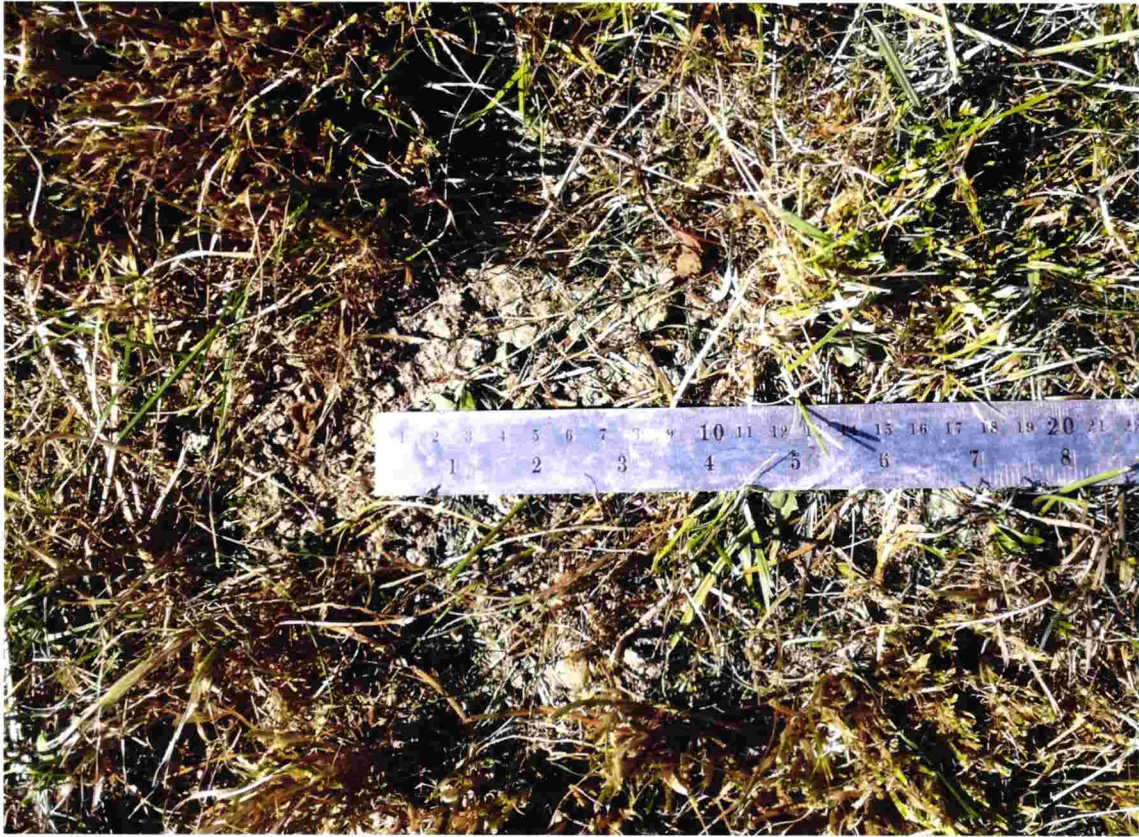
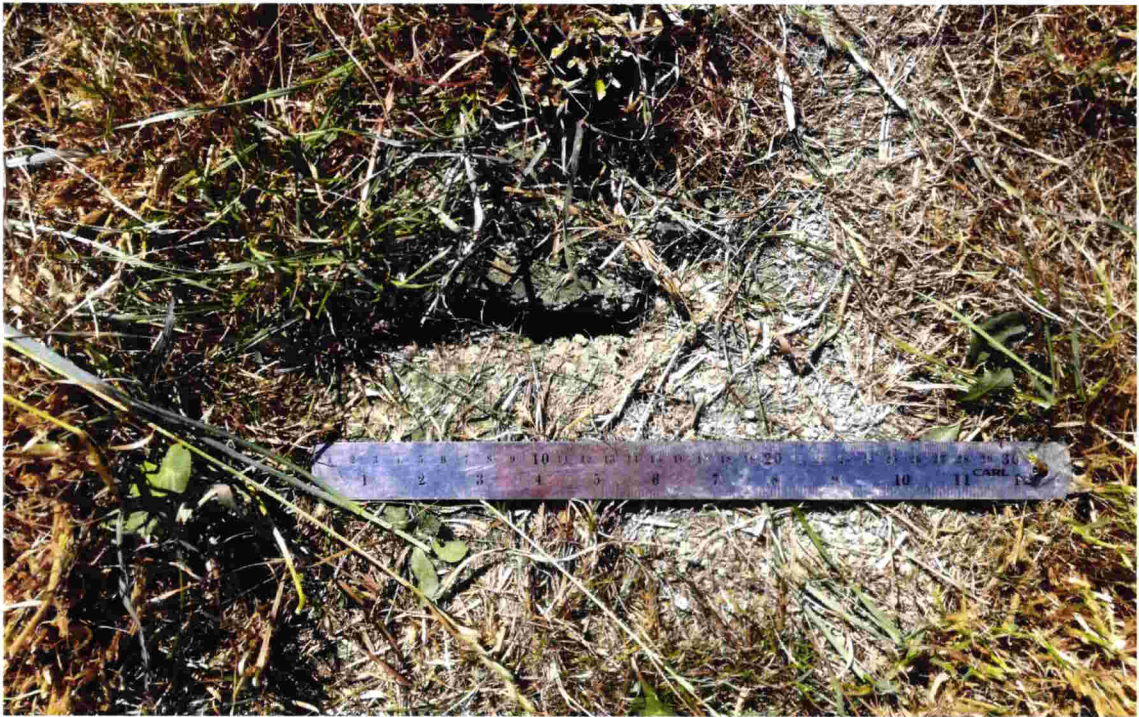
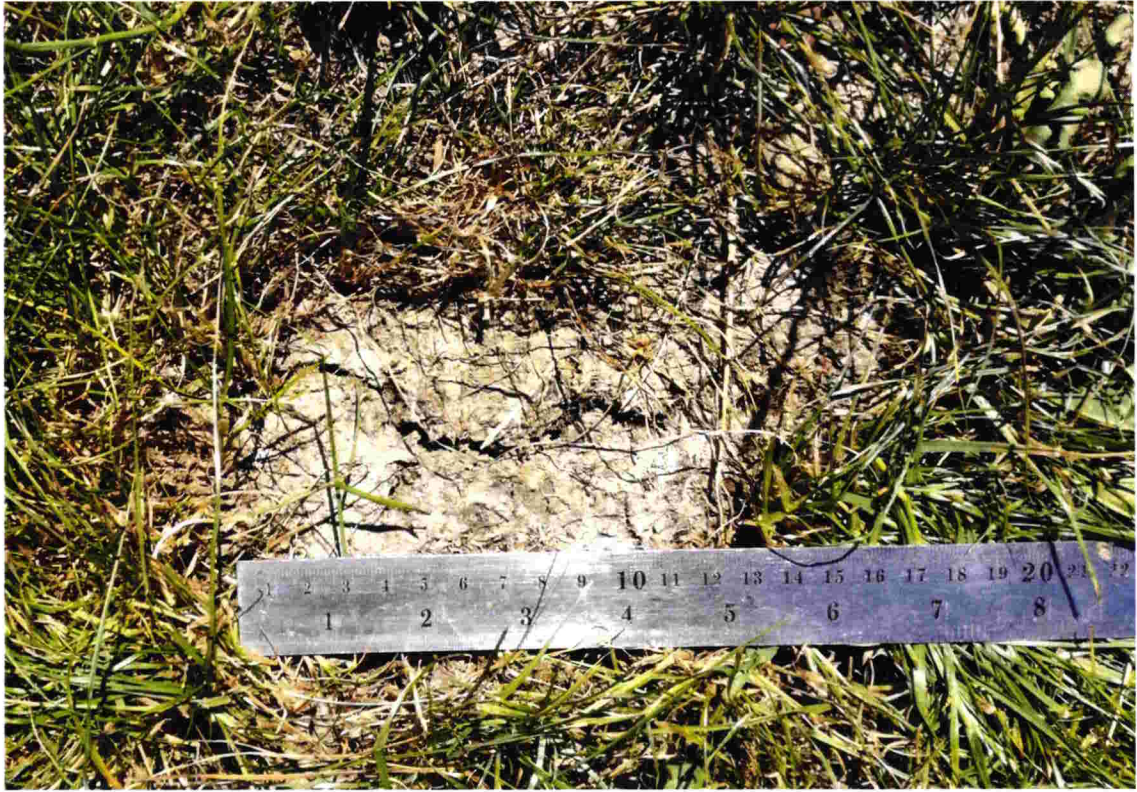
Further pictures of soil cracks follow, at the risk of emphasizing these at the expense of areas where cracks were few or absent. As there are not many pictures of the cracks, however, they are included here for interest.
