*WW1&2 consent application*

# *Appendix B*

## **Soil type assessment of soils at Woldwide 1 & 2 dairy farms**

Investigation of cracking soils: Heddon Bush, January 2018.  
Michael Killick, Technical Specialist (Soils and Groundwater Quantity)

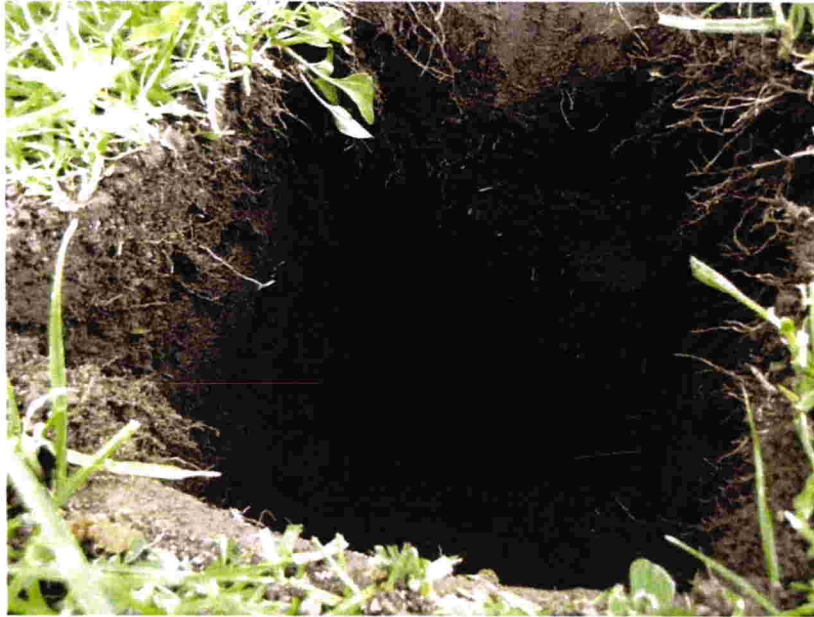
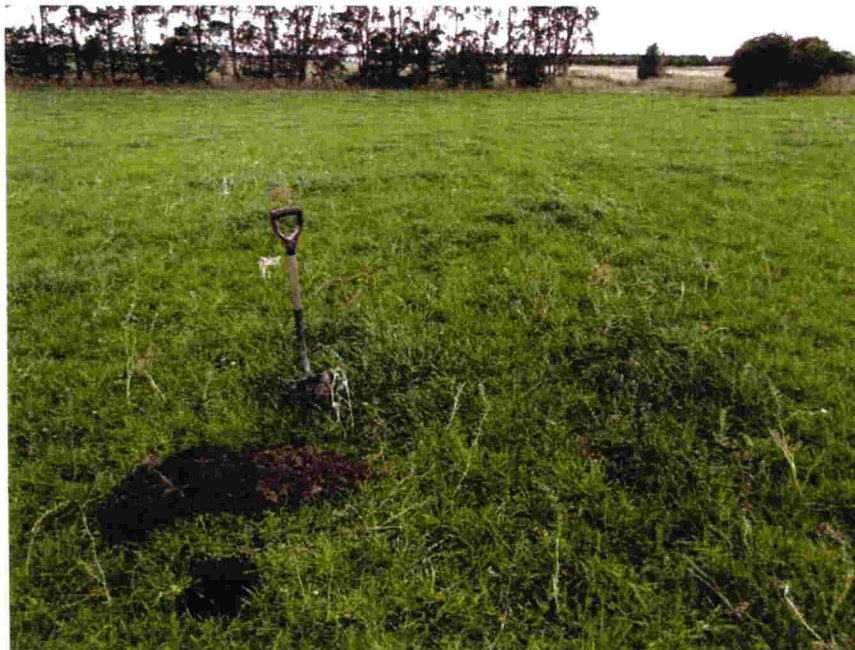
### Paddock 23

Topoclimate suggests a Glenelg soil type for this area. However, there was no stone in the topsoil and there was a well-developed subsoil. The subsoil was free draining with no mottling to the bottom of the subsoil level at 0.5 m. This profile is more characteristic of a Drummond soil type. The sample site was on a broad ridge. The paddock had recently been cultivated and the profile was reported as being uniform to plough depth across it, i.e. no stones in the topsoil.

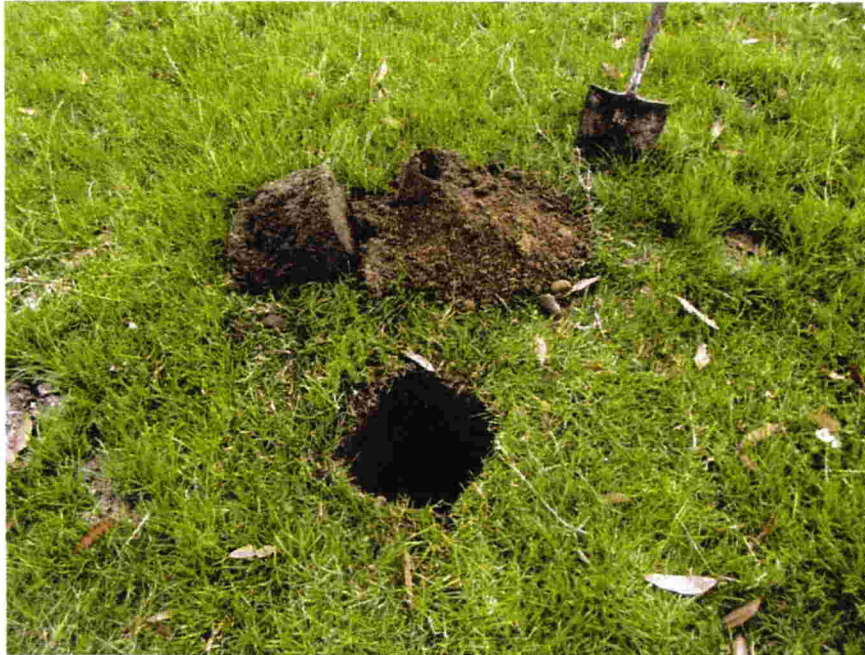
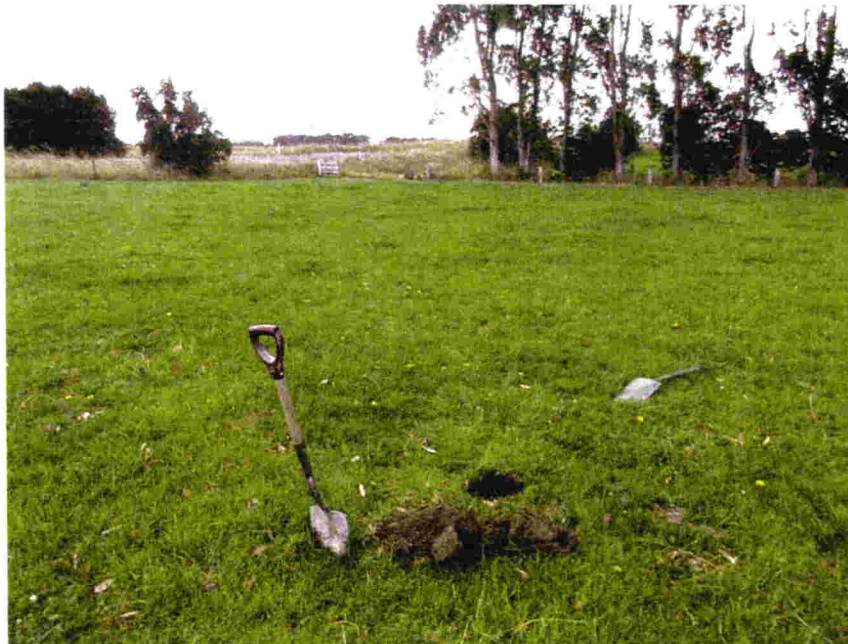
## Paddock 24

Topoclimate suggests a Braxton soil type for this paddock. There was 250 mm depth of soil overlying stone. The profile was better than a typical Glenelg soil which has stone throughout all horizons. The south west corner where this hole was dug is the lightest part of the paddock according to Mr de Wolde.

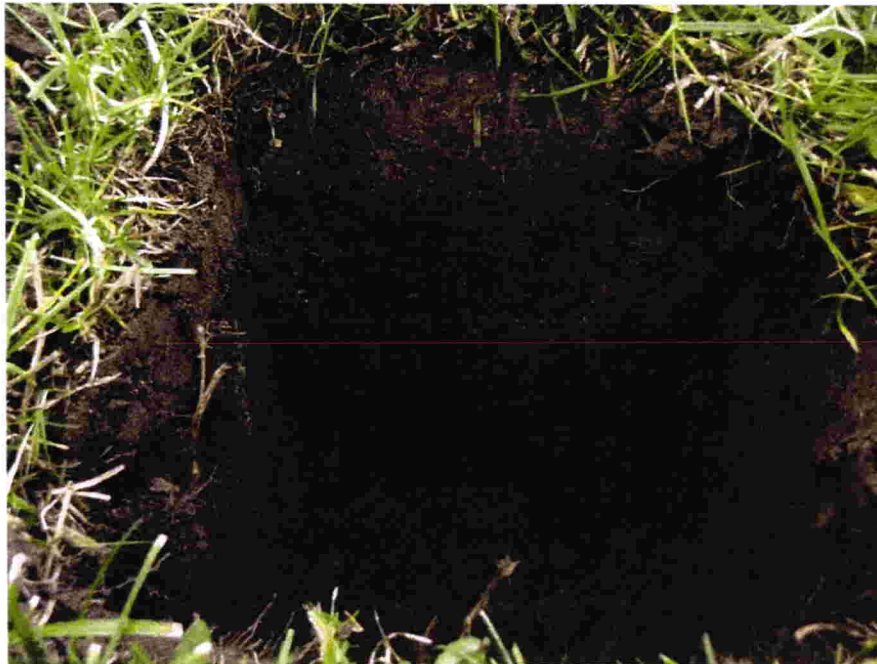
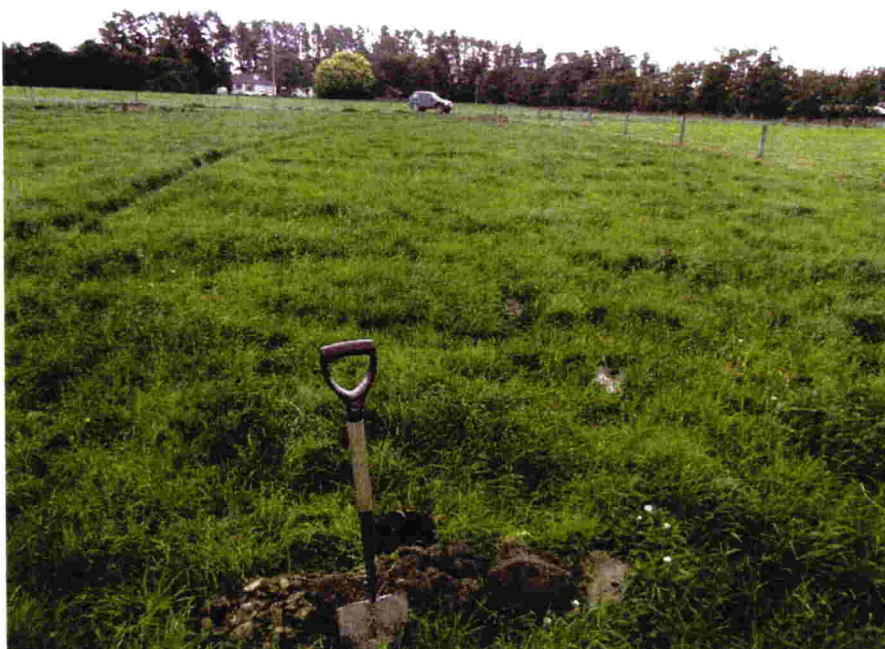
## Paddock 21

Topoclimate suggests Braxton and Pukemutu soil types cover this area. The profile was 250 mm depth of topsoil, no mottles present, well-structured, overlying a heavier textured subsoil. There were some mottles present in the subsoil and no stone with 0.5 m of the surface. This profile is tending towards the Braxton soil type. The sample site was in a slight but distinct hollow and would be expected to have a wetter profile compared to the higher adjoining ground.

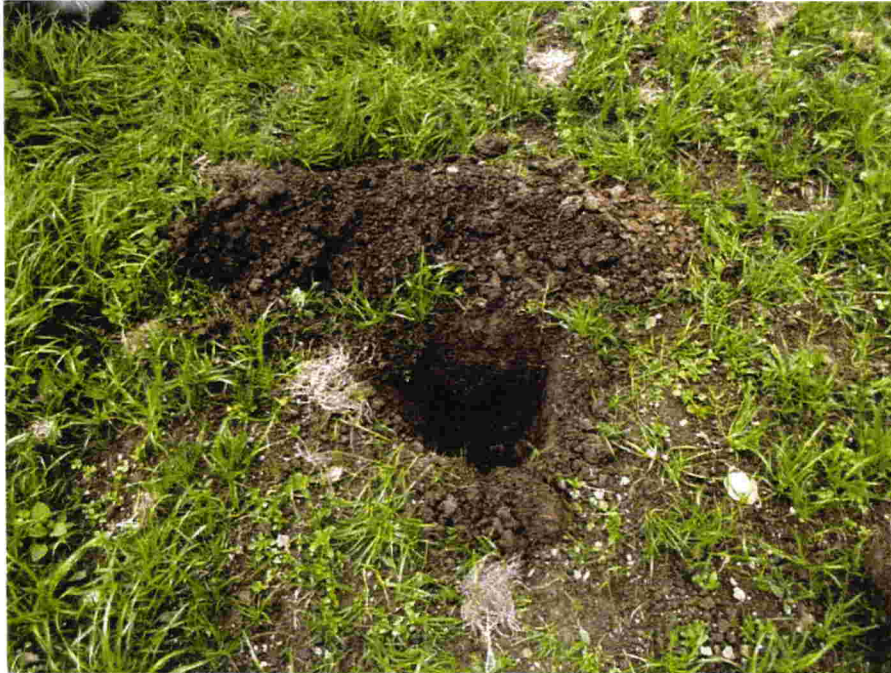
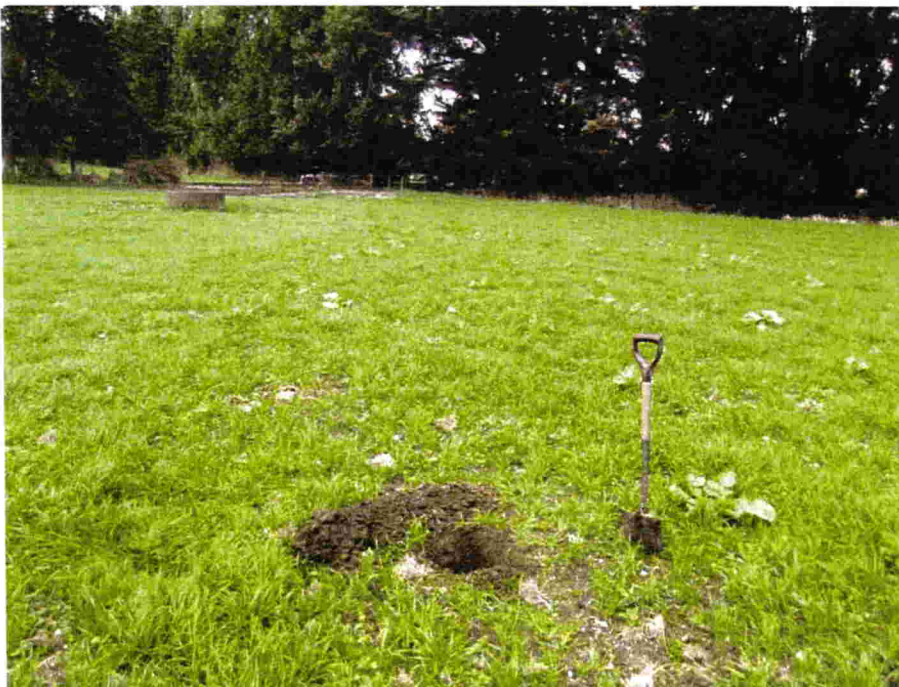
### **Paddock 7**

Topoclimate suggests Braxton and Pukemutu soil types cover this area. The topsoil depth was 200 mm, overlying a 50 mm thick intergrade layer between the topsoil and subsoil overlying a heavy and mottled subsoil. This profile showed poorer drainage than the profile in paddock 21 and is more characteristic of a Braxton soil type.

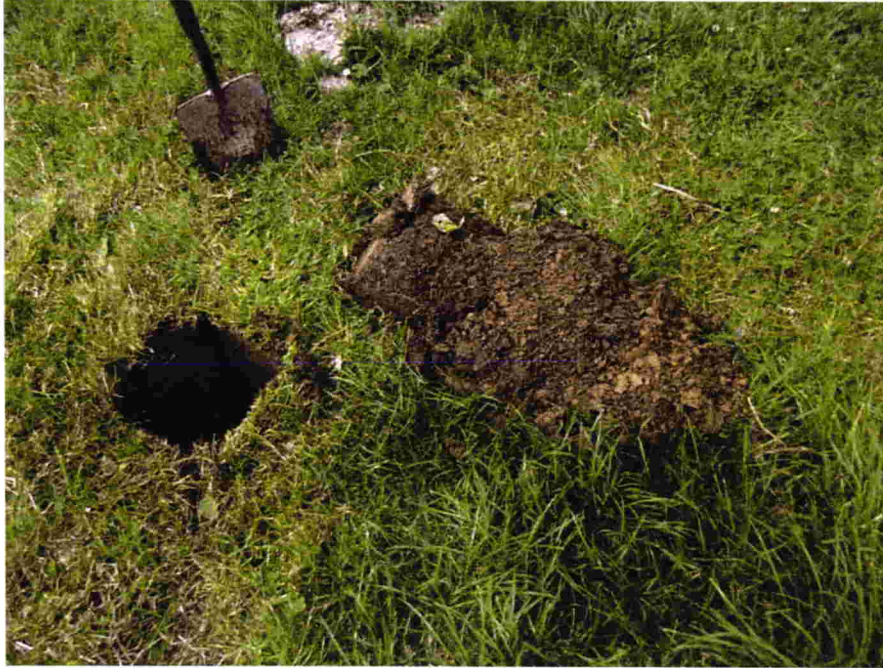
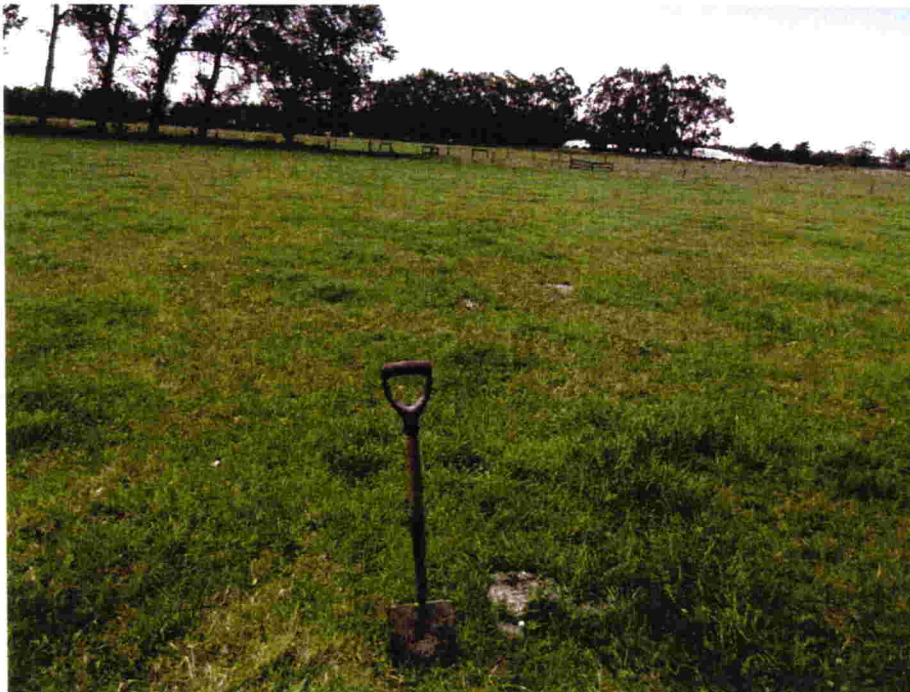
### Paddock 10

Paddock 10 had a well structured, well drained topsoil overlying a well structured subsoil with no indication of impeded drainage until 0.5 m depth where some mottles occurred. Topoclimate maps this paddock as being of the Braxton type where as it is more characteristic of the Drummond type.

Topoclimate suggests Braxton and Pukemutu soil types cover this area. The topsoil was well structured with no mottles to a depth of 250 mm, overlying a well structured subsoil. Mottles didn't occur in the subsoil until 0.5 m depth. This soil is more characteristic of the Drummond soil type.

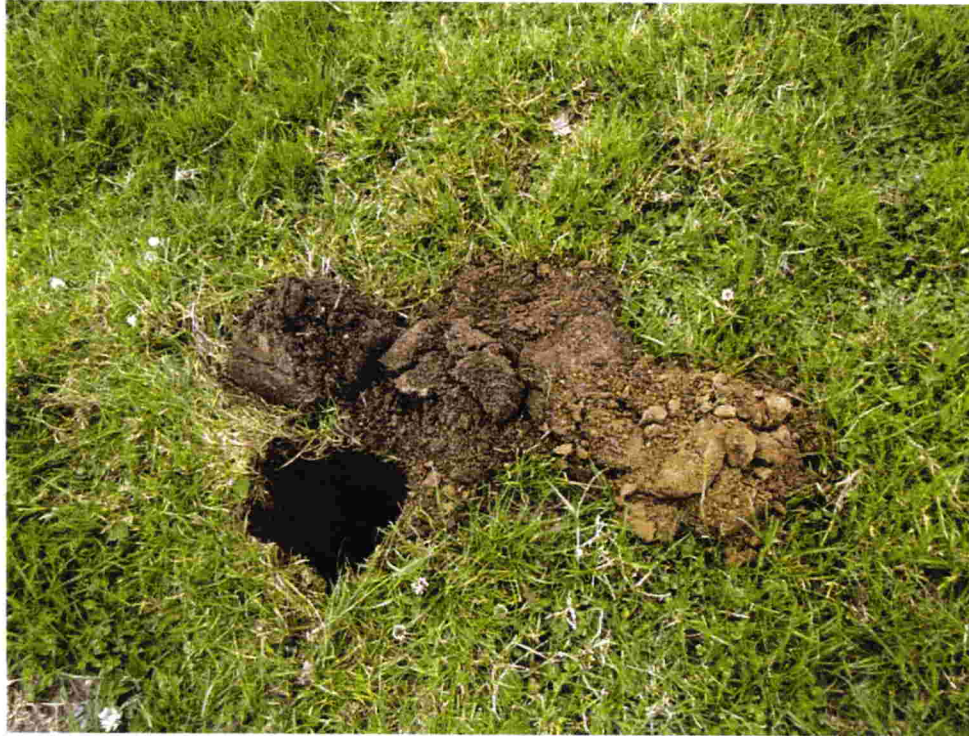
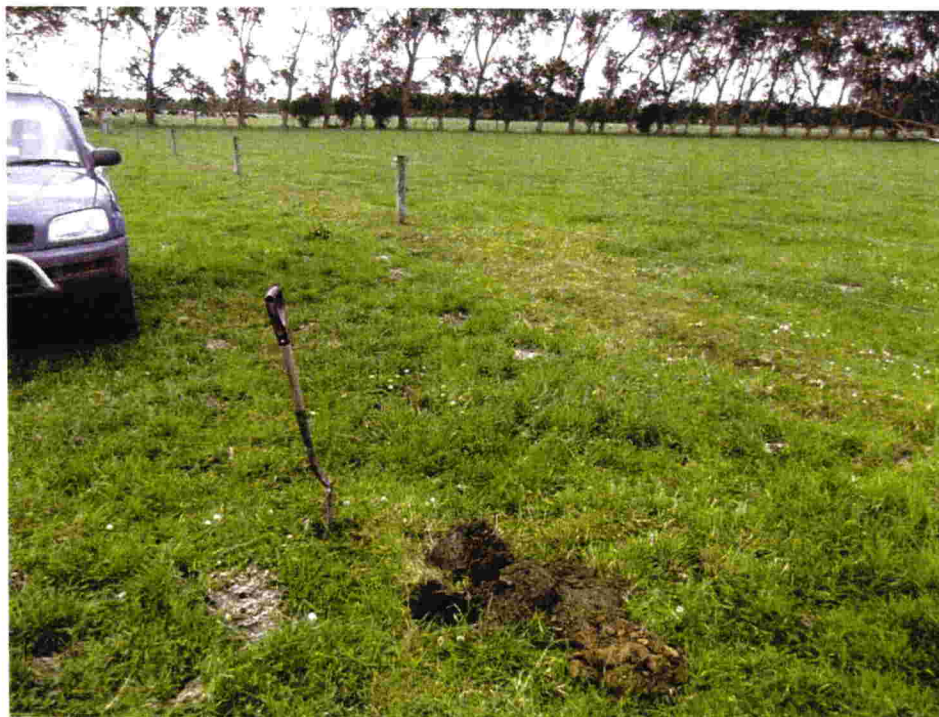
### **Paddock 8, East side**

Two paddocks to the west of paddock 10 paddock 8 had the properties of an intergrade between Drummond and Braxton soils.

Topoclimate suggests Braxton and Pukemutu soil types cover this area. The topsoil was 200 mm deep and free of mottles. The subsoil had increasing mottling with depth, and was heavily mottled at 450 mm depth. Braxton soils are mottled in all horizons, this soil was representative of an intergrade between Braxton and Drummond soils.

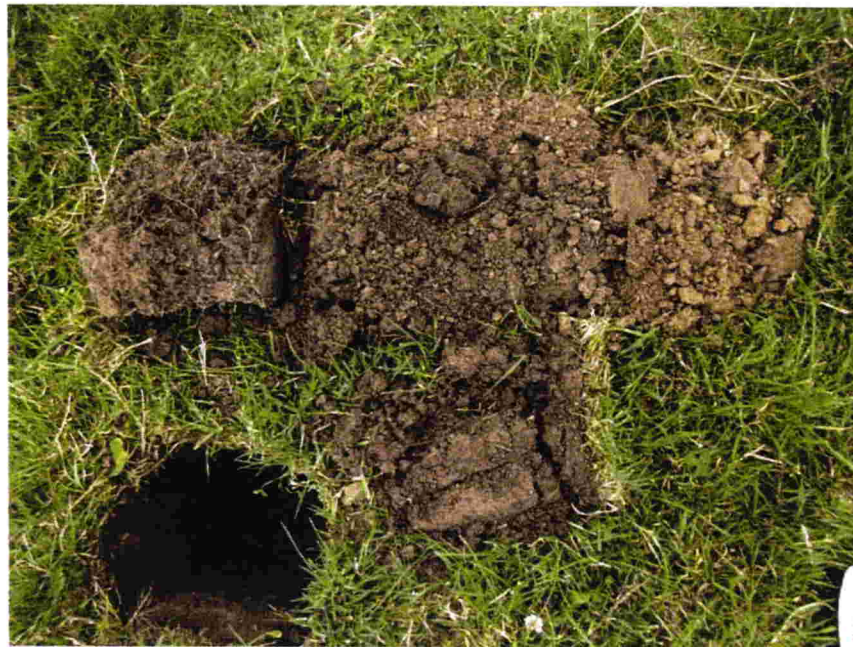
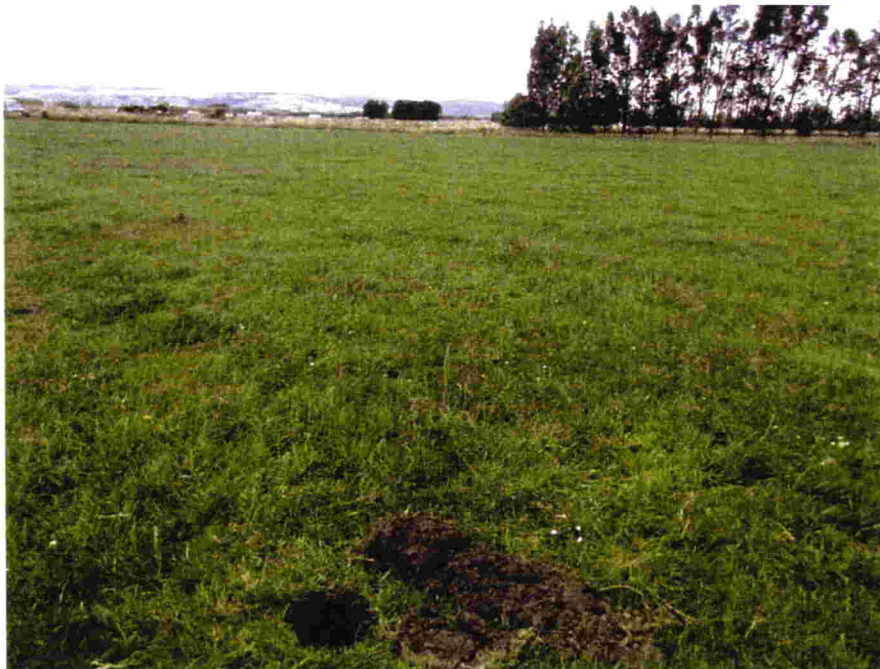
## Paddock 16

Four paddocks to the north of paddock 8 is paddock 16 which was mapped by Topoclimate as being predominantly of the Braxton soil type. Five test holes in this paddock revealed that the soil is typical of a shallow Drummond soil.

Topoclimate suggests Braxton and Pukemutu soils cover this area. Several holes were checked in this paddock. In a shallow hollow running through the paddock there was faint mottling in the topsoil tending to heavy mottling at 0.5 m deep in the subsoil. The majority of the paddock is a broad ridge with 250 mm depth of topsoil, no mottling, over a subsoil with variable stone content. Mottles were absent from the subsoil. This soil is not of the Braxton type but more like a shallow Drummond soil or Drummond Glenelg intergrade.

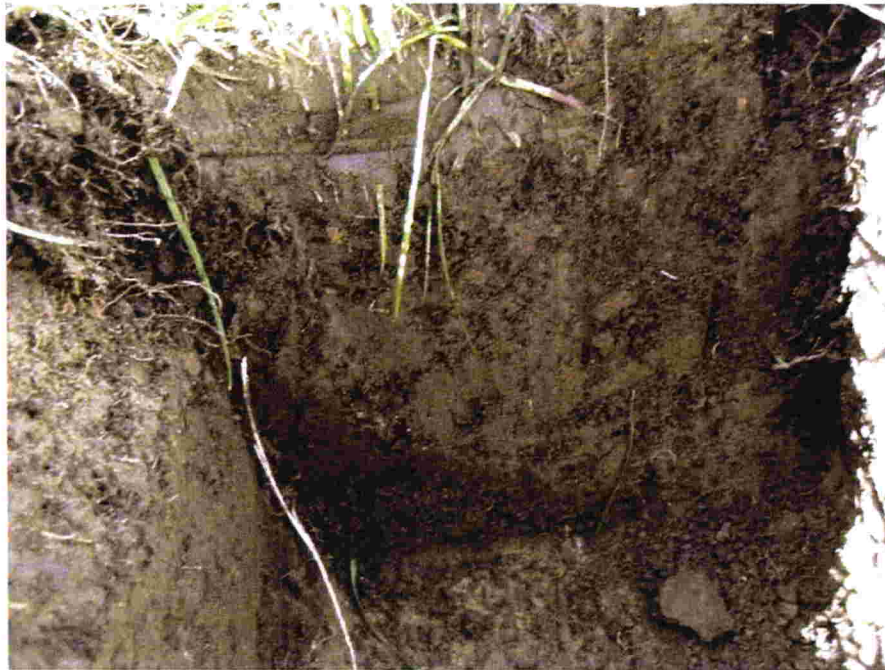
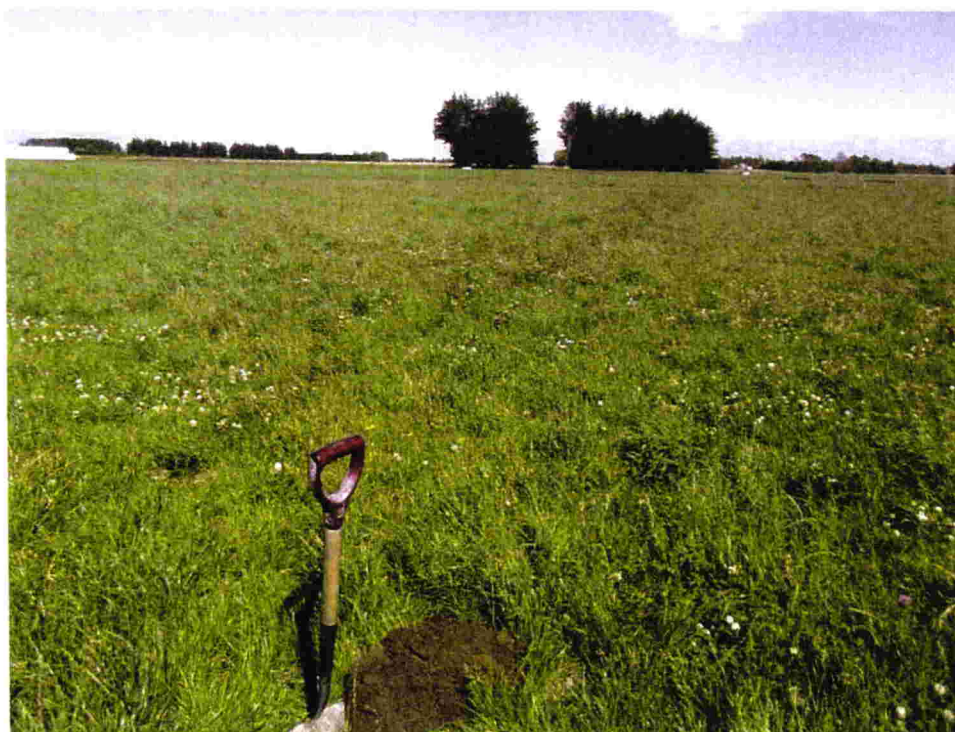
**Support Block, to be part of Woldwide Two  
Paddock SH2**

Topoclimate suggests Braxton and Pukemutu soils. This paddock has a shallow hollow running through it. In the hollow the profile was mottled in all horizons. The paddock had been used for wintering stock and was showing signs of soil compaction. The profile in this hollow was characteristic of the Braxton type. Holes either side of the hollow showed a much lighter and better drained profile.

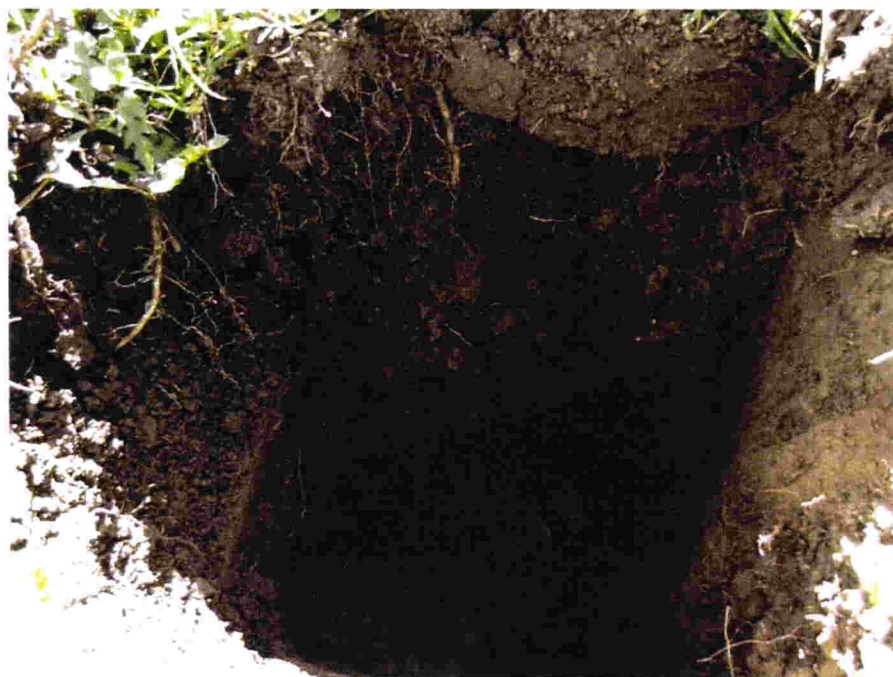
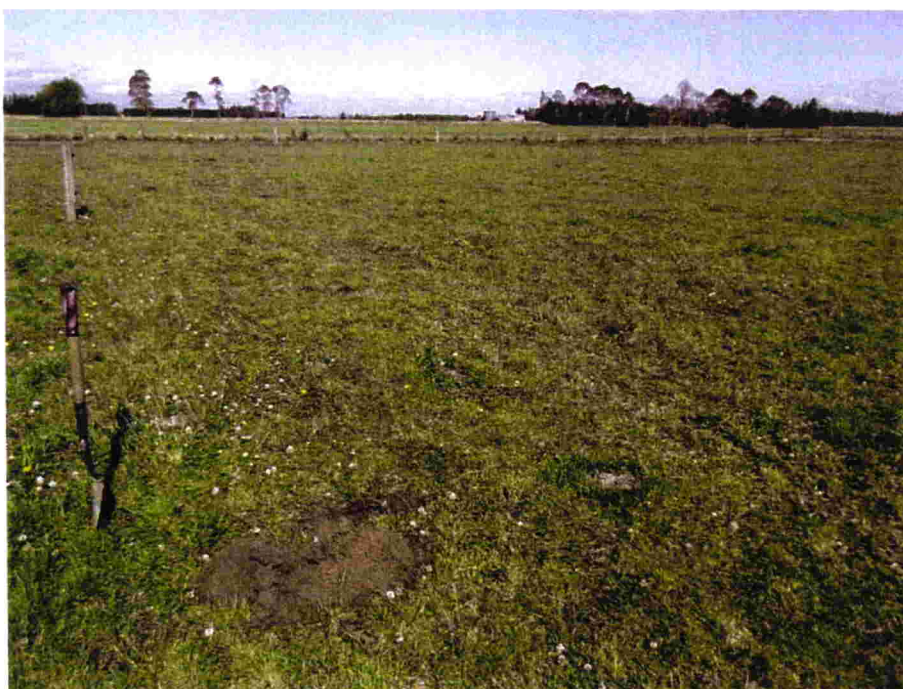
## Paddock SH1

Topoclimate suggests Braxton and Pukemutu soil types. The profile was free draining with an absence of mottles in the topsoil and subsoil. The topsoil was 250 mm deep to a stoney subsoil. This profile is similar to that observed in paddock 16 and is not of the Braxton type.

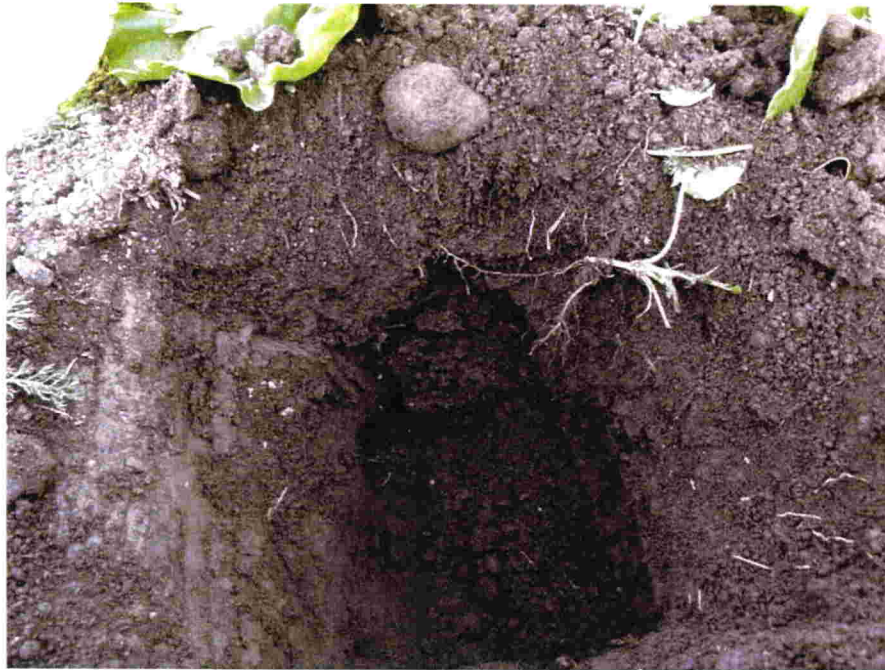
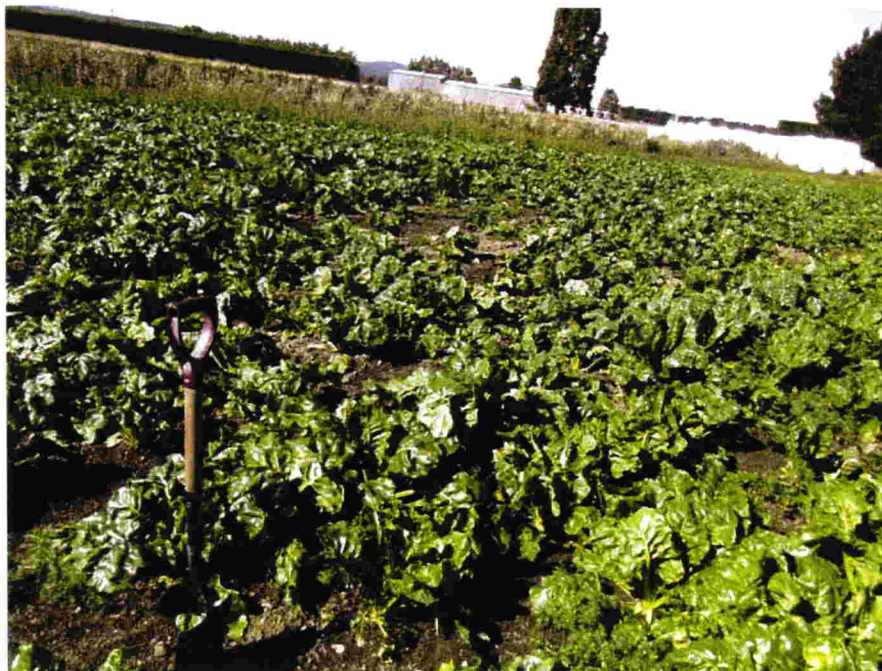
## Paddock 12

Topoclimate suggests Glenelg soils. This paddock had been cultivated and was in winter crop. The profile was stoney in all horizons, typical of the Glenelg soil type.

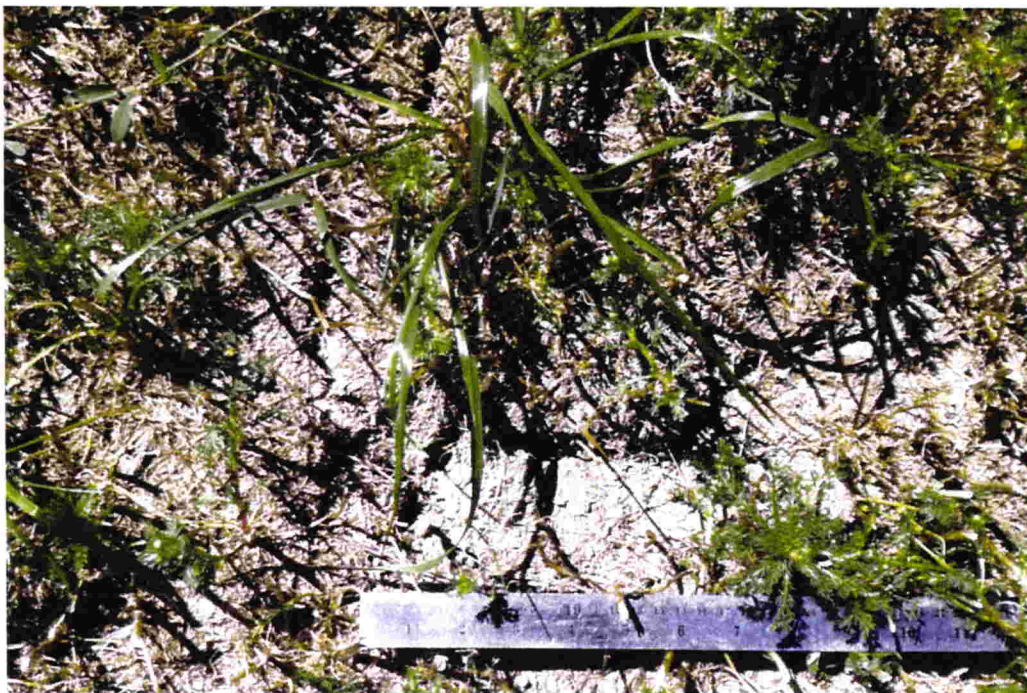
On January 30, 2018, I visited dairy farms of the Woldwide group with the owner, Abe de Wolde, in the area of Heddon Bush, to see if we could observe soil cracking as is described for the Central Plains physiographic unit. We looked at a paddock ('Site 1') on the corner of Hundred Line Road and Drummond Heddon Bush Road which in the Topoclimate survey is mapped as Braxton + Pukemutu soils. There were noticeable cracks in the soil at this site, 3-10mm wide, less than 150mm long, 5-10m apart. It was not clear how many cracks might be hidden by pasture, but there were areas of sparse pasture which had no cracks.

Figure 1. Cracked soil at Site 1.

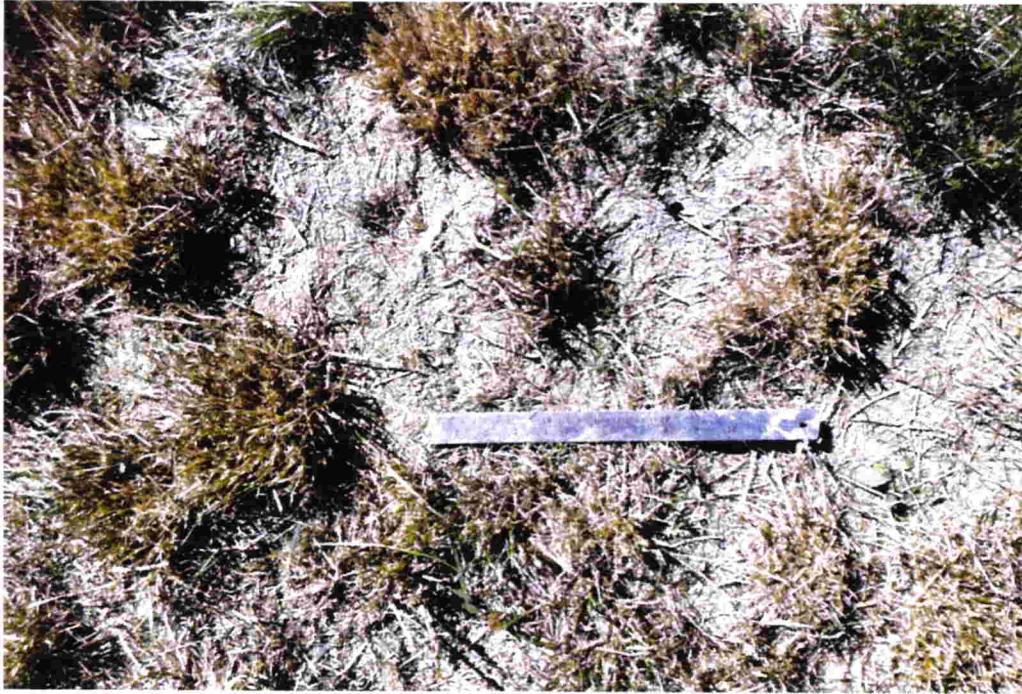
Figure 2. Uncracked soil at Site 1.

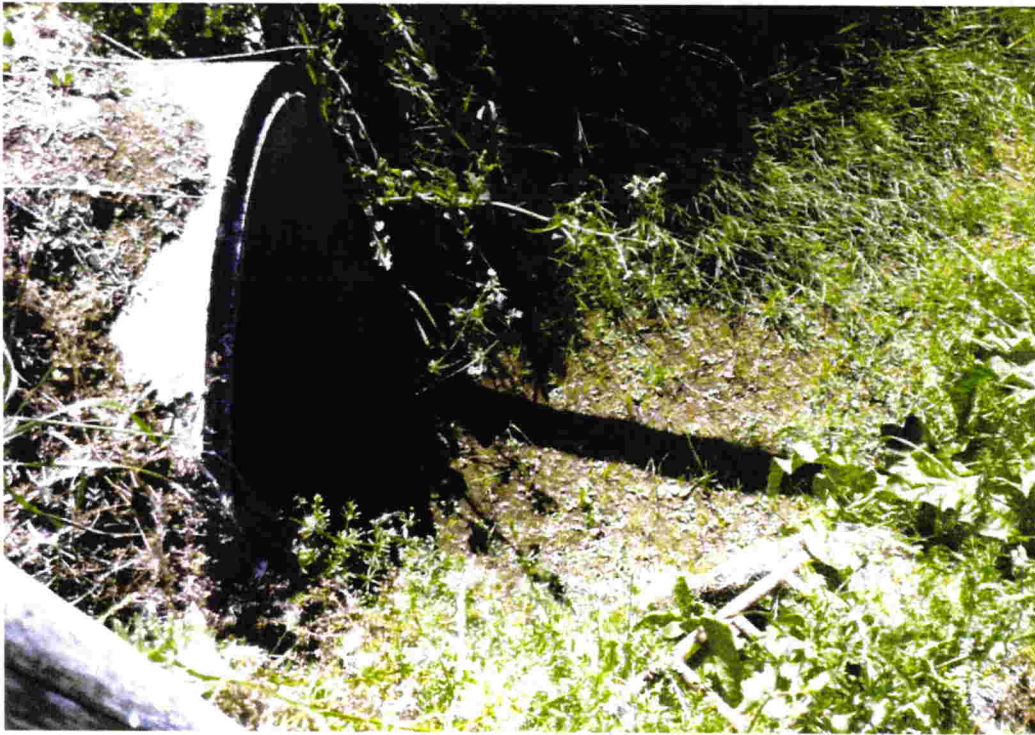
A shallow hole (~15cm deep) at the site showed the soil was friable with many small to medium well-formed peds. A creek on the west side of the paddock which is a small tributary of Middle Creek was dry at the culvert where the bed was a metre or so below ground level. Site 1 was described by Abe as wet in winter with areas of standing water, the effects of which could still be observed in the dry conditions of our visit (re-sowing with new pasture had been prevented in one place due to previous muddy conditions). See figures 1-5.

Figure 3. Creek bed at Site 1.

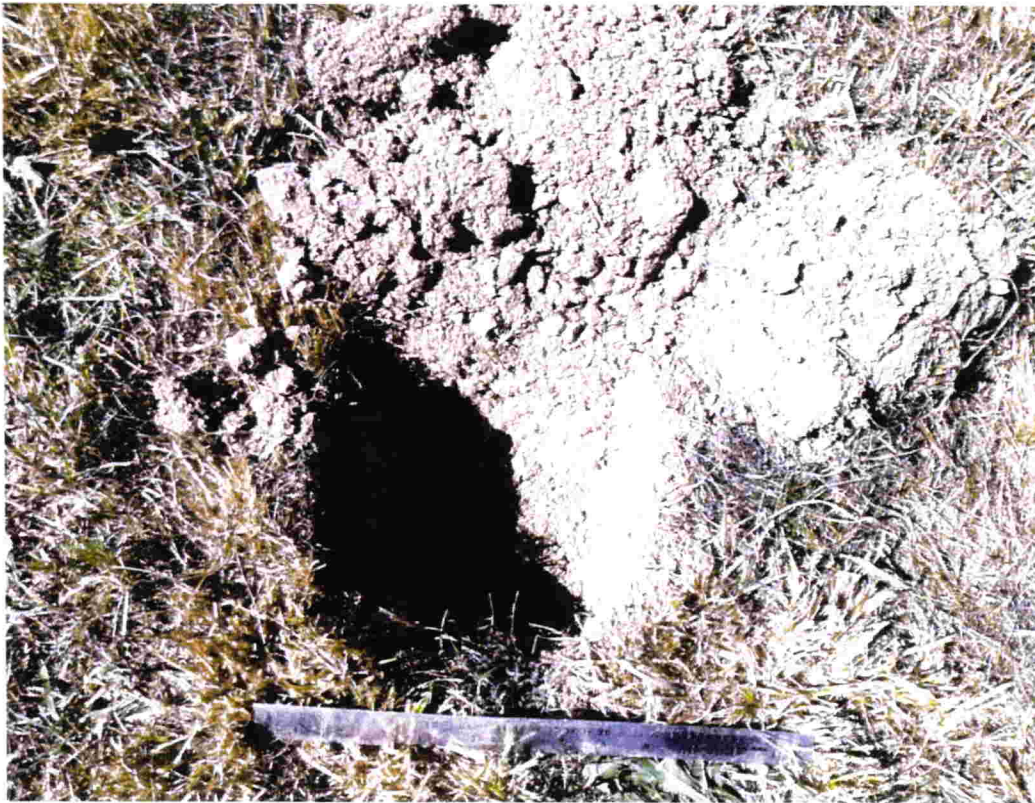
Figure 5. Soil at Site 1.

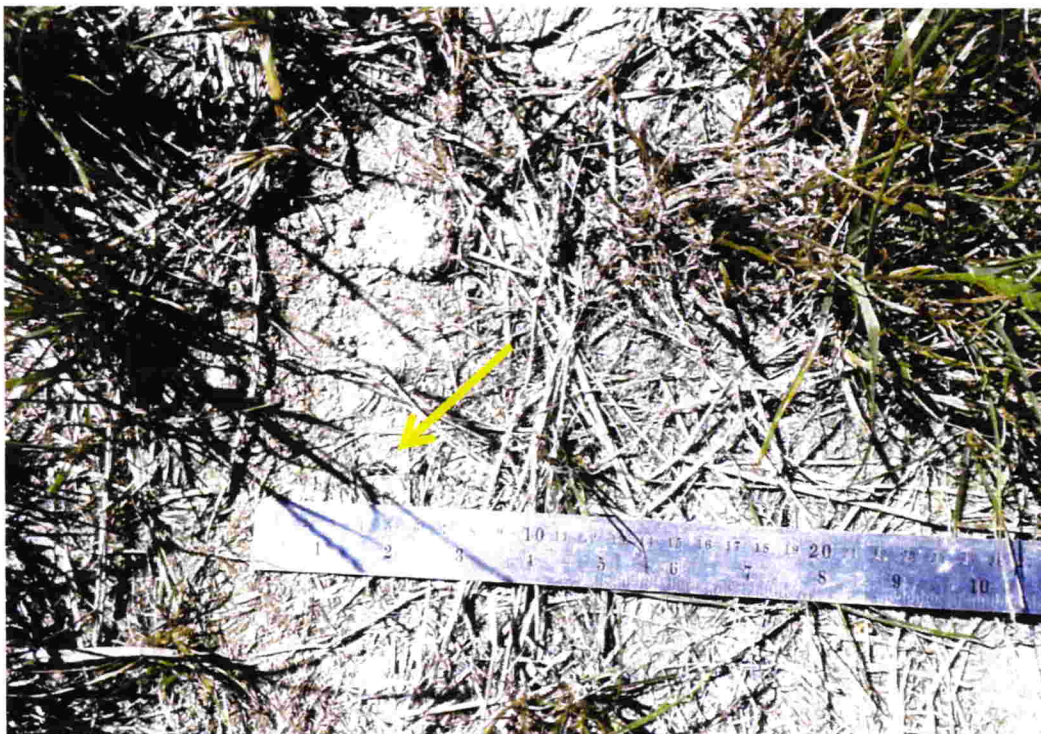
We walked a transect of approximately 50m at a third site ('Site 3', Figure 7) mapped as Glenelg + Drummond soils (close to the boundary of Braxton + Pukemutu soils). Cracks in this soil were observed at a density of at least one in the region of each stride i.e.  $1/m^2$ . The cracks were smaller than at Site 1, 2-4mm wide and less than 100mm long (see Figure 6). A hole dug to about 15cm depth at this site brought up two large stones (~90mm) and a number of small stones. A steel ruler was inserted easily into a crack to a depth of ~20cm, but could be inserted with similar ease to similar depth in soil without cracks at the site. (The depth of the cracks could not otherwise be ascertained as it was not visible from the surface and the soil structure and cracks collapsed easily with digging.)

Figure 6. Cracking at Site 3. These cracks do not show up well in the photo because of their smaller size and the high contrast shadows but were easily visible at the time.

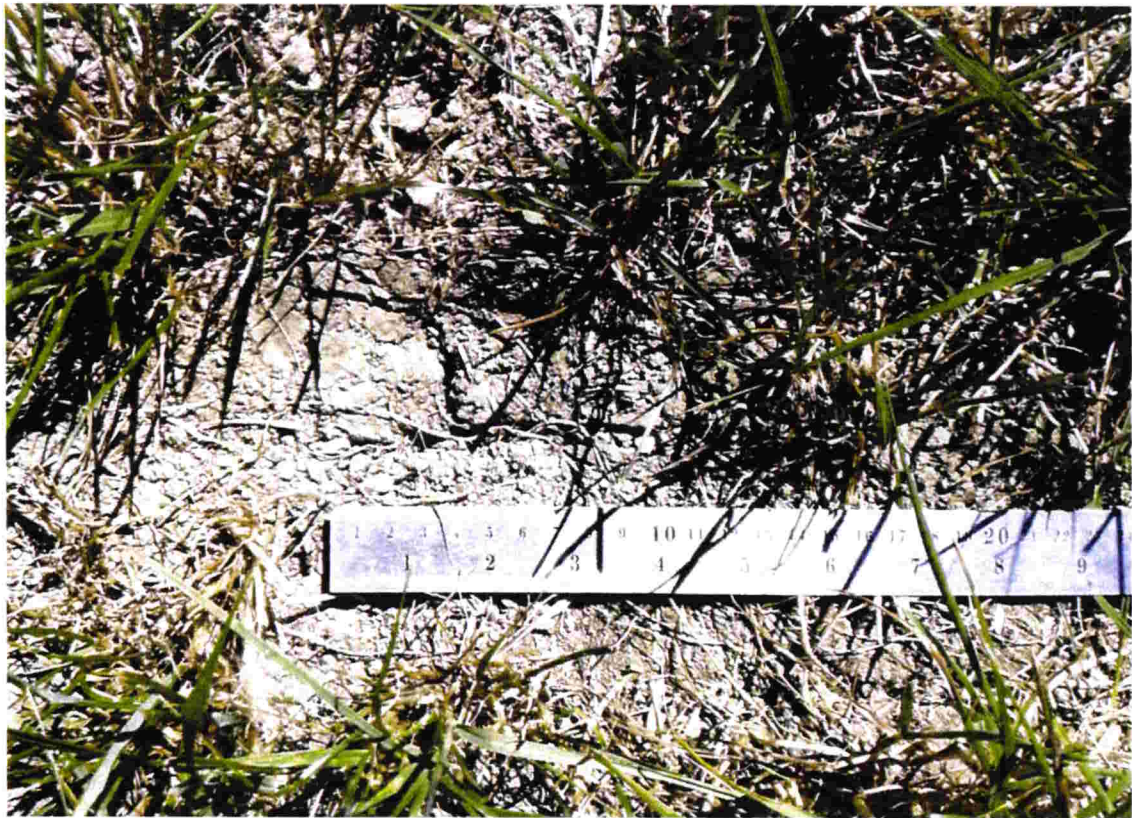
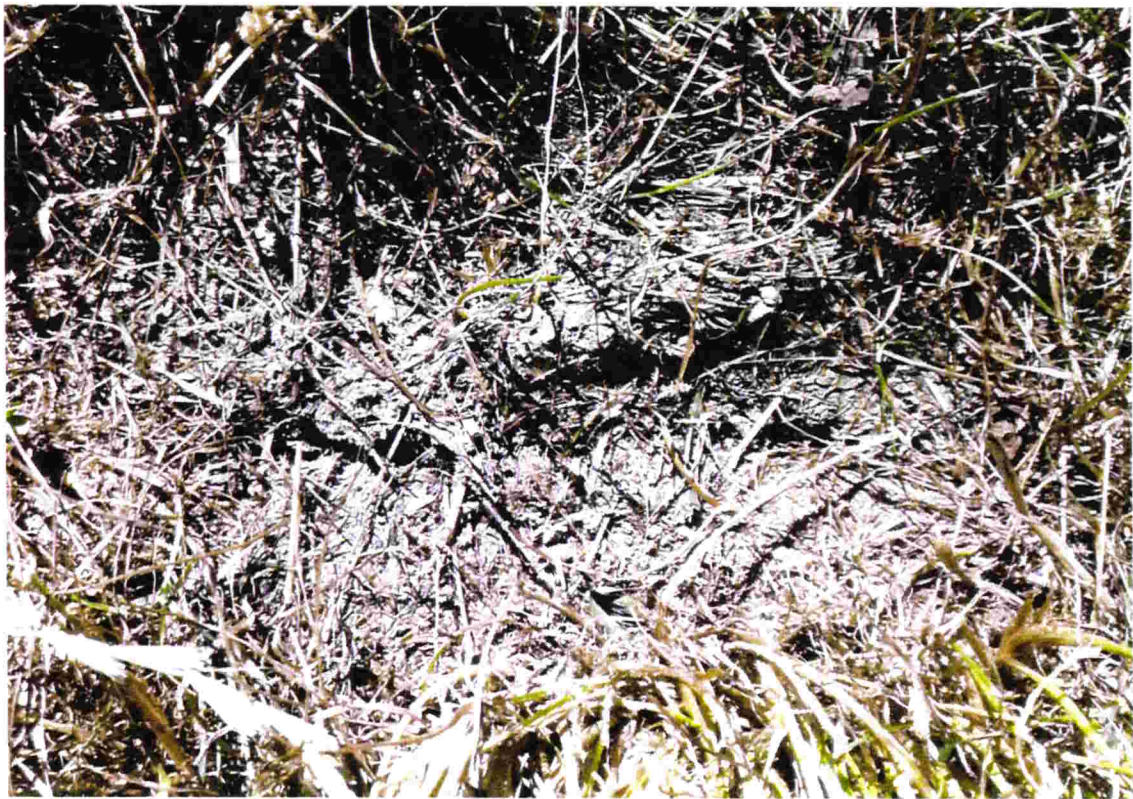
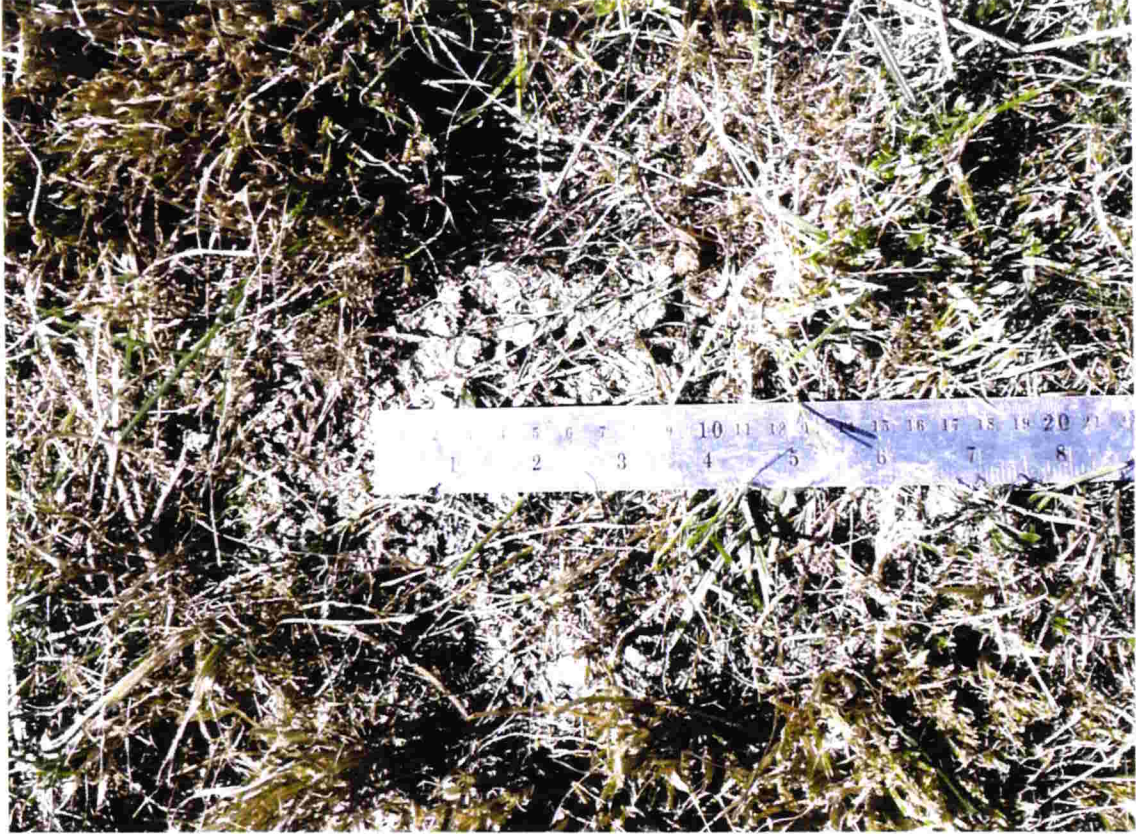
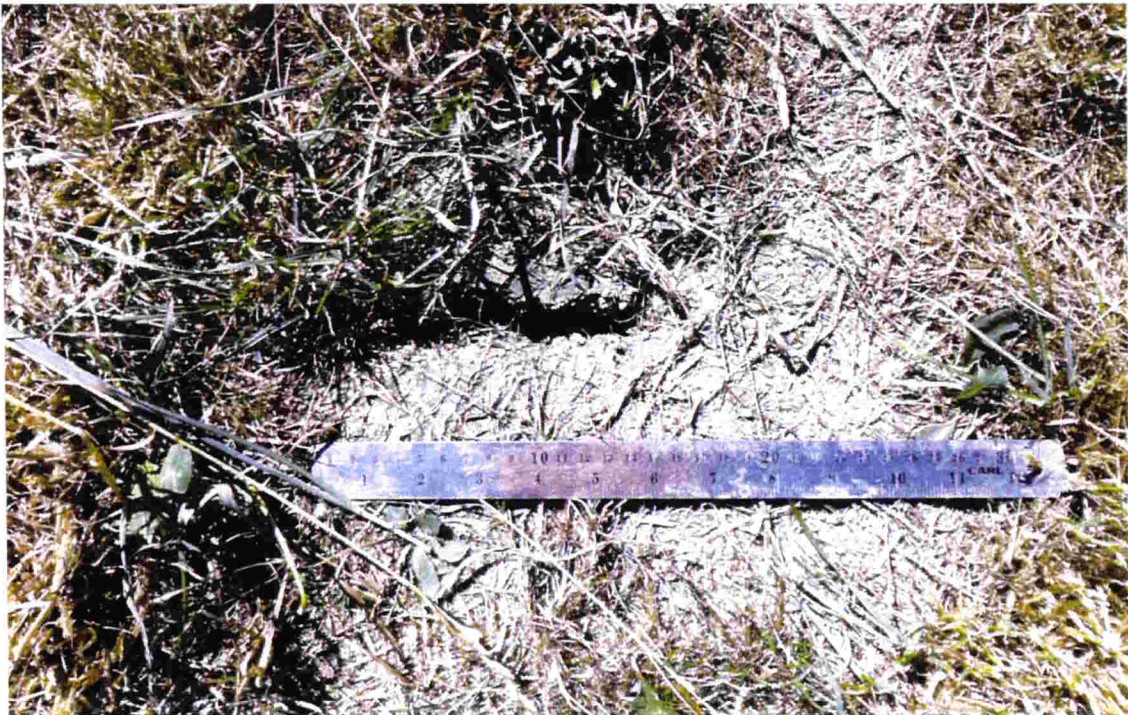
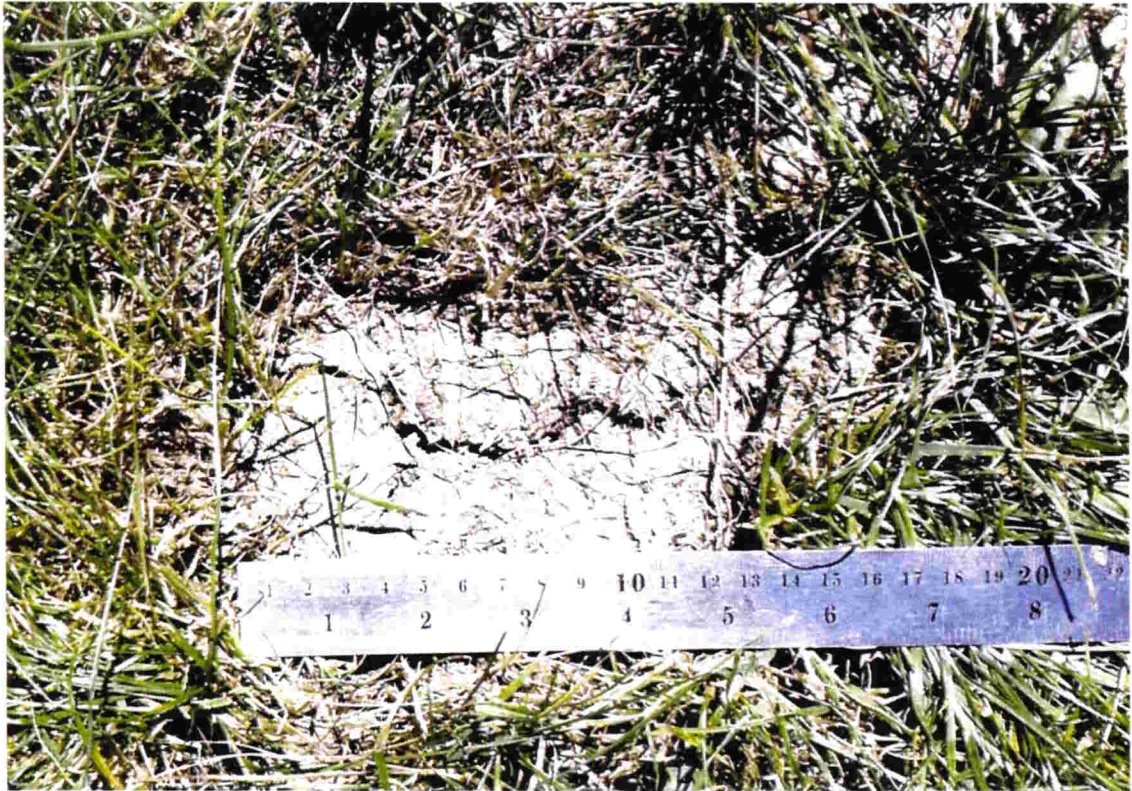
Further pictures of soil cracks follow, at the risk of emphasizing these at the expense of areas where cracks were few or absent. As there are not many pictures of the cracks, however, they are included here for interest.

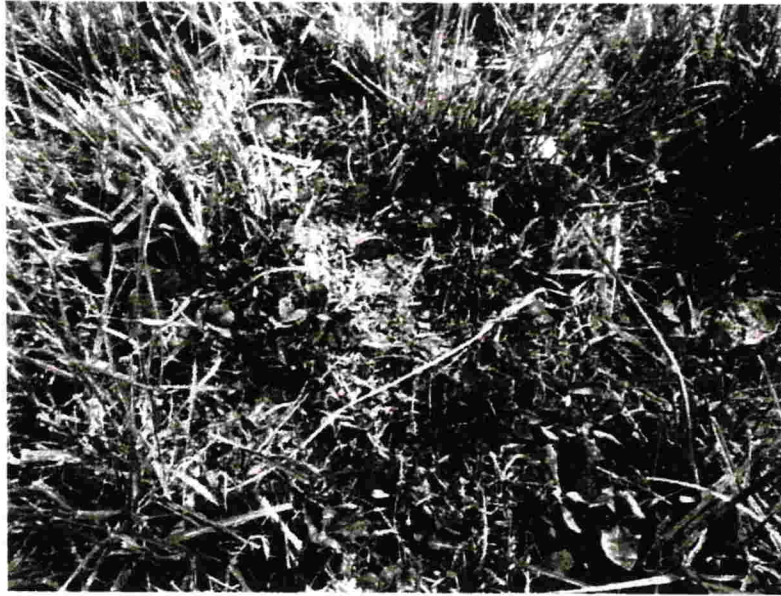
33 My experience is that silt loam soils that have dried out such that the soil moisture content is close to wilting point may exhibit cracking but the degree and size of surface cracking is highly related to the soil cover. A well established pasture with good grass content is unlikely to show large soil cracks, i.e. no greater than 1 – 2 mm in breadth and of limited depth. That is because grass, particular ryegrass has a strong fibrous root system which provides significant soil strength and controls shrinkage.

36 The first is on a well-established pasture on a Drummond soil type on Woldwide One.
