*WW1&2 consent application*

# *Appendix B*

## **Soil type assessment of soils at Woldwide 1 & 2 dairy farms**

Investigation of cracking soils: Heddon Bush, January 2018.  
Michael Killick, Technical Specialist (Soils and Groundwater Quantity)

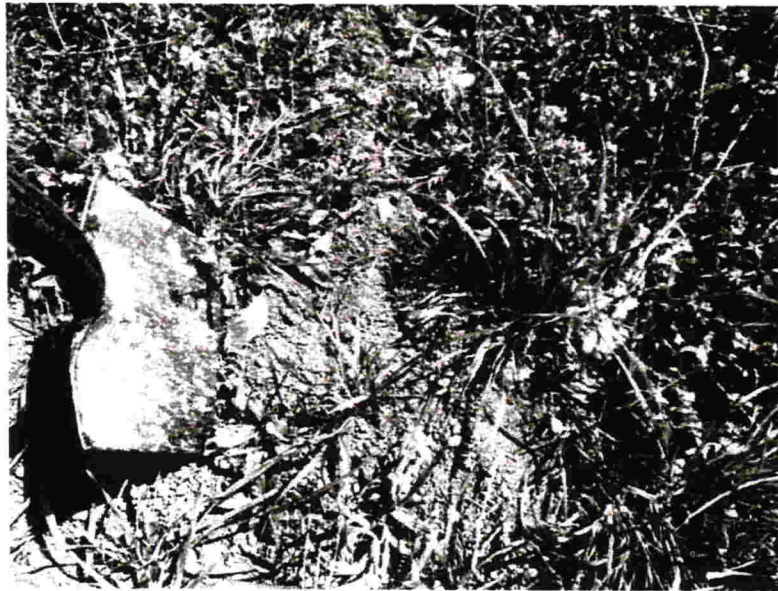
34 By comparison soils with a sparse cover or newly establishing pasture will be much more prone to significant shrinkage cracks which could easily be 5mm wide or more.

The second is on a newly establishing pasture on a Braxton soil type.
