Jacobs River Estuary

Macroalgal Monitoring 2009/10

Prepared
for
**Environment
Southland**
April
2010

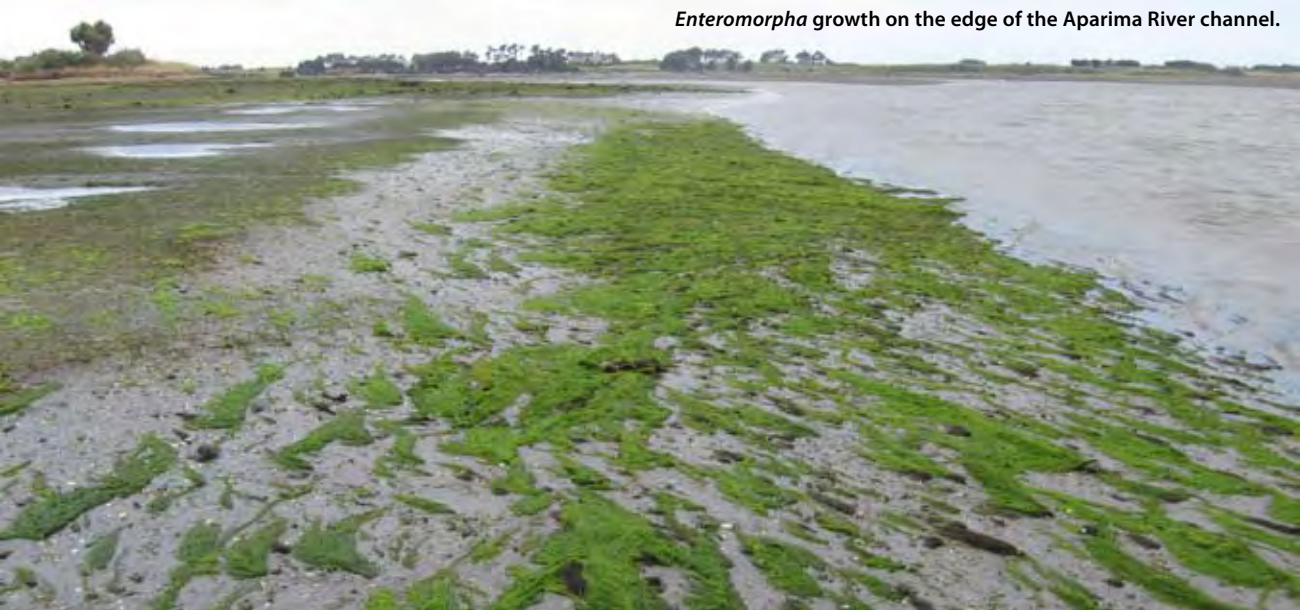
Enteromorpha growth on the edge of the Aparima River channel.

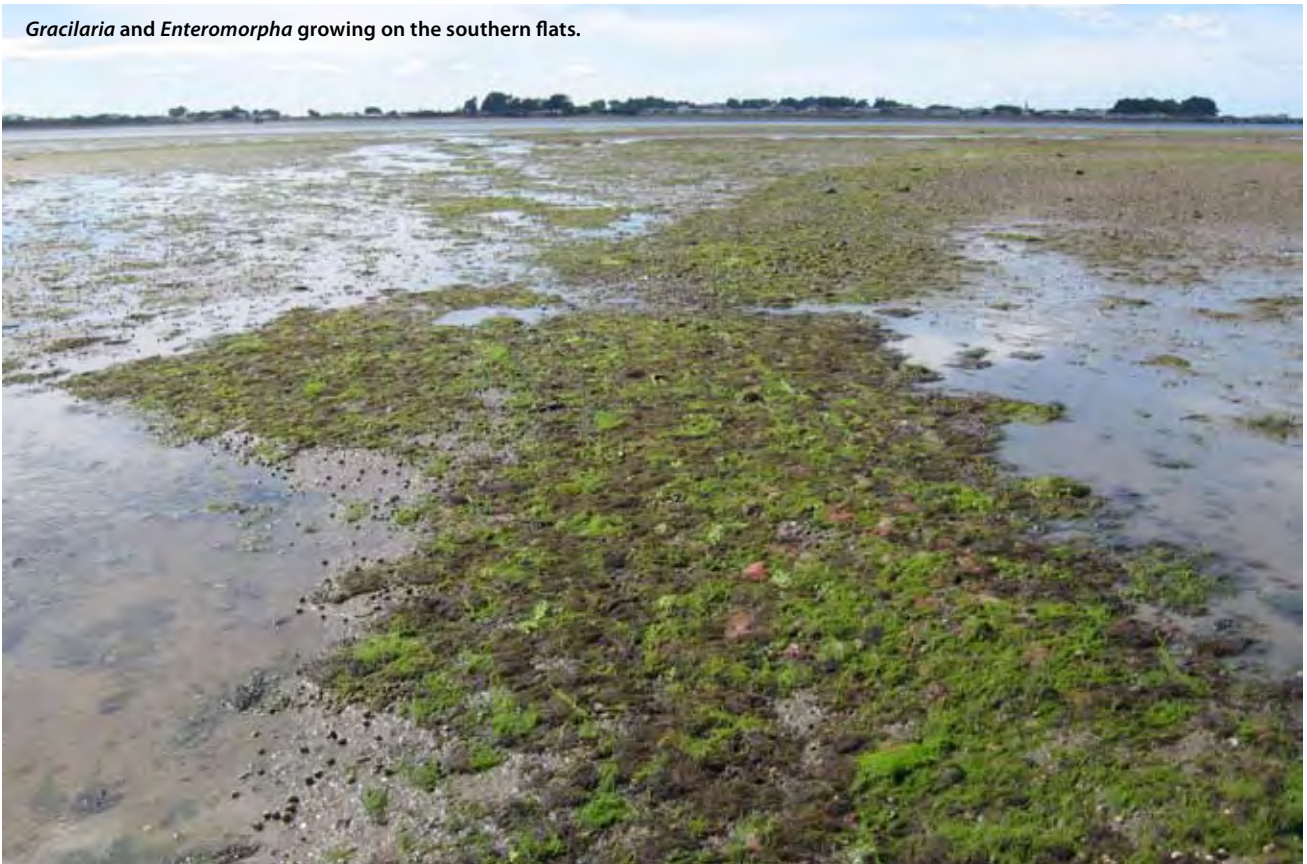
Gracilaria and *Enteromorpha* growing on the southern flats.

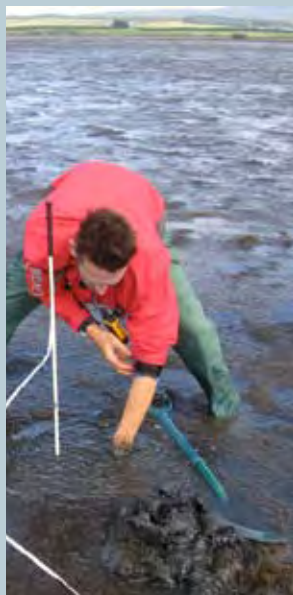
100% cover of *Gracilaria* growing in anoxic muds in the Pourakino Arm.

The extensive and often smothering cover of growing and decaying macroalgae in these areas (see top sidebar photo) was reducing sediment dissolved oxygen and causing sulphide rich sediments and nuisance odours. Macroalgae was also trapping fine muds, and limiting the natural removal of it, by reducing the re-suspension of sediment by wind generated waves. As a consequence, sediments are expected to become deeper, softer, and muddier over time, while oxygen levels will further reduce. This will see ongoing displacement of the existing biological communities and a continuing decline in the health of the estuary. To address the potential for ongoing sedimentation within the estuary, and to measure its magnitude, 12 sediment plates were deployed at three sites in 2010 (see Appendix 1 for site locations).

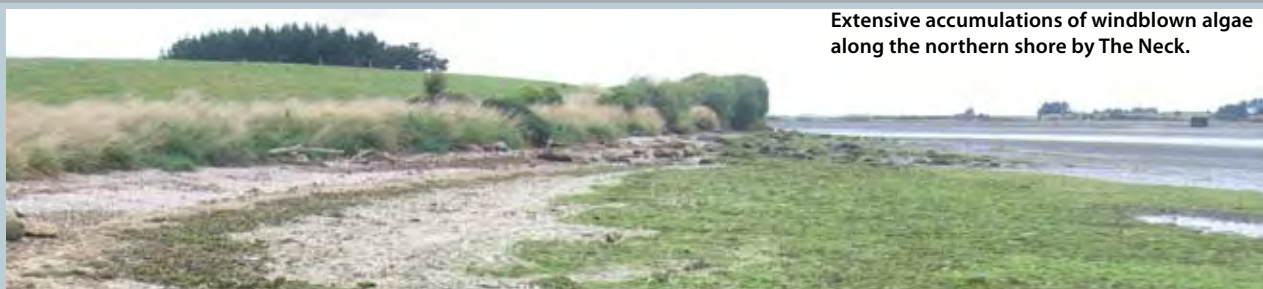
Table 2, which summarises the Condition Rating and Macroalgal Coefficient (MC) results for the 2007-2010 period, shows a continuing increase in macroalgal growth since 2007. The most recent increase is due largely to macroalgae growing and accumulating along the northern shoreline of the estuary either side of The Neck (see photo below). Much of this algae is likely to have come from estuary channels where macroalgae grows rapidly wherever substrate allows, and where it regularly breaks off and gets deposited by wind, wave and currents around the estuary margins.

Extensive accumulations of windblown algae along the northern shore by The Neck.
