New River Estuary

Macroalgal Monitoring 2010/11

Prepared
for
**Environment
Southland**
July
2011

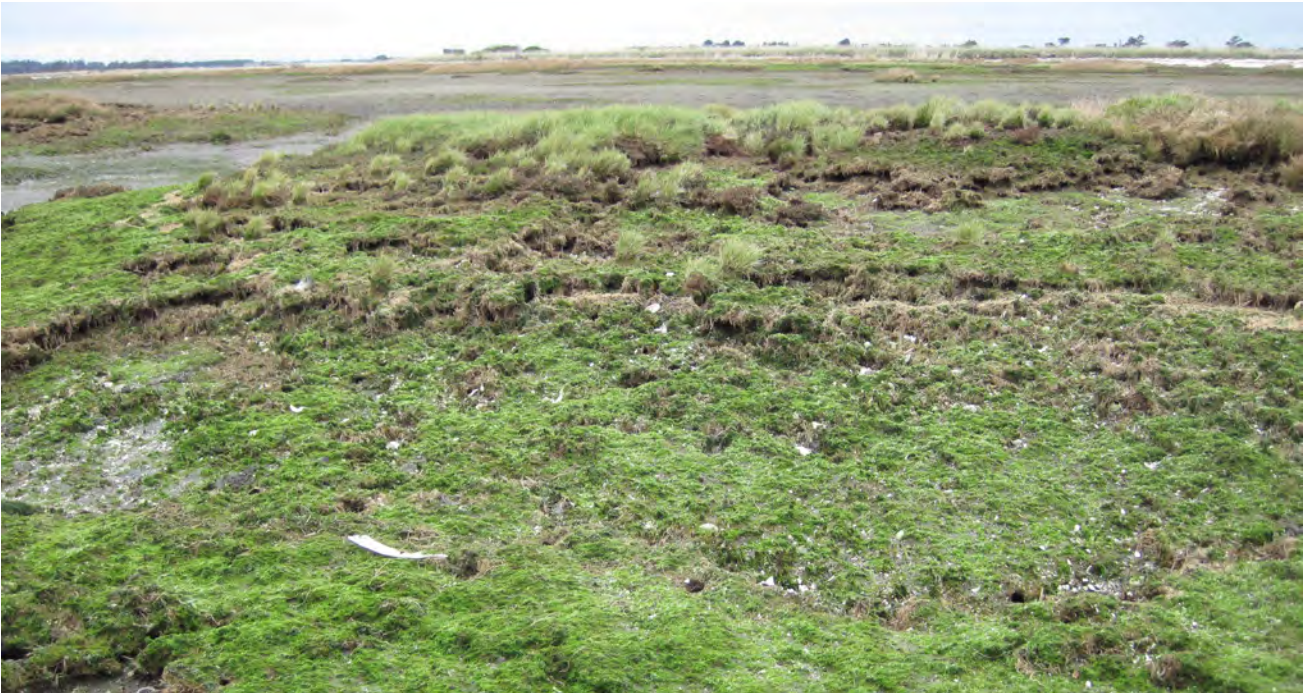
Ulva (Enteromorpha) growth in the east of New River Estuary on old *Spartina* roots.

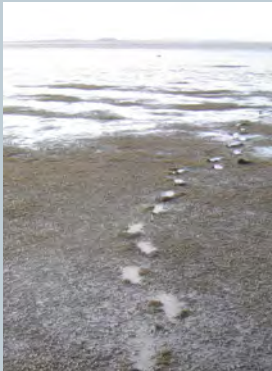
Figure 1 and Table 1 summarise the results of the 2011 macroalgal mapping of New River Estuary. 11% (308ha) of the estuary had >50% macroalgal cover, the most extensive growths located on the northwestern flats between Bushy Point and the Waihopai River channel (e.g. top photo), and in pockets around the Oreti River mouth and on the relatively sheltered western flats, particularly Daffodil Bay (Figure 1). The area covered by both high macroalgal cover and soft muddy sediments in 2011 was estimated to be 8% of the whole estuary (Robertson and Stevens 2011), with the majority in the western side of the Waihopai Arm and a smaller area in Daffodil Bay. In these areas macroalgae was causing gross nuisance conditions which had worsened over the past year. Sediment oxygenation beneath thick macroalgae was very poor with sediments anoxic from the surface to >15cm (middle photo), and sulphide bacteria growing at the surface (Figure 2).

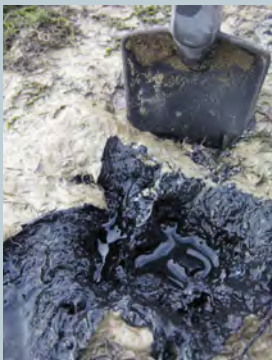
These conditions will kill or displace most estuarine animals and shellfish, and also release nutrients previously bound in the sediments. As these nutrients will predominantly be released in the form of ammonia, which is much more readily available to fuel macroalgal growth, a cycle of increasing habitat deterioration has established that is likely to be difficult to reverse. Because this is occurring predominantly in the relatively rare sheltered tidal flats of the estuary most favourable for the growth of high value seagrass habitat, the ecological cost of such extensive growths is significant.

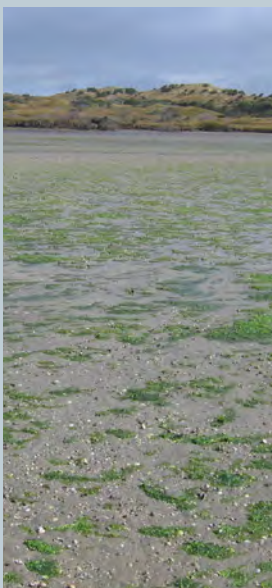
Overall, the red alga *Gracilaria* was the dominant species in the estuary, followed by the green alga *Ulva (Enteromorpha) intestinalis*. *U. intestinalis* is most common along channel margins and on the root systems of sprayed *Spartina* beds, while *Ulva lactuca* (sea lettuce) was most common on sandy flats near Bushy Point and Omaui (bottom photo).

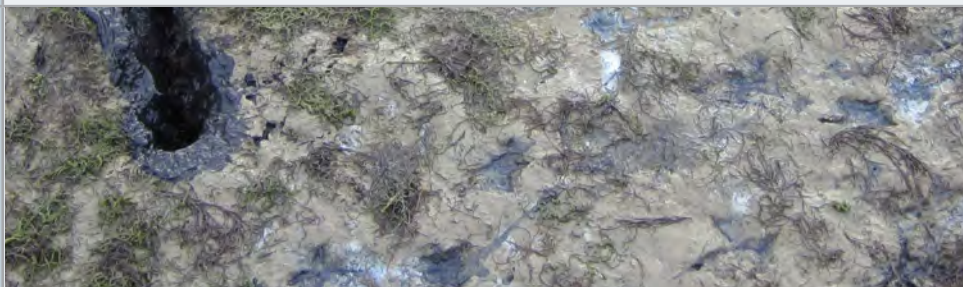
Figure 2. Soft, muddy, anoxic sediments with sulphide bacteria growing on the surface - northwestern flats of the Waihopai Arm.
