Recreational Waters of Southland

Recreational Waters of Southland 2012/13

August 2013

**Prepared for Environment Southland by
Greg Larkin - Environmental Scientist**

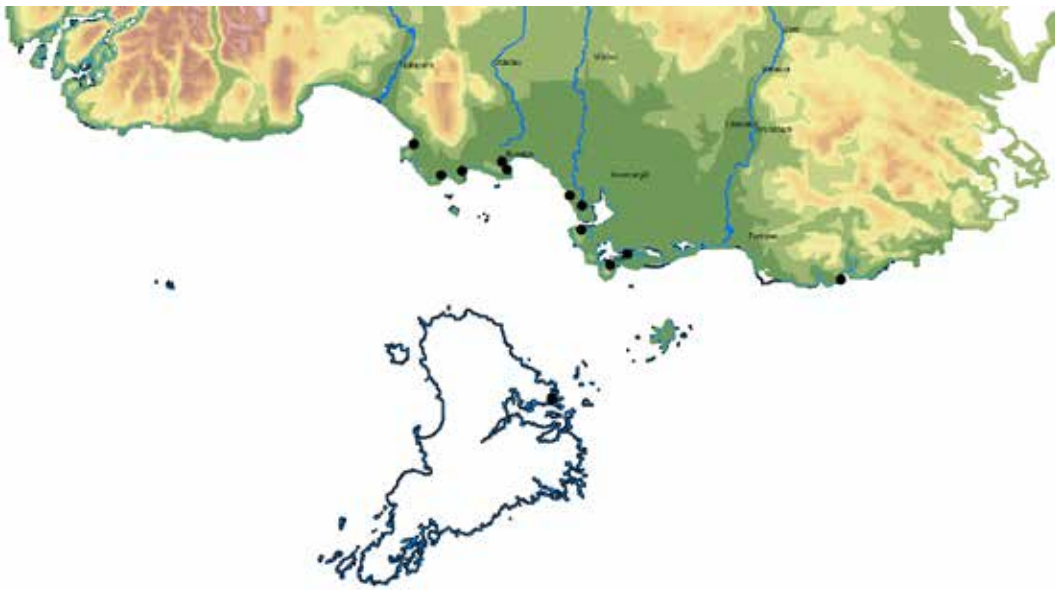
Figure 1: Southland's marine bathing sites

Water quality monitoring was undertaken at 13 marine bathing sites (Figure 1) in Southland over the 2012/13 summer. Ten of the sites were sampled weekly and three sites fortnightly. The fortnightly sampled sites have been deemed low risk to recreational bathers by historically having 'very good' SFRGs. However, as these sites are still well used by swimmers, surfers and kayakers, monitoring continues.

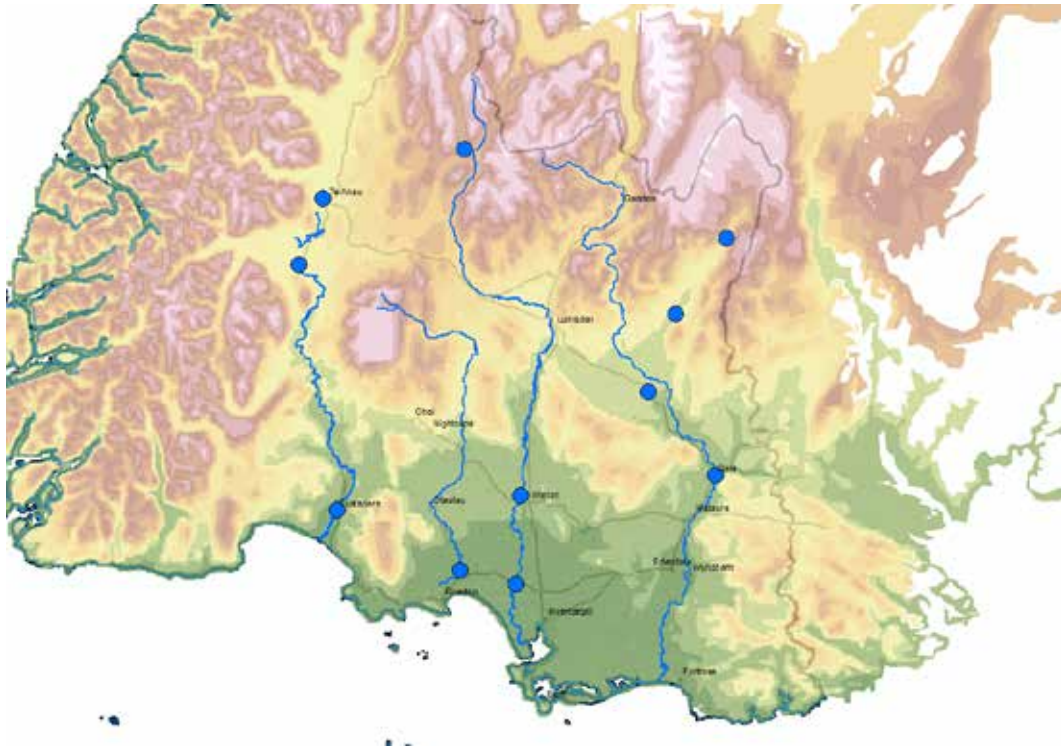
Figure 2: Southland's freshwater bathing sites

Water quality monitoring was undertaken at 11 freshwater bathing sites (Figure 2) in Southland over the 2012/13 summer. Seven of the 11 sites were river sites sampled weekly over the summer. The remaining sites were two lake sites and two high country river sites. These four sites have been deemed lower risk to bathers, and therefore sampled monthly.

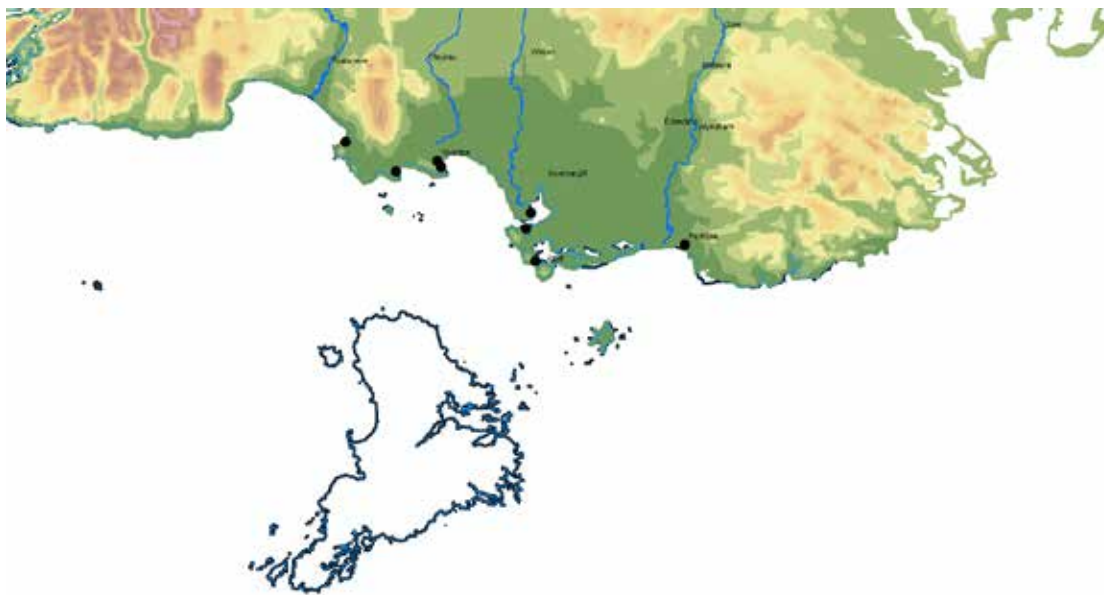
Figure 3: Southland's recreational shellfish sites

Water quality monitoring at shellfish gathering sites was undertaken at eight sites in Southland over the 2012/13 season (Figure 3). Each of the sites was sampled monthly from 1 July 2012 to 30 June 2013. Water samples were collected on the second Tuesday and Wednesday of each month.

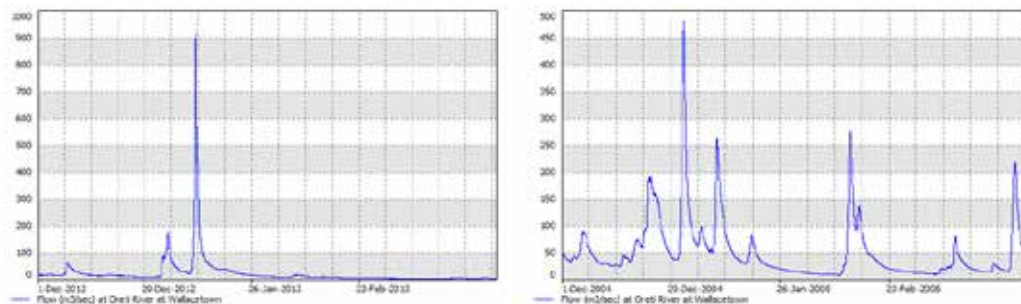
Figures 3 and 4: Oreti River at Wallacetown Hydrograph, 2012/13 (left) and 2004/05 (right) bathing season
(*Environment Southland hydrological data, Hilltop Software*)

Southland’s marine bathing sites are usually only prone to bacterial contamination after sustained catchment rainfall. Both guideline breaches last summer occurred in early January 2013, after widespread rainfall was recorded across the region. The “event driven” pattern is consistent with that previously recorded for bathing sites in Southland and in New Zealand (*Water 2010: Our Health* report, Greenley et al, 2012). Following high river flows in mid-January 2013, river levels decreased to median flow at most sites for the remainder of the bathing season (Figure 3). This accounts for the low levels of bacteria recorded over the rest of the summer as no flushing events occurred. By contrast, the worst bathing season occurred in 2004/05 with 18 recorded guideline breaches - the Oreti River recorded over a dozen flushing events and spent little time at median flow (Figure 4).

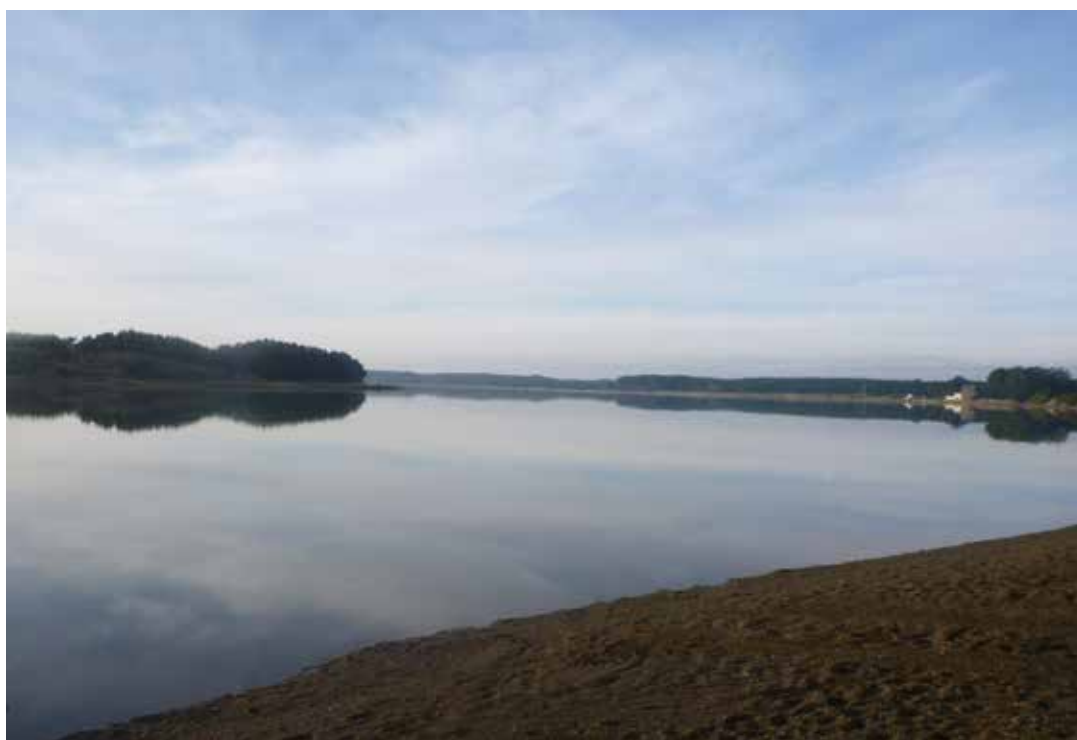
Figure 5: New River Estuary (1 km north of Water Ski-Club)

The two sites in the New River Estuary (at the Water Ski Club and Omaui) have seen reductions in their respective SFRG grades, from “good” to “poor”. Both sites have a “high” SIC grade, which is related to the microbiological “risk” from untreated animal excreta in their intensively farmed catchments. The New River Estuary has previously been described as a partially degraded estuarine system, in terms of both microbiological status and ecological health (Robertson & Ryder 1995/96, Robertson & Steven, 2007-2012, *Water 2010: Our Health & Our Ecosystem*).

The lower Oreti River and the New River Estuary are exposed to multiple industrial discharges and untreated stormwater, and also receive treated wastewater from Invercargill City. The influence of the industrial discharges and diffuse source pollution to both bathing sites was uncertain at varying river flows, hence the high SIC grade. The “poor” SFRG does not mean that bathing at either site will always be poor, however, it does highlight the increased risk to bathers, especially after rainfall in the Oreti and Waihopai Catchments.

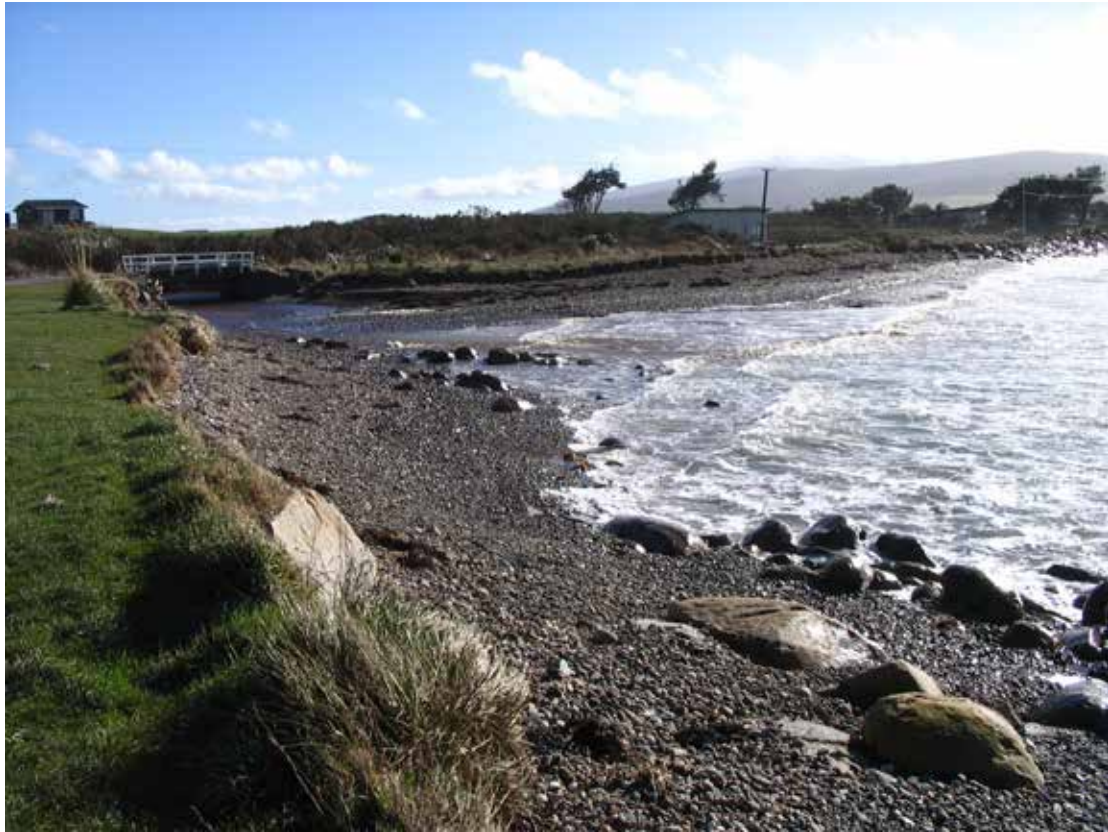
Figure 6: Huraki Creek mouth at Colac Bay

Although the marine bathing site at Colac Bay recorded low levels of bacteria in 2012/13, its SFRG assessment still requires a “follow up”. Colac Bay has historically been prone to moderate bacterial levels, especially toward the shellfish gathering site adjacent Huraki Creek. A Southland Regional Council investigation (1999) found both animal and human faecal bacteria contaminating the bathing and shellfish gathering sites, but the contamination was sporadic and often localised. Subsequent work by the territorial authorities identified and made improvements to several septic tanks deemed to be causing concern.

Long-term data (1995-2010) for the shellfish gathering site shows 93% of all samples breach the MfE (2003) recreational shellfish gathering guidelines. Over the 2012/13 season, Colac Bay again failed to meet the MfE (2003) recreational shellfish harvest guideline, with a median of 24 fc/100 ml. All faecal counts above 43/100 ml in 2012/13 were recorded after rainfall (Environment Southland hydrological data, 2013). This highlights the close linkage between bacterial sources, hydrological factors and coastal water contamination in the catchment.

In the last 10 years, the Colac Bay catchment has undergone further development for housing and agriculture (Environment Southland Aerial Images, 1995-2012). Therefore, identifying and discriminating faecal sources and their influences on the bathing and shellfish gathering sites at Colac Bay requires verification. It is recommended duplicate water samples be collected in the coming bathing season to allow microbial source tracking.

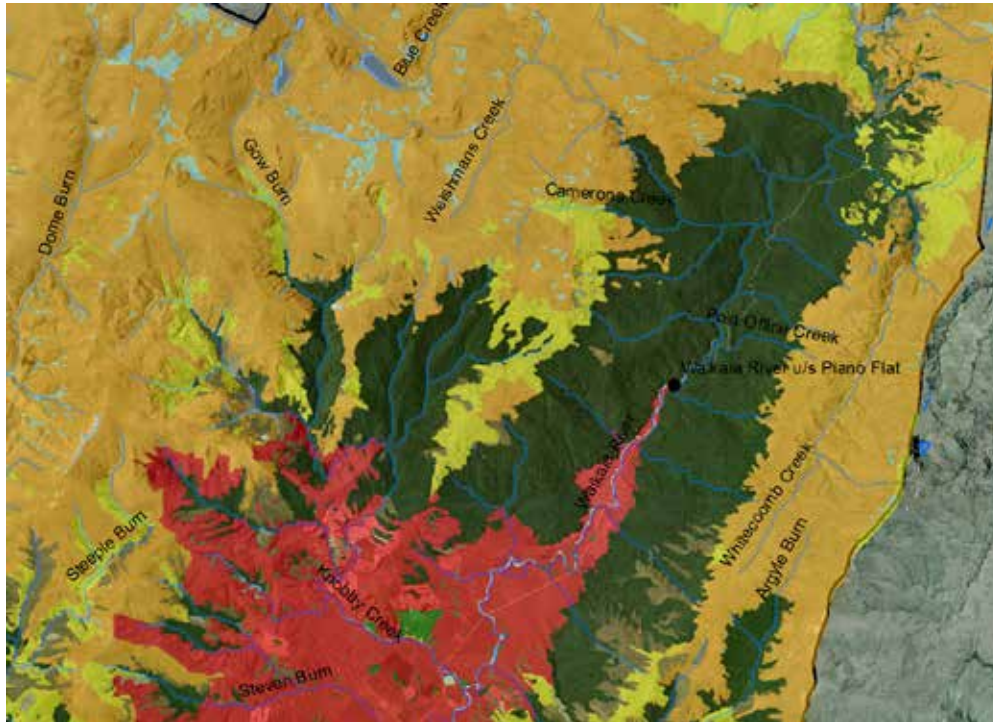
Key

Red	High producing grasslands
Yellow	Low producing grasslands
Orange	Tall tussock grasslands
Green	Indigenous forest

Figure 8: Gow Burn land cover (LDCB 3) Black dot indicates bathing site

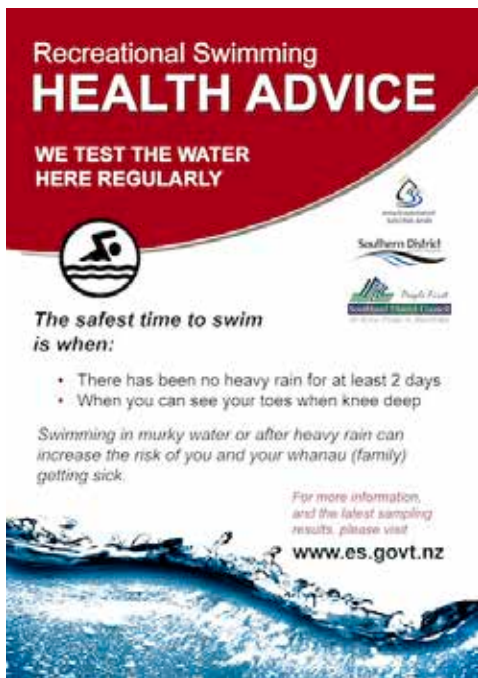
Figure 9: Southland’s contact recreation bathing sign

In other regions throughout New Zealand, the use of permanent bathing sites has been adopted. However, in Southland where bathing sites are spread across a large geographic area, this approach can be costly. The use of temporary signage across the region has historically been problematic in terms of sign management, vandalism, effectiveness and the perceived “poor public image”.
