**A HEARING BEFORE
ENVIRONMENT SOUTHLAND**

Under An application under the Resource Management Act
APP-20171445

Applicant **WORLDWIDE ONE LIMITED
ABE AND ANITA DE WOLDE**

**BRIEF OF EVIDENCE OF JOHN SCANDRETT
16 September 2019**

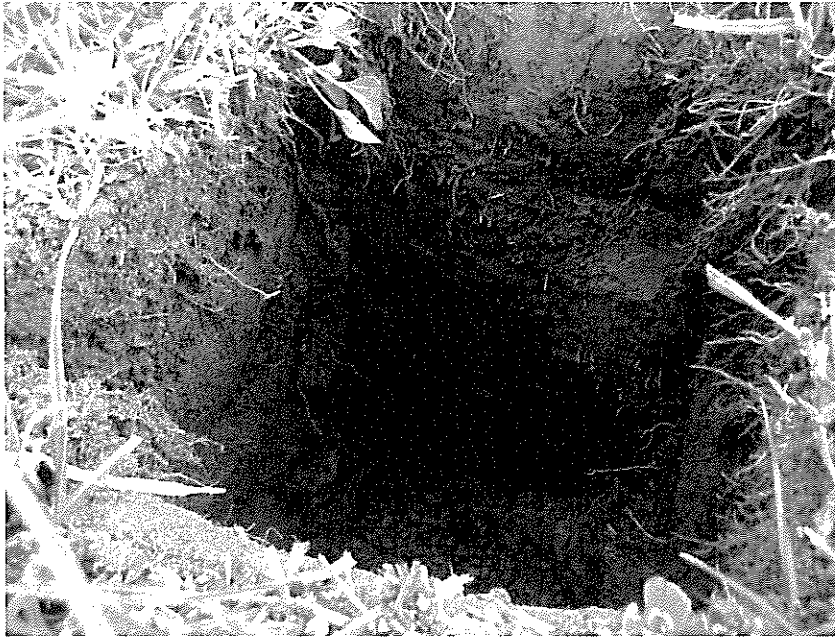
- 39 An example of a test hole dug in paddock 23 on Woldwide One which is recorded as a Glenelg soil by Topoclimate but has no stones in the topsoil or subsoil to 0.5m depth is shown below.

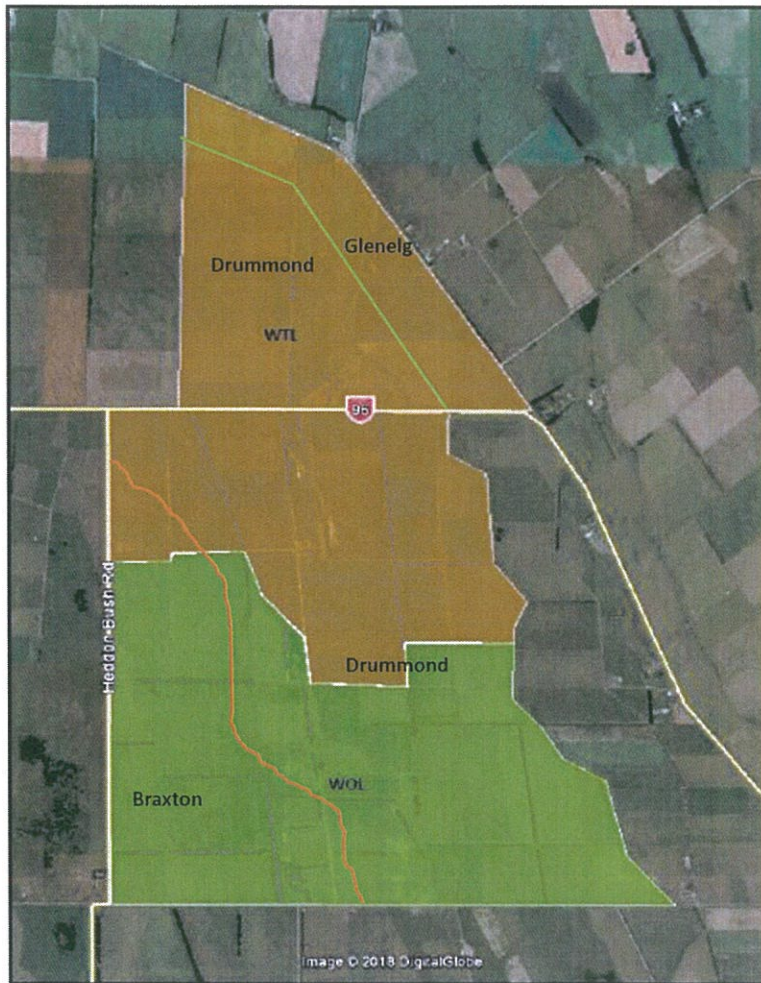
Farm plan showing Woldwide One and Two boundaries and revised soil boundaries.

- 40 A farm plan with revised soil boundaries was compiled, which is shown below.

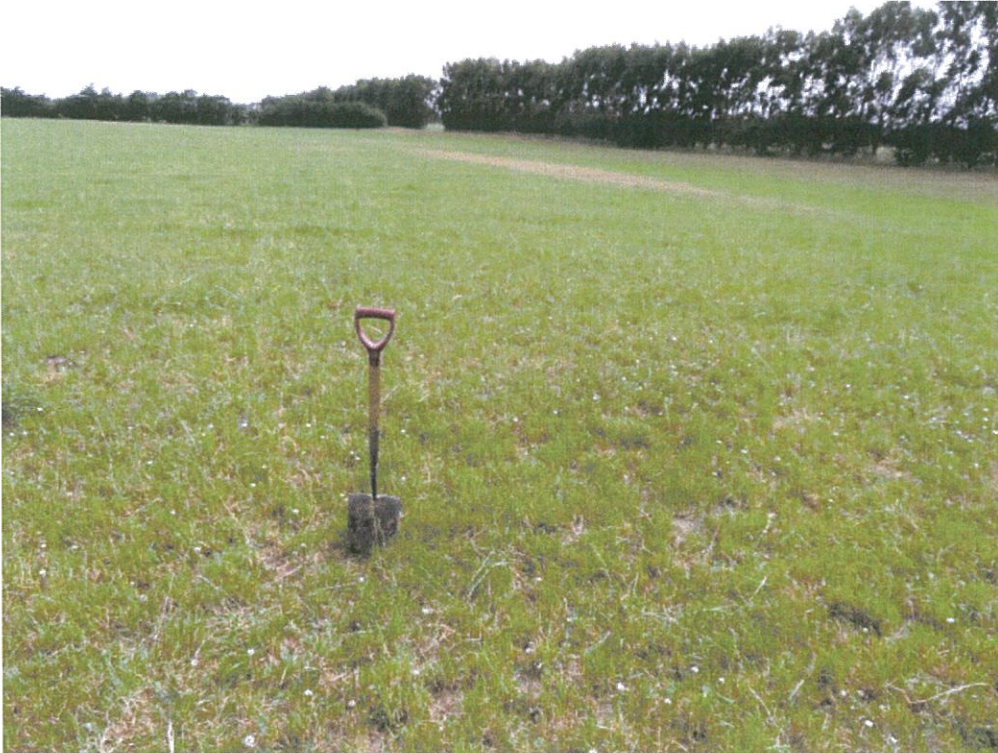
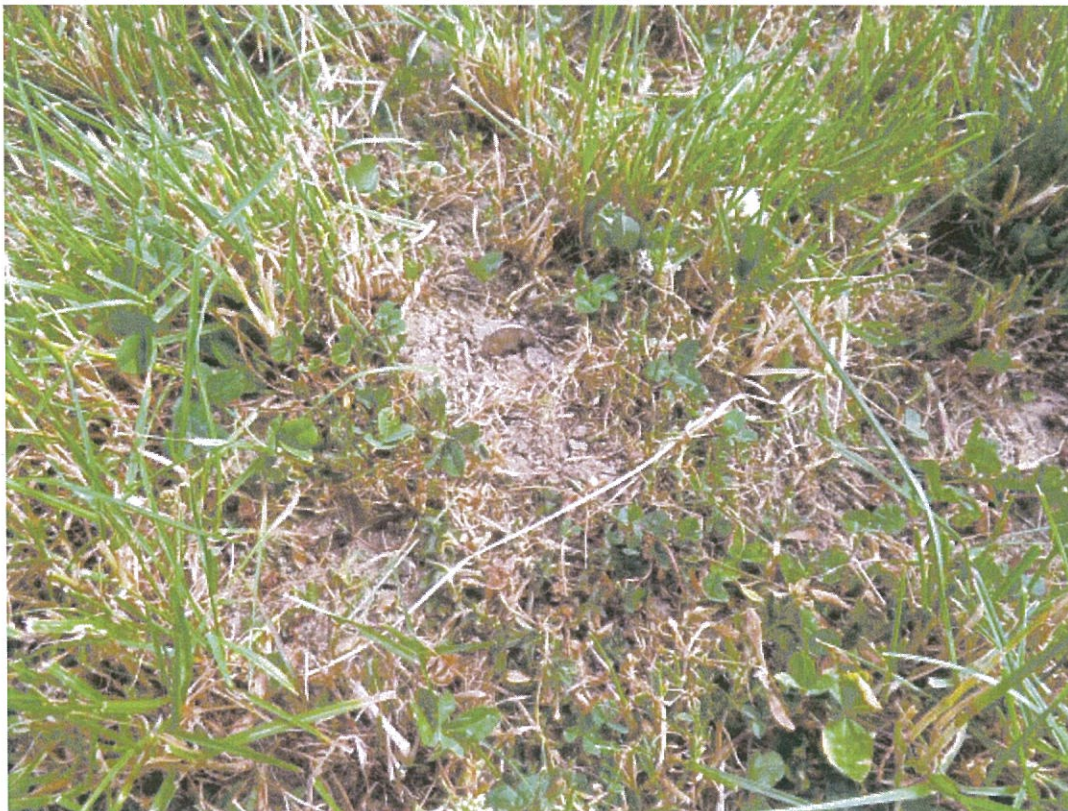
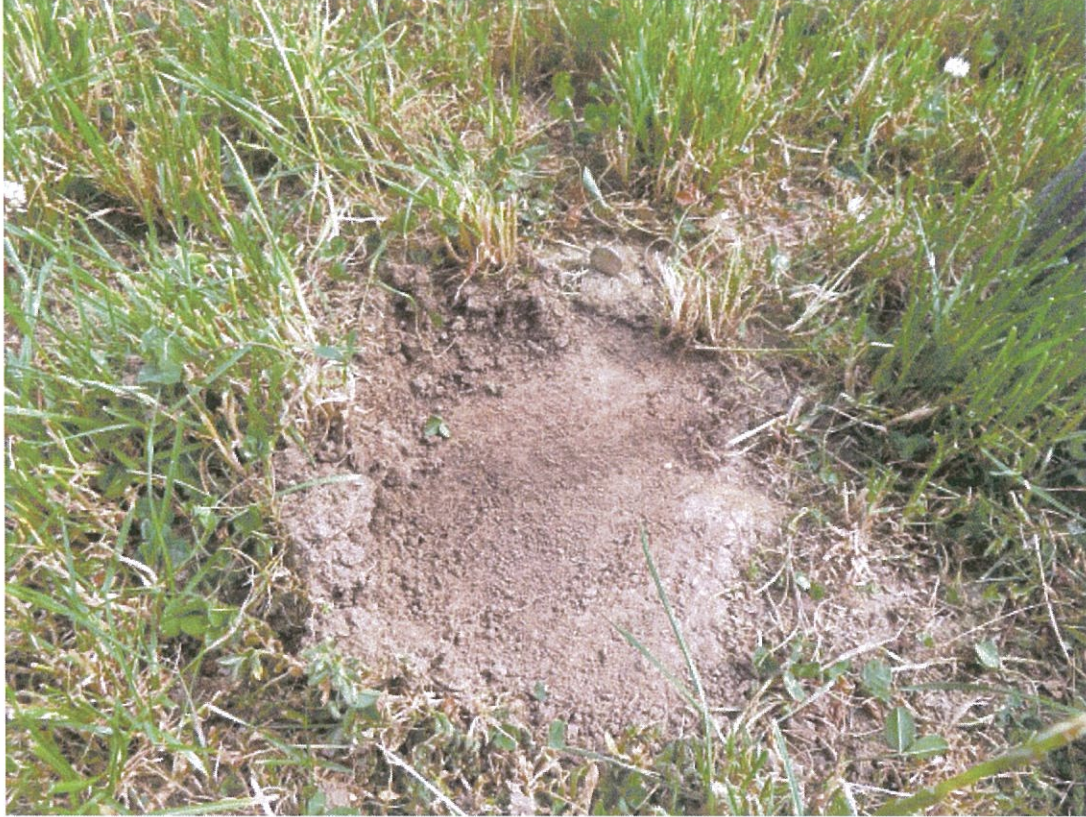
- 54 The following 3 photos were taken on 6 December 2017 during a very dry period. A localised area of lighter soil in the background had burnt off. They show paddock 23 on Woldwide One

which was in one year old pasture at the time on a Drummond soil type. The soil cracking was limited and there were no large cracks extending down the profile.
