# **PRELIMINARY SITE INVESTIGATION (PSI)**

CNR NORTH CHATTTON WAIKAKA RD AND WAIKAKA RD, WAIKAKA

**Reference Number:** REP-1773/PSI/AUG2022

**PREPARED FOR:** WAIKAKA GOLD MINES LTD

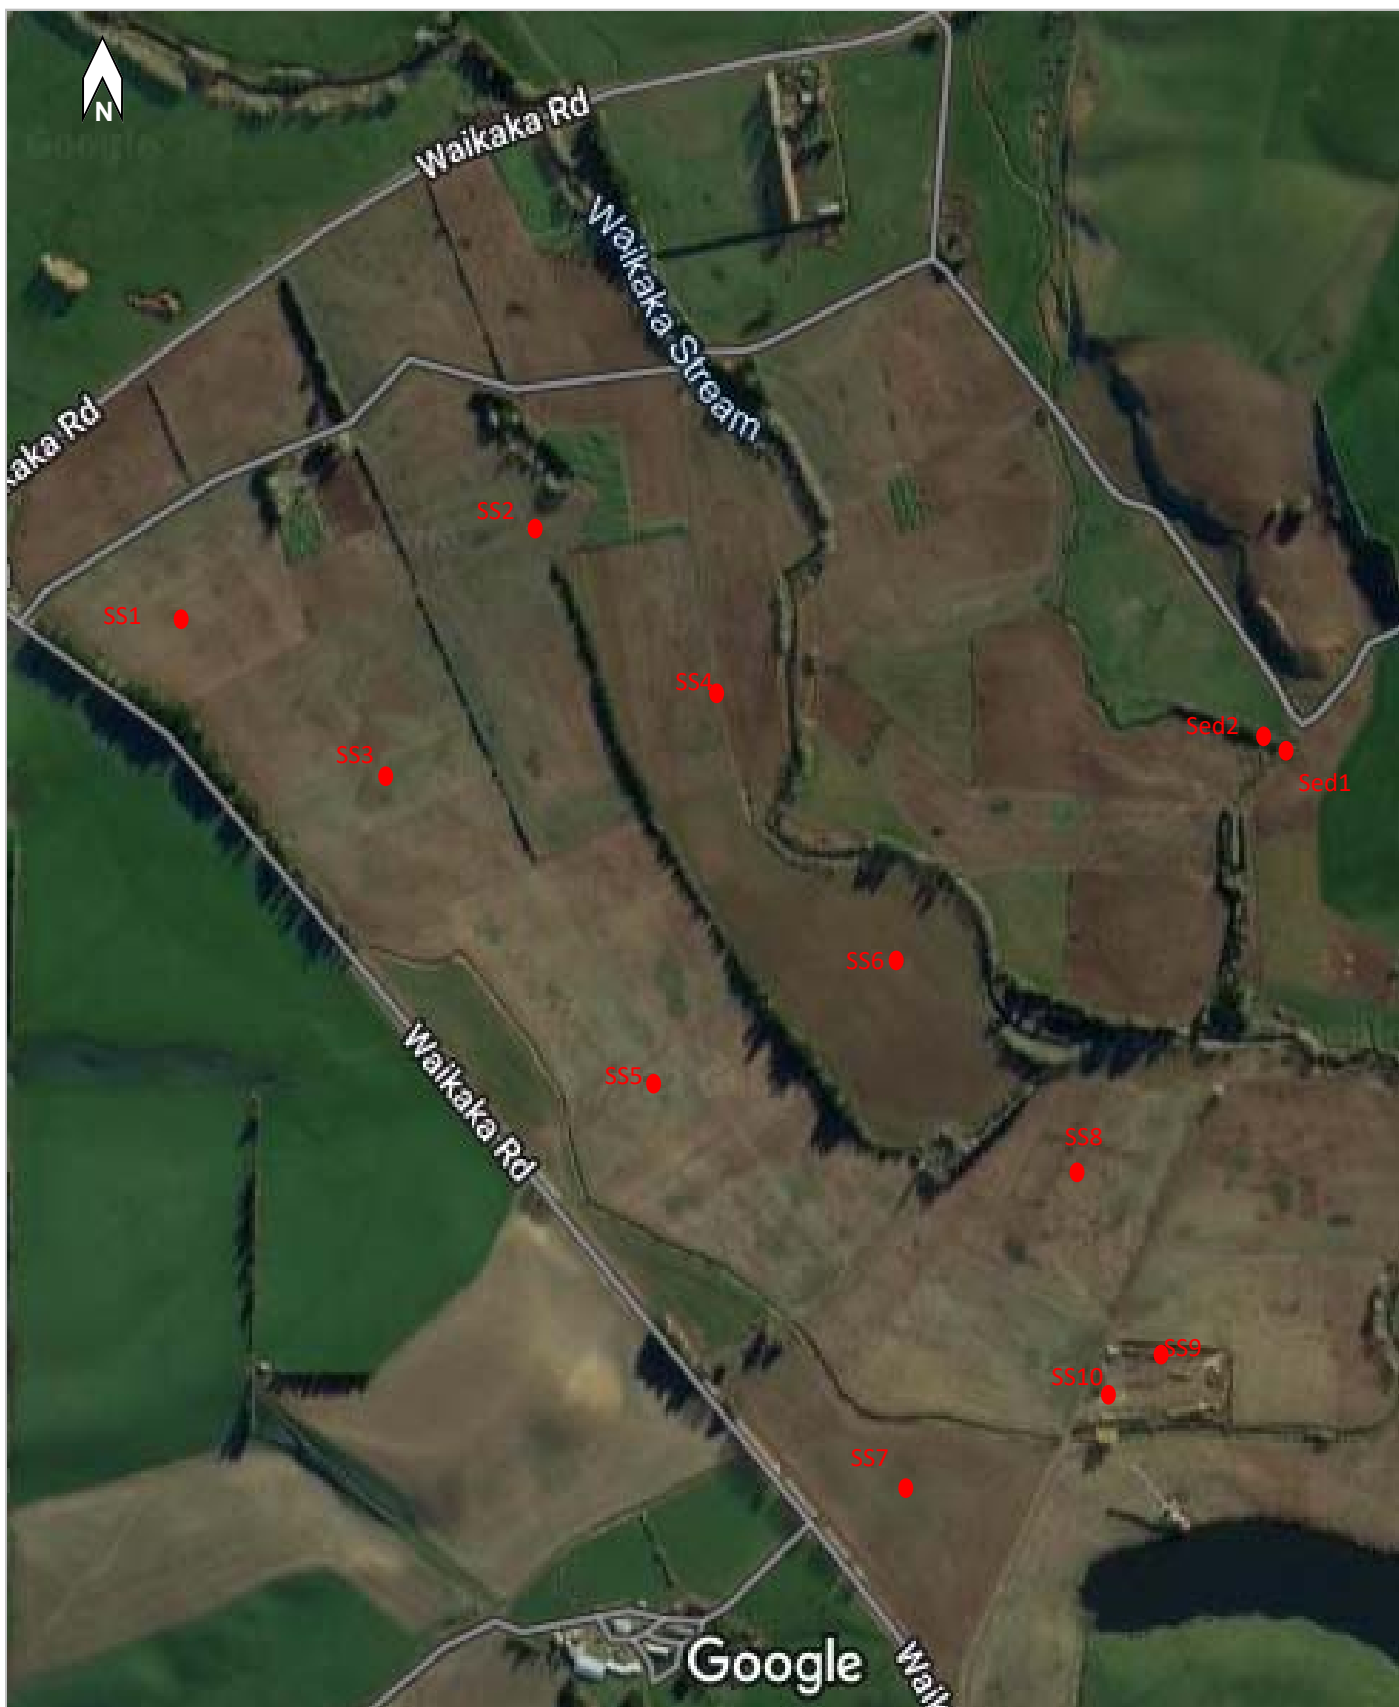
| <b>Title:</b> | <b>Figure 3 — Soil Sample Locations</b> | <b>Reference:</b> Job-1773 |

Two discrete sediment samples were collected from the Shepherd's Creek in close proximity of the closed landfill to determine whether contaminants from the landfill have leached into the creek. Two discrete surface soil samples were also collected from the Assembly and Storage area. One was collected beneath an abandoned excavator track and the other from an area where surficial evidence of a recent burn was noticed.

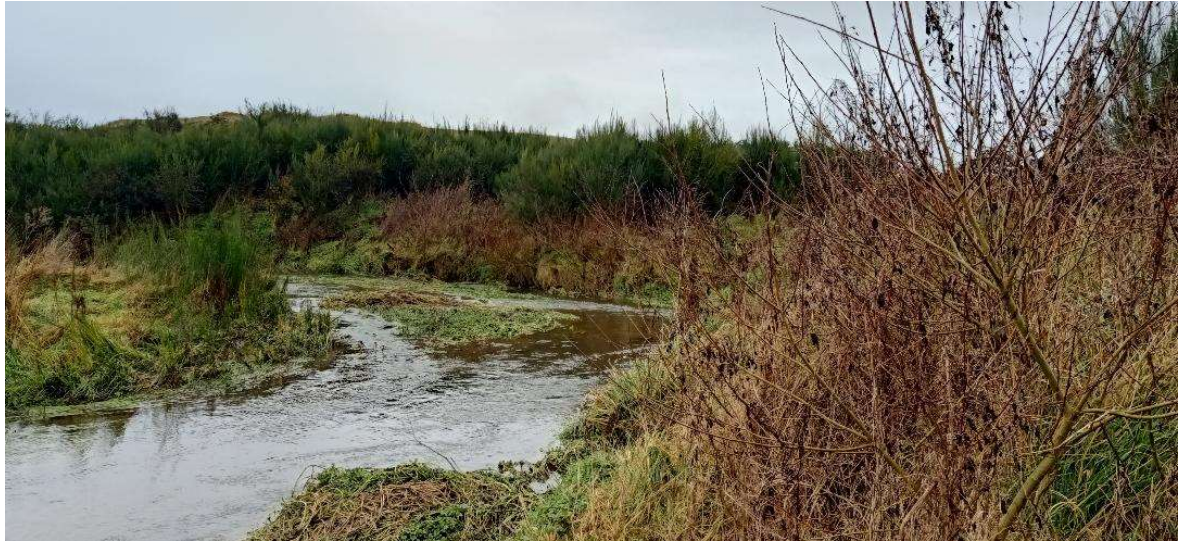
**PLATE 1: FOOT OF CLOSED LANDFILL**

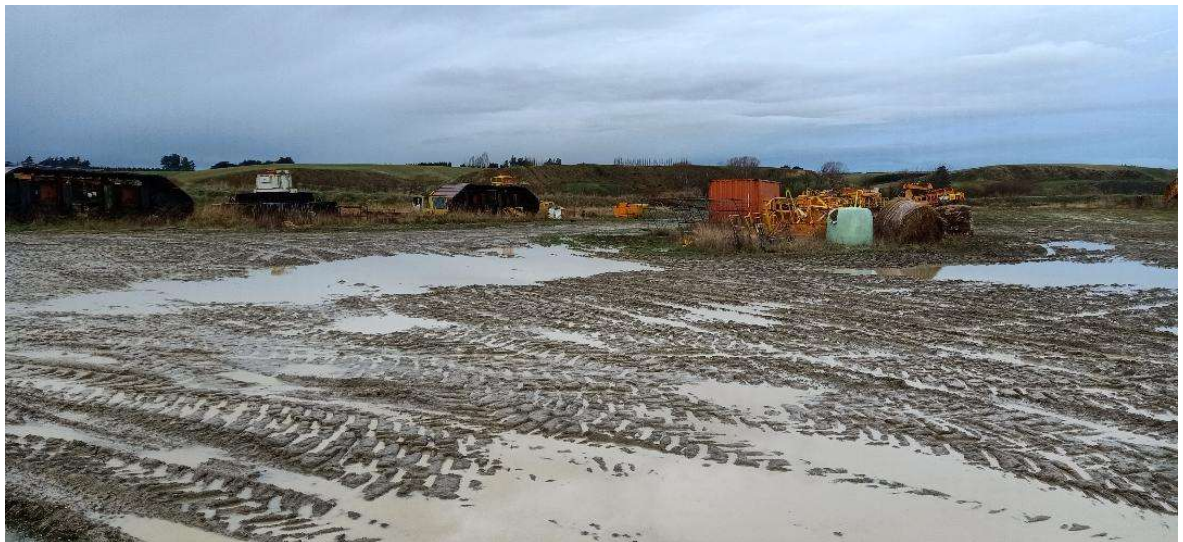
There is a bare unsealed area north of the pond with mainly abandoned machinery such as excavator tracks and cabins. There was also a small empty shipping container and silage bales. A small area of ash on the edge of the pad was noted where recent burning had occurred, this appeared to consist of mainly organic matter such as wood. No visual or olfactory evidence of hydrocarbon egress from the area or surrounding soils was noted.

**PLATE 2: STORAGE AND ASSEMBLY AREA**
