# Jacobs River Estuary 2007

## Macroalgal Monitoring

Prepared  
for  
**Environment  
Southland**  
June  
2007

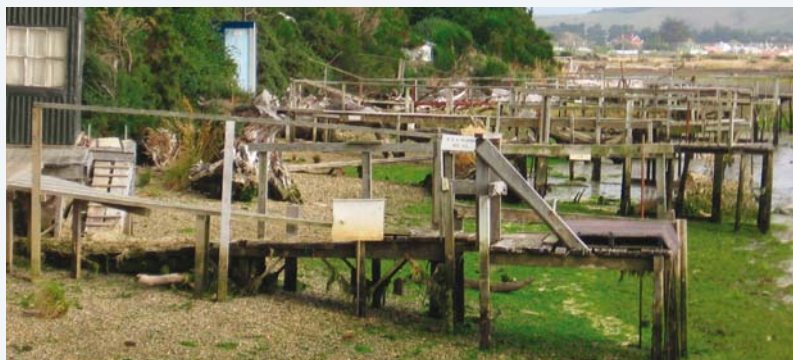
Figure 2 Green macroalgae, *Enteromorpha* sp., Jacobs River Estuary
