New River Estuary

Macroalgal Monitoring 2008/09

Prepared
for
**Environment
Southland**
June
2009

Leigh Stevens and Barry Robertson

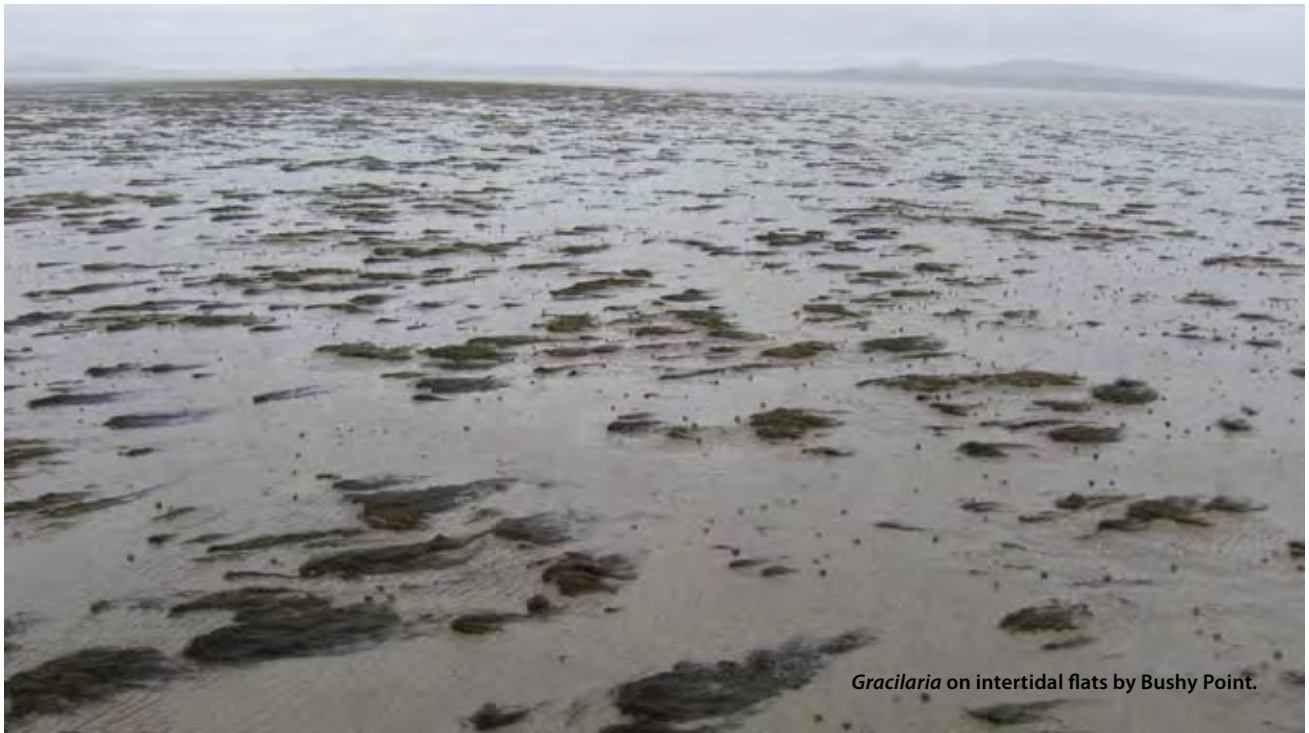
Gracilaria on intertidal flats by Bushy Point.

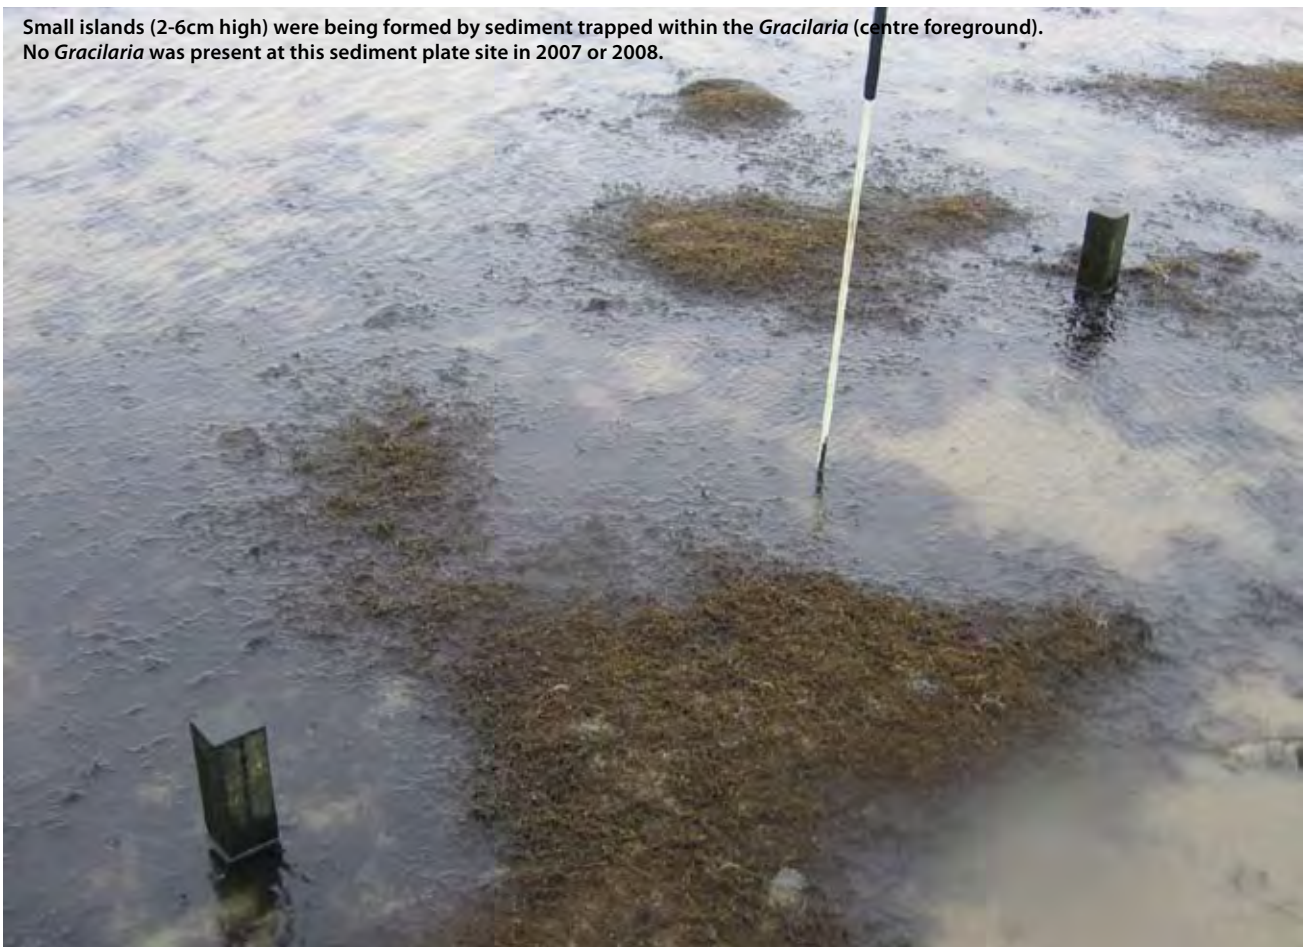
Small islands (2-6cm high) were being formed by sediment trapped within the *Gracilaria* (centre foreground). No *Gracilaria* was present at this sediment plate site in 2007 or 2008.

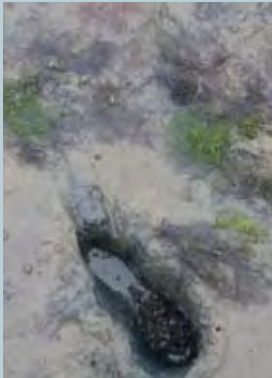
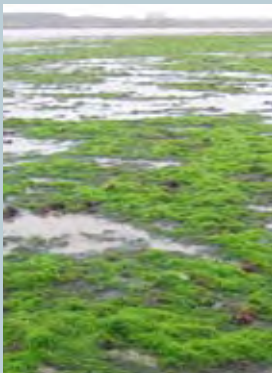
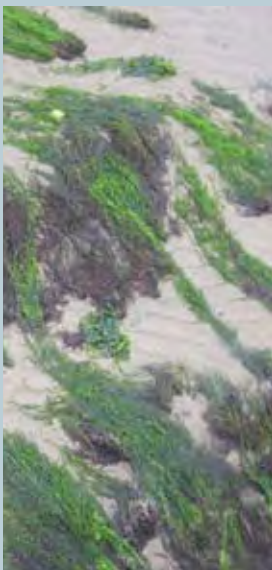
The 2009 Macroalgae Coefficient for the estuary was 1.4, which equates to a condition rating of “fair”. This rating was primarily driven by the portion of the estuary (12.5%, 337ha) with a high (>50%) macroalgae cover (Table 1), but also the significant increase in localised nuisance conditions of anoxic muds and sulphide odours associated with *Gracilaria* beds in the northwestern and western flats since 2007.

Figure 1 and Table 1 summarise the results of the 2009 macroalgal mapping and show that macroalgal cover was low across most of the well flushed lower estuary and central basin, as well as the northeastern flats. Pockets of high cover were present around the Oreti River mouth and in the relatively sheltered western flats, and along the margin of saltmarsh in the east on decaying *Spartina* roots. The most extensive growth was present on the northwestern flats and between Bushy Point and the Waihopai River channel. In these areas there were 130ha of *Gracilaria* dominated beds with an 80%-100% cover, and 81ha with 50%-80% cover.

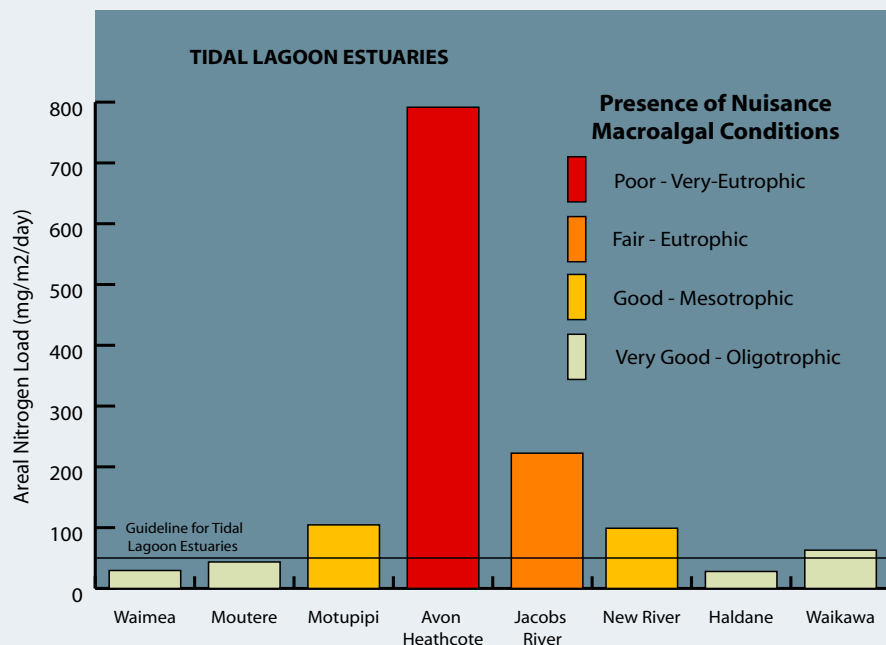
Figure 2. Relationship between nitrogen inputs and nuisance macroalgal conditions in selected tidal lagoon estuaries.

Figure 2 shows that the estimated nitrogen input to New River Estuary (as estuary areal load) is ~100 mg.m².day which is double the 50 mg.m².day upper limit suggested by Heggie (2006) for ensuring no eutrophication of temperate tidal lagoon estuaries. In addition, nitrogen concentrations in the estuary (0.8-1.5mg nitrogen/litre - ICC monitoring data) almost always exceed levels that limit sea lettuce growth (0.25 mg nitrogen/litre - Pederson and Borum 1997). Consequently, reducing nutrient inputs to the estuary is an obvious management need if macroalgal growth is to be limited.

RESULTS	While Figure 2 shows that overall New River Estuary is in a mesotrophic state, parts of the estuary are eutrophic and quality is declining as localised macroalgal cover increases. In particular, the increase in decaying macroalgae is causing sediments to become anoxic, sulphide rich, and muddier in the northwestern and parts of the western flats. Management action is needed to address the changes in these locations.
CONCLUSION	2009 macroalgal cover had a condition rating of "fair" with nuisance conditions (rotting macroalgae and poorly oxygenated and sulphide rich sediments) concentrated in the northwestern flats, and in small sheltered areas in the western flats. Macroalgal cover is not causing problems in the well flushed central basin and lower estuary.
RECOMMENDED MONITORING AND MANAGEMENT	<p>The increase in macroalgal cover from 2007, combined with the presence of nuisance conditions, means macroalgae should continue to be monitored annually. In addition, the following management is recommended:</p> <p>Set Limits on Nutrient Inputs</p> <ul style="list-style-type: none"> Because nutrient inputs to New River Estuary are high and strongly related to the eutrophication symptoms (Robertson and Stevens 2008), it is recommended that catchment nutrient inputs be reduced. A Total Daily Maximum Load to the New River Estuary of 2.0-2.5 tonnes N/day (as opposed to the current input of 3.6 tonnes/day) is suggested as a preliminary guide to maintain the mesotrophic state in the lower estuary and achieve less enriched conditions in the upper estuary areas near the Oreti and Waihopai River inputs. Further work is needed before a definitive limit can be set. <p>Identify and Manage Major Nutrient Sources</p> <ul style="list-style-type: none"> The identification of nutrient sources to the estuary is seen as a priority given the very significant nature of both point and non-point discharges. Once identified, a plan should be developed to prioritise and reduce the key inputs.
