**MEMORANDUM OF COUNSEL FOR SOUTHLAND REGIONAL COUNCIL  
ATTACHING AMENDED REPORT ON CAUSES OF WETLAND LOSS  
5 December 2019**

# CAUSES OF WETLAND LOSS IN SOUTHLAND REGION

## **Contract Report No. 5223**

The purpose of the project is to identify the cause of a recent and continuing reduction in the extent of wetlands in Southland.

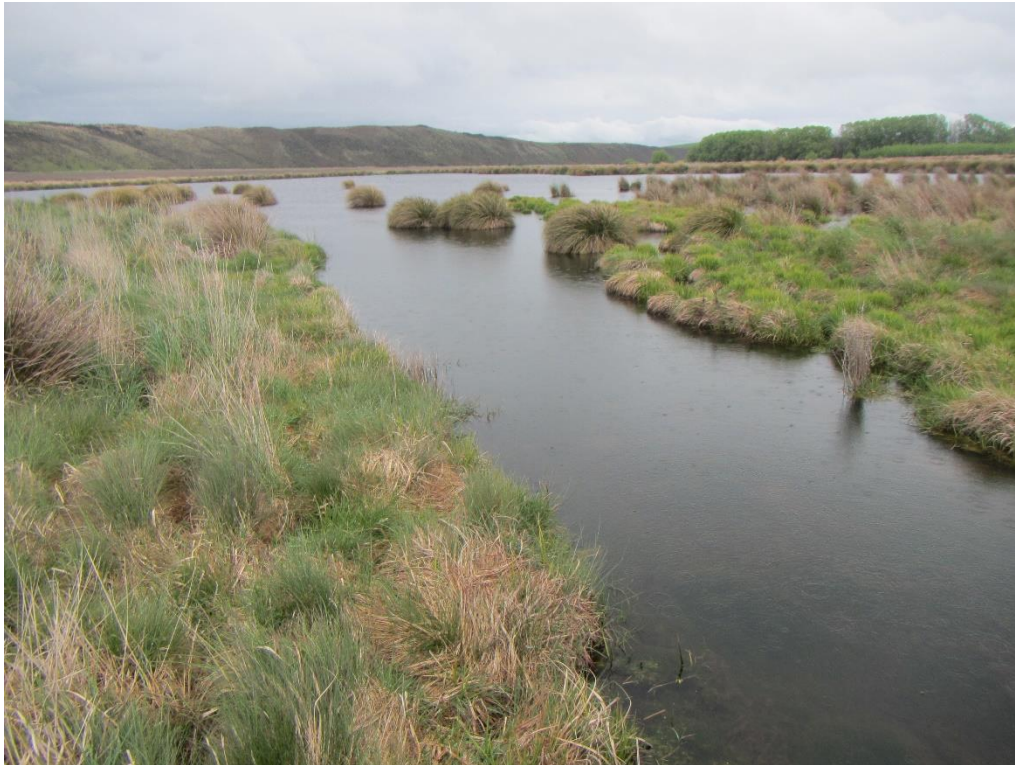
*A wetland at Mt Prospect Station, showing both drainage (foreground) and inundation (background) activities.*

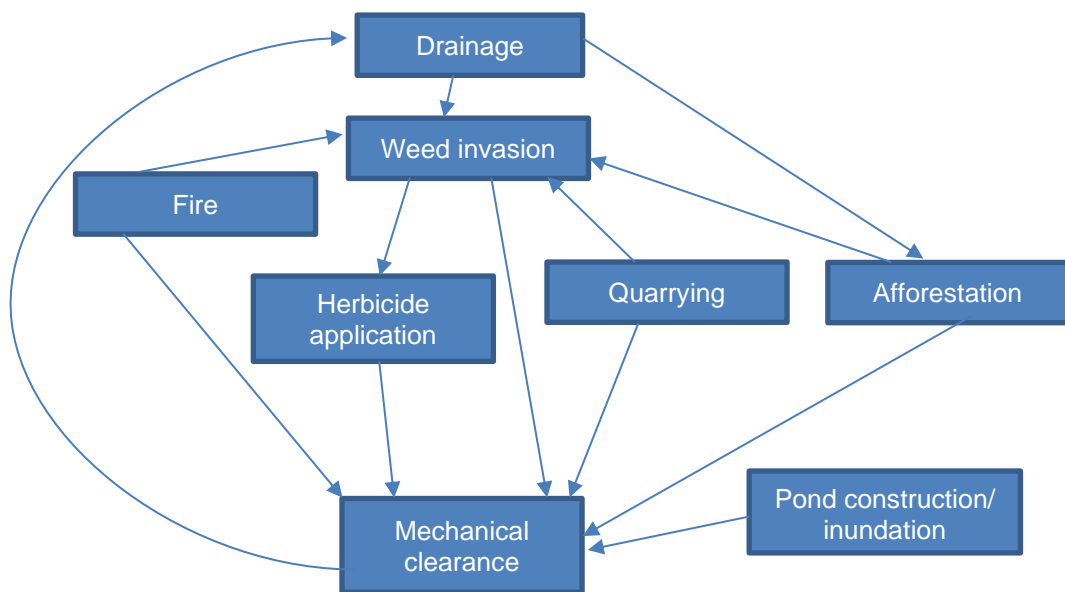
Figure 2: Observed relationships between wetland clearance mechanisms.

Other mechanisms identified in this study include afforestation, subsequent harvesting, then conversion to pasture; clearance of burnt vegetation following fires; quarrying, and inundation. Figure 2 below shows the interaction between clearance mechanisms noted during this study.

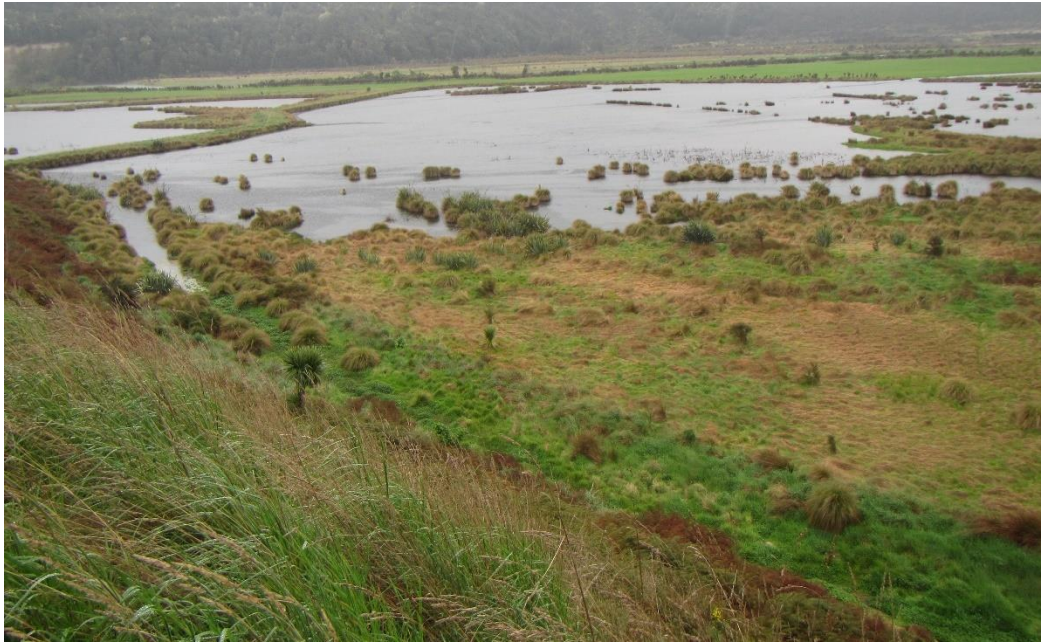
The downstream wetland has similarly-vegetated wet flats, pūkio on open water margins, and expanses of open water (Plate 1) resulting from the creation of two bunds

across the wetland in 2005 (Mark Sutton, Waiau Trust, personal communication). The bunds were created partly to flood and destroy areas of Scotch broom (*Cytisus scoparius*) scrub which formerly dominated the wetland areas. Dead Scotch broom emerging from the water is evidence of its former distribution within the wetland. Prior to the Waiau Trust purchasing the land in 2000, stock had access to the wetland vegetation and had heavily modified it (Mark Sutton, Waiau Trust, personal communication).

Plate 1: The downstream wetland showing wet flats, pūkiō lining open water margins, and open water ponded behind one of the bunds

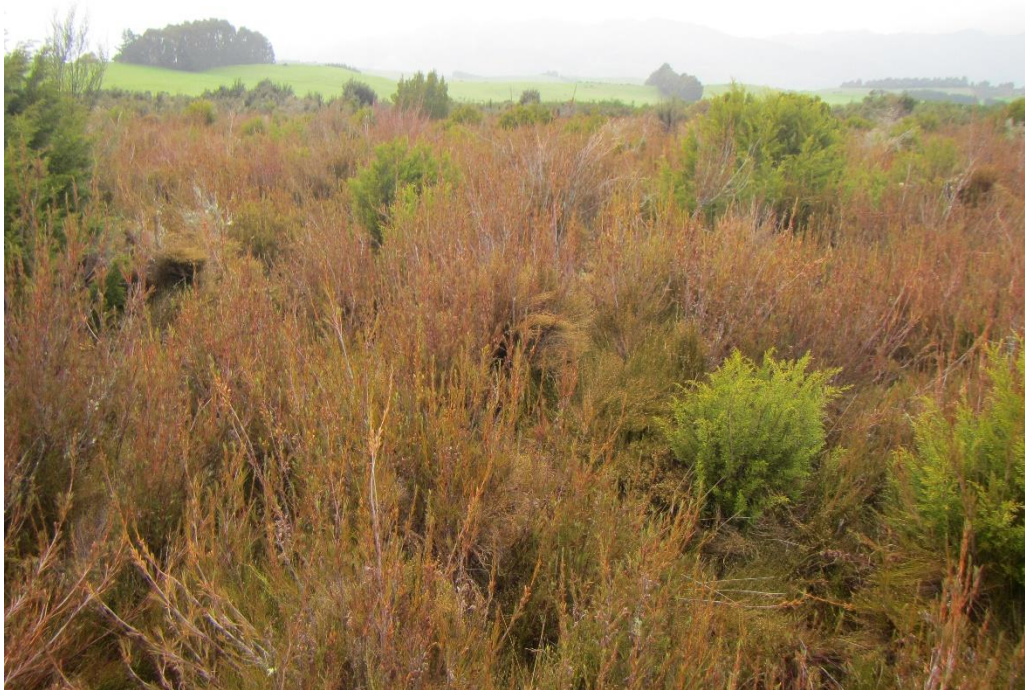
The larger, southern-most bog wetland was assessed on foot. Away from the wetland margins, the wetland was notable for a very high degree of intactness, with sizeable areas containing only indigenous plant species (mainly bog pine (*Halocarpus bidwillii*), wire rush (*Empodisma minus*) and *Dracophyllum* spp.) and no exotic species (Plate 2). This changed near drains that form a T-shape within the wetland. In these areas, pūkio dominated the drain margins, while Scotch broom and gorse dominated the mounds of excavated material beside the drains (Plate 3). Gorse also occurred locally slightly further away from the drains. The internal drains were excavated at some stage prior to 2007.

Plate 2: Intact bog wetland within the southern wetland, dominated by *Dracophyllum* spp. and bog pine.

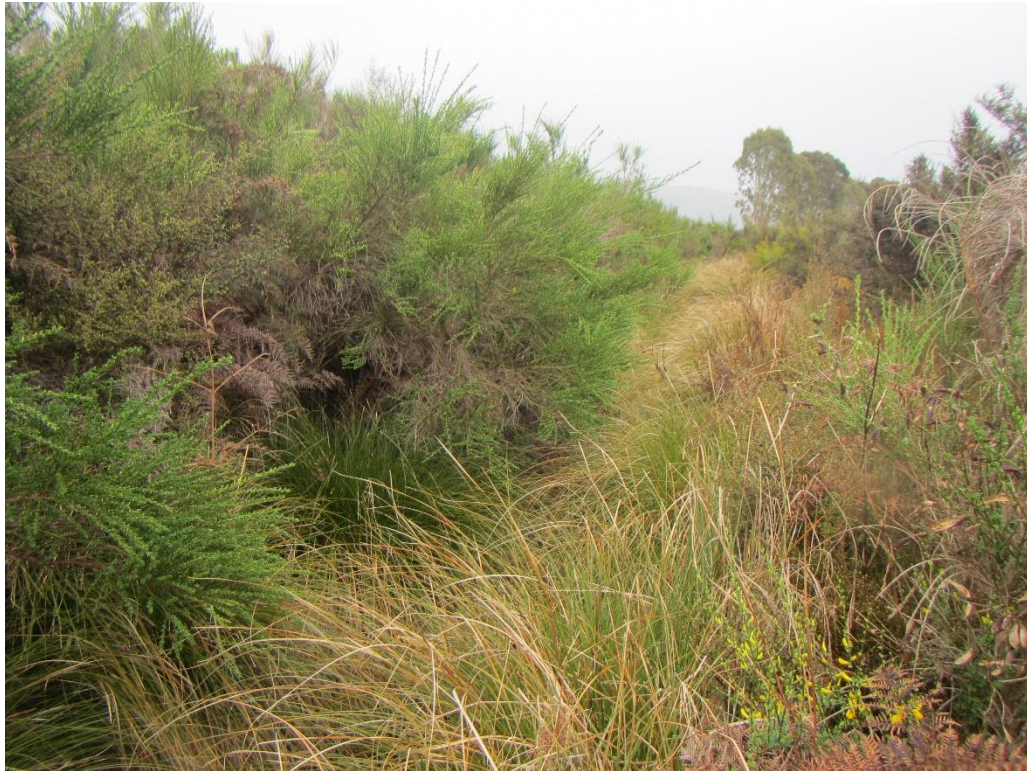
Plate 3: The drain through the southern wetland, with Scotch broom scrub on excavated mounds and pūkio sedges on the drain margins.

These wetlands would likely have been assessed as “At Risk” by Robertson *et al.* (2019) due to the presence of nearby drains, drains within the southern wetland, and areas of Scotch broom and gorse scrub adjacent to drains within the southern wetland.

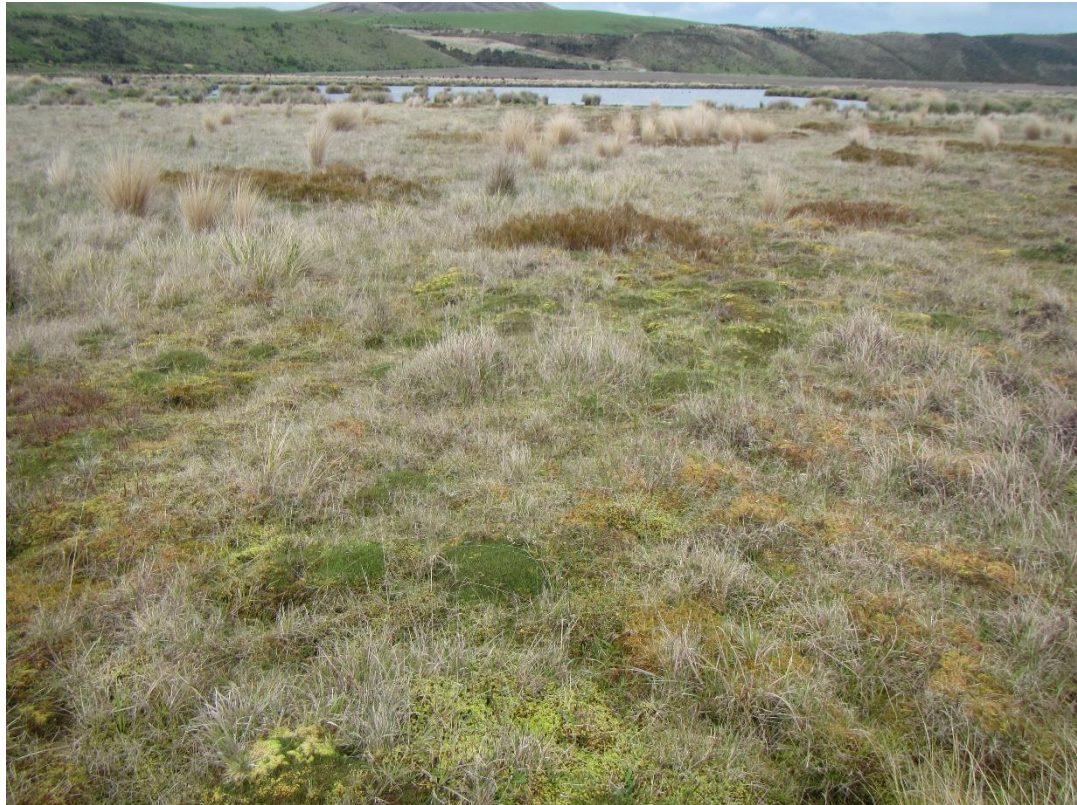
Plate 4: Cushion bog vegetation in the Mt Prospect wetland, with common exotic grasses among the cushion bog species, and the recently created pond in the background.

The wetland would have been assessed as “At Risk” by Robertson *et al.* (2019) because of the presence of drains within the wetland. At some stage after 12 January 2014 (outside the period analysed by Robertson *et al.* 2019), the wetlands have been significantly affected by pastoral development in the northwestern copper tussock marsh wetlands, and by excavation of a large pond in the modified cushion bog wetland (see the Inundation example, Appendix 2). These developments subsequent to 2013 have resulted in loss of approximately four hectares of copper tussock marsh and approximately 1.9 hectares of cushion bog.

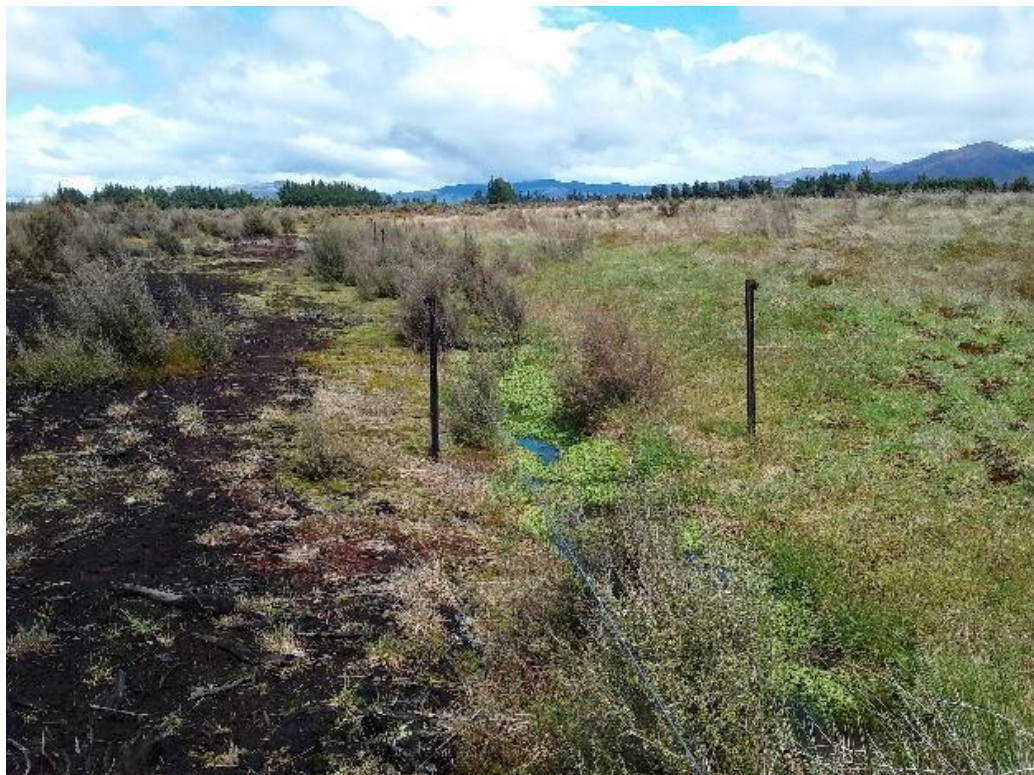
The wetlands classifications of Robertson *et al.* (2019) were only partly accurate, in part due to effects on wetlands occurring after the 2012 end date of their analysis. North-western parts of wetland 1364 (classified as “Gone”) still contained areas of indigenous wetland vegetation, albeit modified (Plate 5). There had been mechanical clearance in wetland 1384 (classified as “Little Change”) between 2013 and 2018, and the field assessment and discussion with the landowner for another part of this wetland indicated that it was also at risk of clearance, with historic drainage, and recent inundation and mowing. “At Risk” status would currently be more appropriate for this wetland. Northern parts of wetland 1367 (classified as “At Risk”) would be currently classified as “Gone”, with indigenous wetland vegetation having been replaced by the exotic soft rush over pasture (Plate 6).

Plate 5: Drain, humping and hollowing, and indigenous vegetation in wetland 1364 (classified as “Gone”, but retaining some wetland character).

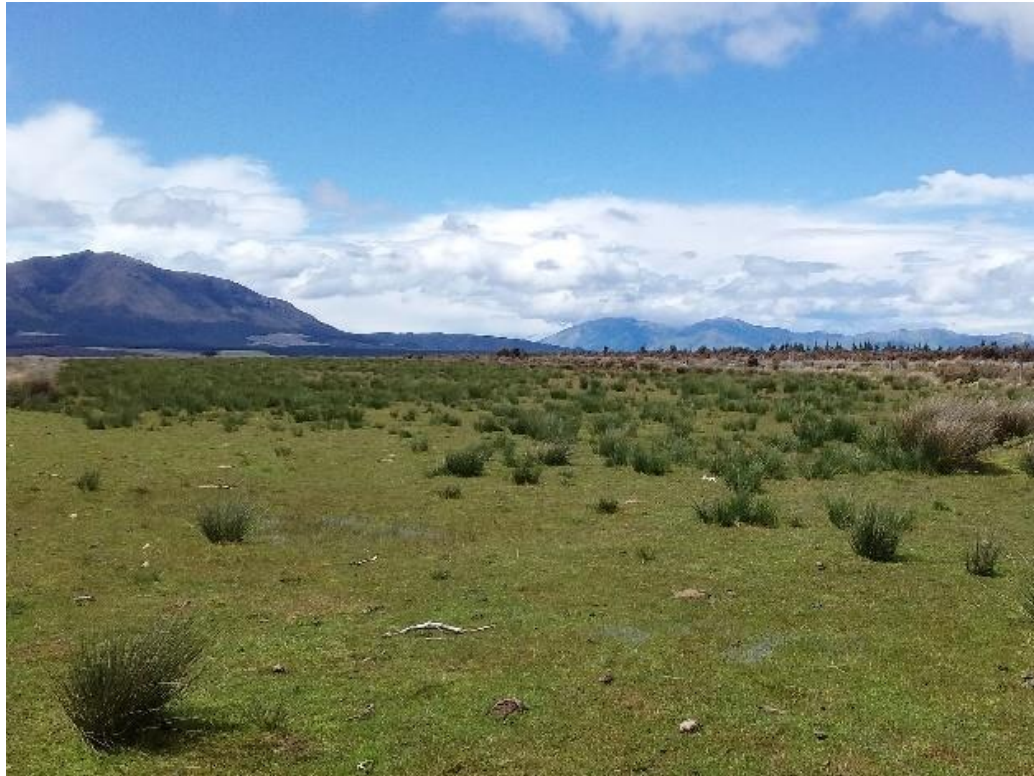
Plate 6: The northern part of wetland 1367 (classified as “At Risk”) comprises soft rush/pasture.

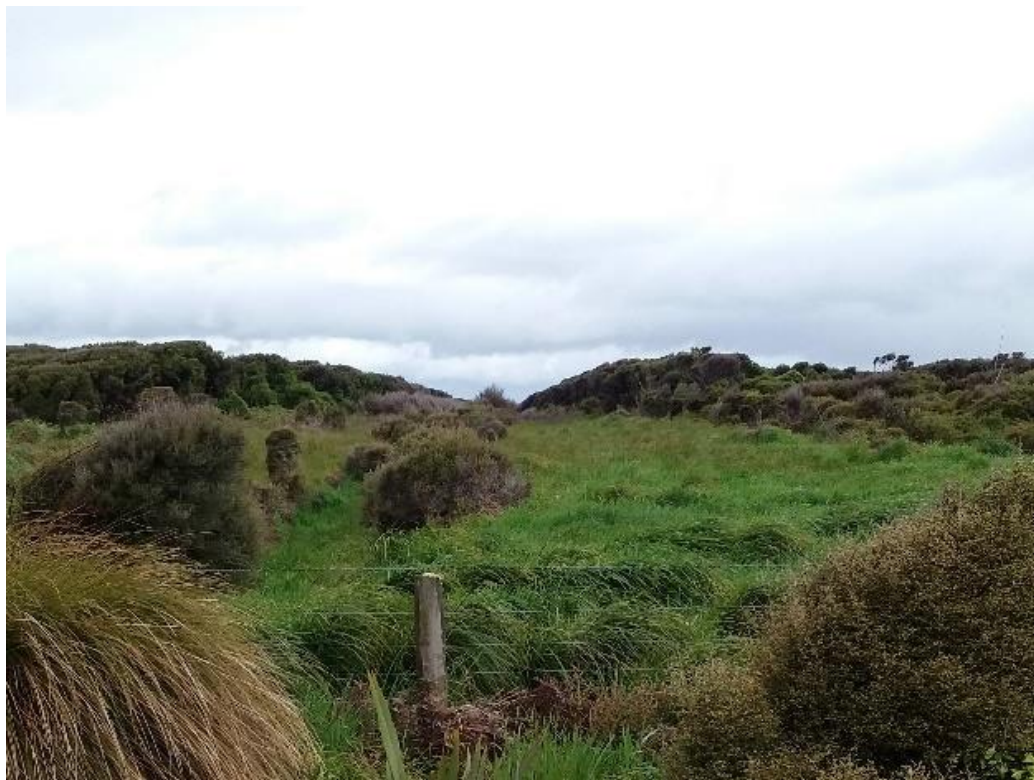
The wetland status classifications of Robertson *et al.* (2019) are now partly out of date for these wetlands. The privately-owned wetland (classified as “At Risk”) did not appear to have any recent activity in it, and apart from the historic drains and a low incidence of marginal weeds, wetland condition was relatively good (Plate 7). The “At Risk” status would have been applied due to the historic drainage and is still appropriate. However, the wetland closest to Ryan Road (classified as “Little Change”) had been partly cleared and a marginal drain excavated between 2010 and 2011. An “At Risk” part of the wetland to the south is protected by QEII covenant, but the classification likely relates to the presence of marginal drains. The boundaries of the wetlands just to the south of Chisholme Road and in the southeast of the property that were classified as “Gone” were largely correct (Plate 8). However, a large proportion of the “At Risk” part of the wetland in the central part of the site is also now “Gone” or nearly so. The part of the wetland in the southwest (classified as “Little Change”) appears to have been sprayed with herbicide between 2011 and 2013 (the vegetation has now partially recovered), which may have been a result of overspray when former wetlands further to the west were cleared.

Plate 7: Large drains and historic clearance of tall mānuka on the at risk wetland on private land.

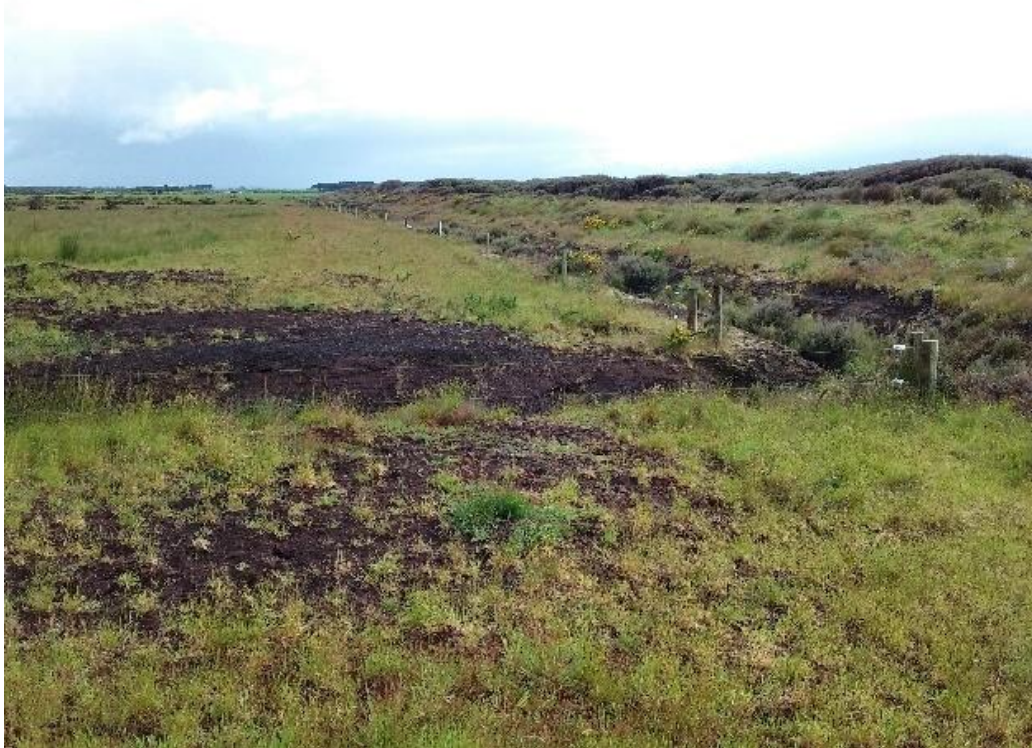
Plate 8: Drains in former wetland partly cleared between 2011 and 2013 (classified as gone), with likely overspray of herbicide occurring over the same period onto now partly recovered mānuka to the right (classified as little change).

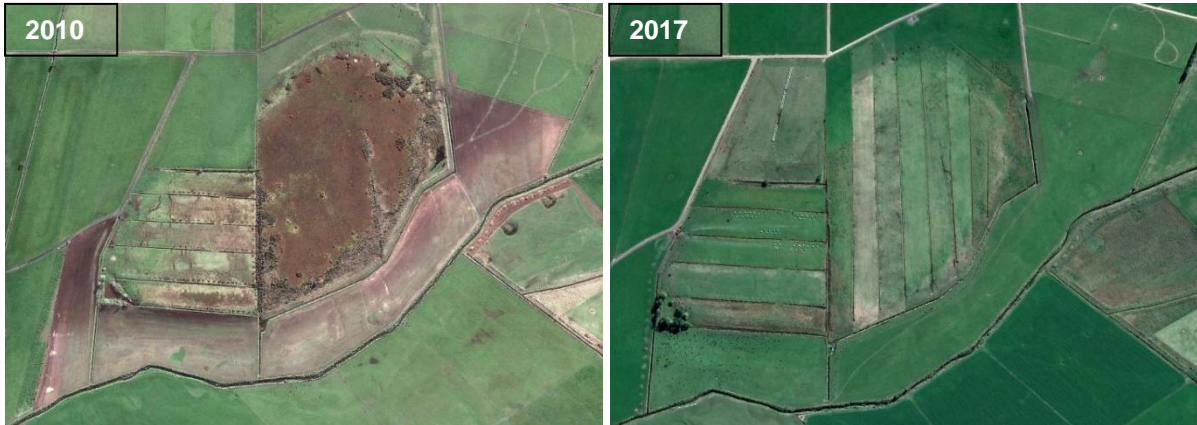
Drainage and mechanical clearance in Wetland 1589, Southland Plains.

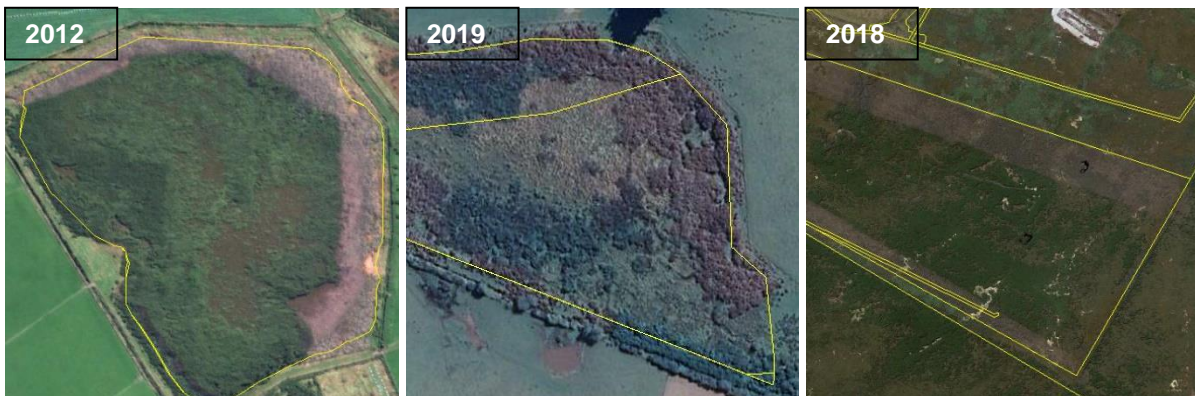
Herbicide application in Wetlands 163 (left) and 507 (middle), which was mostly of gorse on wetland margins, and what appears to be bands of aerially-applied herbicide in Wetland 174 (right).
