# **Environmental Baseline Assessment of freshwater** resources, and characteristics of soils, surrounding proposed rapid infiltration site, Lake Rotoiti

## Ricky Singh & Megan Balks

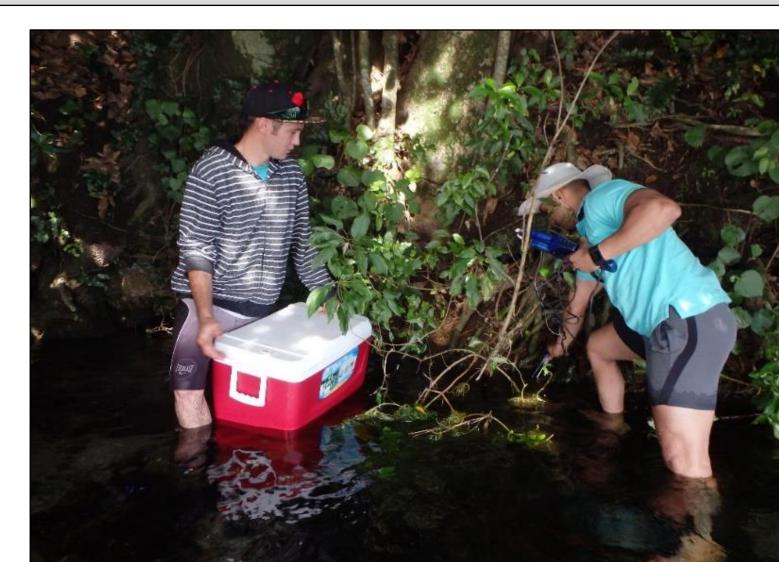
On site water analysis and sample collection

- Water was sampled from five puna (springs) on the margin of Lake Rotoiti, and from ambient lake water.
- The spring and lake water sampled were all of excellent quality meeting guidelines for swimming, ecological standards, and even New Zealand drinking water standards.
- The springs had a higher nutrient content compared to the surrounding lake water; indicative of possible contamination from septic tanks.

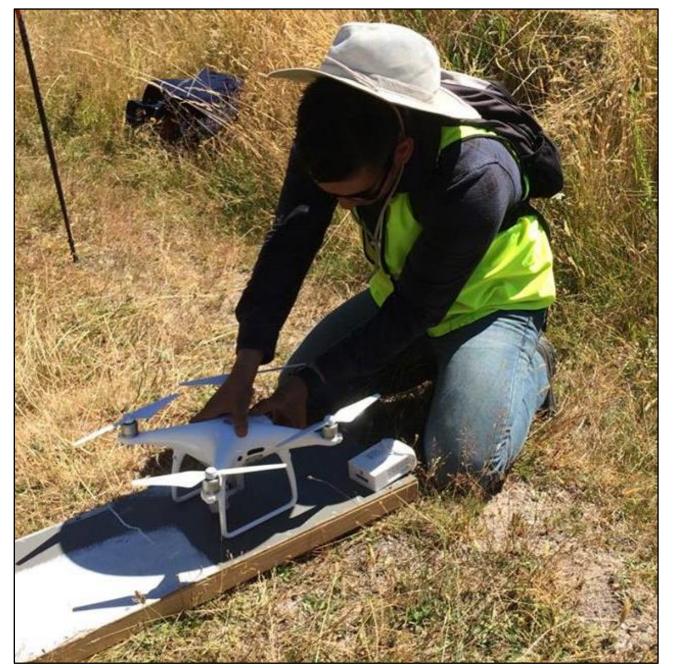
Topographic Analysis (Drone)

- A DJI Phantom 4 Pro Drone and soil analyses with field and laboratory tests were undertaken to understand the topography, potential, and characteristics of soil at the site.
- Soils are formed on scoria deposits of the Tarawera eruption (10/06/1886) which overlie the graded deposits of pumice from Kaharoa Tephra (1314 ± 12 AD) that rests on Rotokawau Tephra (3710 ± 100 AD). The soils were classified as Typic Orthic Pumice Soils belonging to the Rotoiti Series.

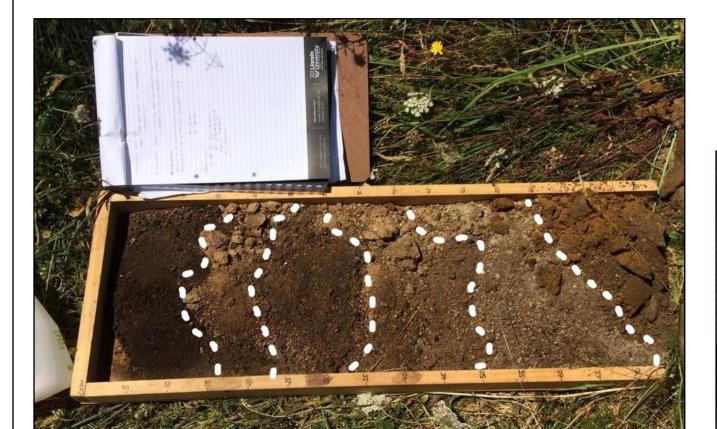
Soil Sampling

- The soil horizons generally comprised gravelly sand, with low dry bulk density, high root penetration, low water retention and low concentration of nutrients.
- The 2bBw horizon, a paleosol formed from Rotokawau tephra, has a higher moisture content and cation exchange capacity than the Bw and Cu horizons.

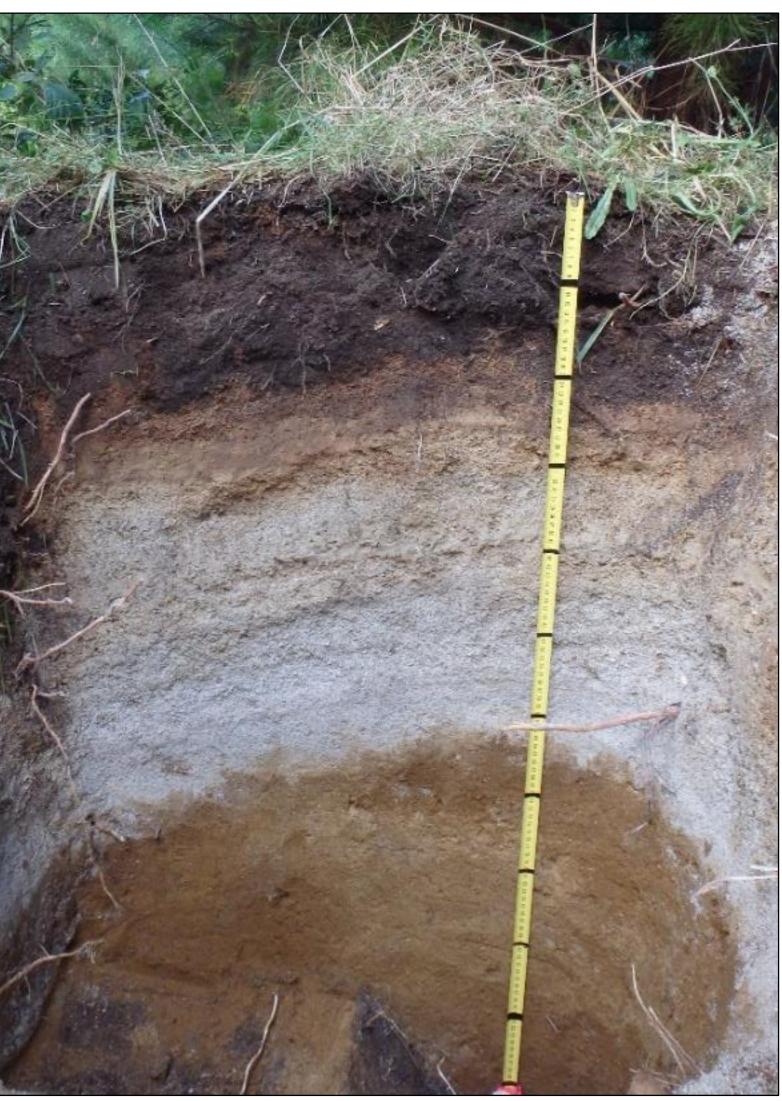
Typical soil profile at study site

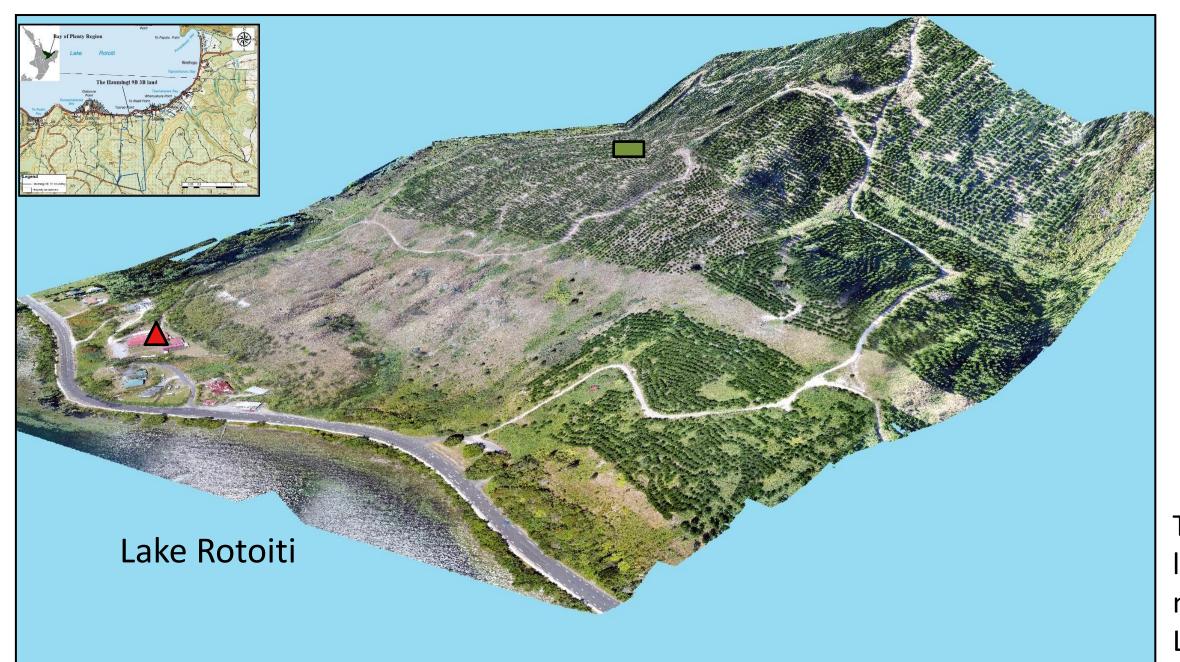
Topographic map displaying location of the study site. (Base map and property boundary: LINZ Data Service, Undated

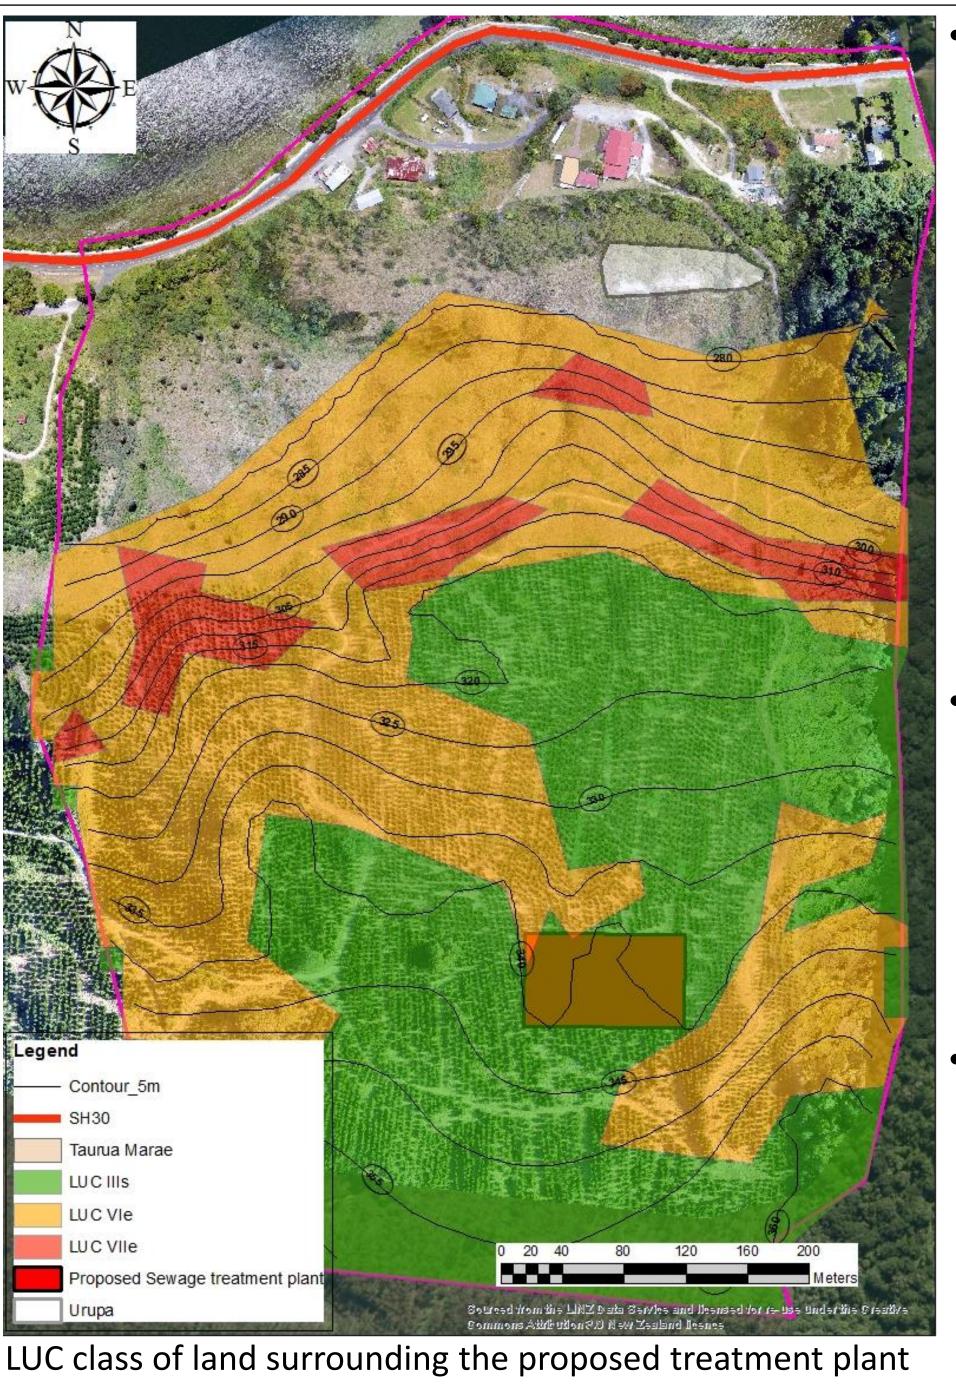
- The steeper slopes 1.9 hectare space (LUC class VIIe) can be utilised for permanent vegetation such as native forest, pine forest, or for Manuka cultivation. The rolling slopes (14.4 hectares, LUC class VIe) can be used for harvestable permanent crops such as harakeke, energy crops for e.g. coppiced poplar, willow or eucalyptus.
- The undulating areas (13.7) hectares, LUC class IIIs) can either be used for all the options above or other high value small scale crops e.g. flower production.
- The undulating areas could potentially be used for an exclusive accommodation tourist venture as the location has attractive views and can be incorporated with cultural experience.

- The soils were generally sandy in nature with minimal clay thus prone to severe wind, sheet, and rill erosion with the potential for gully erosion if left exposed during heavy rainfall.
- There is potential to cultivate crops other than pine forestry if the site is irrigated with treated wastewater.
