Improving Knowledge of Bank Erosion Processes in Southland

Authors: Jane McMecking & Tim Ellis

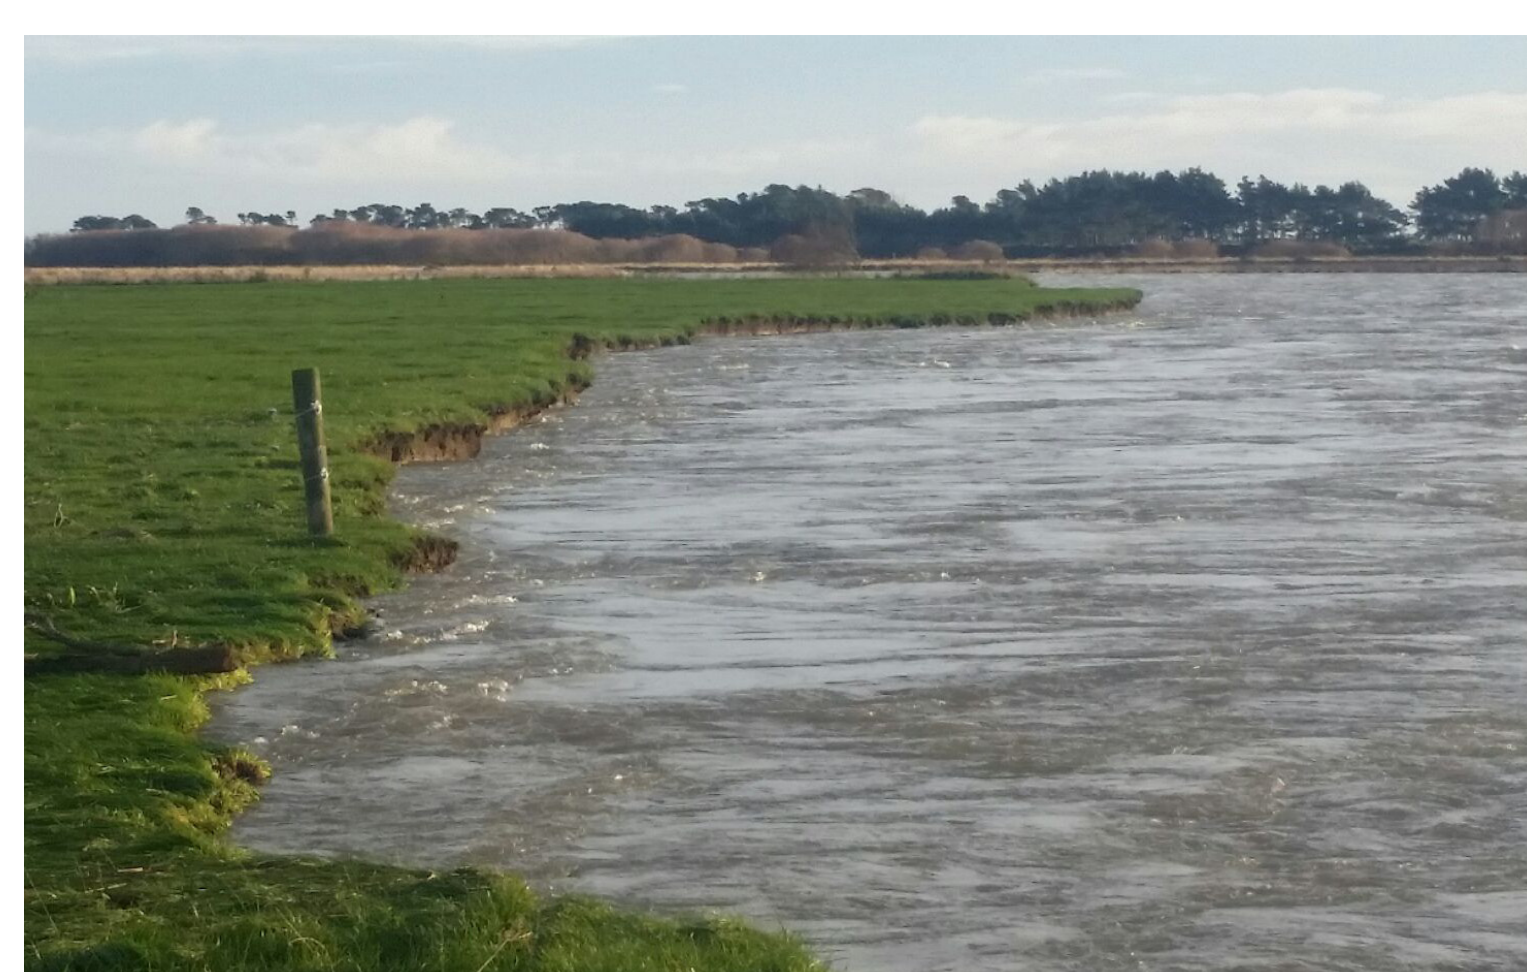
▶ Lower Waiau River – regulated by the Manapouri Power Scheme and heavily influenced by flooding.

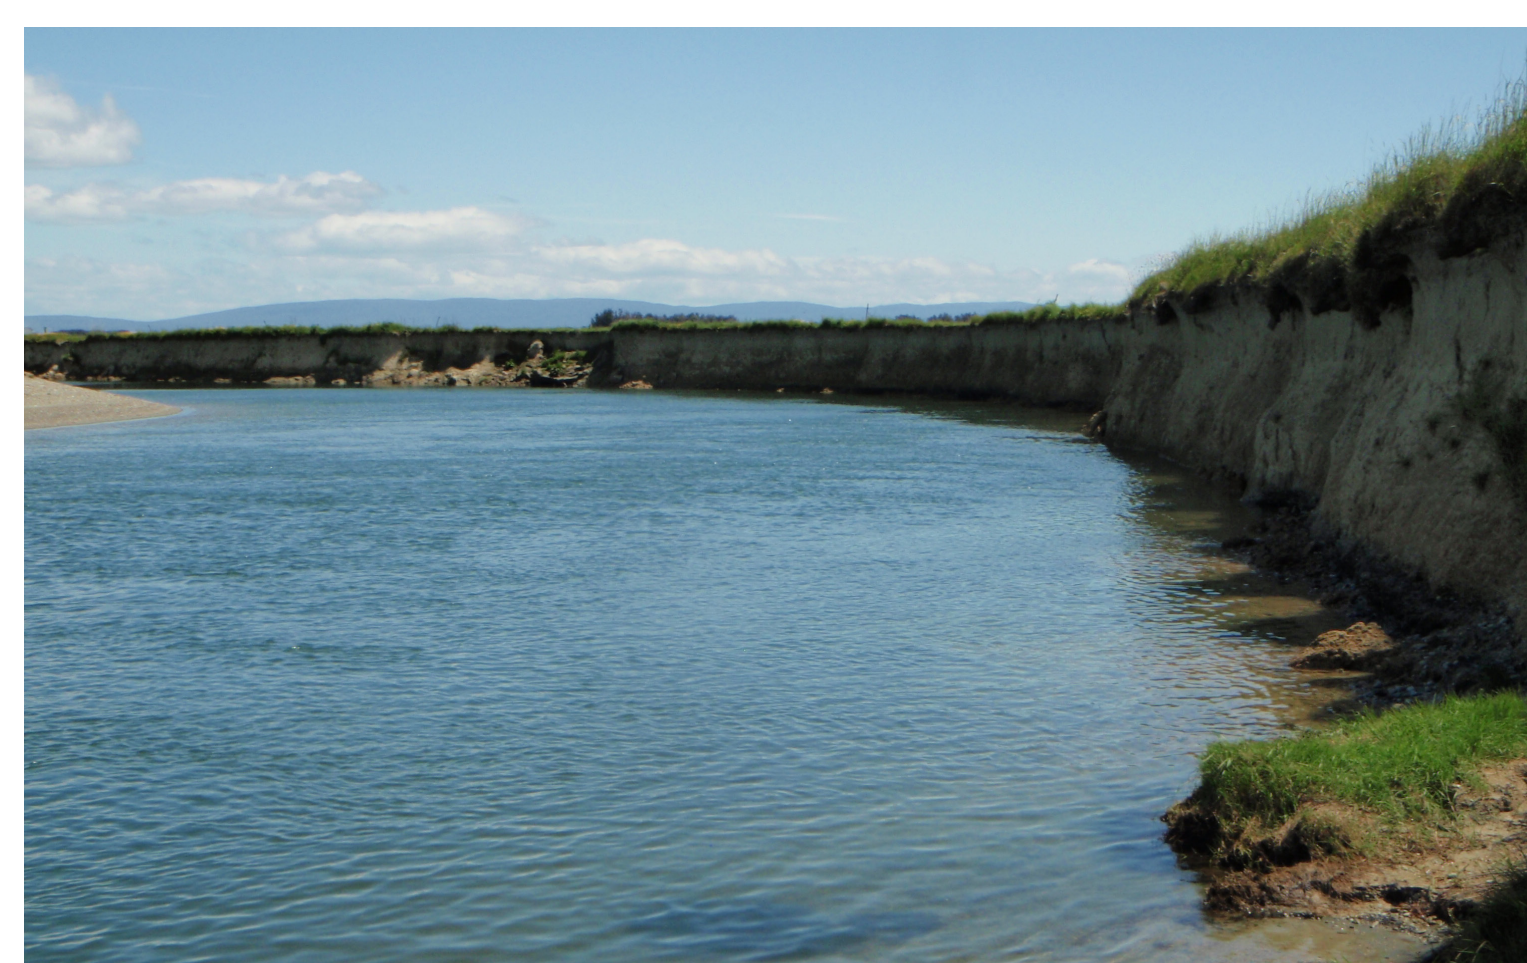
▶ Lower Oreti River – meandering lower reach, flowing into the New River Estuary which has been affected by modification.

Estimates of change in the lower Oreti River ranged from 80 to 100 metres perpendicular to the river.

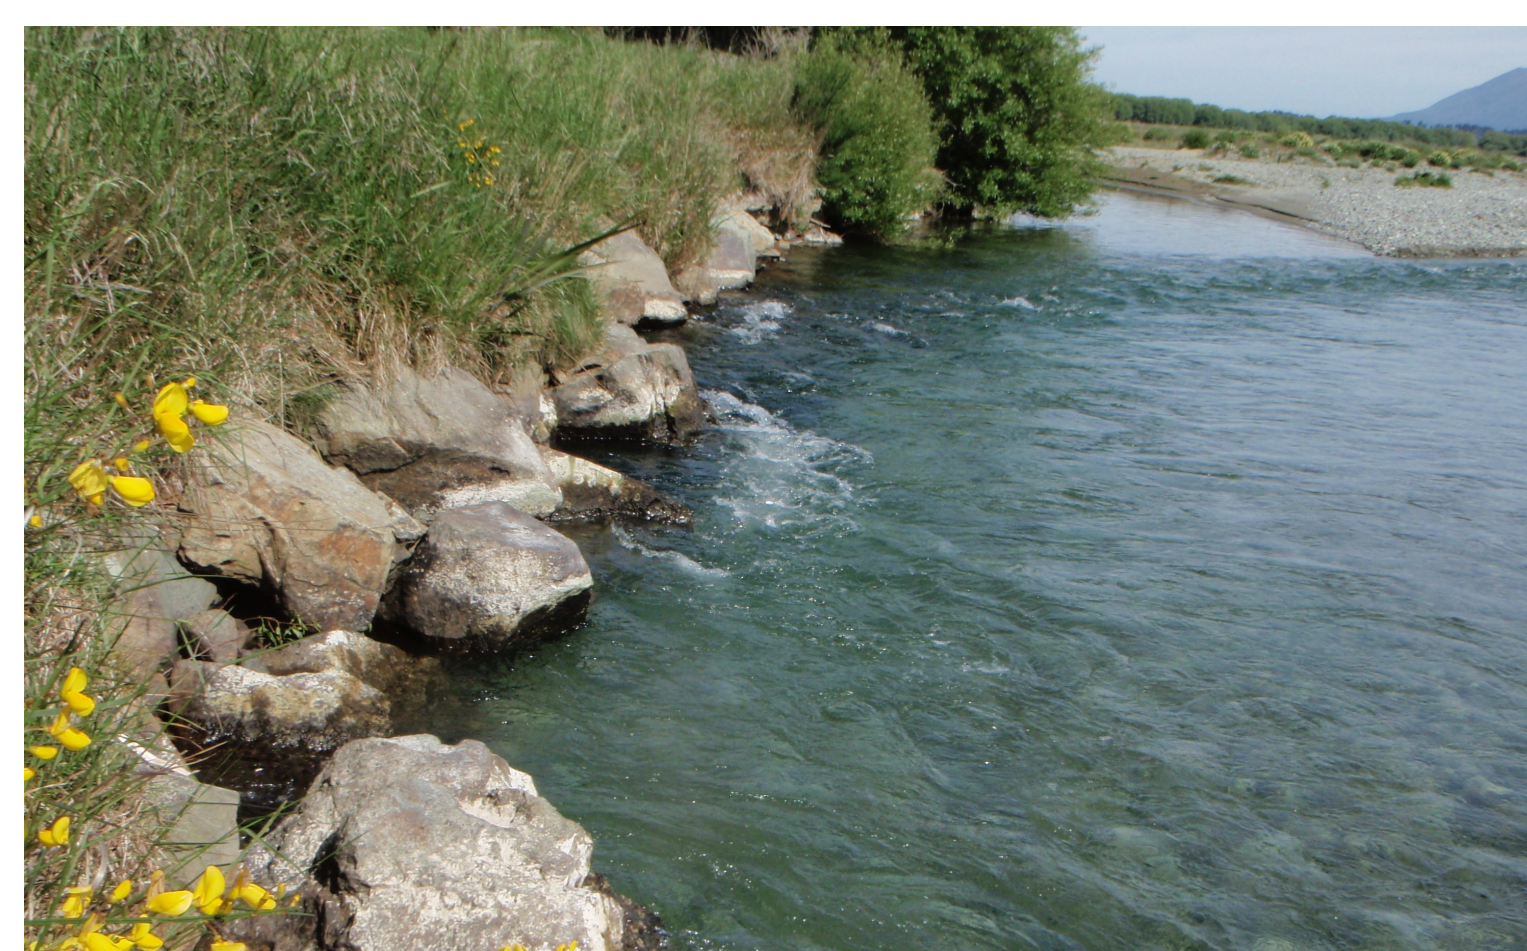
▶ Upper Oreti River – bank erosion arrested by rock protection put in 2007 to protect the bridge abutment.

Estimates of change in the upper Oreti River River ranged from 40 to 80 metres perpendicular to the river.

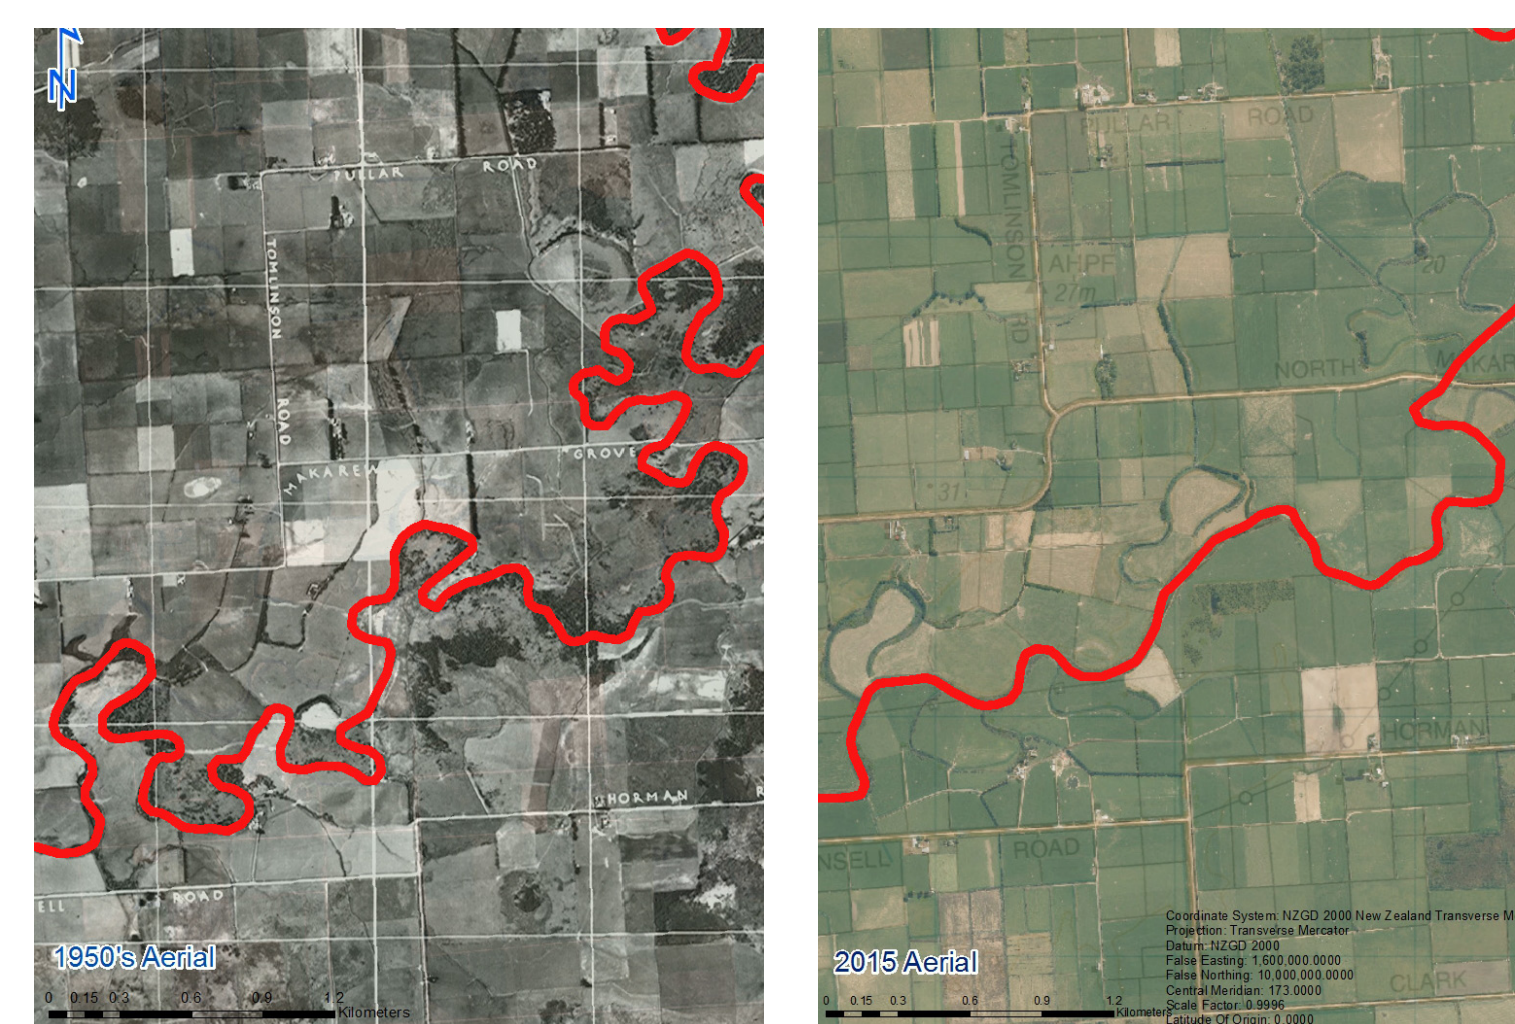
▶ Makarewa River at Counsell Rd – 1950s

▶ Makarewa River at Counsell Rd – 2015

Digital photos, tape measurements and field notes were taken at each site. ArcGIS was then used to compare 1950's aerial photos to 2014 aerial photos and calculate an estimated bank migration rate.

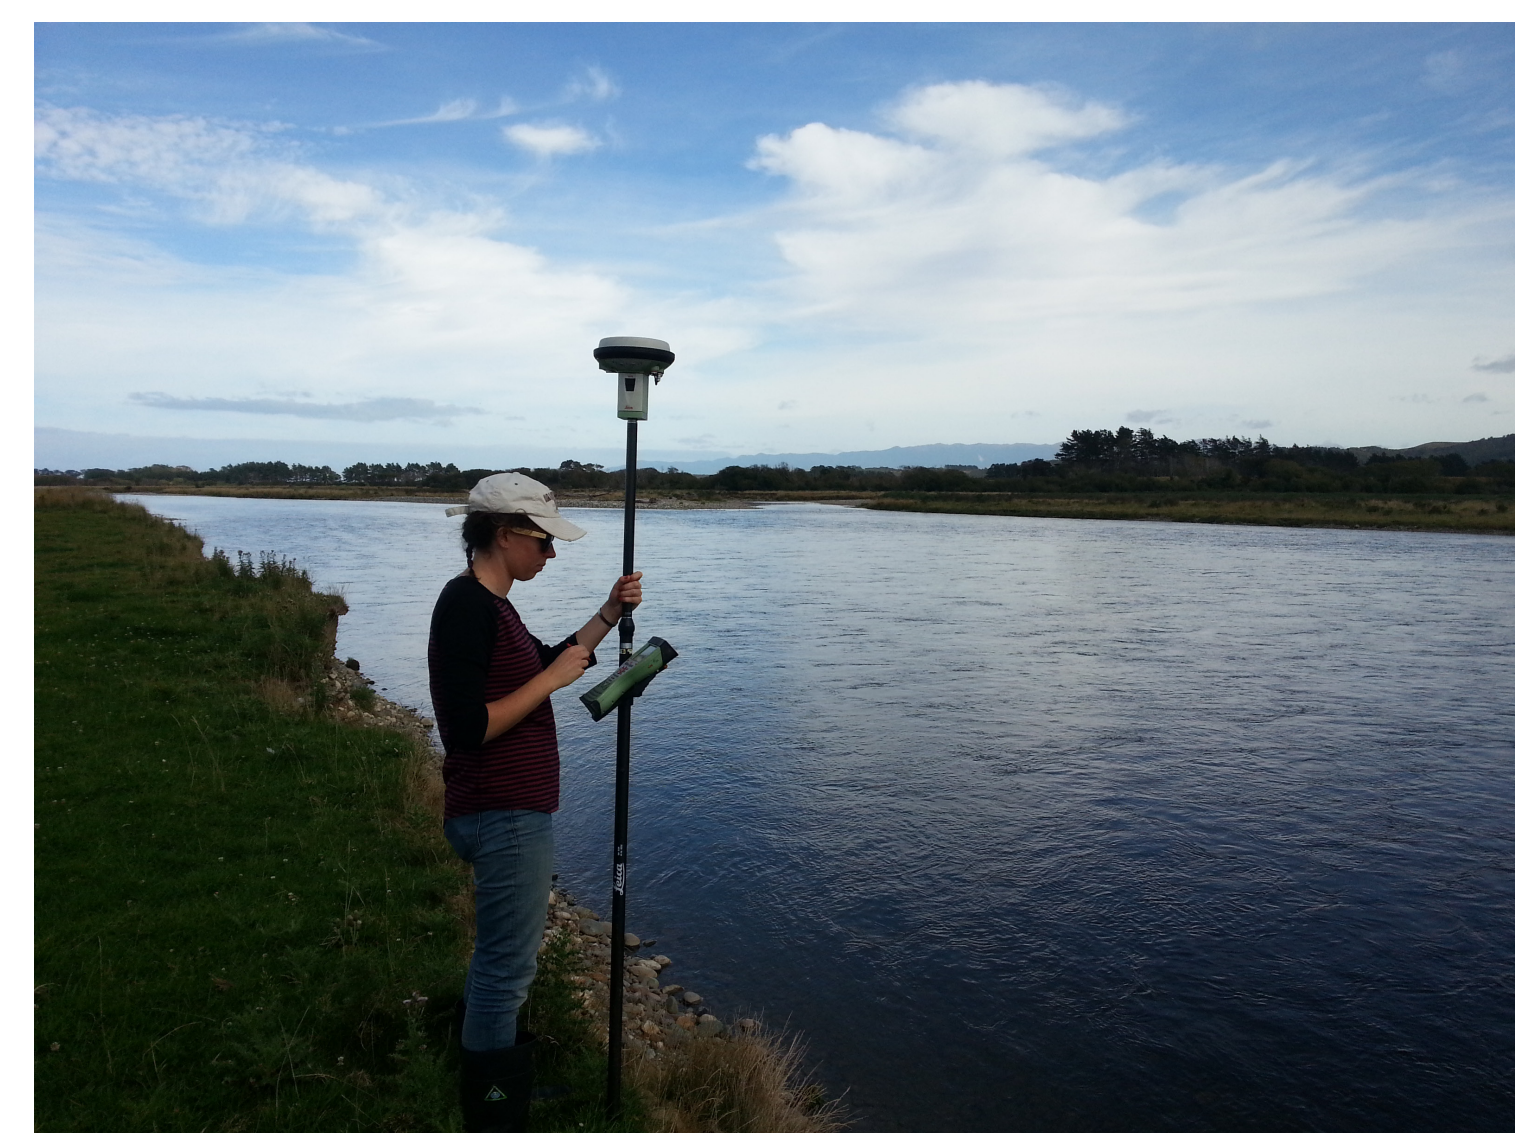
▶ A RTK measures bank erosion on the lower Waiau River site.

At the lower Waiau River site a Real Time Kinematic (RTK) was used to measure erosion. The RTK is an extremely accurate device that aims to reduce and remove both vertical and horizontal positional errors. A Global Navigation Satellite System is connected to a handheld controller which increases the accuracy to tens of millimetres.

RTK GPS coordinates were taken at 2-3 metre intervals along the two metre high river bank where bank erosion was evident. The data was then transferred to ArcGIS to calculate an estimation of bank migration.

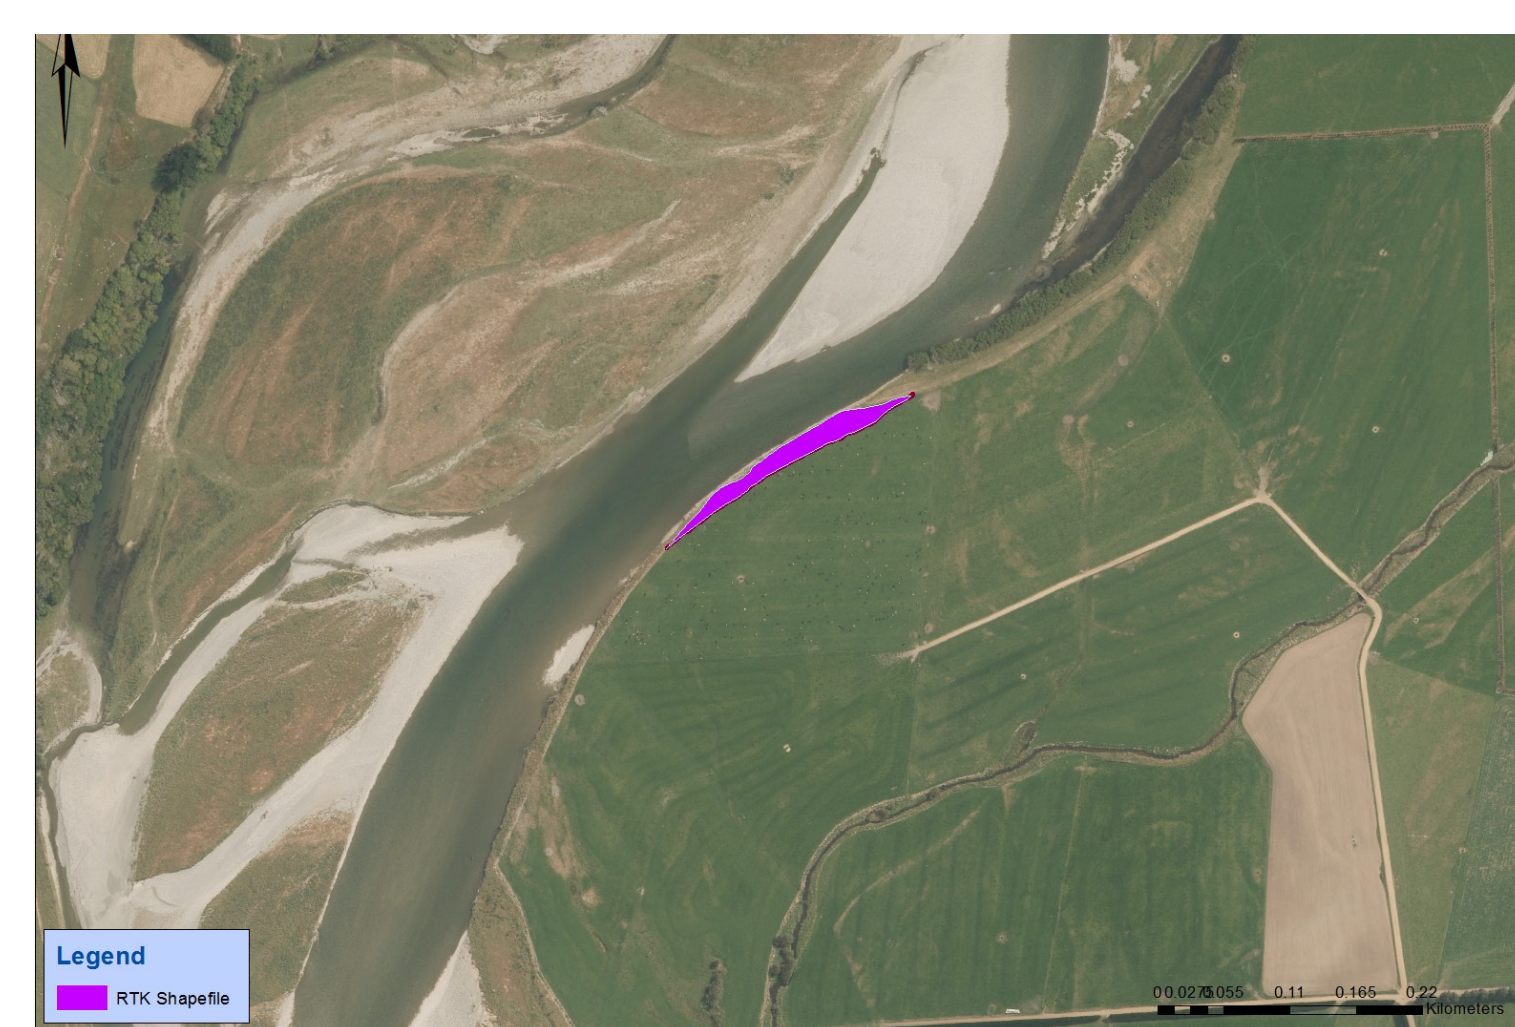
▶ Bank erosion in the lower Waiau River.

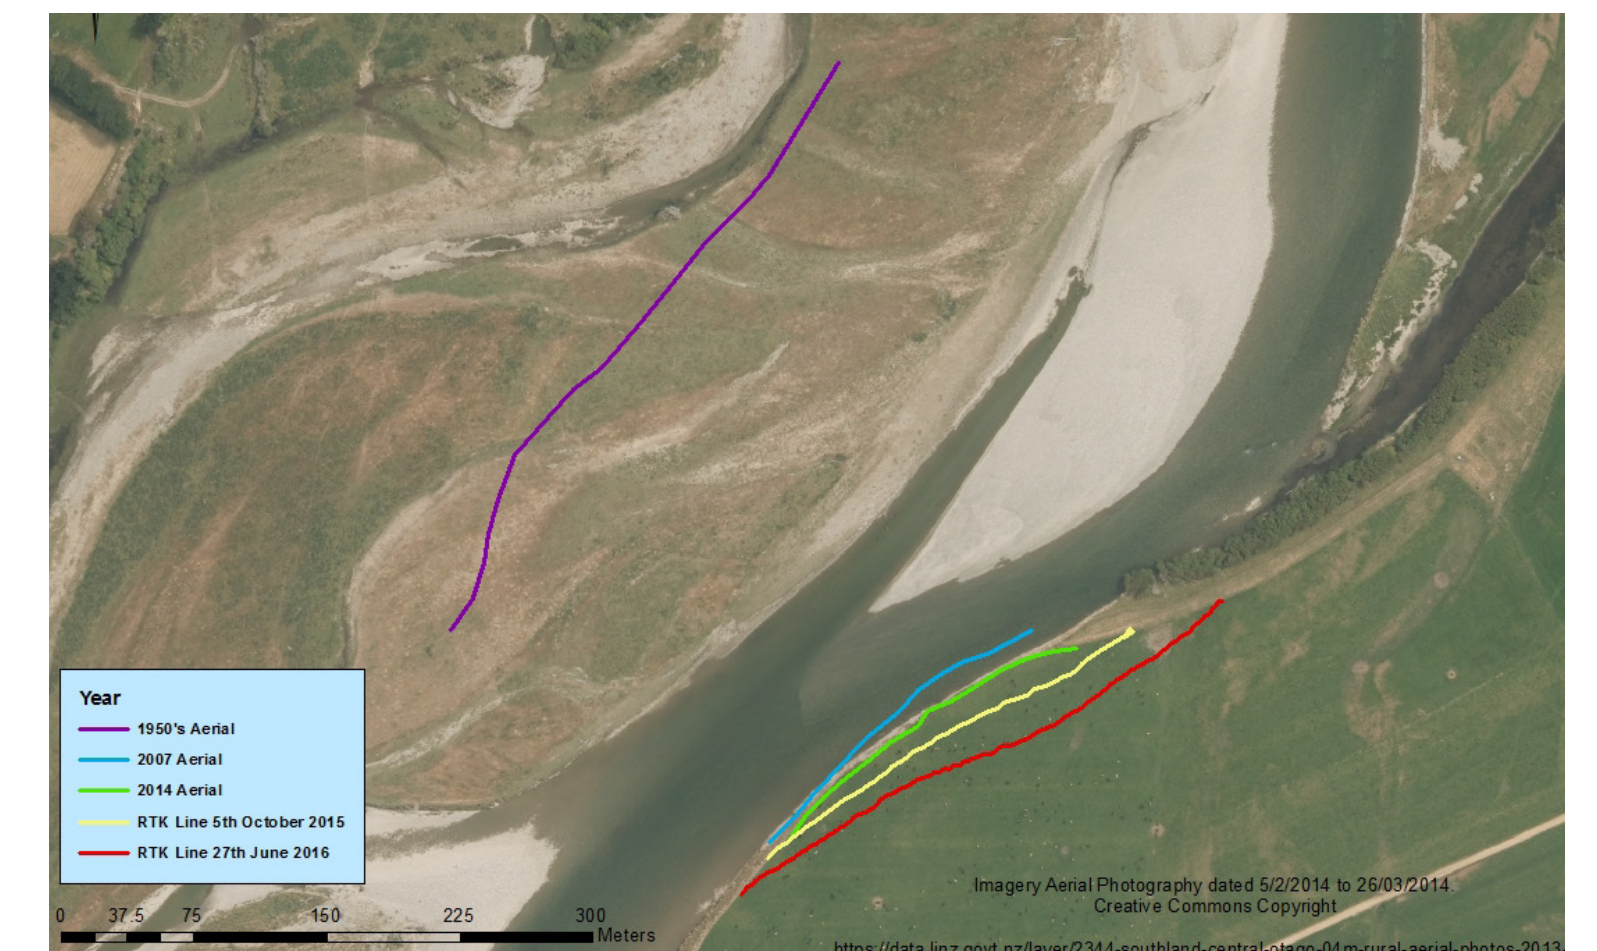
The Lower Waiau River case study estimated 2781m² of bank erosion had occurred, comparing RTK measurements from 20 October 2015 to aerial photography from 2014.

▶ Bank erosion in the lower Waiau River.

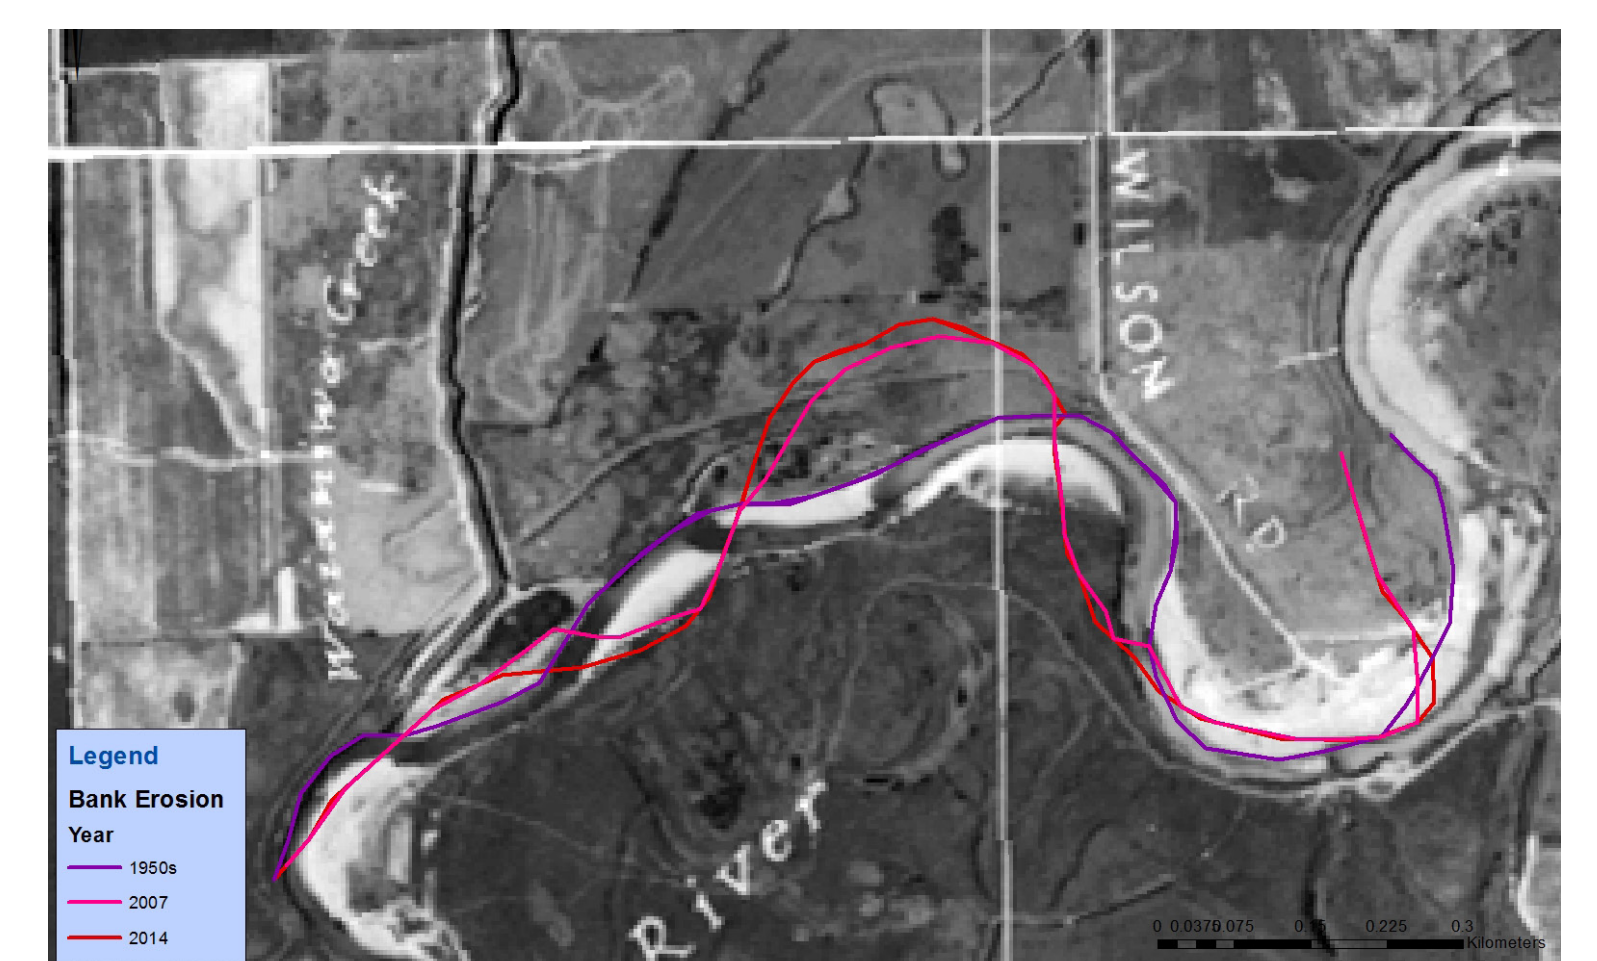
▶ Geomorphic change in the lower Oreti River.

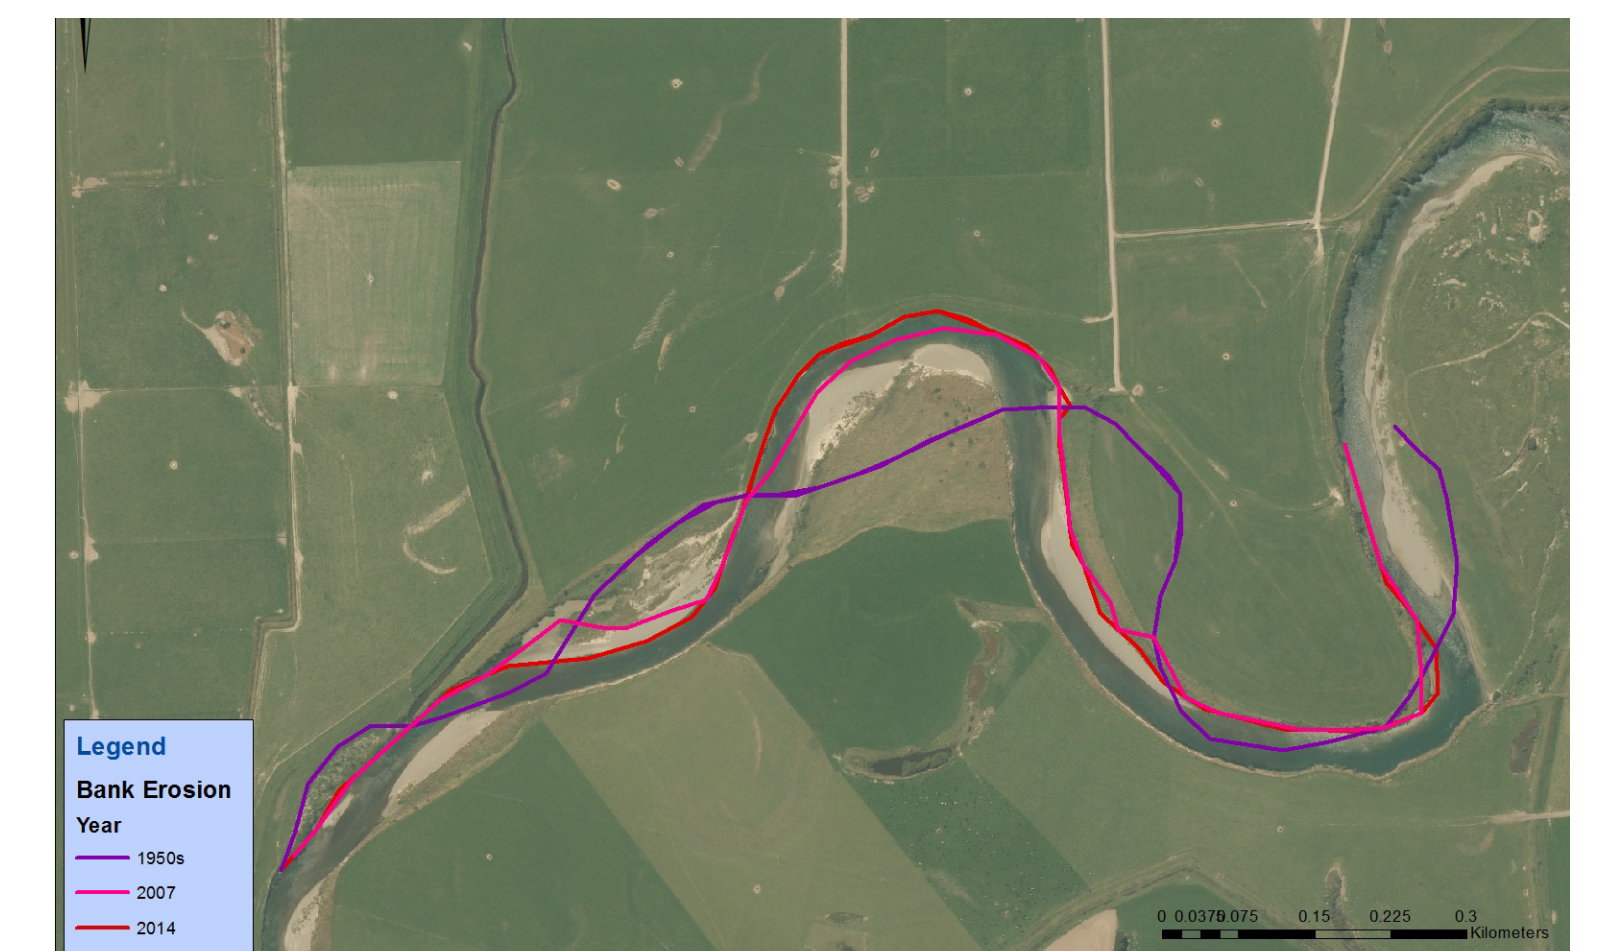
▶ Geomorphic change in the lower Oreti River.

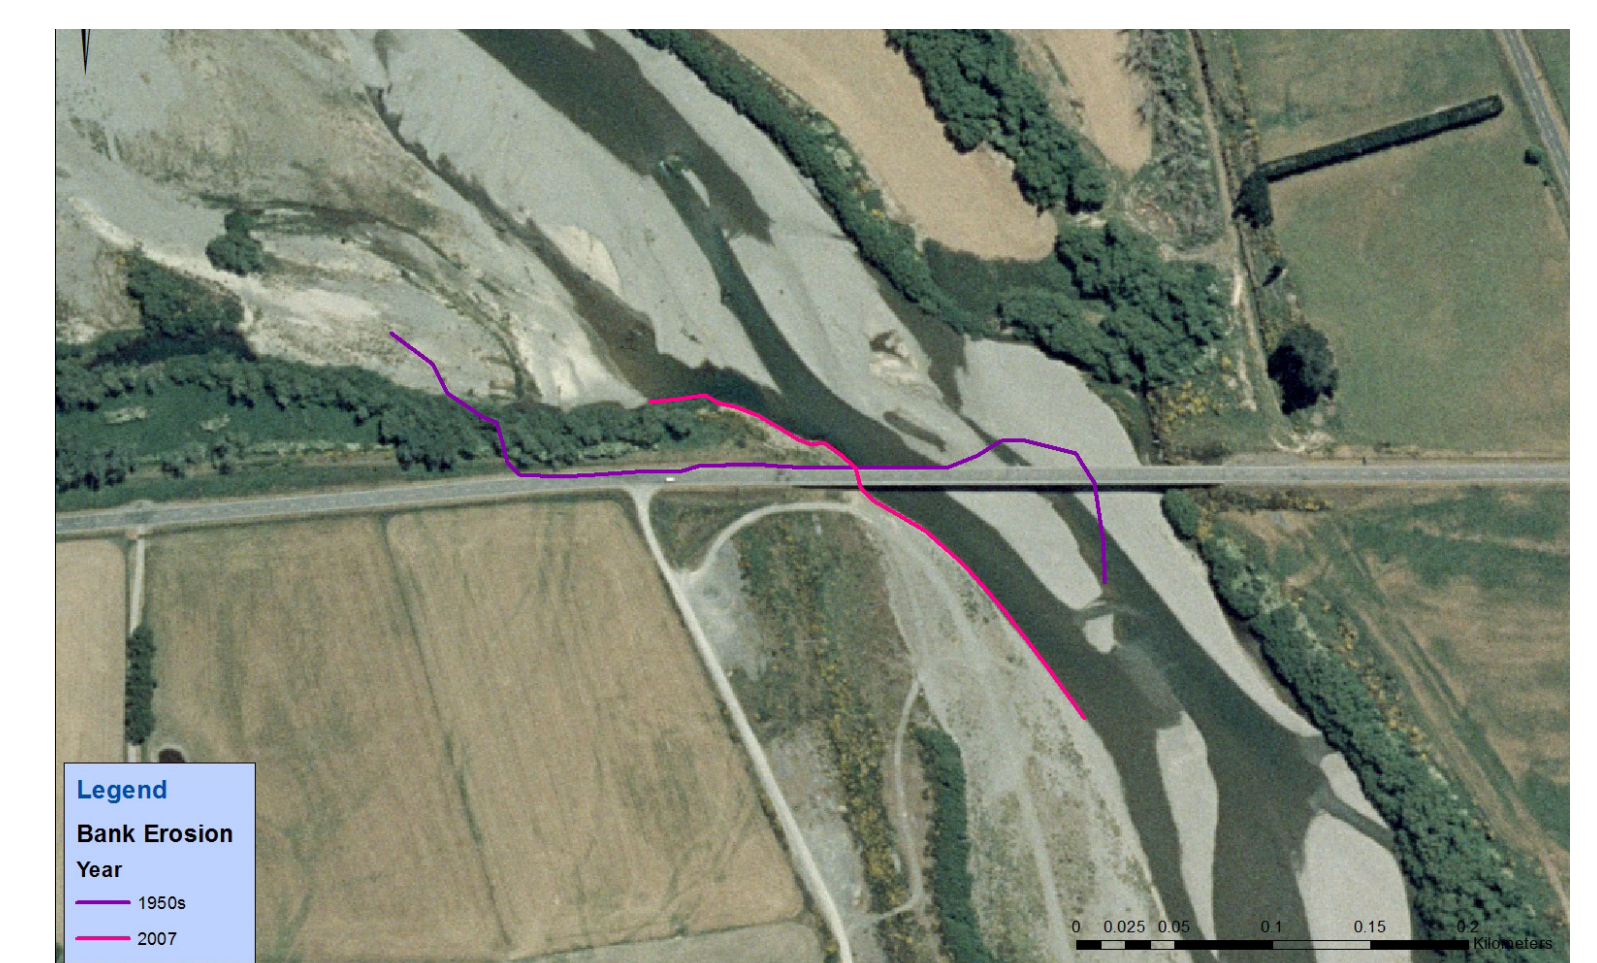
▶ Geomorphic change in the upper Oreti River.
