Protecting coastal lakes from eutrophication

Multiple lines of evidence converge on critical nutrient loading thresholds to maintain ecosystem health

The system: Waituna Lagoon, South Island, New Zealand

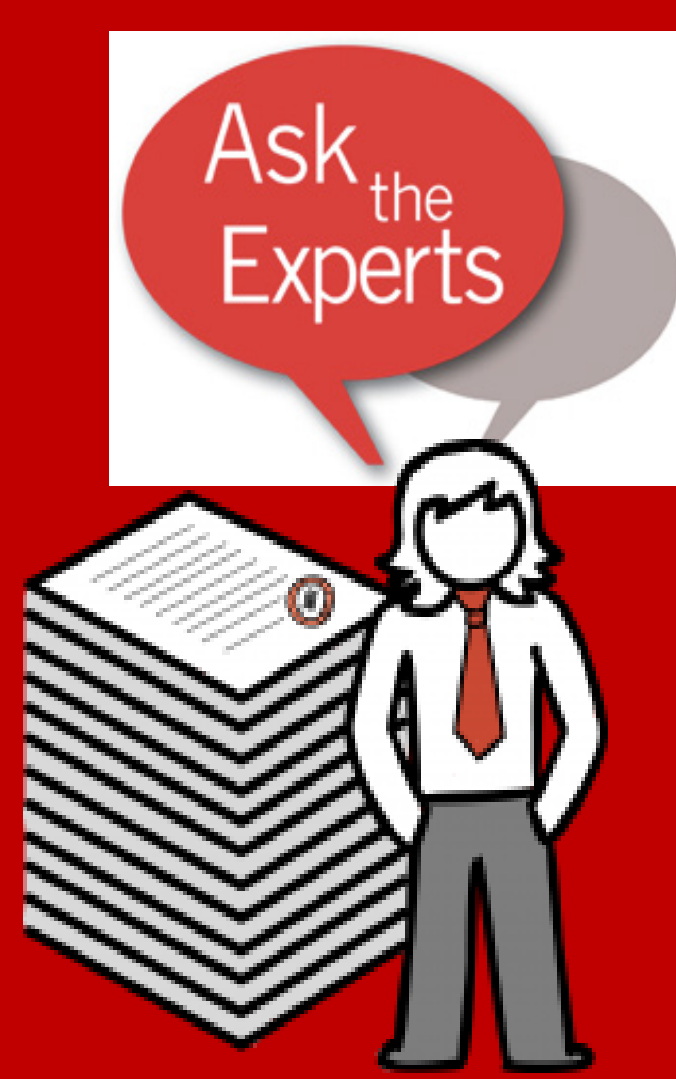
1. Expert Assessment

- Received Waituna data
- Compared Waituna's state with that of barrier bar lakes and lagoons from New South Wales, Australia
