Stop your nutrients going underground

New wintering pad details

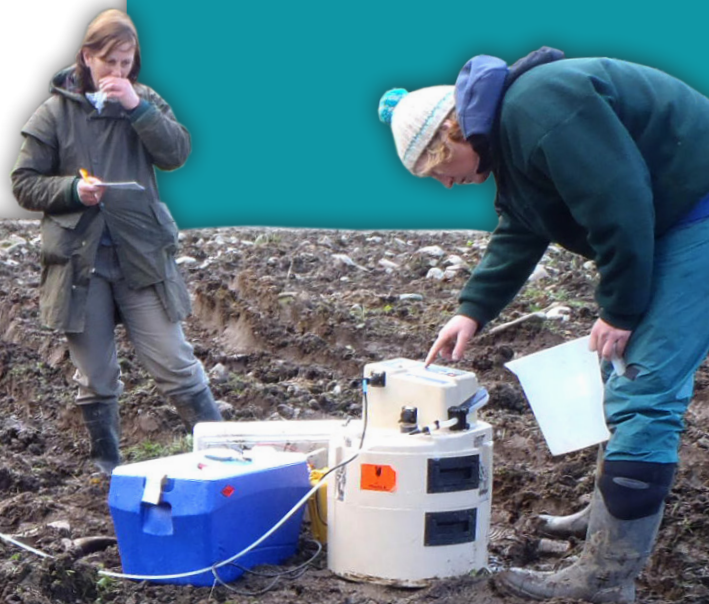
In October 2013 a wintering pad in the Aparima catchment fairly typical of many others around Southland, was investigated to see whether it was having an effect on the groundwater below. Samples were taken of soil water, groundwater from below and around the site, and the nearby stream. The aquifer below the wintering pad was also assessed using an electromagnetic conductor to detect chemicals in groundwater, allowing scientists to see the depth and extent of contaminated water. This revealed a plume of nitrogen-rich groundwater six metres in depth moving through the aquifer gravels into the stream 120 metres away.

In October 2014, after a year without use, the original wintering pad site was tested again to see what was happening to the contaminated plume of groundwater. This aquifer is closely connected to the stream, so groundwater was rapidly leaching. Results show that the plume is disappearing and scientists predict that it should be back to normal levels in three years.

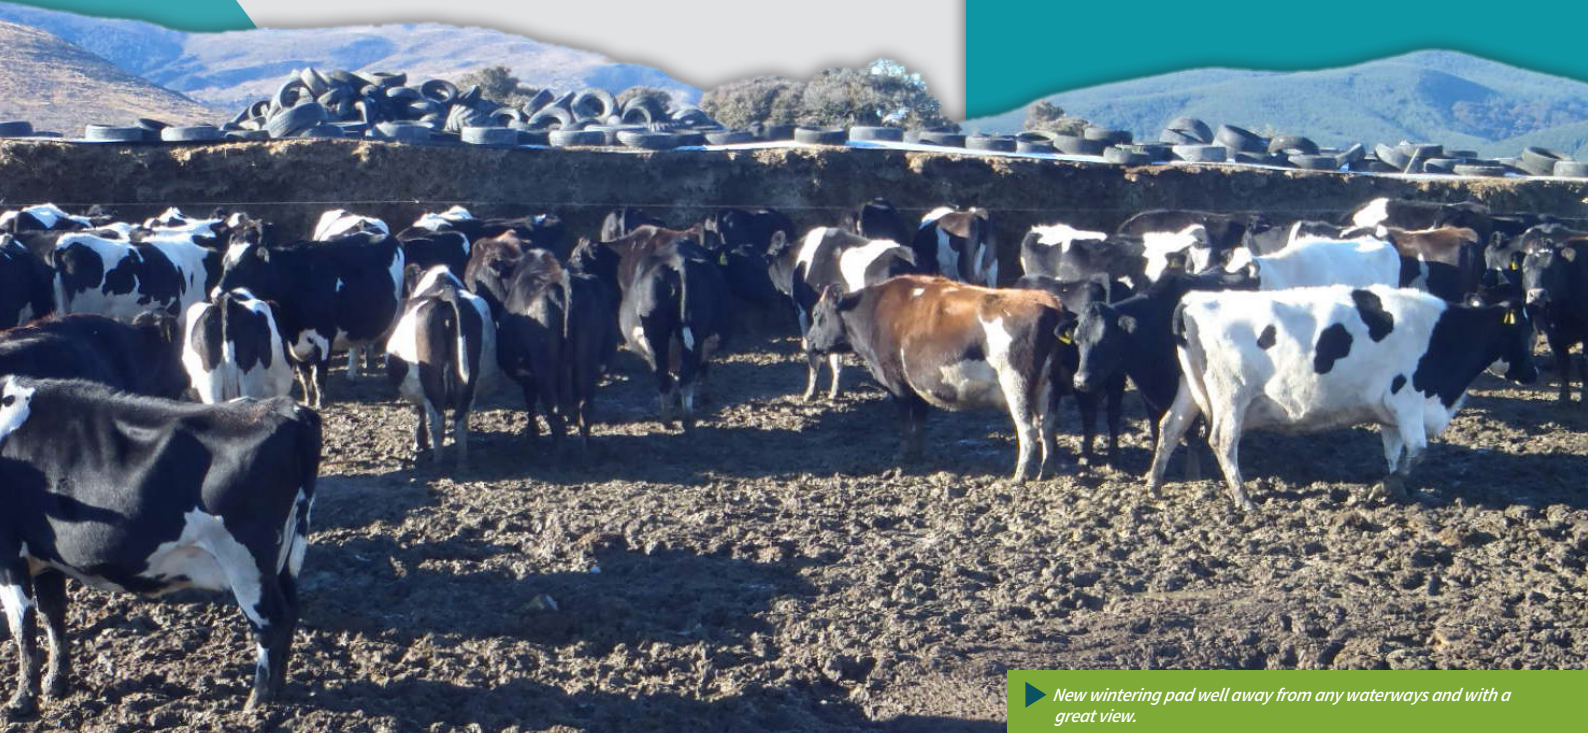
▶ *New wintering pad well away from any waterways and with a great view.*

Having confirmed the leaching from the wintering pad and the connection to the nearby stream, a new wintering pad was developed and located well away from any waterways on land not prone to leaching. The new pad has a base constructed from compacted rock to further reduce leaching. It is designed to collect most of the animal waste, which is spread back onto pasture or cultivated land.

LOCATION:	Aparima catchment
SIZE:	35m x 35m for 99 cows (no consent required*)
SITE:	Stony ridge top, well away from any waterways
BASE:	Compressed quarried rock on top of naturally hard stony land
DESIGN:	Silage stack on the higher end with effluent collection section at the bottom
STOCK:	Rest in a fenced area moving in and out of the wintering pad when hungry
EFFLUENT:	Majority deposited on wintering pad rock base
COSTS:	\$2500 for digger and rock cartage
