Environmental Compliance Monitoring Report

2010/11

Report by –
Environment Southland
Compliance Division

Environment Southland Publication No 2011/8

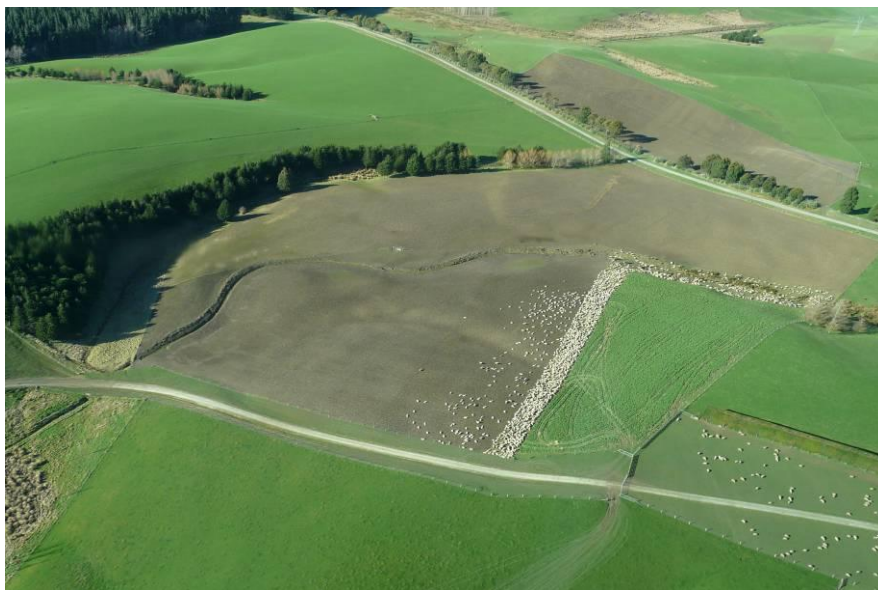
Figure 1: Photo showing sheep on crop which have unrestricted access to a waterway.

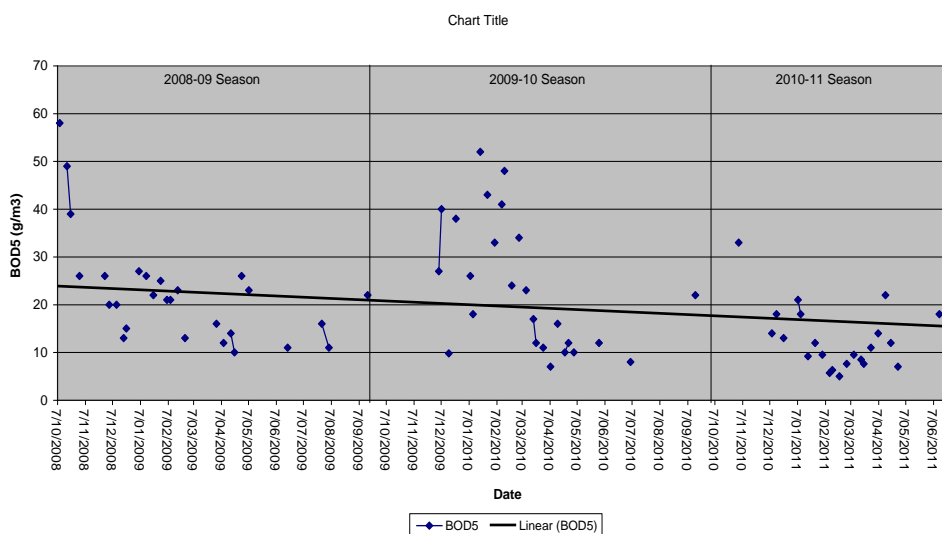
The 2010/11 monitoring results showed that the effluent continued to be of a consistent quality and fully compliant with consent conditions. Figure 16 demonstrates this in the concentration of carbonaceous Biochemical Oxygen Demand (CBOD₅) in the effluent.

Figure 16: Concentration of carbonaceous Biochemical Oxygen Demand in the Alliance Group Lorneville discharge over the last three seasons.

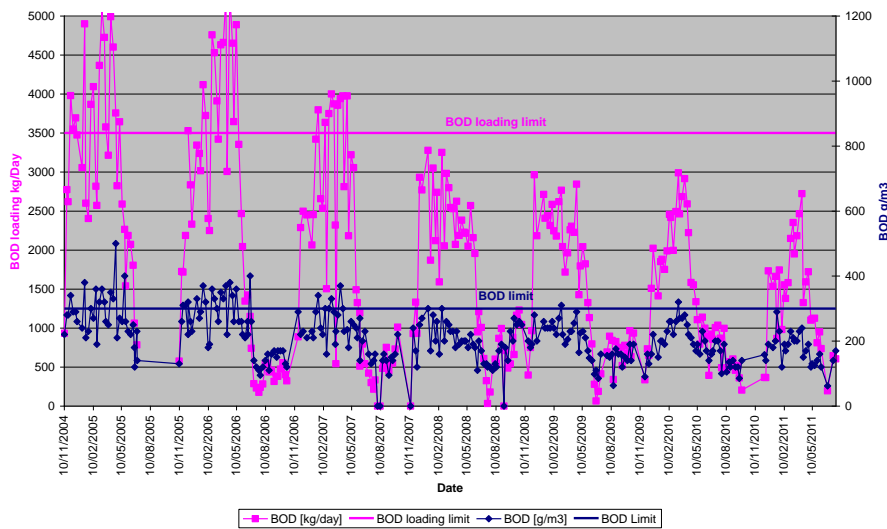
This system has evolved with the changing consent requirements and is now beginning to produce reasonably good quality of effluent consistently. This can be demonstrated in the quality of the carbonaceous biochemical oxygen demand (CBOD₅). In the 2004/05, 2005/06 and 2006/07 seasons there were several incidents when the CBOD₅ concentration exceeded the consent limit. Investigations were undertaken and modifications made to isolate and remove contaminants contributing to these incidents. The frequency of non-compliant events reduced in subsequent years, until this year when no incidents were recorded (Figure 20).

Figure 20: Concentration of carbonaceous Biochemical Oxygen Demand in the Alliance Group Mataura discharge over the last seven seasons.

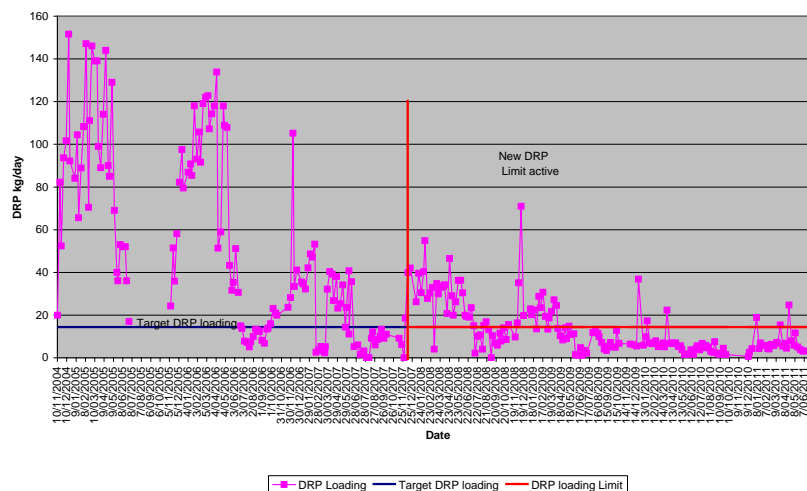
The improved management and understanding of the system has been good, but the mechanical nature of the whole piping network and treatment system increases the risk of breakdowns. Compounding this is the size of the treatment plant, where there is limited containment capacity to hold effluent back in the event of failure. This increases the risk of a consent breach. This was evident this year in the dissolved reactive phosphorus (DRP) loading results in the discharge (DRP loading is calculated by multiplying the DRP concentration by the volume of effluent being discharged and correcting that to read kg of DRP per day). When the plant was operating well, the quality of the effluent was consistently good and well within the consent requirements of maintaining the DRP loading below 14.4 kg/day. This can be seen in Figure 21.

Figure 21: Dissolved Reactive Phosphorus (DRP) loading in the Alliance Group Mataura discharge over the last seven seasons.

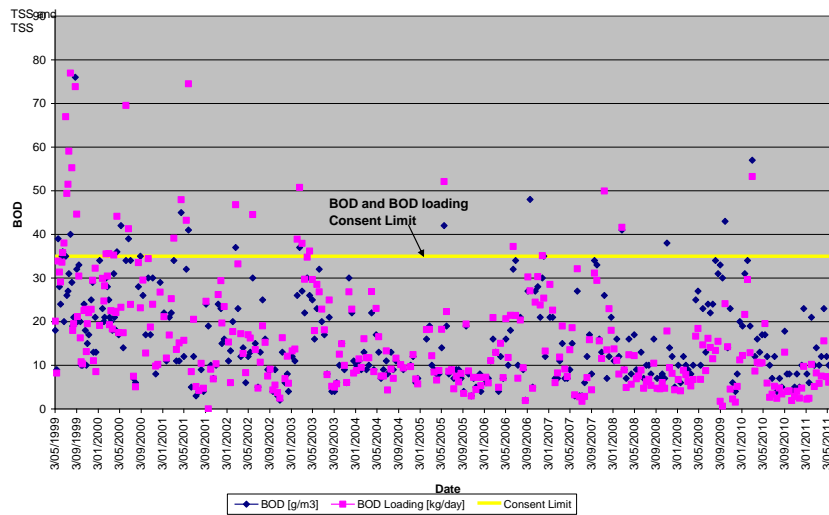
The effluent quality fully complied with the carbonaceous biochemical oxygen demand (cBOD₅) concentration and the total suspended solids (TSS) limits specified in the consent during the year (Figures 24 and 25).

Figure 24: Concentrations of cBOD₅ and BOD loading in the Prime Range Meats effluent (1999 – 2011) and the current consent conditions.

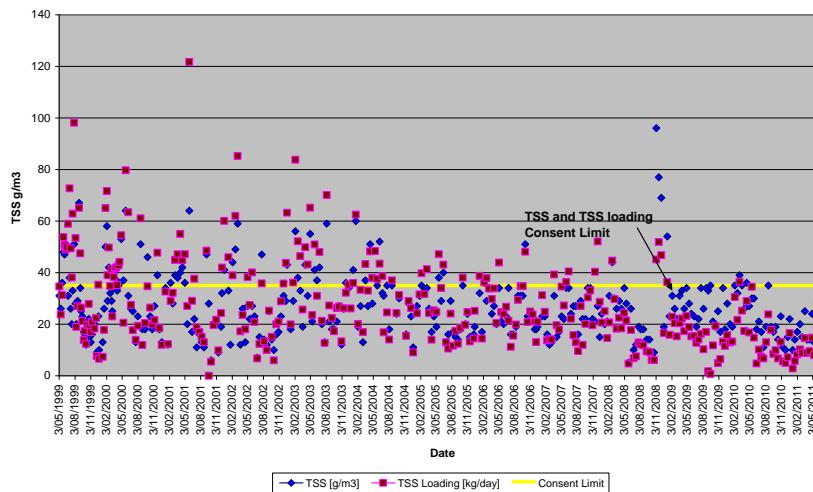
Figure 25: Concentrations of TSS and TSS loading in the Prime Range Meats effluent (1999 – 2011) and the current consent conditions.

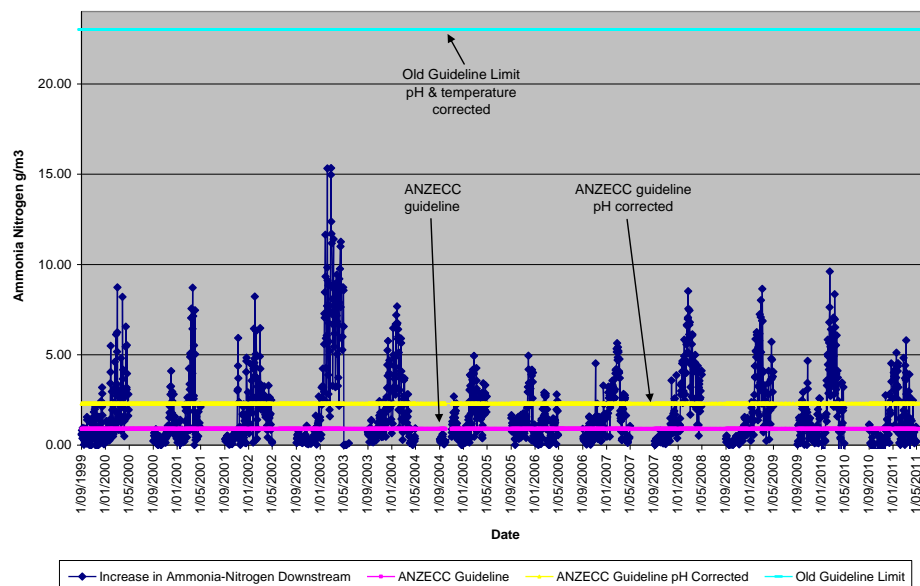
PRM has looked at options to reduce the levels of ammonia nitrogen in the discharge and the in-stream ammonia nitrogen levels. Ammonia nitrogen in waterways, above the ANZECC guidelines, has the potential to be toxic to aquatic life.

Figure 26: In-stream ammonia nitrogen from PRM discharge with respect to previous seasons and ANZECC guidelines.

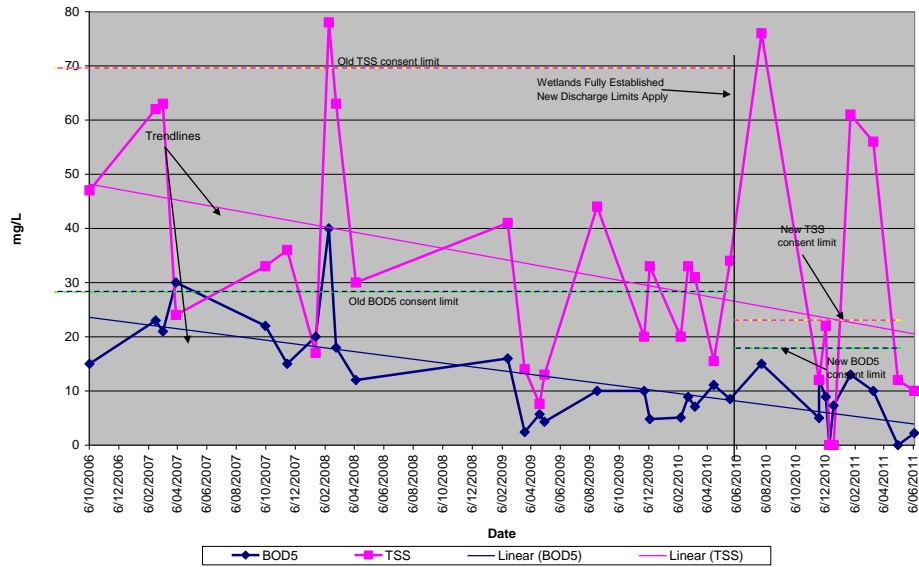
Figure 41: Discharge BOD₅ and TSS results. Note: An improvement in the BOD₅ can be seen since the installation of the wetlands in December 2008 and their full establishment in June 2010.

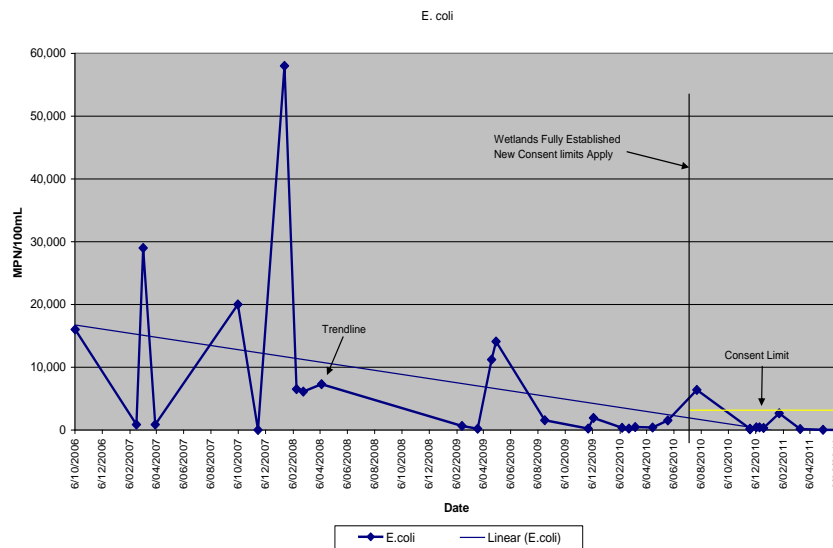
Figure 42: *E. coli* results. Note: An improvement in the *E. coli* can be seen since the installation of the wetlands in December 2008 and their full establishment in June 2010.

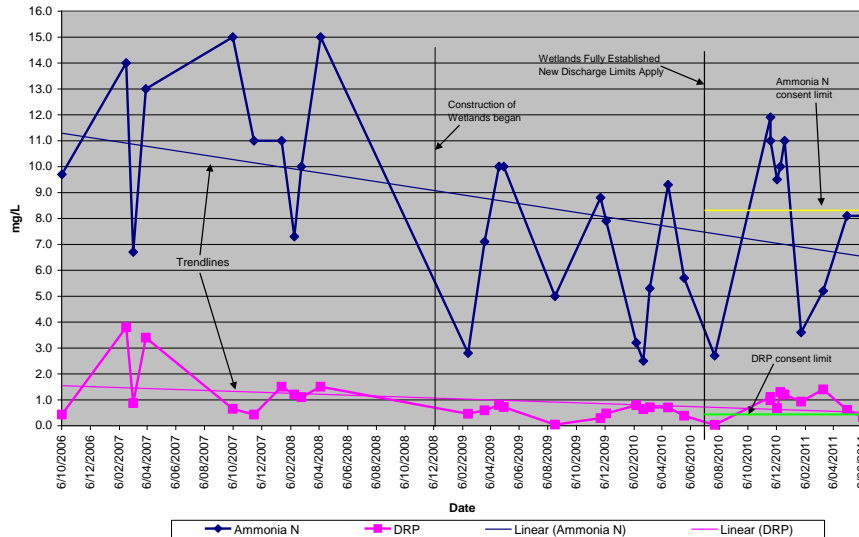
percentile consent limit for the Gore oxidation pond discharge when the river flow is less than 25 m³/s. The Mataura oxidation pond ammoniacal nitrogen limit for the discharge is also significantly lower than any of the Gore limits for the discharge. Due to these factors, and the breaches of consent relating to the DRP and ammoniacal nitrogen concentrations, Gore District Council is currently investigating different measures to enable it to comply with its consent conditions (see Figure 43).

Figure 43: Discharge ammonia nitrogen and DRP results. Note: Overall there has been an improvement in the concentrations since the issuing of this consent in 2006. However the results are frequently over the new consent limits.

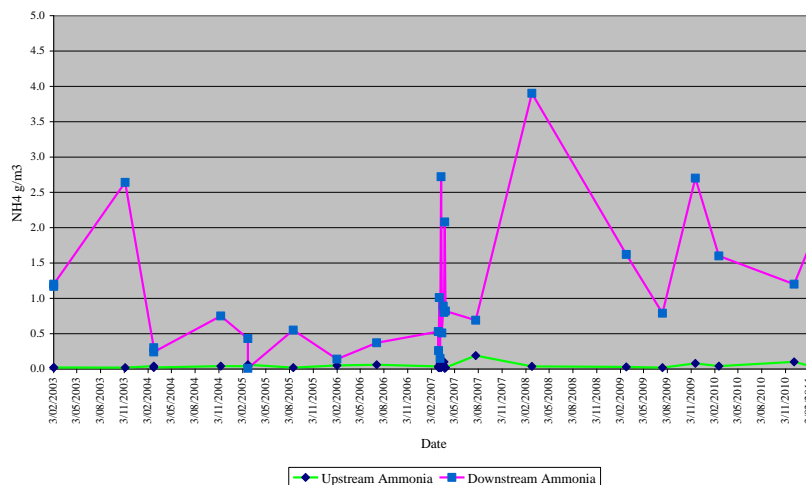
ammonia nitrogen and total phosphorus in the discharge remained relatively stable, the level of total ammoniacal nitrogen downstream of the treatment plant exceeded the trigger level for 95 per cent protection of aquatic life (Australia and New Zealand Guidelines for Fresh and Marine Water Quality (ANZECC)) on all four occasions since November 2009 (see Figure 45).

Figure 45: River NH4 2003-11.

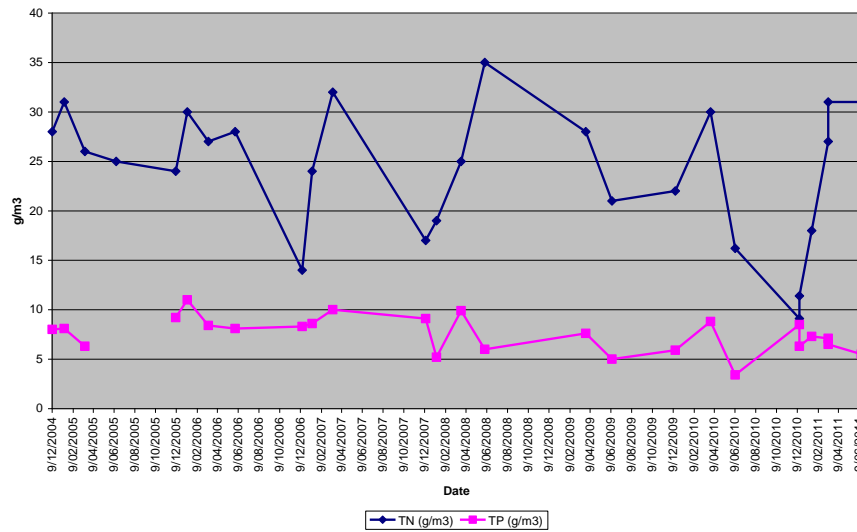
The total phosphorus concentration in the discharge was relatively consistent with all results ranging between 5.5 g/m³ and 8 g/m³. The total nitrogen concentration was noticeably more variable (Figure 48).

Figure 48: Total phosphorus and total nitrogen concentrations in the wastewater discharged to the Upukerora River.

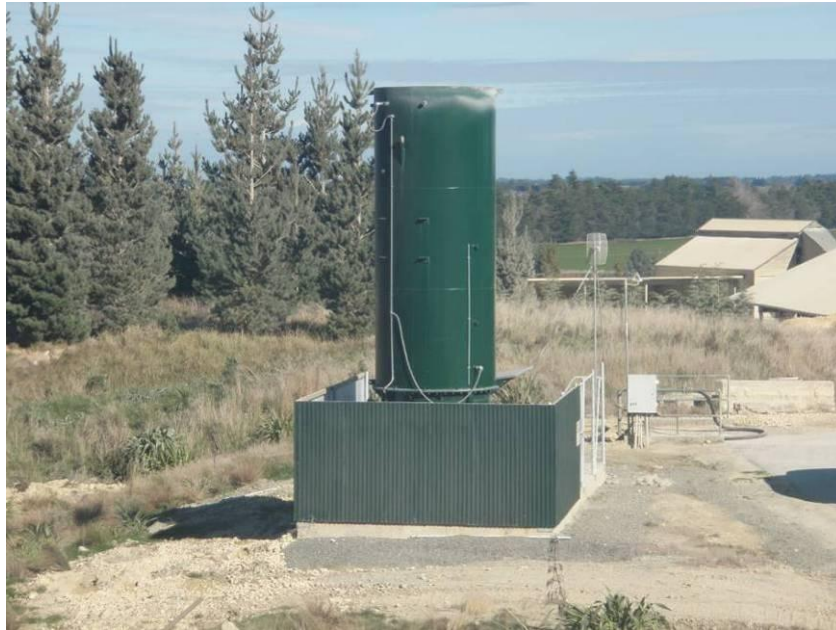
Figure 54: AB Lime permanent gas flare

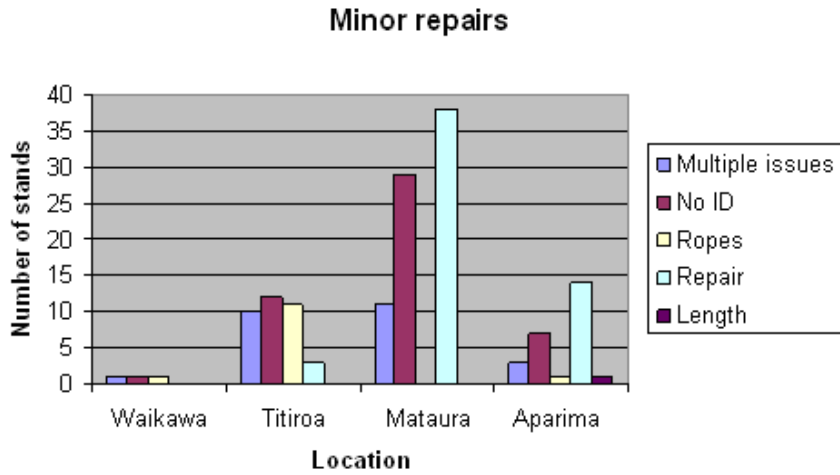
Figure 62: Minor repairs

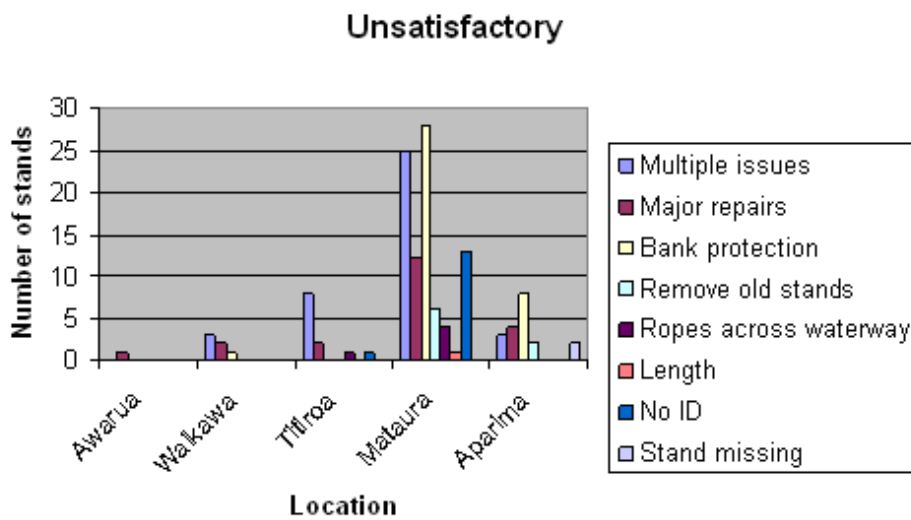
Figure 63: Unsatisfactory stands

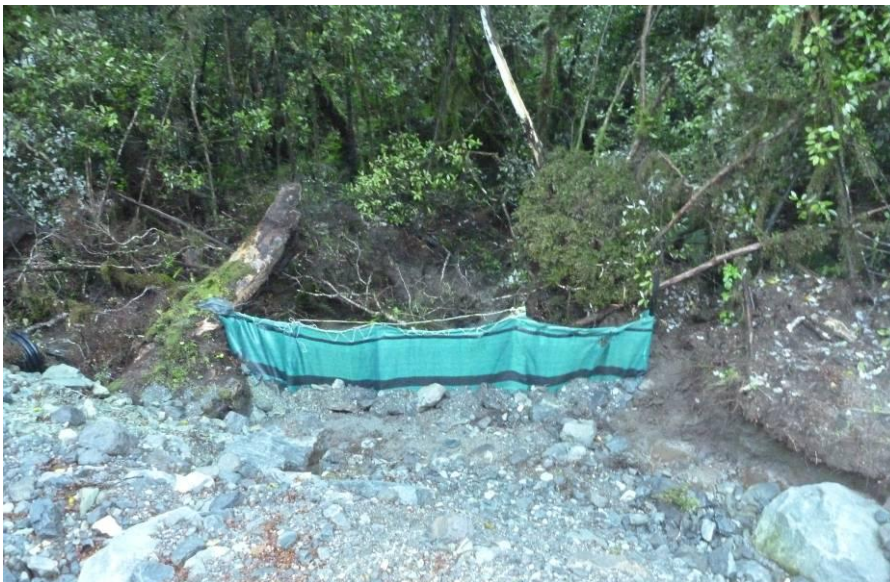
Figure 69: Sediment control at borrow area, 15 June 2011.

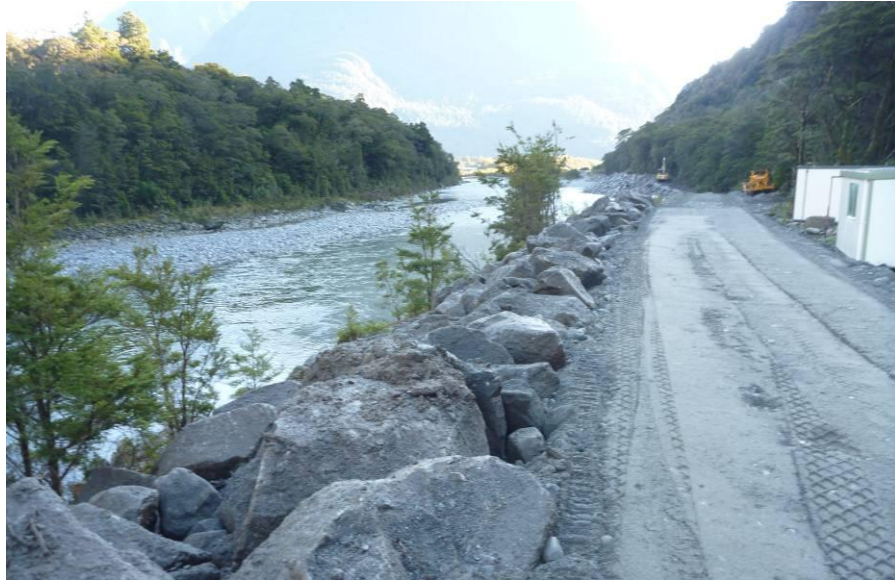
Figure 70: Newly constructed rip rap flood wall behind Milford Lodge, 15 June 2011.

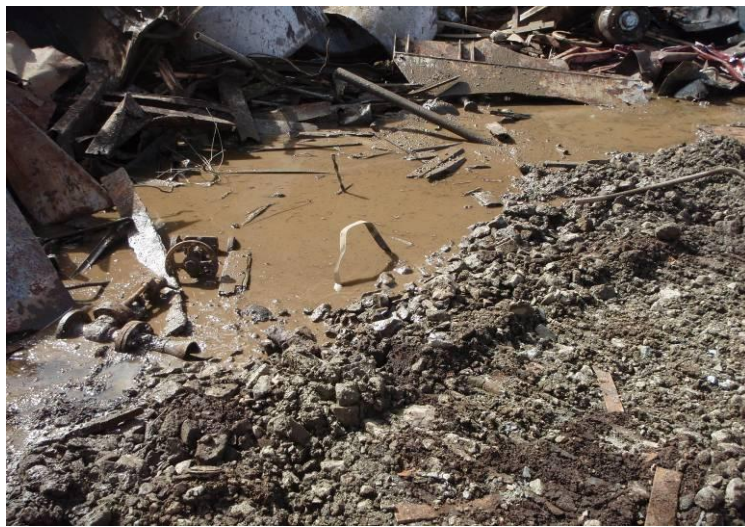
Figure 75: Ponding at Sims Pacific Metals at an early site visit, 2010.

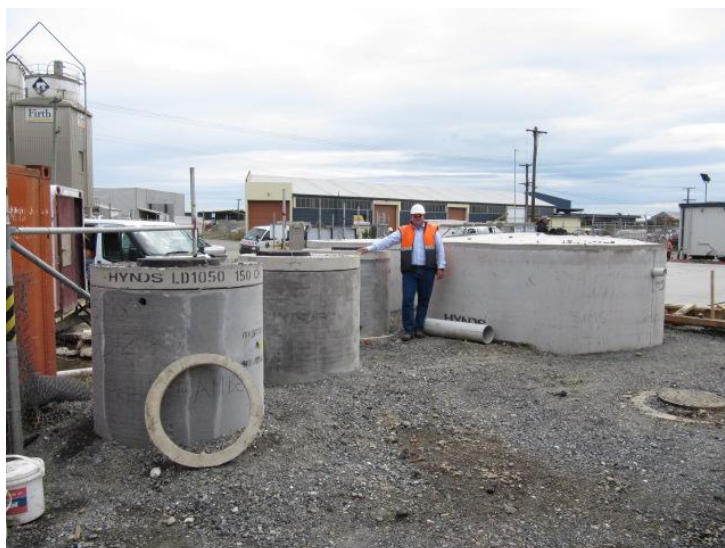
Figure 77: Stormwater treatment system prior to installation, February 2011 (photo supplied by Sims Pacific Metals).
