## Environmental Compliance Monitoring Report

2005/06

**Report by -  
Environment Southland  
Environmental Compliance Division**

**Environment Southland Publication No 2006/07**

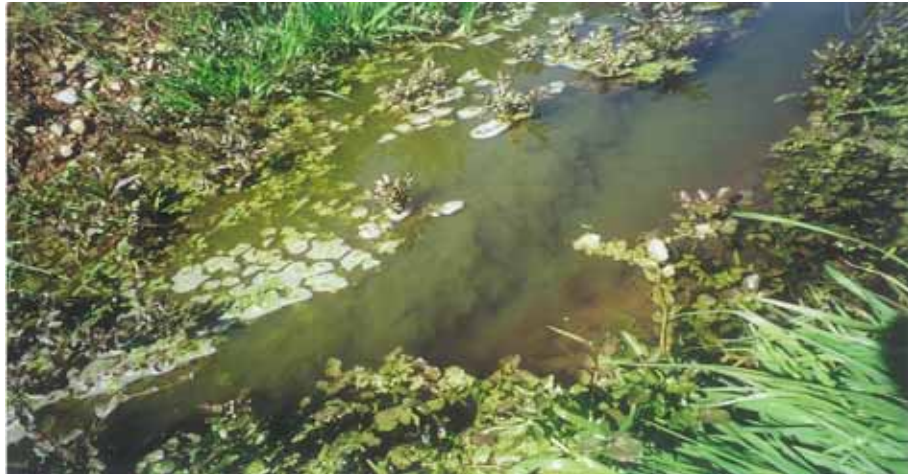
**Figure 4 - Example of an unsatisfactory sample, where effluent was entering a waterway via a tile in October 2005**

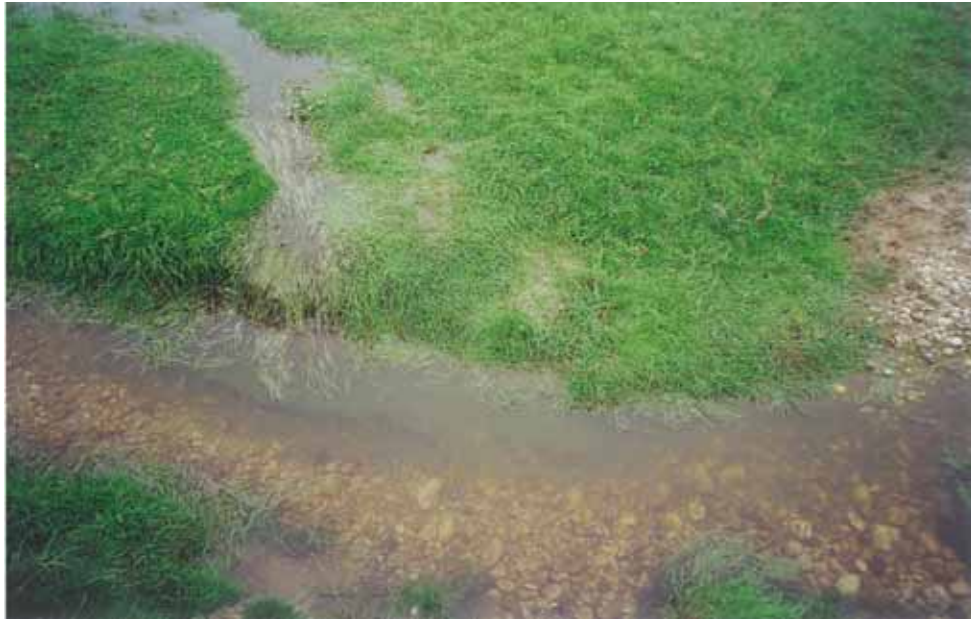
**Figure 6 - Example of an unsatisfactory sample result where effluent entered a tile and discharged to an open waterway September 2005**

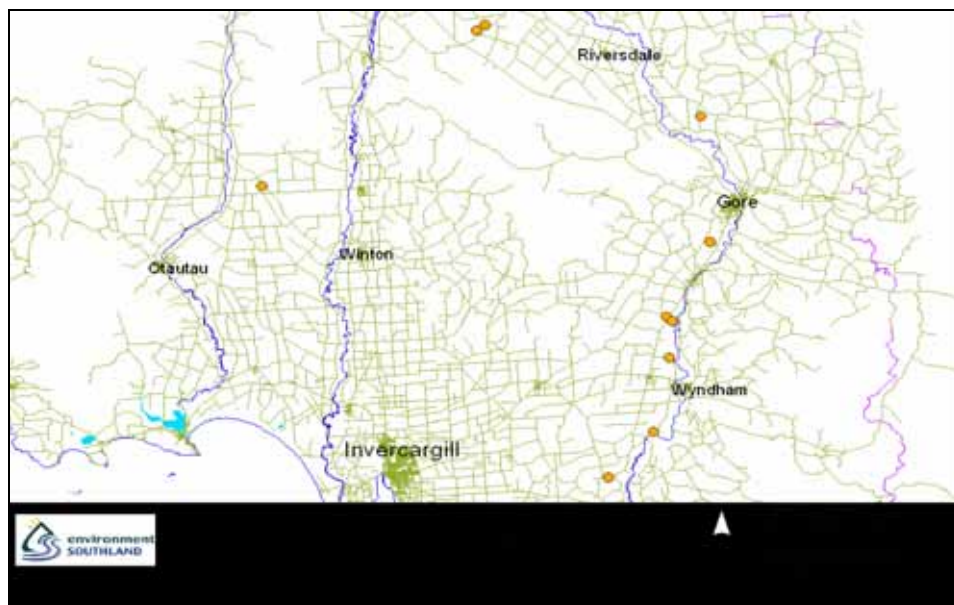
**Figure 11 - Location of groundwater samples which exceeded NZDWS 2005 standards of 11.3 mg/L during the 2005/06 season**

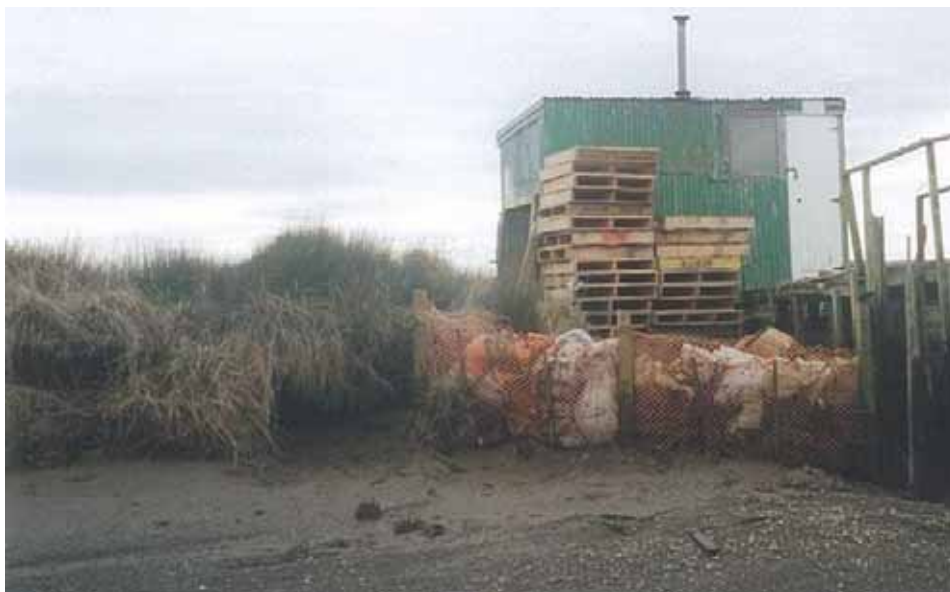
Several other warnings have been issued where iron and other materials have been placed in an attempt to prevent bank erosion (see photo below).

**Figure 14 – An example of unconsented bank work**

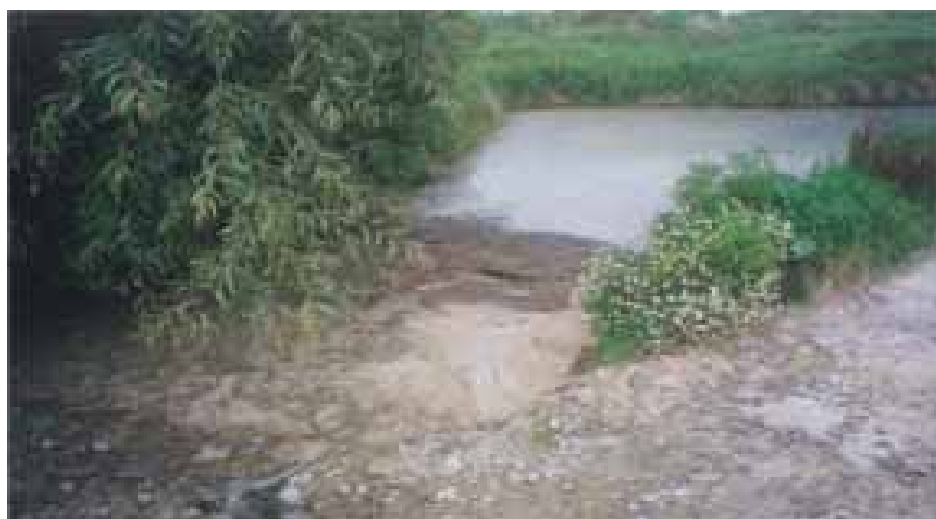
A number of public complaints have been received about the operation of a truckwash site near Mossburn. The truckwash has a soakhole close to a major river, and in view of a major tourist route. Complainants have also indicated that they consider the site aesthetically unappealing and noted that some unpleasant odour was being emitted.

**Figure 15 - The consent for this site comes up for renewal in 2007**

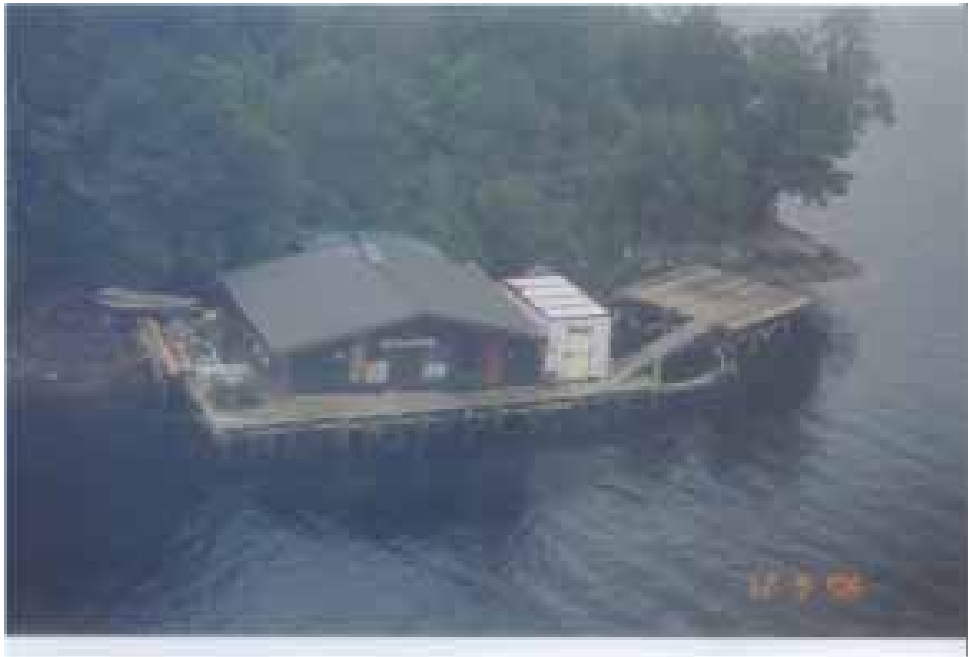
**Figure 16 – A structure in Blanket Bay**

The building inspector noted only two structures had a problem, one related to the building code requirements concerning the alterations undertaken, and the other general maintenance/repairs. Both problems have been rectified.

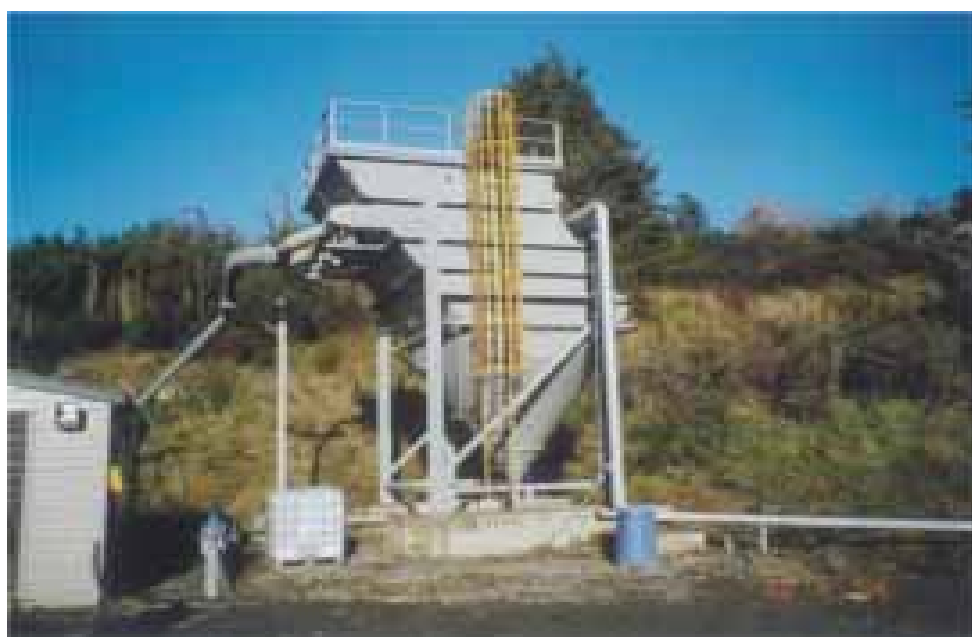
The second company is a well established company and had implemented a comprehensive wastewater management system. All water from roadside drains and coal washing operations are directed through a 'Lumella' (wastewater treatment system) before being discharged.

**Figure 34 - Photograph showing the "Lumella"**

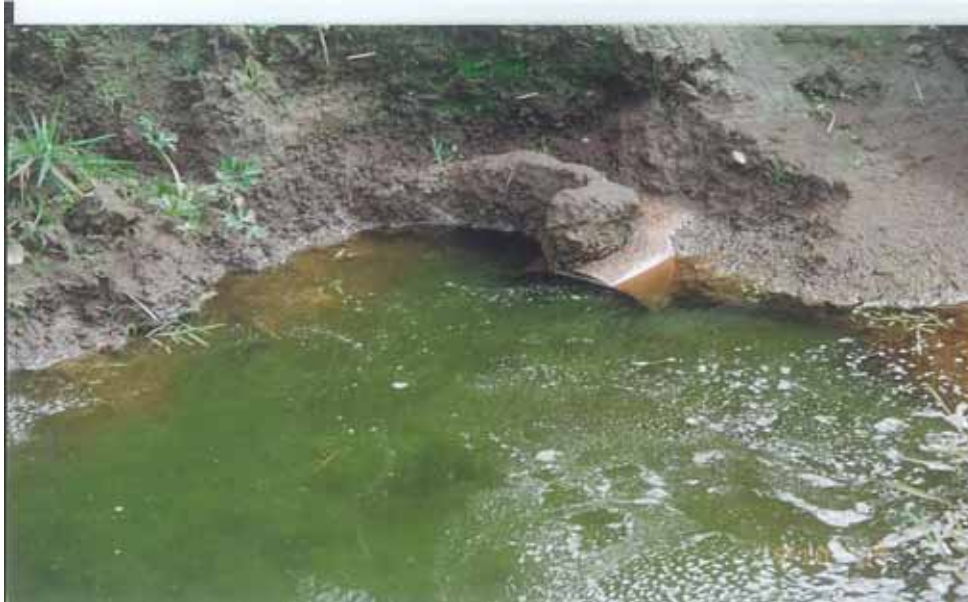
**Figure 44 - DSE flowing from clay drainage tile**

Discharges of dairy shed effluent to waterways via drainage tiles are the most common major complaint. The photograph above shows dairy shed effluent flowing into a waterway on a dairy farm.

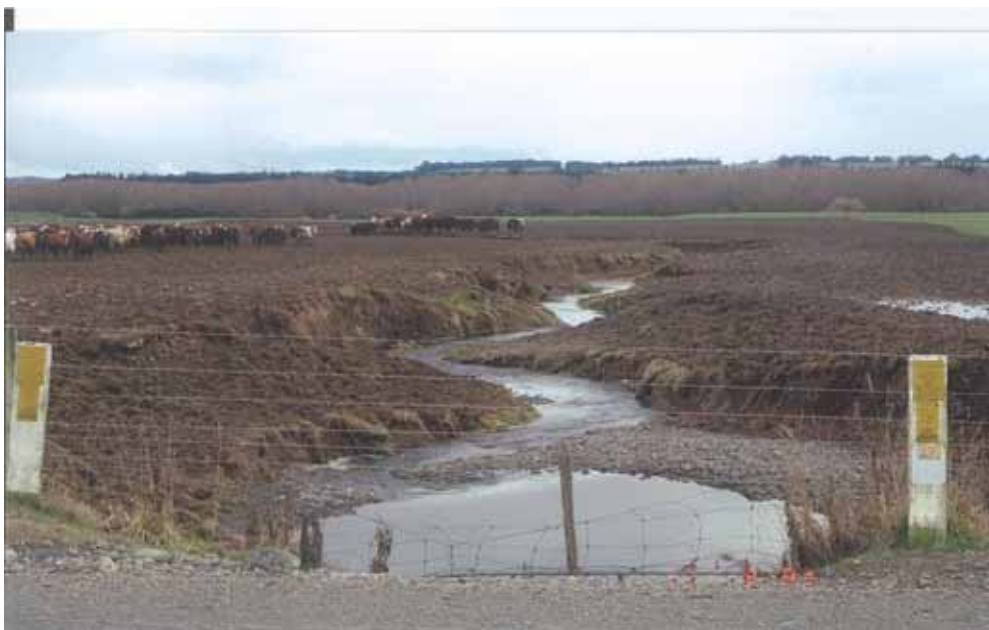
**Figure 45 - Severe bank degradation caused by unrestricted stock access to a waterway**

This photograph (Figure 44) relates to a prosecution taken this year due to the landowner refusing to exclude stock from the affected waterway.

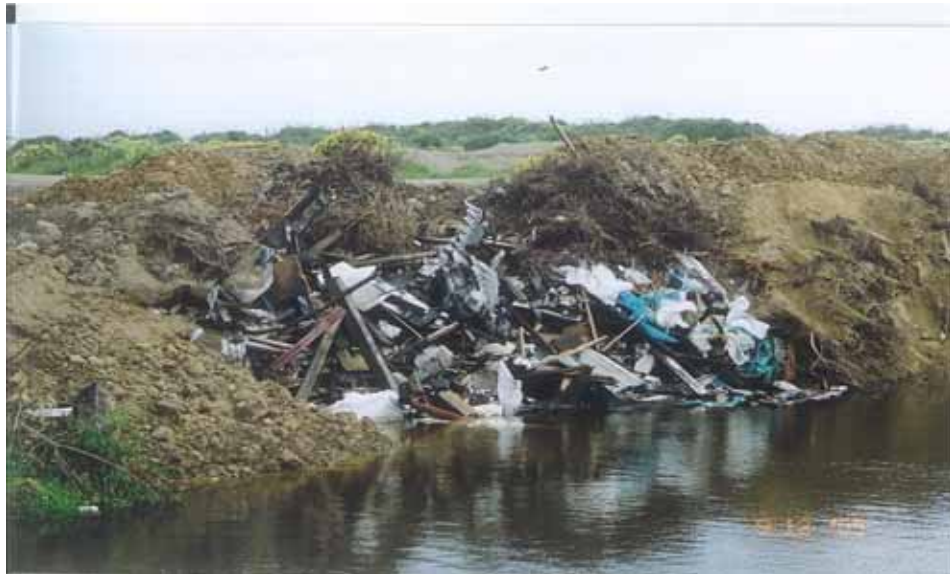
**Figure 46 - Unconsented material deposited in a 'Cleanfill site'**

In the above photograph, the consent holders were instructed to remove the unconsented material and dispose of it in an appropriate manner.

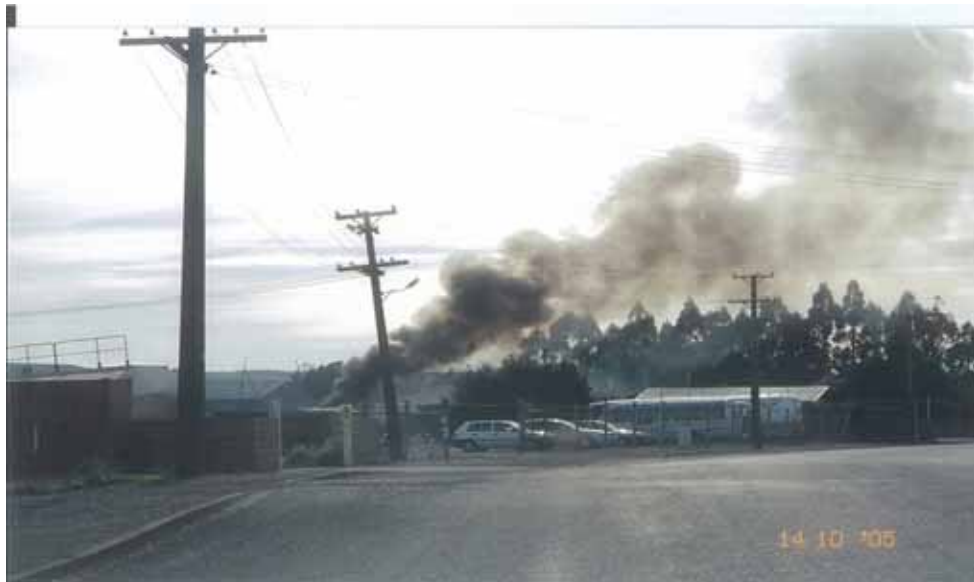
**Figure 47 - Toxic smoke from an industrial site**

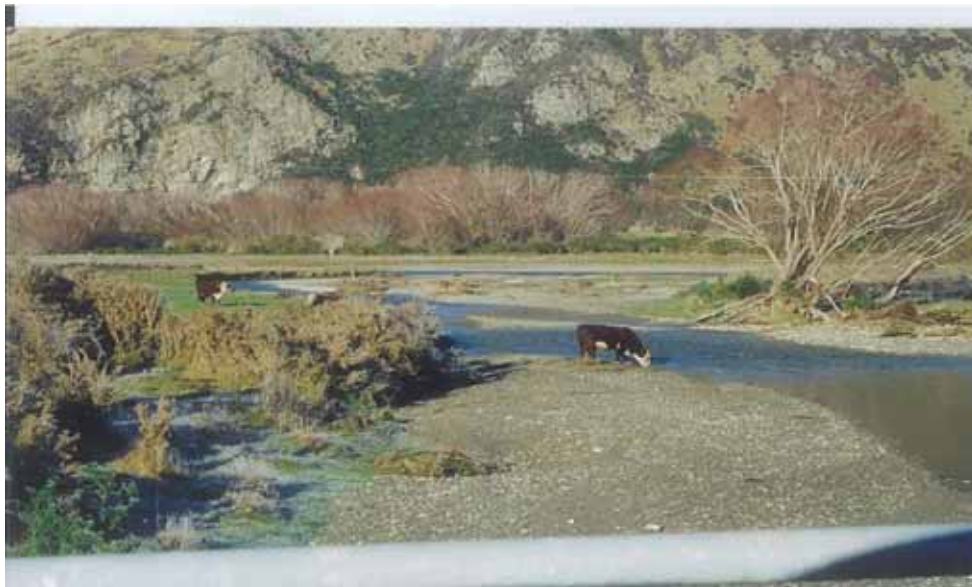
Seven potential issues were identified during the June 2006 flight. One was identified as serious - the offender was warned and provided with advice and information on best practice.

Figure 51 - Unrestricted access to waterway

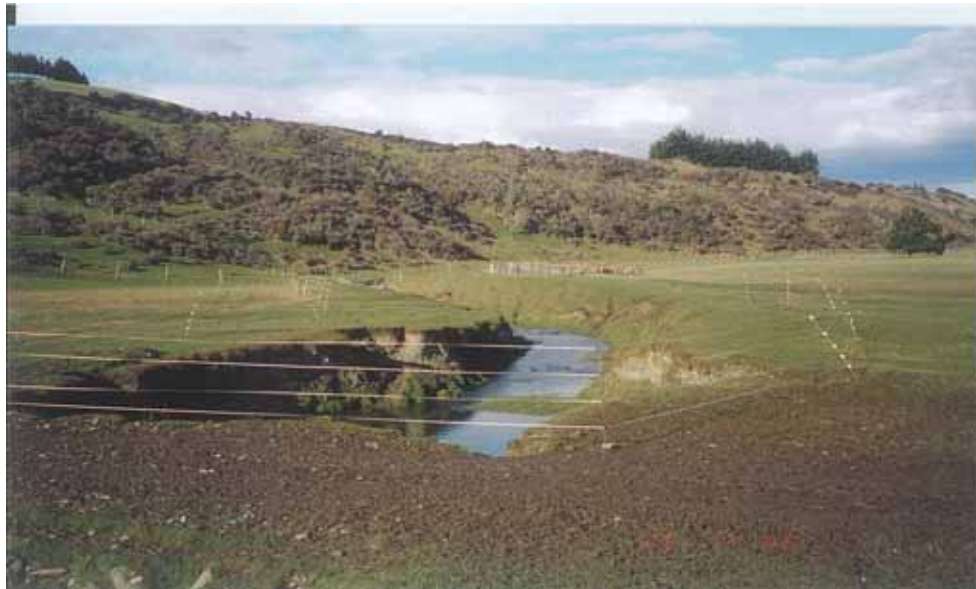
Mr Evan Brunton uses a deer hot-wire to prevent deer having unrestricted access to this section of the Flaxy Creek, playing his part in helping overall water quality in this catchment.

**Figure 52 - Deer hot-wire**

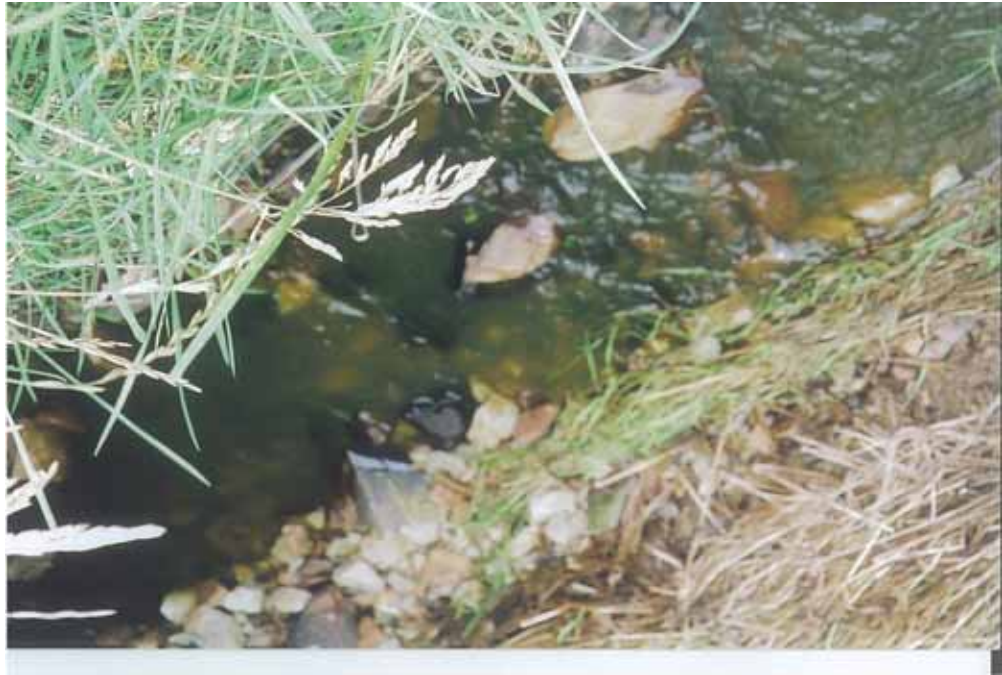
**Figure 53 - Dairy shed effluent having significant effect on a small waterway**

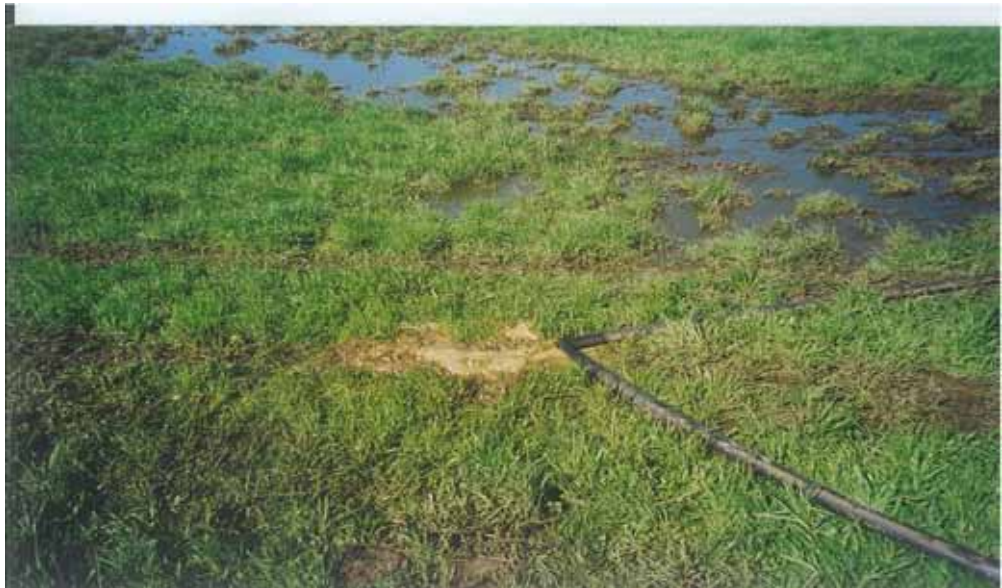
**Figure 54 - Poned dairy shed effluent (DSE)**

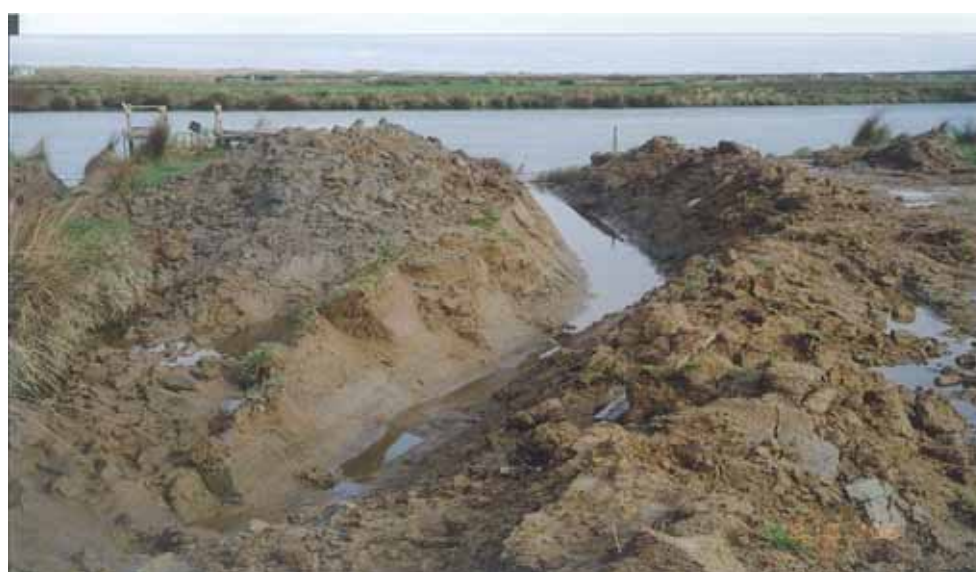
**Figure 55 - Unauthorised excavation on Mataura River**

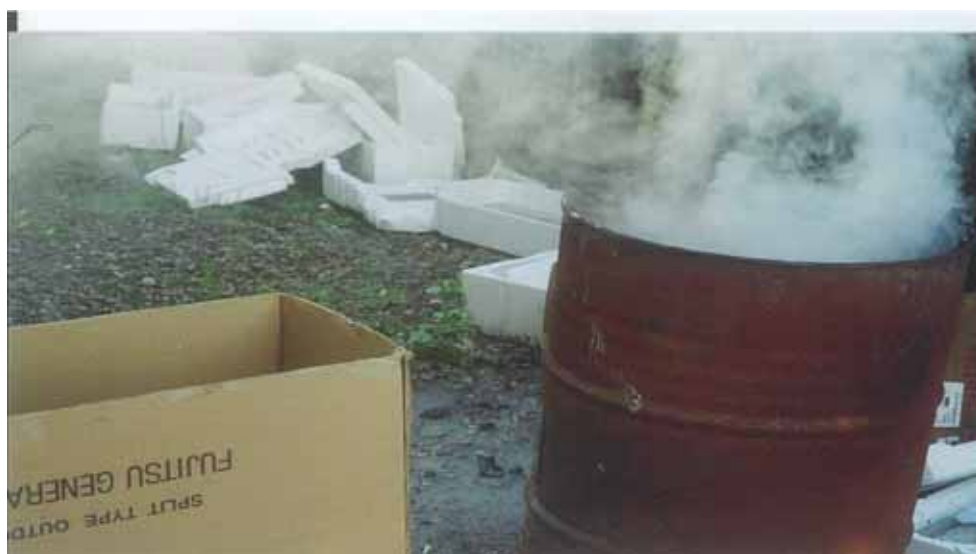
**Figure 56 – Polystyrene burning in a drum**

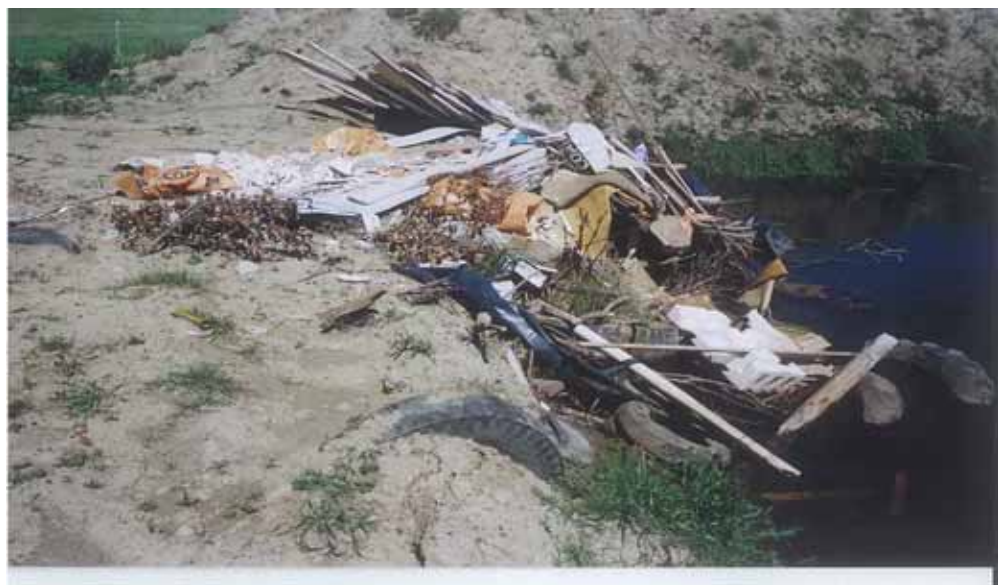
**Figure 56 - Anything but “cleanfill”**
