## Environmental Compliance Monitoring Report

2007/08

Report by –  
Environment Southland  
Compliance Division

Environment Southland Publication No 2008-07

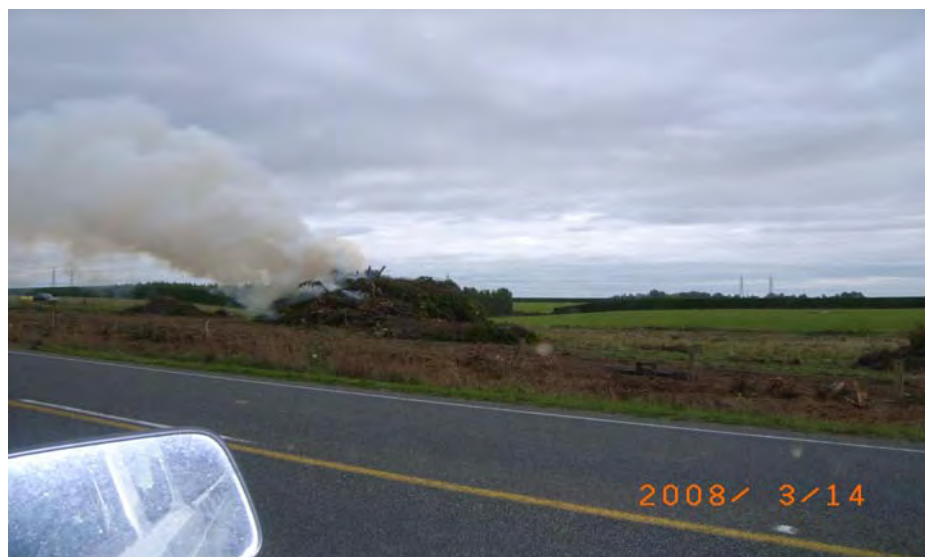
Figure 1 - Vegetation being burned on the side of the road

The main reasons for the nuisance smoke appear to be poor management, timing of the burning (burning on still days) and non-notification of neighbours.

Contractors enter an area to trim or cut vegetation. The foliage is then pile up and burnt “green”, resulting in a poor fire that can smoke or smoulder for hours and, in some cases, days.

Environment Southland staff have attended incidents, and warned offenders that this practice is not permitted. The officers have then required the offender to stop the activity and followed up by offering advice on best management practices, such as ensuring the materials are dried out thoroughly before burning.

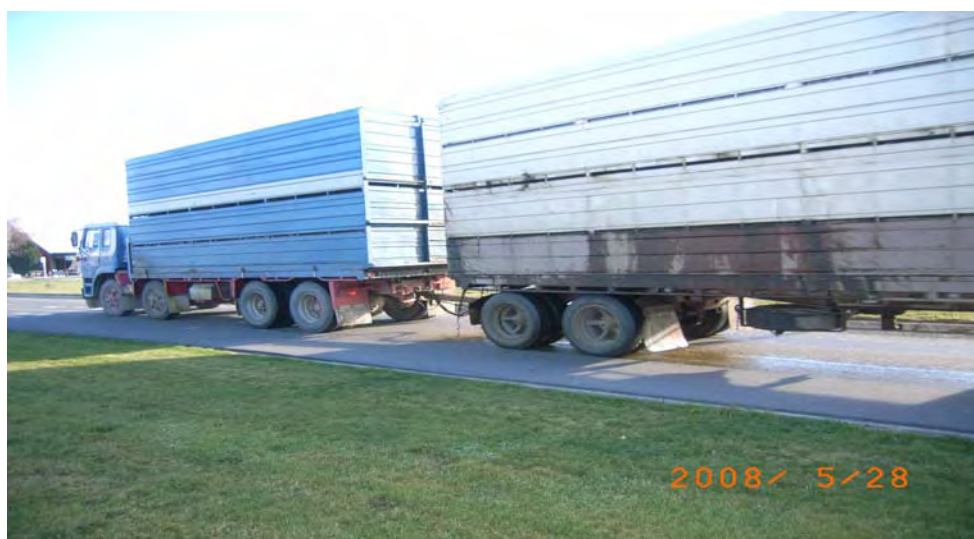
It was noted that one offender had accepted stock for cartage without adequate effluent storage capacity for the planned journey. There have been unconfirmed reports of trucks that do not have storage tanks at all.

Figure 7 - Effluent leaking from a stock truck

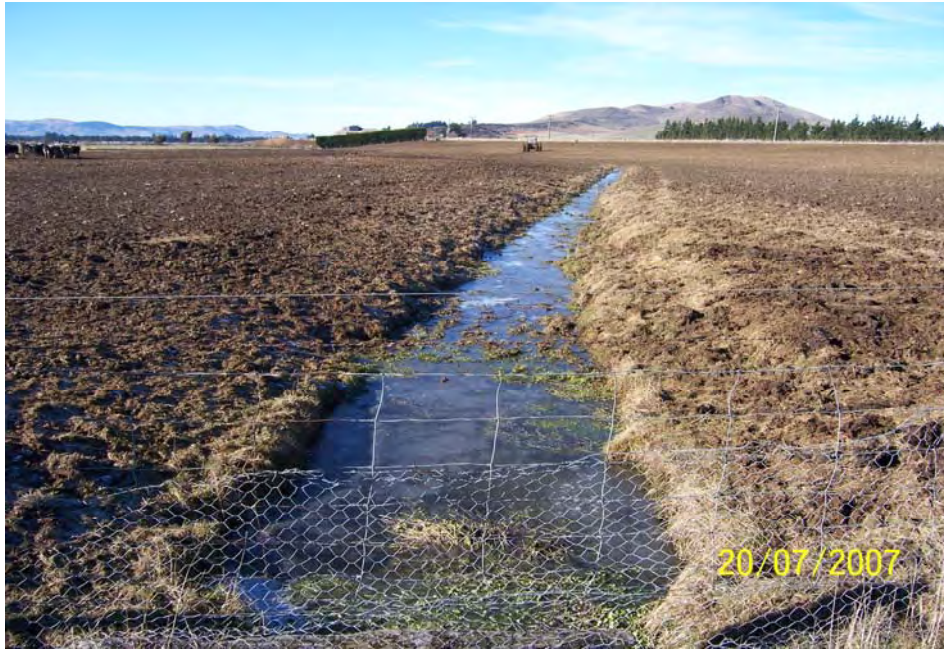
Figure 8 - Degraded waterway identified during July flight

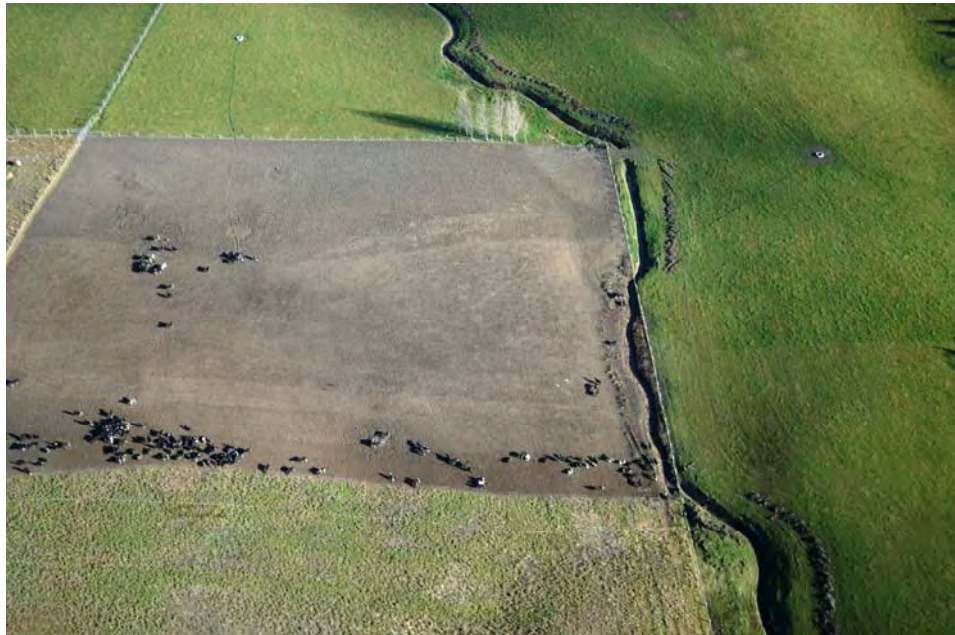
Figure 15 - A waterway has been fenced to allow stock access from both paddocks

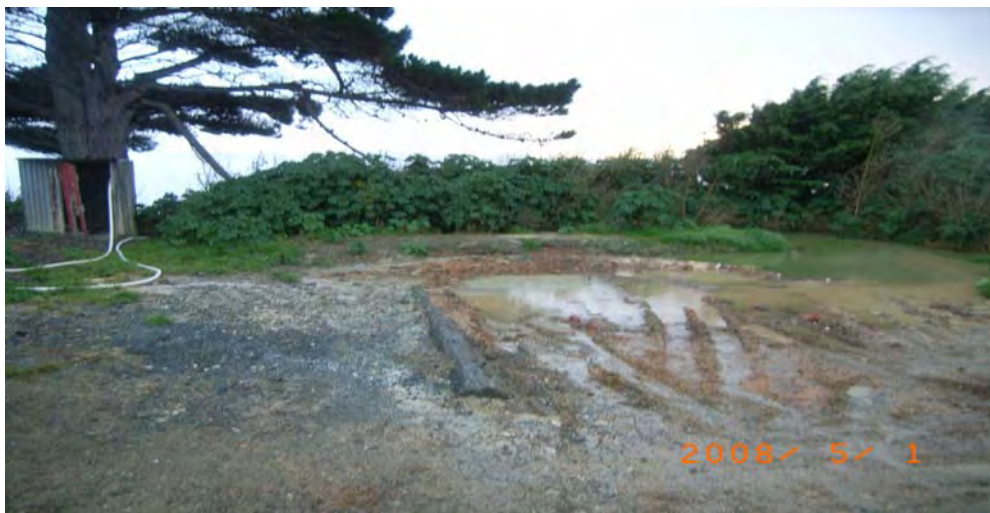
An unconsented truckwash was located close to the coastal marine area near Bath Street, Riverton. The subsequent abatement notice required the truckwash to be disbanded and the area tidied up. The requirements have since been met and Council has recovered costs from the investigation.

Figure 27 - Unconsented truckwash

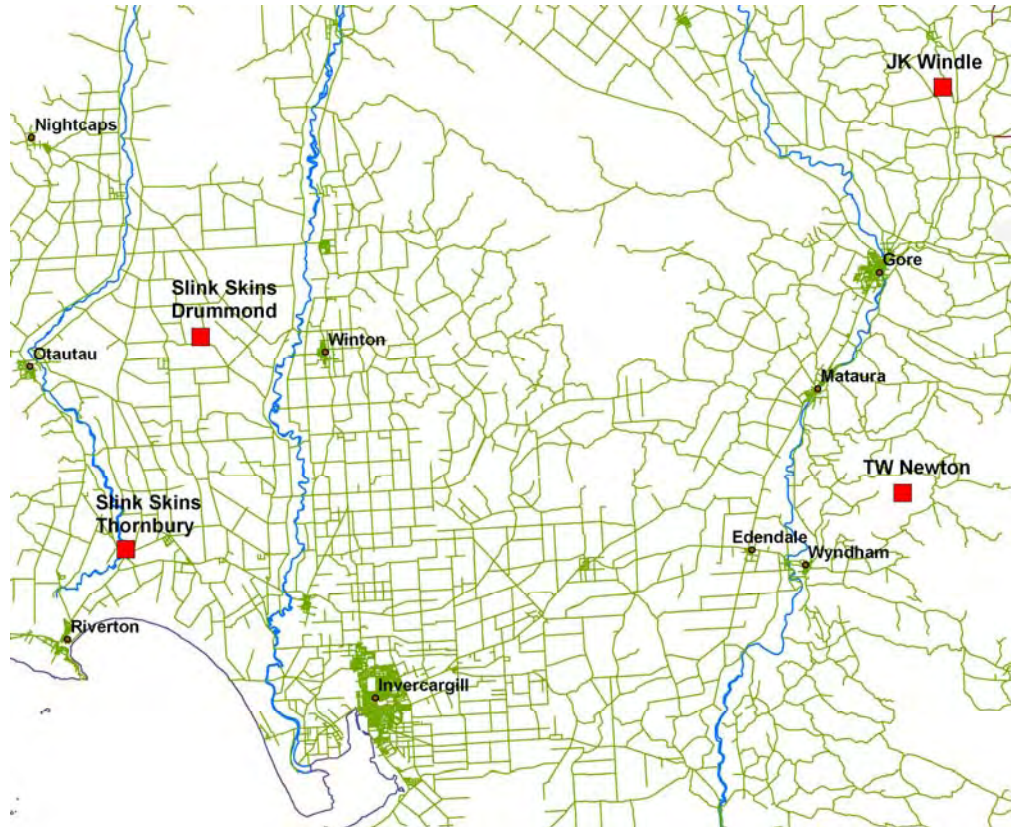
Figure 39 - Map showing slink discharge to land locations

There are four slink skin consents in Southland with discharge permits to land. All were inspected in September 2007, with no non-compliance found.

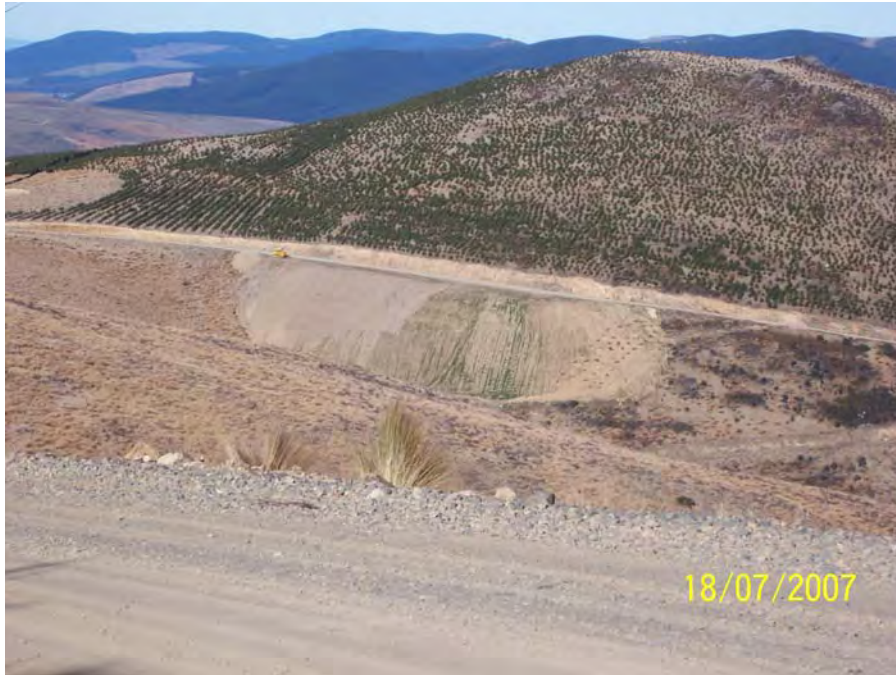
Figure 40 -A view of an area adjacent to the roadway that has been hydro-seeded

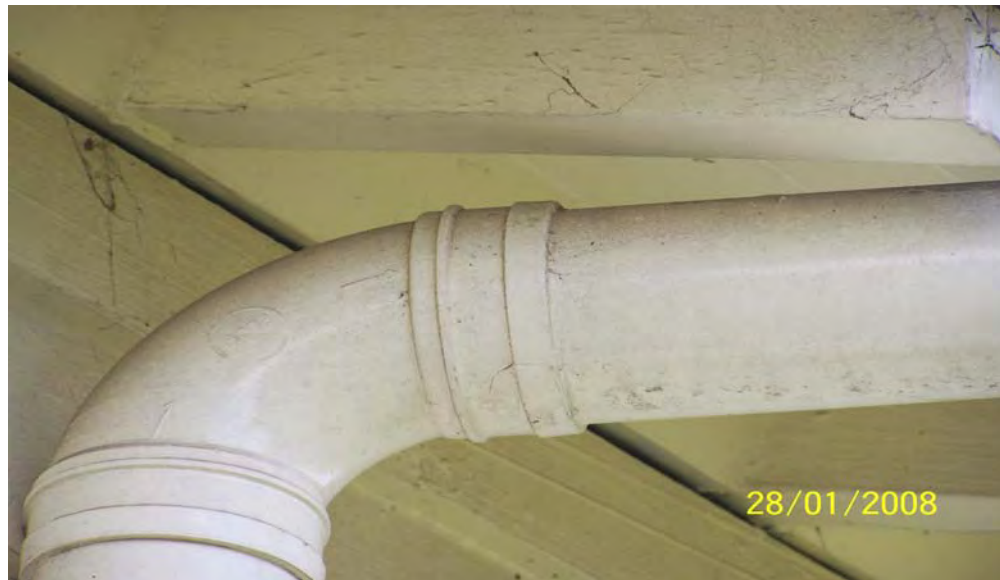
Environment Southland staff responded to several reported incidents of dust covering neighbouring properties from two separate coal mining sites in Southland. The incidents were occurring in dry, windy conditions.

Figure 42 - Coal dust on neighbouring property

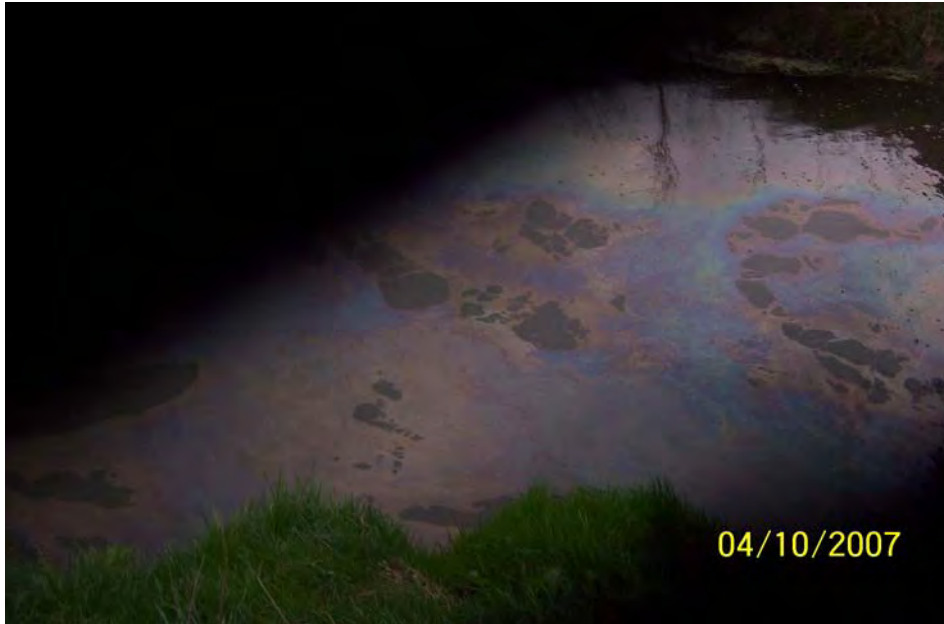
Figure 53 – “Rainbow sheen” from a diesel spill into Otepuni Creek

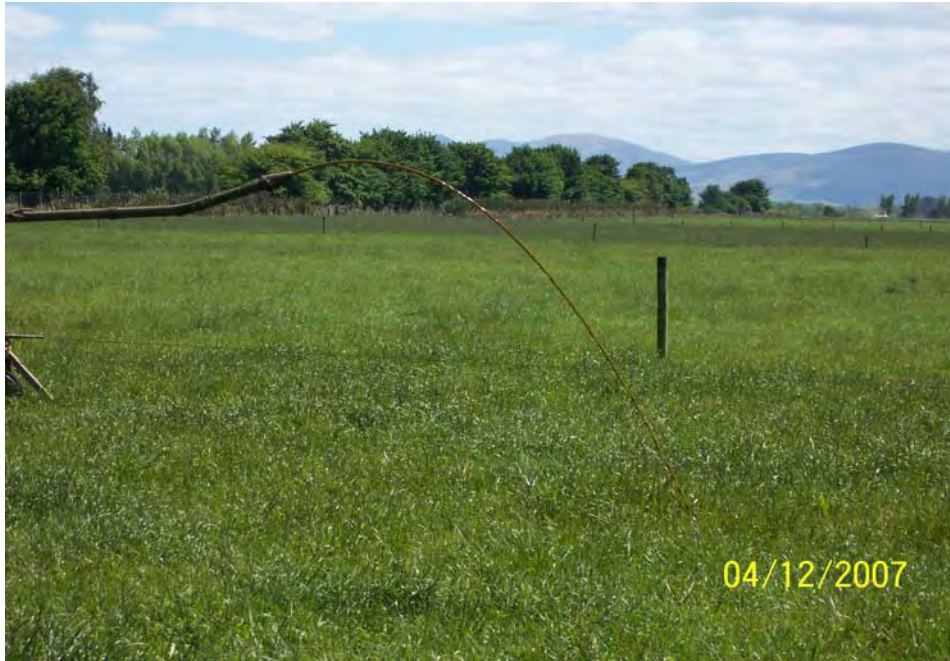
Figure 55 - Picture showing a travelling irrigator stalled and siphoning onto pasture.

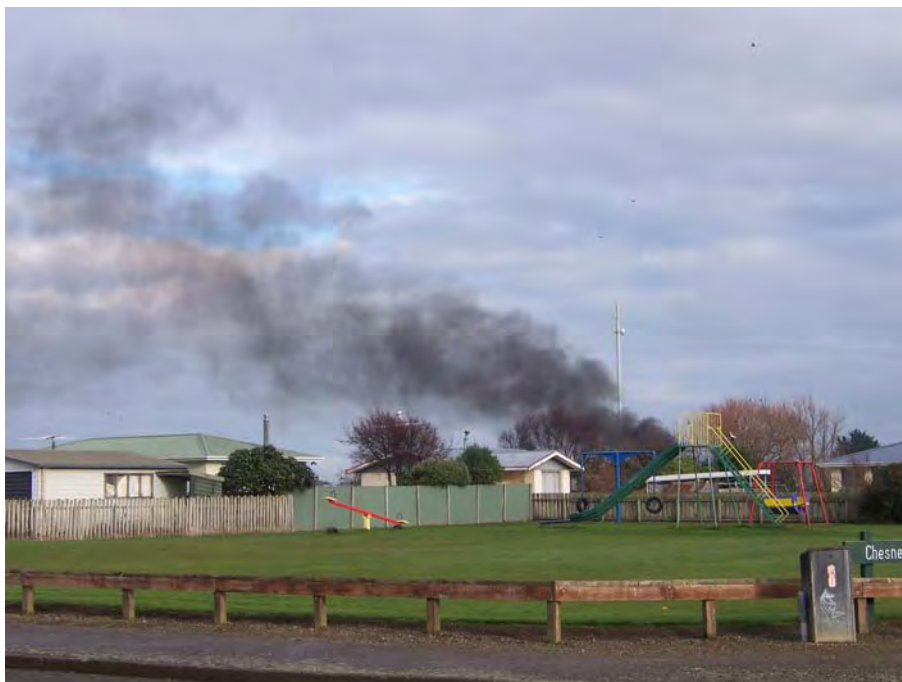
Figure 56 -Discharge of contaminants to air from bitumen burning

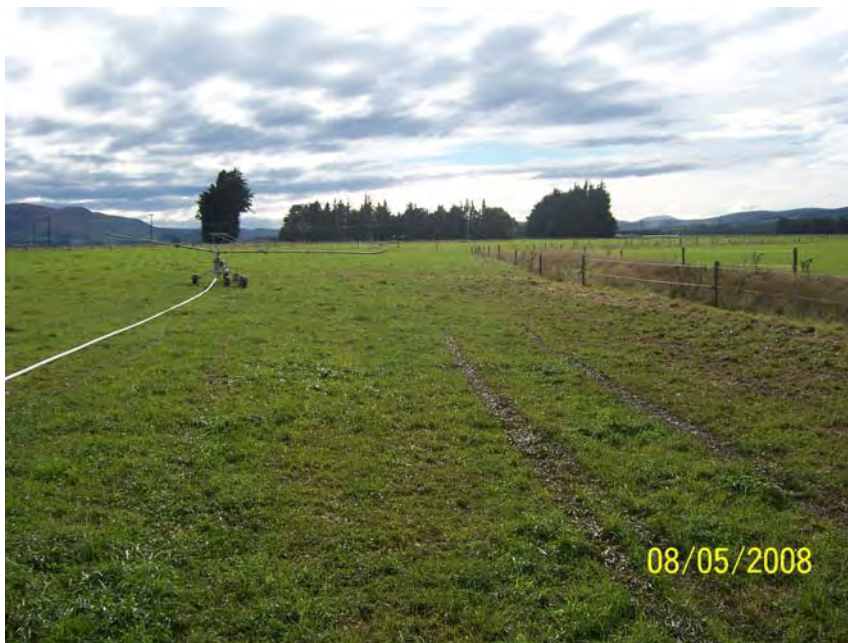
Figure 57 -Travelling irrigator too close to a waterway
