Application for Discharge Permits for Invercargill Stormwater Network

STORMWATER DISCHARGES – APPLICATION DOCUMENT

Prepared for the Invercargill City Council

September 2016

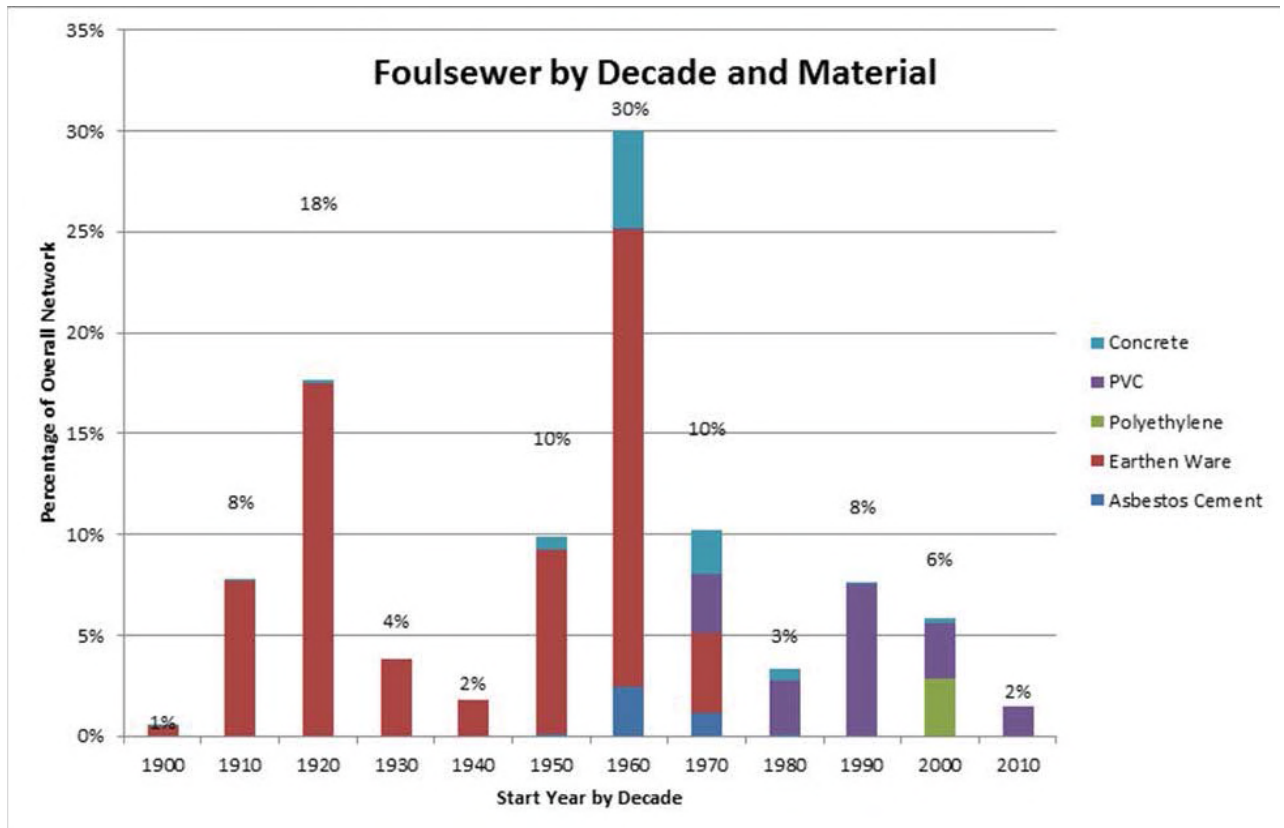
Figure 2-1: Length of sewer pipes by decade of construction and material

The age of the sewer network also results in inflow and infiltration to the system which can result in overflows from the sewer network, and deterioration with age can lead to cross contamination between the systems.

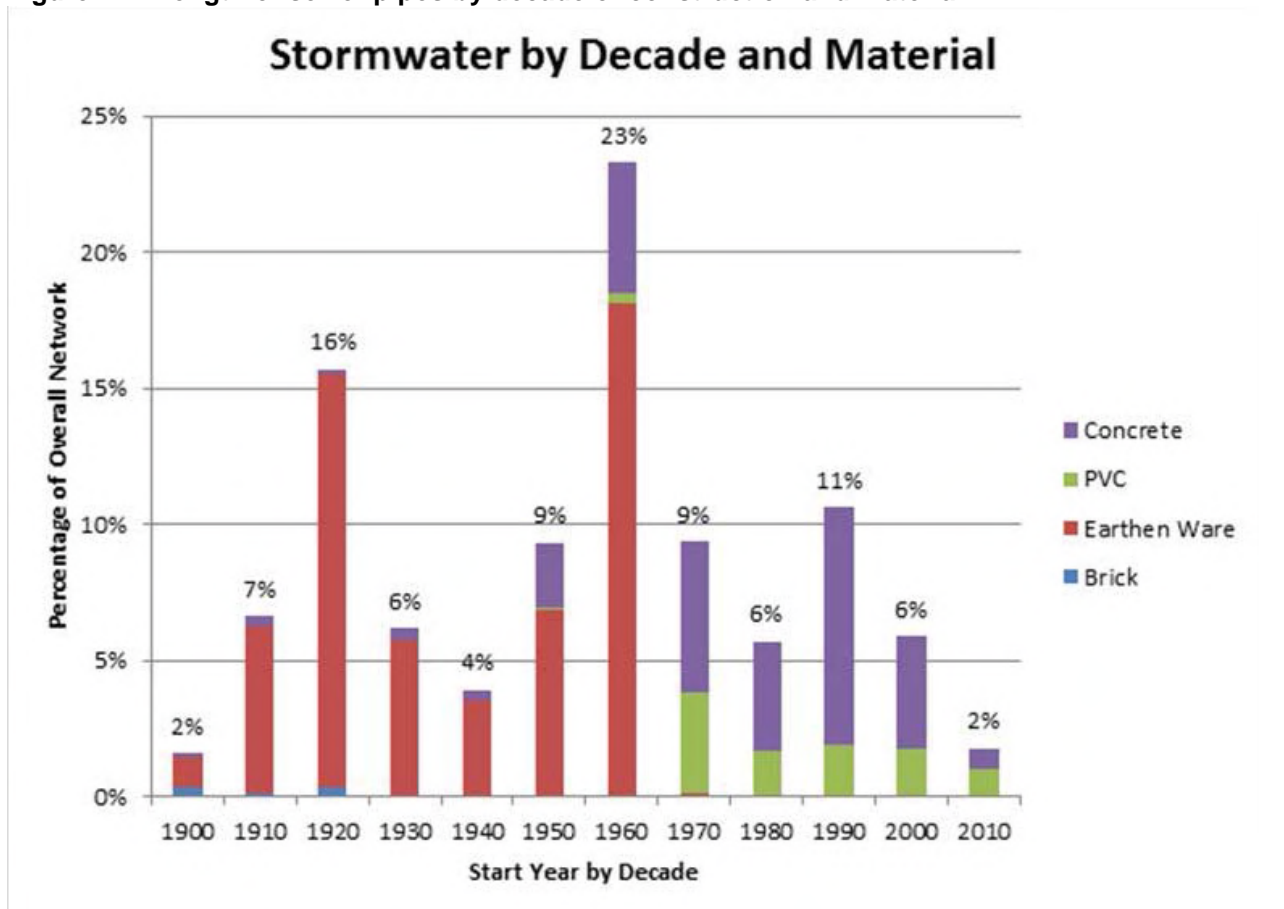
Figure 2-2: Length of stormwater pipes by decade of construction and material

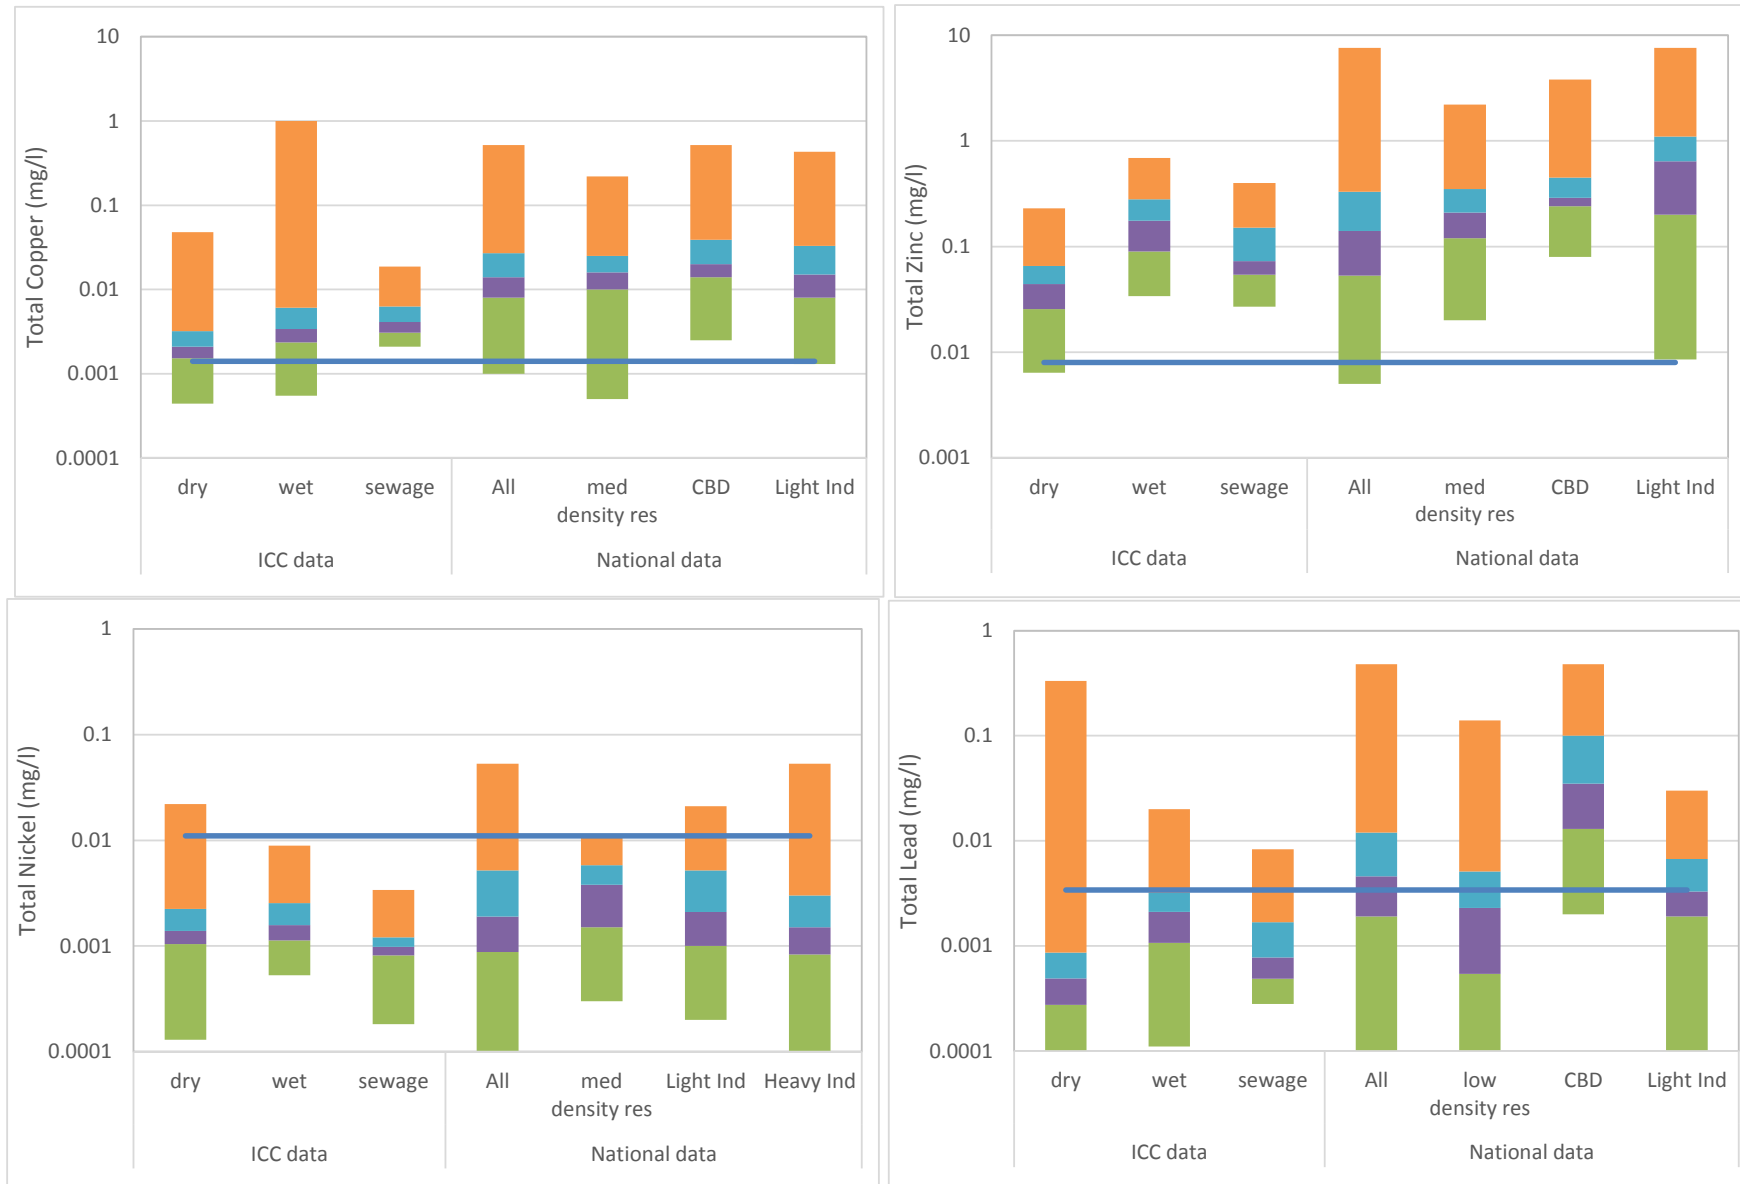
Figure 2-8: Comparison of ICC Metal concentrations against national data and the toxicity trigger value

For nickel and lead, the ICC data is generally similar to the national data and is generally less than the toxicity trigger value, indicating minimal risk of toxicity due to these metals in the discharges, especially given that the analysis is for the total fraction rather than the dissolved fraction which is more bioavailable. It is noted that this differs from the findings of the sediment monitoring for nickel as described in Section 3.4.

For copper and zinc, the recorded concentrations in ICC are lower than those in the national data set, but still exceed the 95% trigger value for prevention of toxicity. Generally, a dilution of 5 to 30 fold respectively would be required to be less than the toxicity trigger value. From the median concentrations of the URQIS data, the dissolved component of copper is 50% of the total, and for zinc, the dissolved phase is 30% of the total. Therefore, it is considered that there is minimal risk of toxicity effects posed by the copper in the discharges, but there is a moderate risk of a toxicity effects from zinc.

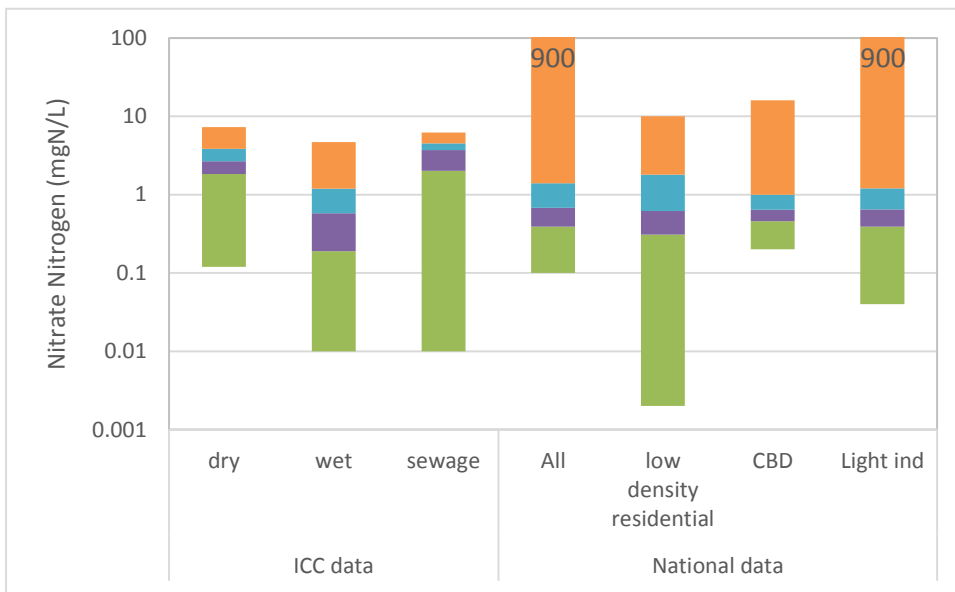
Figure 2-9: Comparison of ICC Nitrate Nitrogen concentrations to national data

The pattern of concentration between wet and dry weather was different with nitrate concentrations generally being higher in dry weather, and the DRP being higher in wet weather. This probably reflects the different sources of the nutrients, with particularly elevated nitrate being present in the low lying catchments probably as a result of groundwater infiltration, which is then diluted in wet weather conditions. Whereas, the DRP is sourced from surface contamination and hence is higher in wet weather conditions due to run-off.

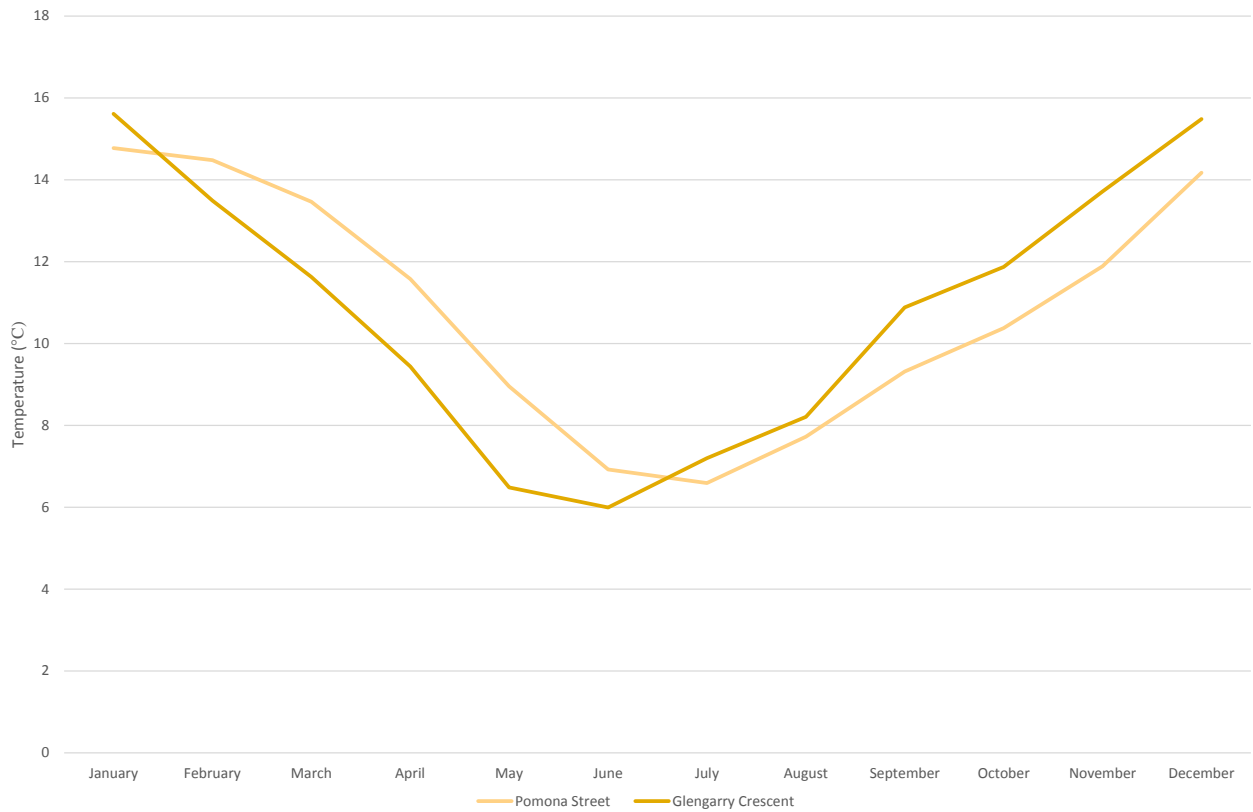
Figure 3-4 Average daily temperature for Pomona and Glengarry street stations

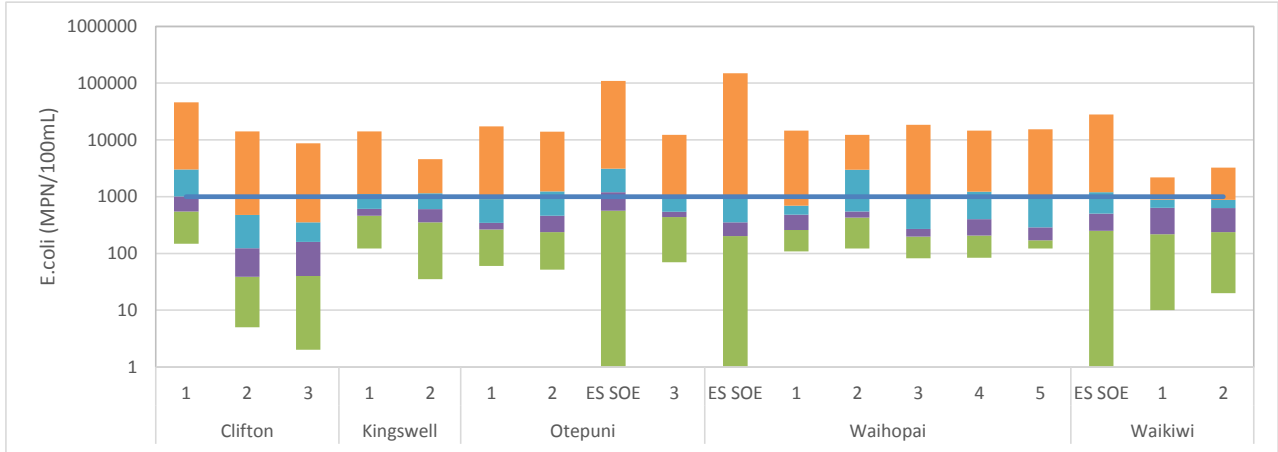
Figure 3-8: Range of *E.coli* from ICC and ES SOE monitoring⁶

Figure 3-8 presents a summary of the data from both the ICC monitoring and the ES State of the Environment (SOE) monitoring, which is for a much longer period, and includes significantly more data points. The data is grouped by catchment, with 1 being the most upstream location, then progressing down the stream in order.

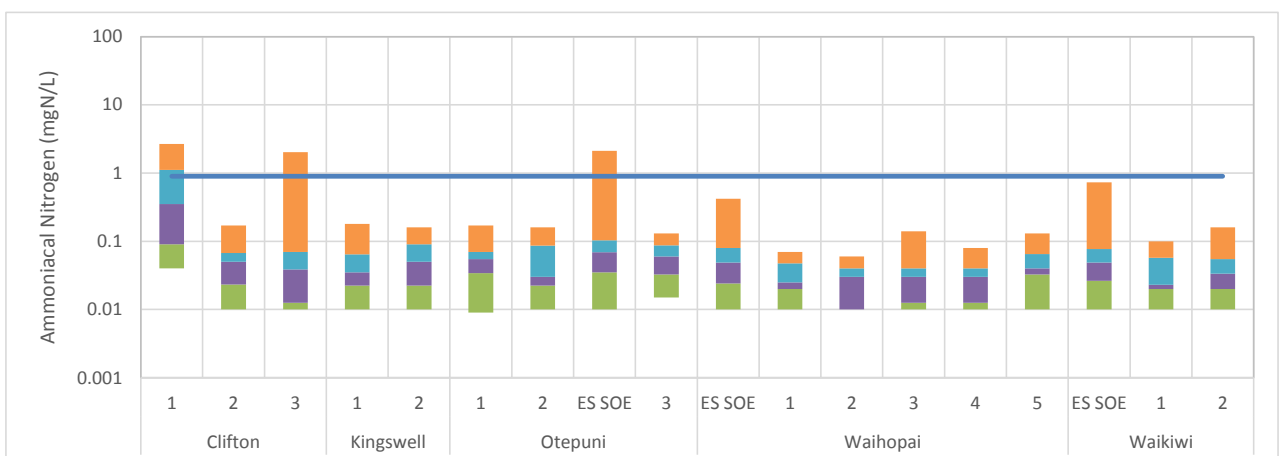
Figure 3-11: Range of Ammoniacal Nitrogen from ICC and ES SOE monitoring

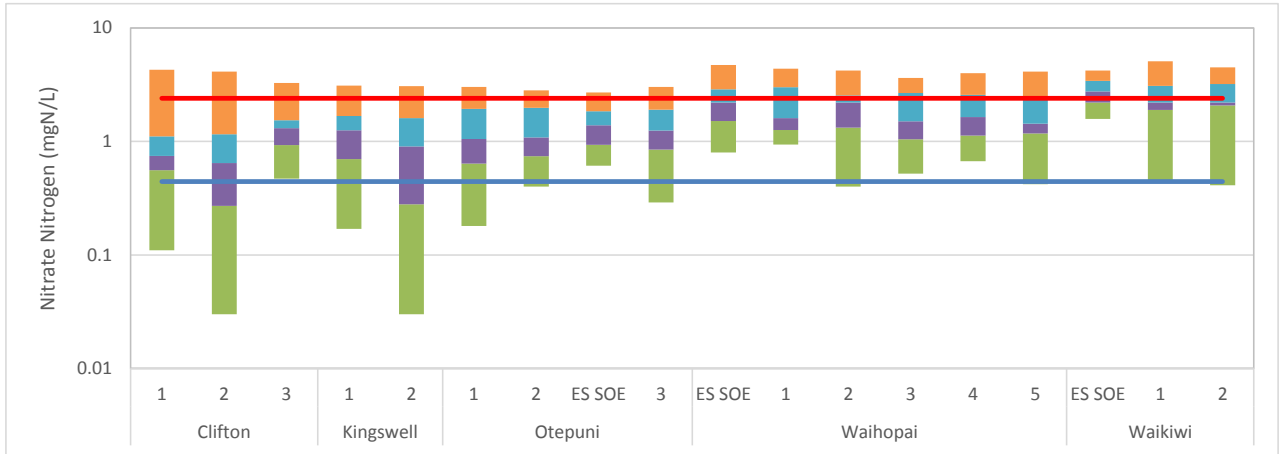
Figure 3-14: Range of nitrate nitrogen from ICC and ES SOE monitoring

Given the spatial pattern, it is considered that while the stormwater discharges will be contributing nutrients to the streams, they are not as significant as those upstream, except possibly for Otepunu Stream.

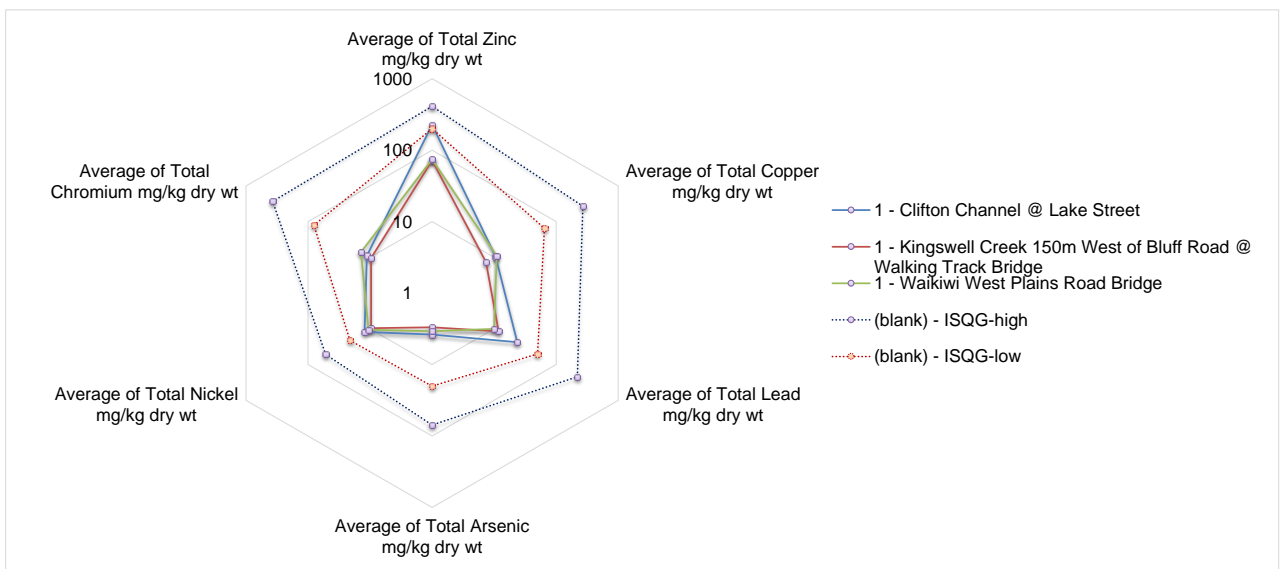
Figure 3-18: Average of metal concentrations in sediment in Clifton Creek, Kingswell Creek and Waikiwi Stream from ICC monitoring

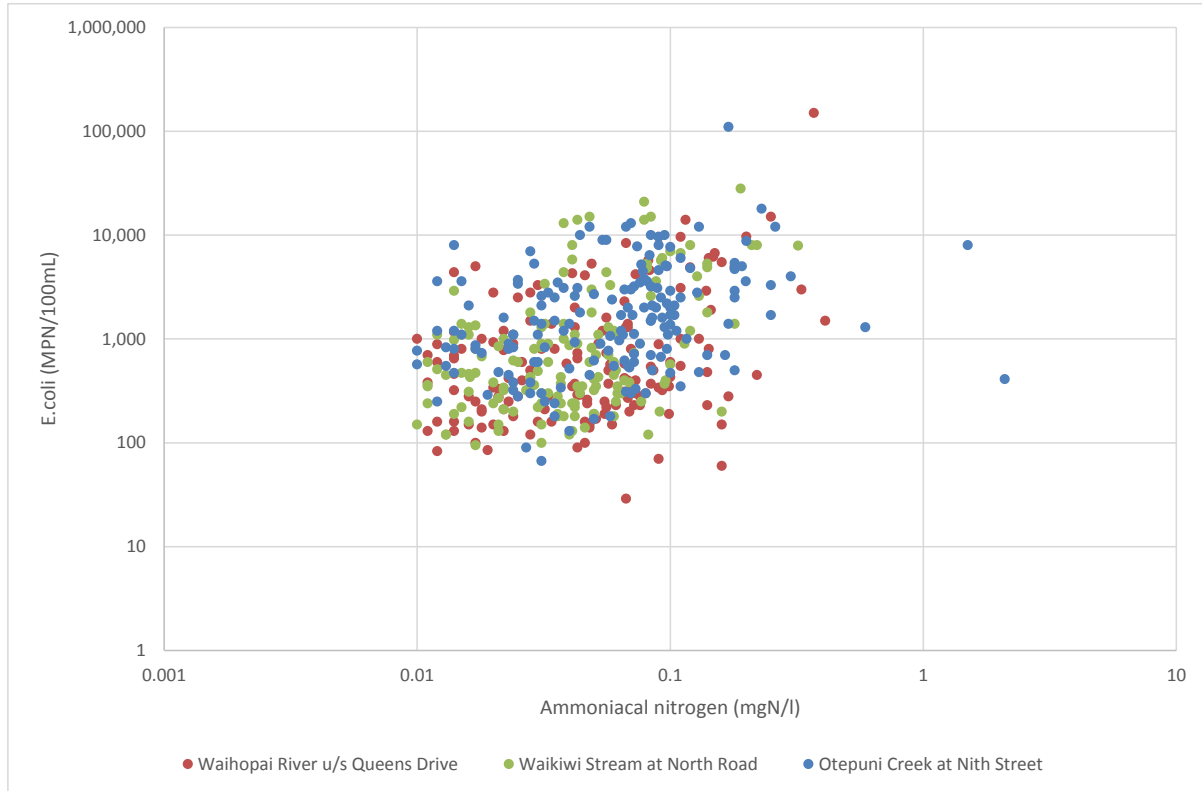
Figure 5-2: *E.coli* versus ammoniacal nitrogen concentrations in receiving water from ES SOE monitoring

The ES SOE monitoring includes two locations upstream of the urban area (Waihopai and Waikiwi) and one in middle of urban catchment (Otepunu). There is no differentiation of wet and dry conditions in the monitoring results hence Figure 5-2 includes monitoring from all conditions collected monthly from 1995 to 2015.

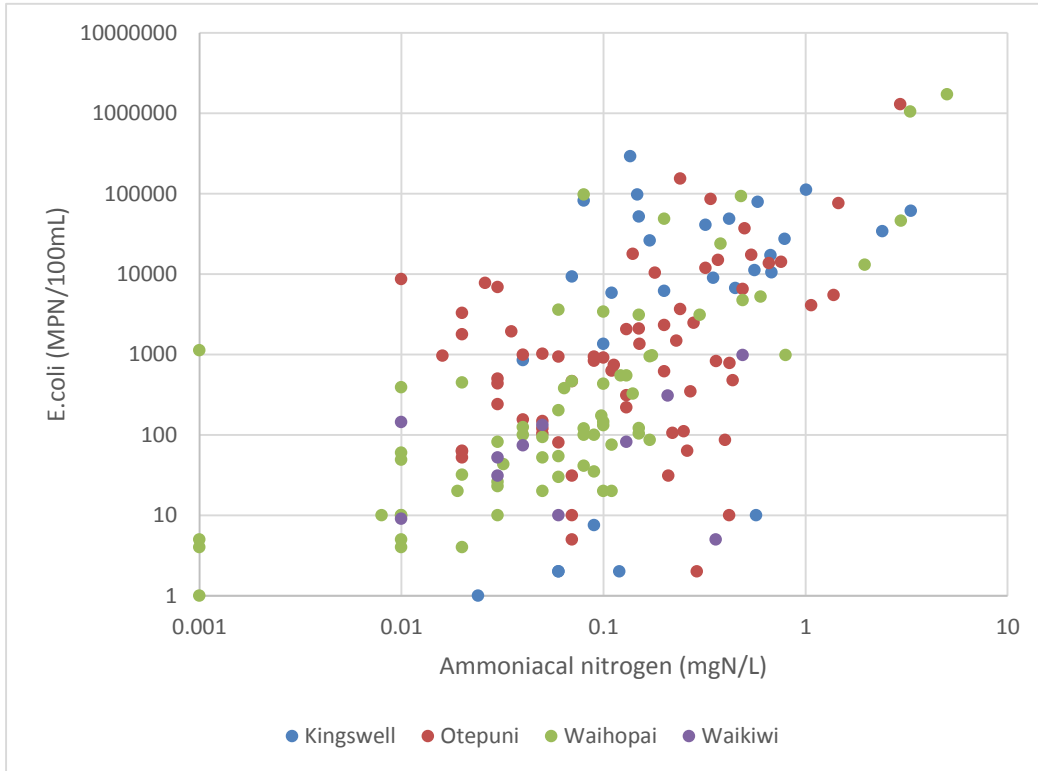
Figure 5-3: *E.coli* versus ammoniacal nitrogen concentrations in dry weather discharges from ICC monitoring

The following triggers are proposed for dry weather discharges to instigate investigation for sewage contamination: *E.coli* over 10,000 MPN/100mL or ammoniacal nitrogen over 1 mg/l.

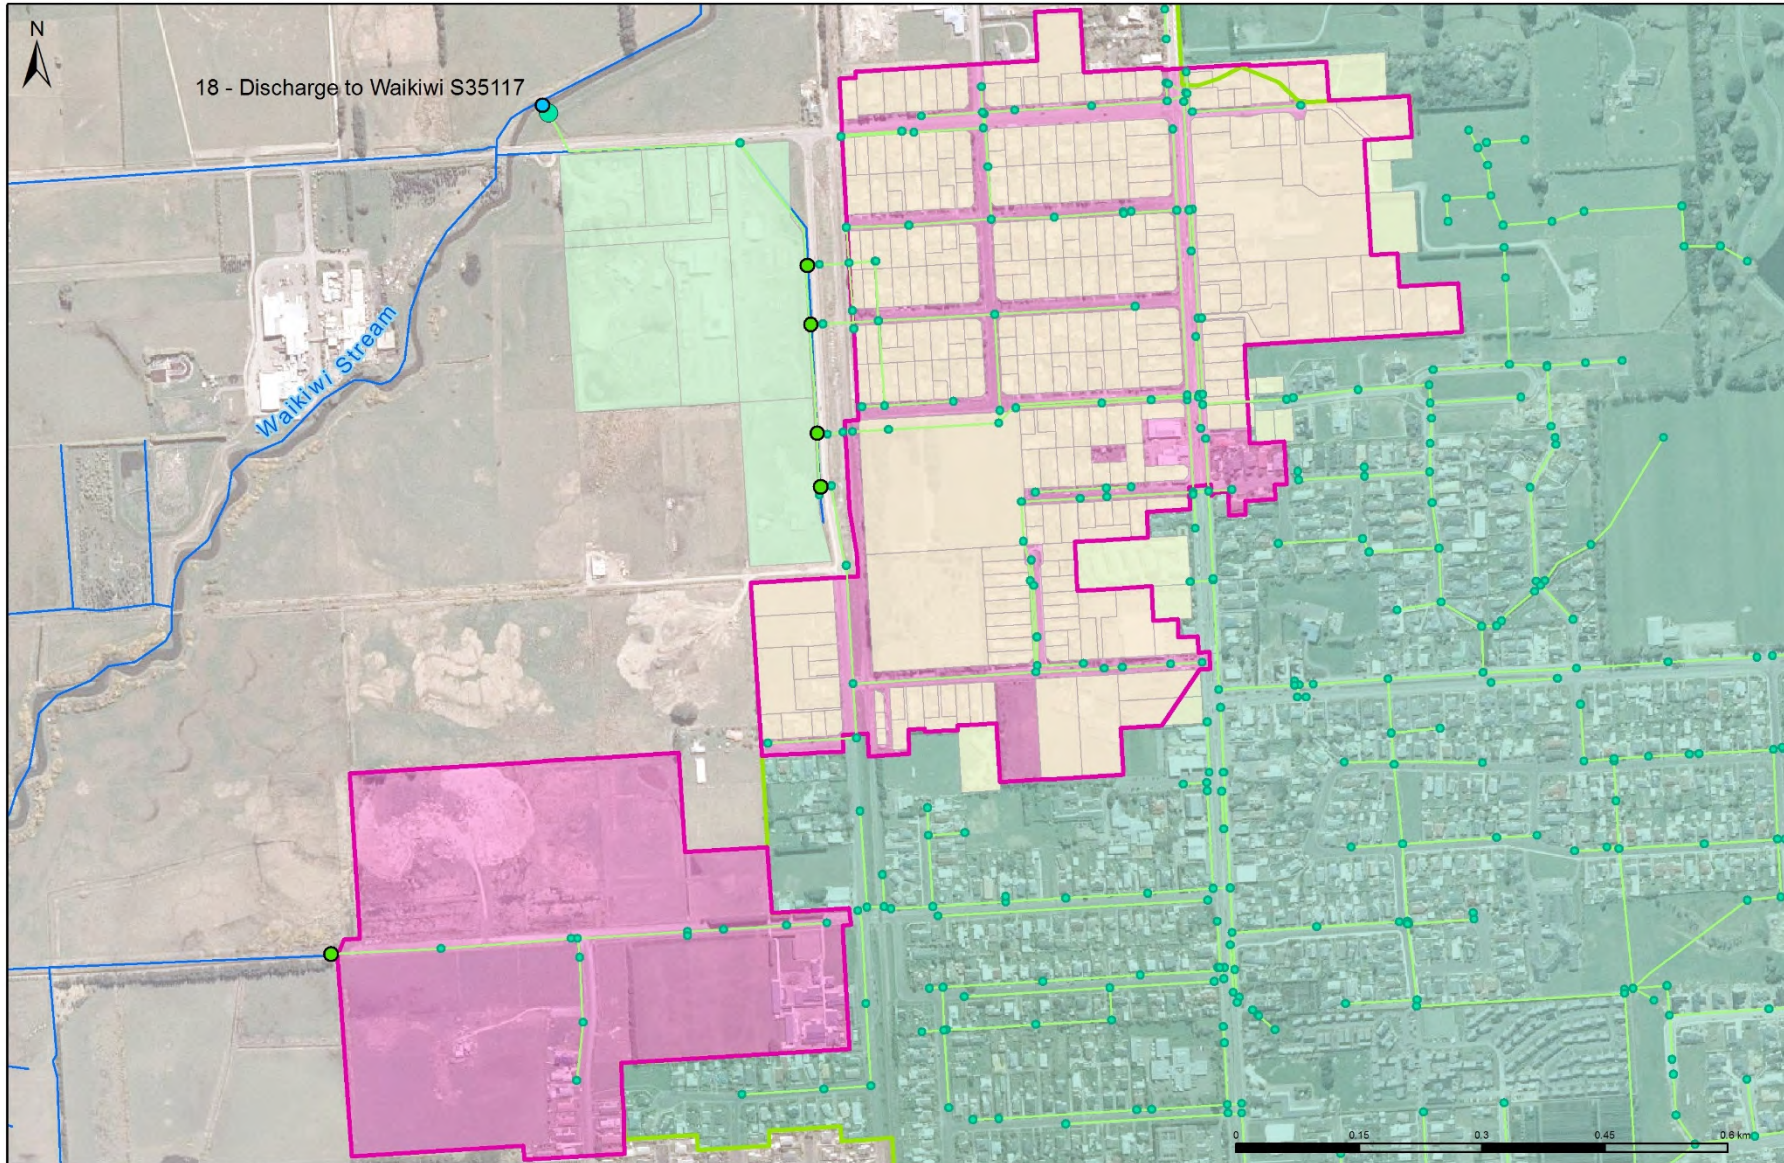
Waikiwi stormwater catchment showing points and network

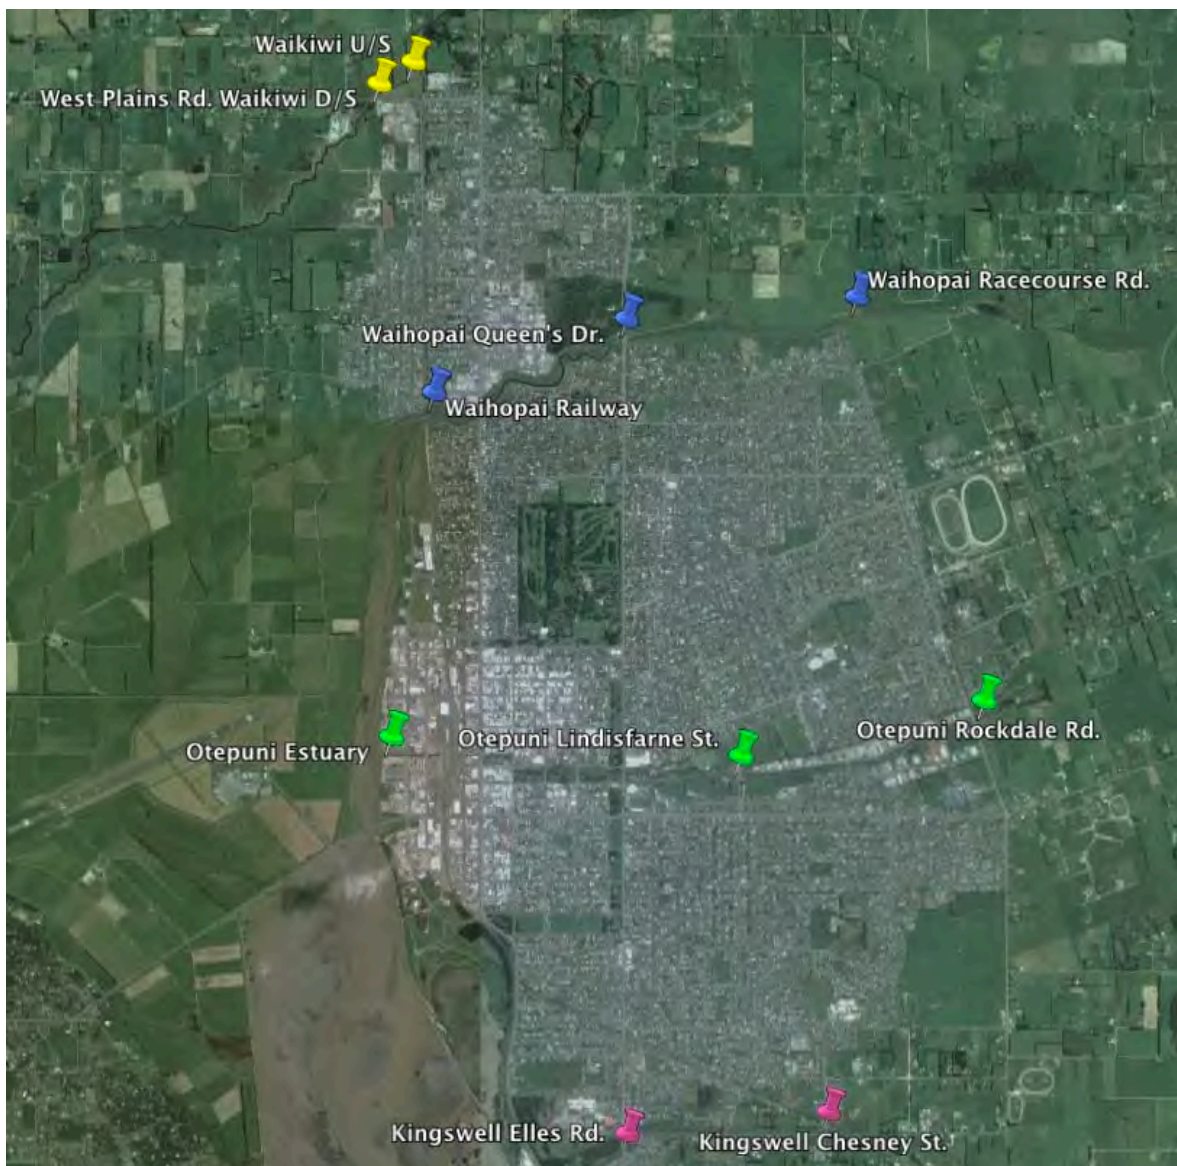
Figure 1 Map outline of sampling sites and locations, Invercargill City.

Macroinvertebrate monitoring was carried out on four sub-catchments of the Invercargill City network: the Kingswell sub-catchment, Otepunī sub-catchment, Waihopai sub-catchment, and Waikiwi sub-catchment (Figure 1).

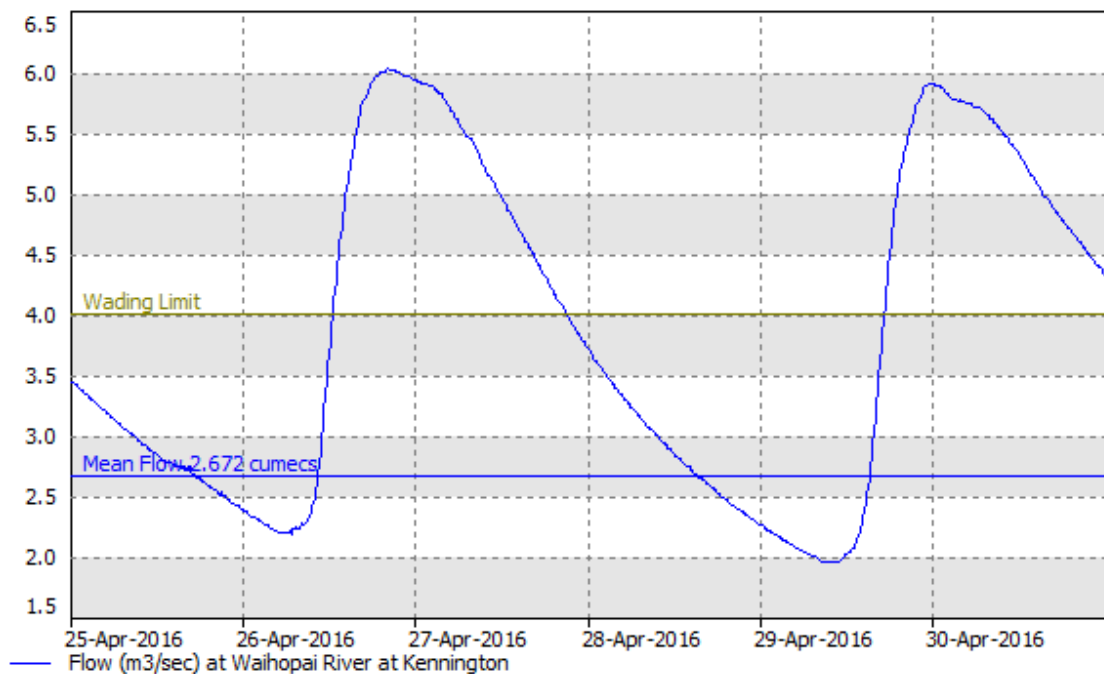
Figure 2 Waihopai River flow data at Kennington, April 2016 (Environment Southland).

Benthic macroinvertebrate samples were collected on the 28th of April 2016 when the flow in the Waihopai River at Kennington ranged from approximately 2.3 to 3.7 m³/s (Figure 2). Flows were slightly above the prescribed survey flow limit of 1.25 m³/s stated in the consent conditions (Condition D (iv)). However, there was limited opportunity to do the required work within the given time frame and the streams were easily wadeable at the time of sampling (Figure 2). The maximum flow in the six weeks prior to the survey was 6.0 m³/s. It is believed that the higher flow level will not have unduly affected the results given in this report.

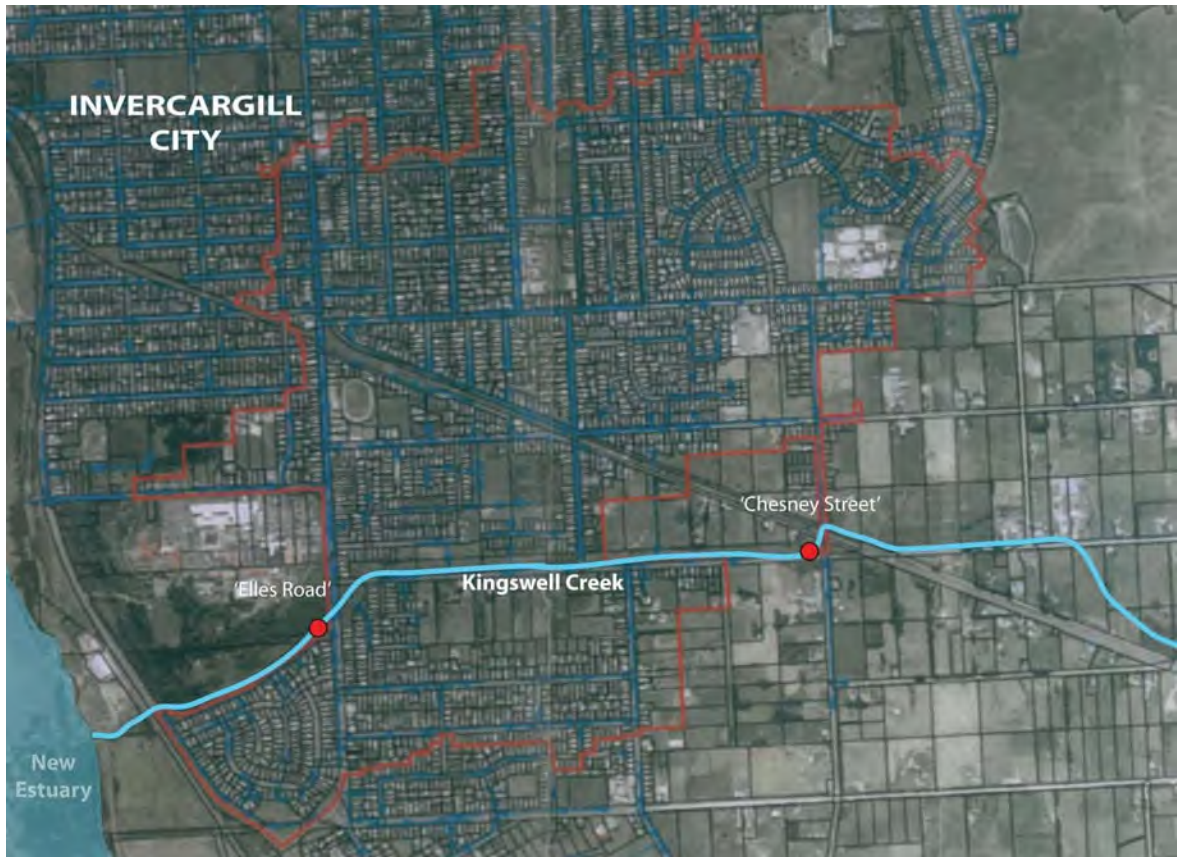
Figure 3 Map outline of sampling sites and locations along Kingswell Creek, Invercargill City (blue line). The Kingswell sub-catchment of the ICC stormwater network is outlined in red. The direction of river flow is from the right to left of the map.

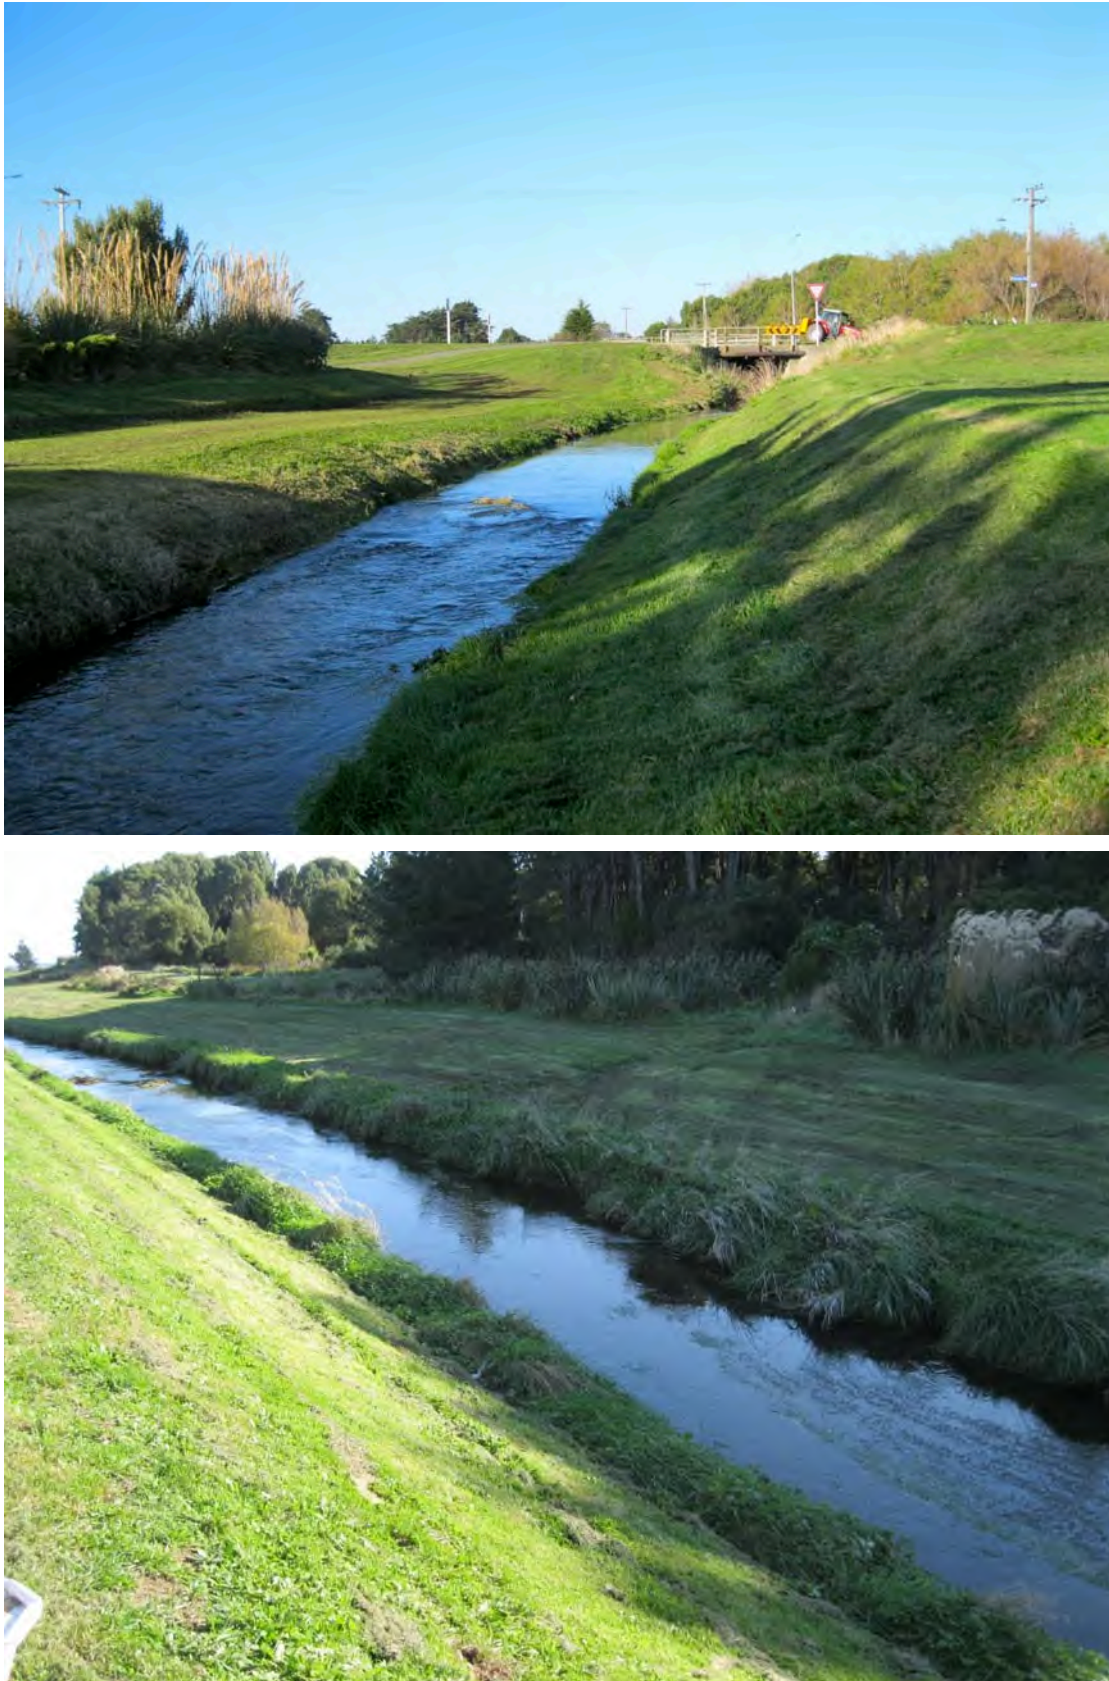
Figure 4 Upstream 'Chesney Street' (top) and downstream 'Elles Road' (bottom) macroinvertebrate sampling sites in Kingswell Creek, April 2016.

The downstream 'Elles Road' site (Figure 4) was located approximately 20 m below Kingswell Creek Bridge and approximately 2000 m downstream of the stormwater outfall. The riparian vegetation was similar to that of the upstream 'Chesney Street' site, and similar urban land uses surrounded the sampling reach. Stream flow was moderate and water depth was greater than upstream. Mud and fine sediment was the dominant substrate type and aquatic plants grew densely and covered most of the stream bed.

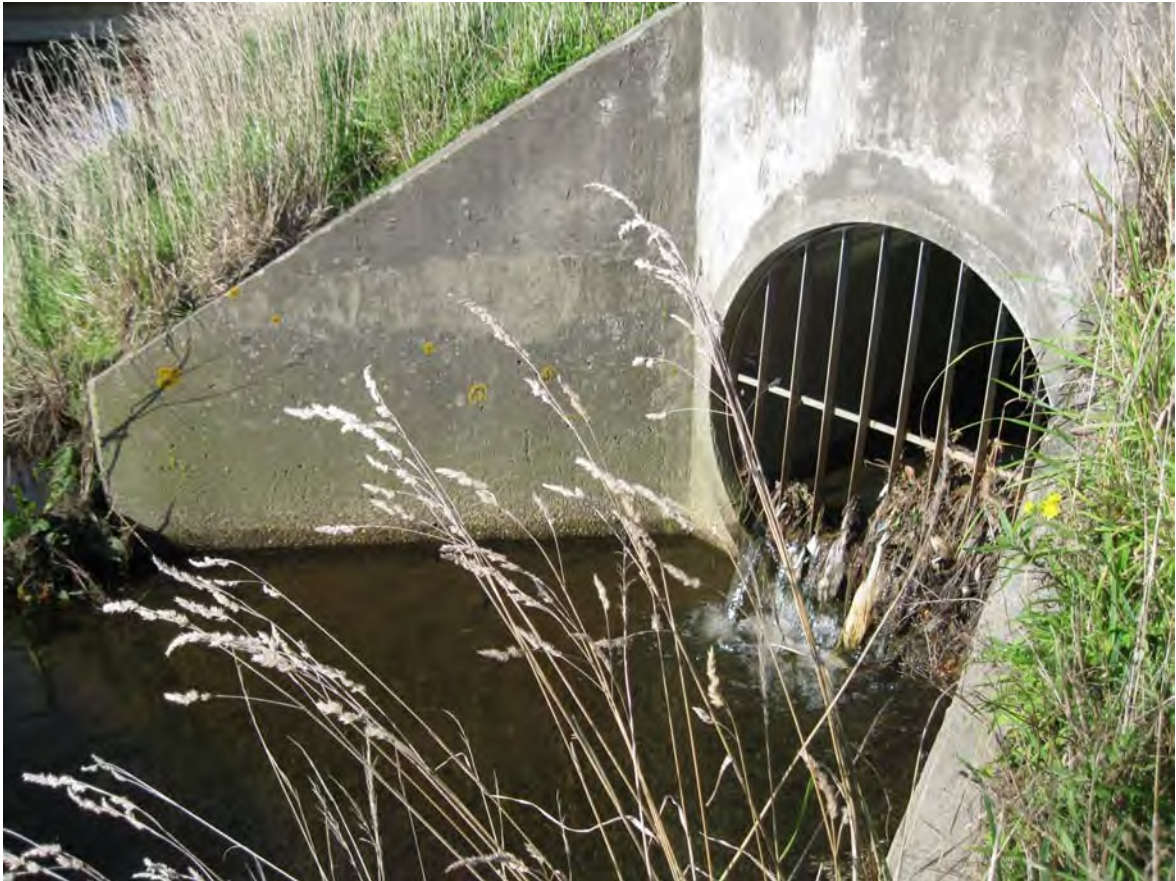
Figure 9 View of a stormwater drain entering Otepuni Creek (left) near Lindisfarne Street, Invercargill. View taken from true left, April 2016.

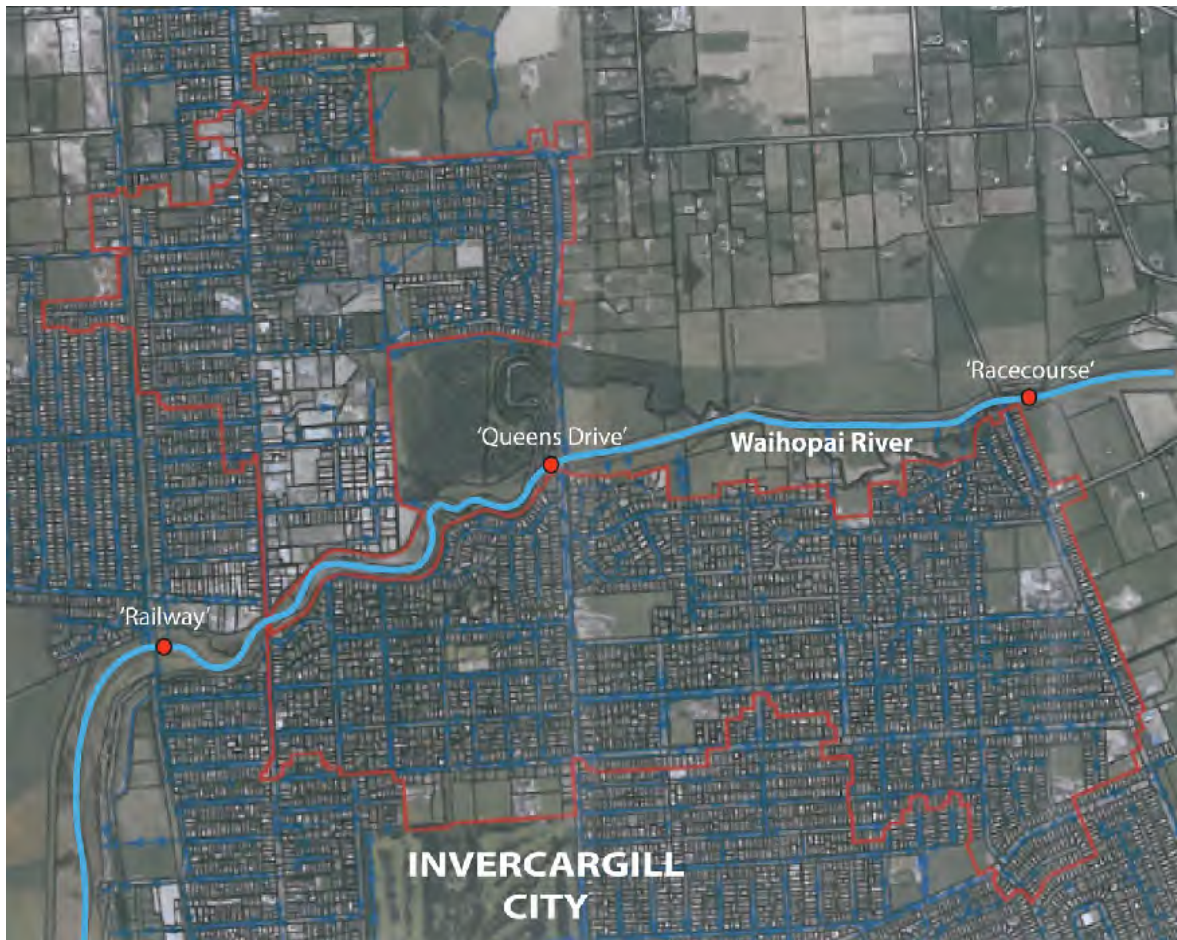
Figure 11 Map outline of sampling sites and locations along the Waihopai River, Invercargill City (blue line). The Waihopai sub-catchment of the ICC stormwater network is outlined in red. The direction of river flow is from the right to left of the map.

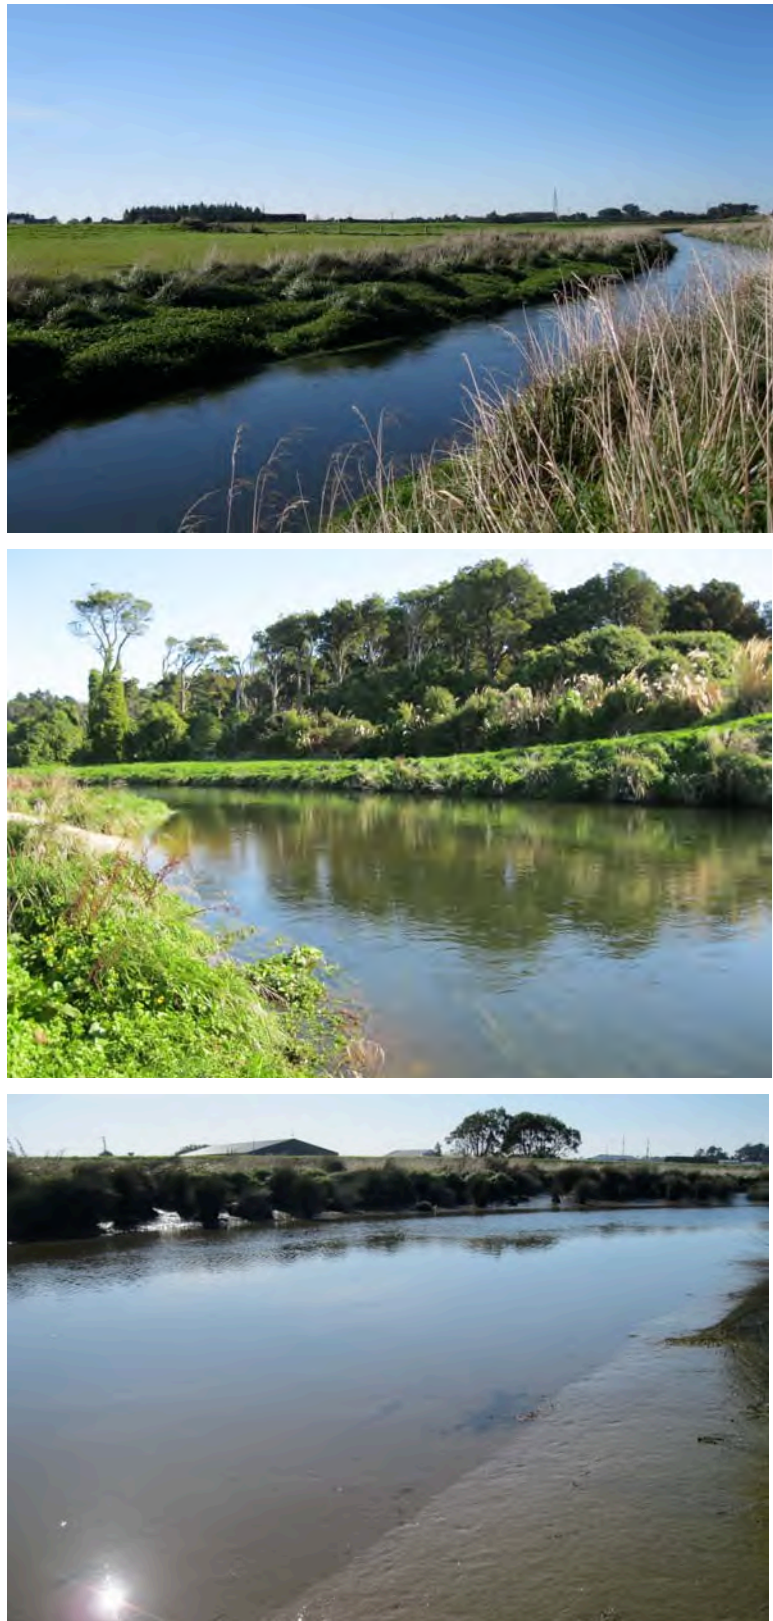
Figure 12 Upstream 'Racecourse' (top), downstream 'Queens Drive' (centre), and estuarine 'Railway' (bottom) sampling sites in the Waihopai River, April 2016.
