Application for Discharge Permits for Invercargill Stormwater Network

STORMWATER DISCHARGES – APPLICATION DOCUMENT

Prepared for the Invercargill City Council

September 2016

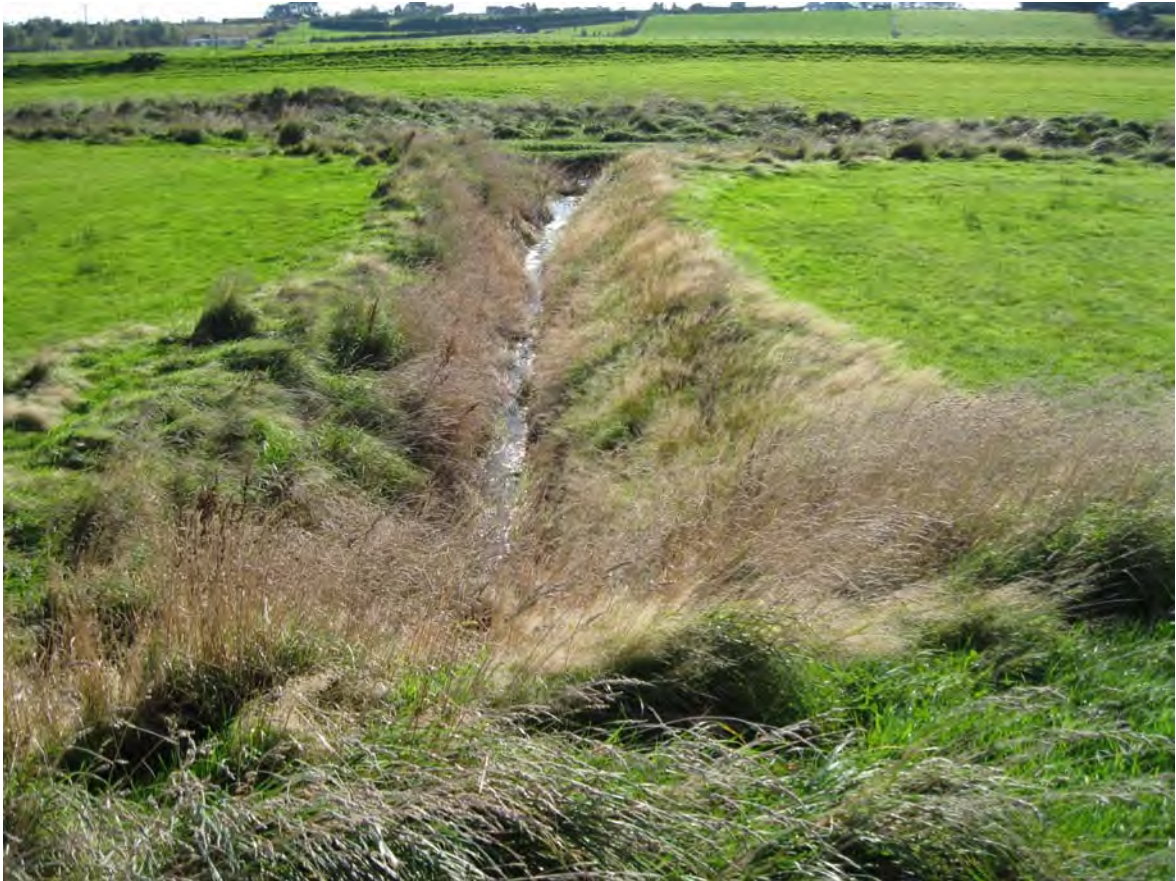
Figure 13 Downstream view of a stormwater drain that enters the Waihopai River near Racecourse Road, Invercargill, April 2016.

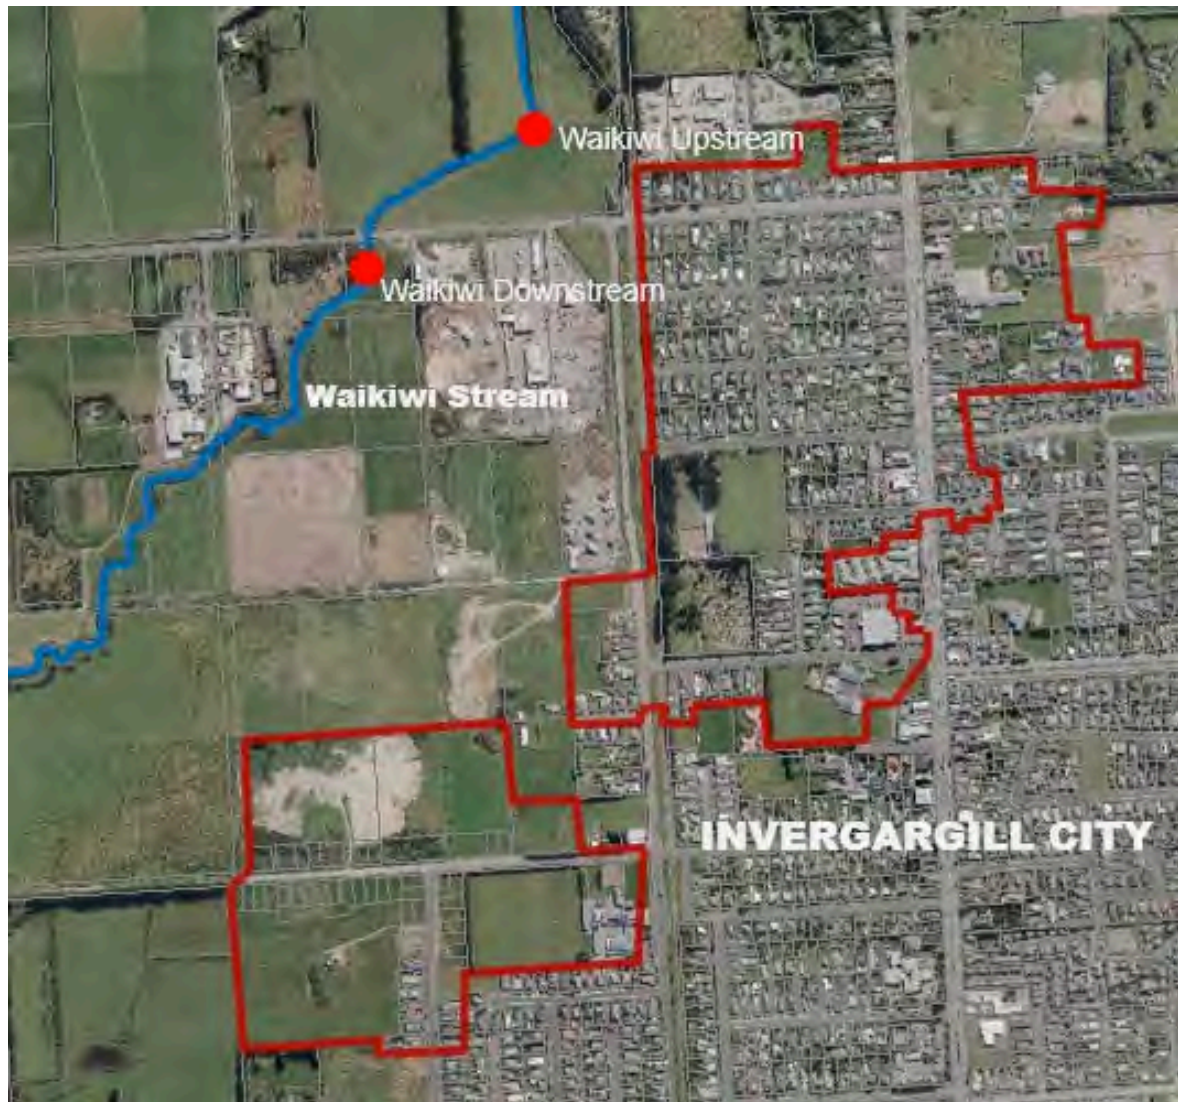
Figure 15 Map outline of sampling sites and locations along the Waikiwi Stream, Invercargill City (blue line). The Waikiwi sub-catchment of the ICC stormwater network is outlined in red. The direction of river flow is from the top to the bottom of the map.

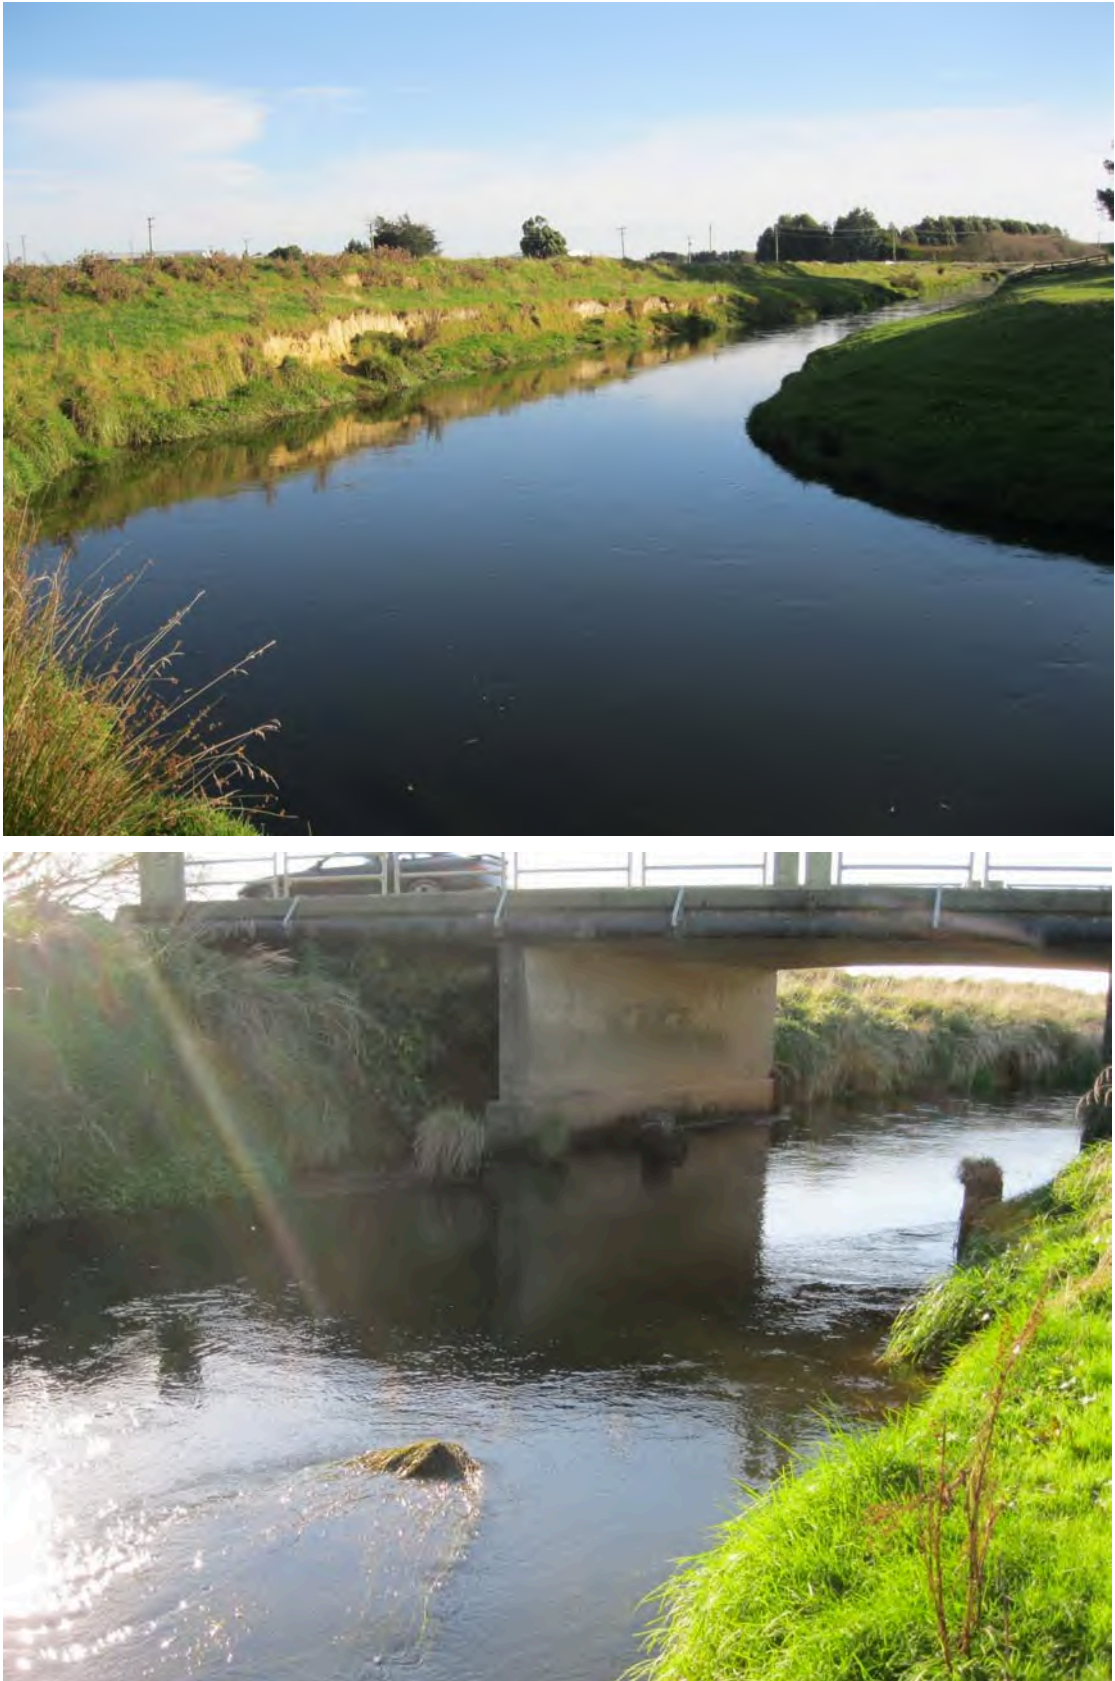
Figure 16 Upstream (top) and downstream (bottom) sampling sites in Waikiwi Stream, April 2016.

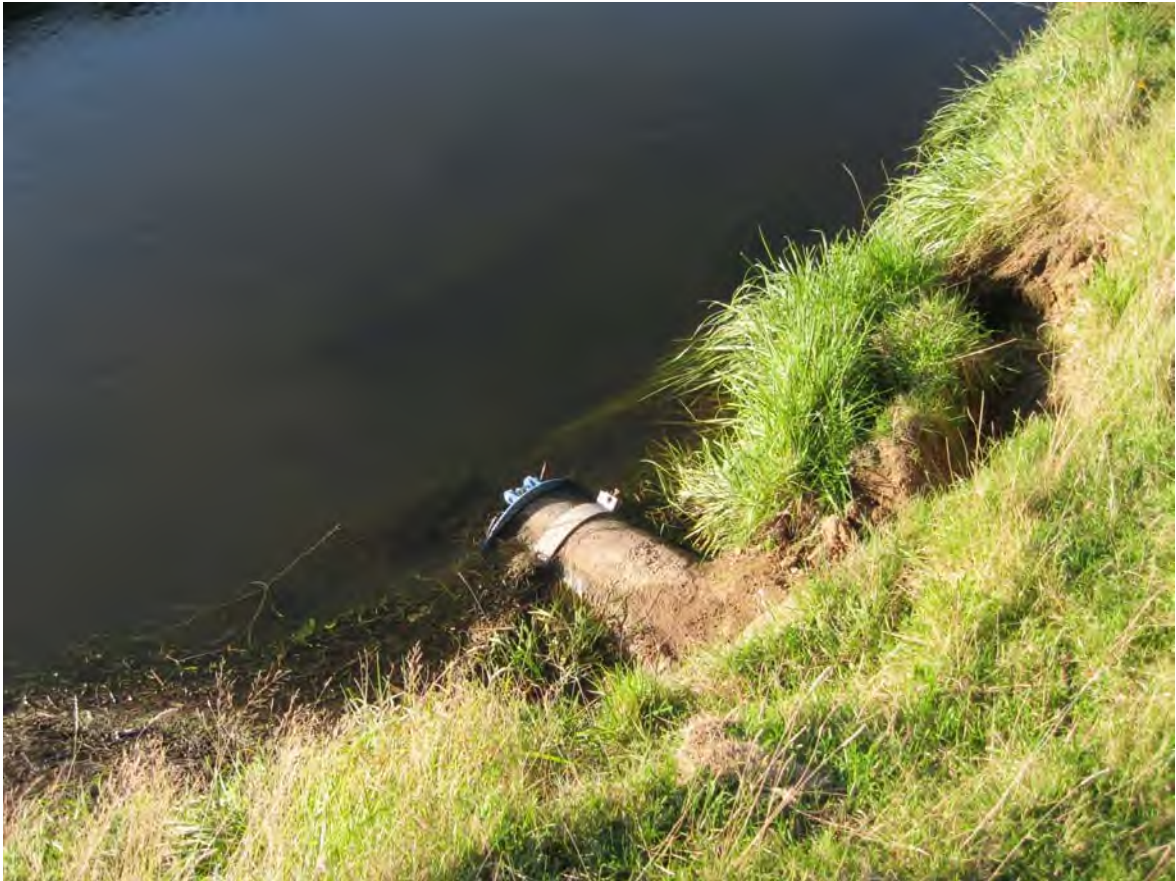
Figure 17 Stormwater drain entering Waikiwi Stream upstream of West Plains Road Bridge, Invercargill. View taken from true left, April 2016.
