RE: Drop Test Results – Miraka Farms Ltd

DAIRY EFFLUENT POND DROP TEST REPORT

JOB TITLE	MIRAKA DAIRY
ADDRESS	162 BOYLE ROAD, WINTON
JOB NUMBER	50596

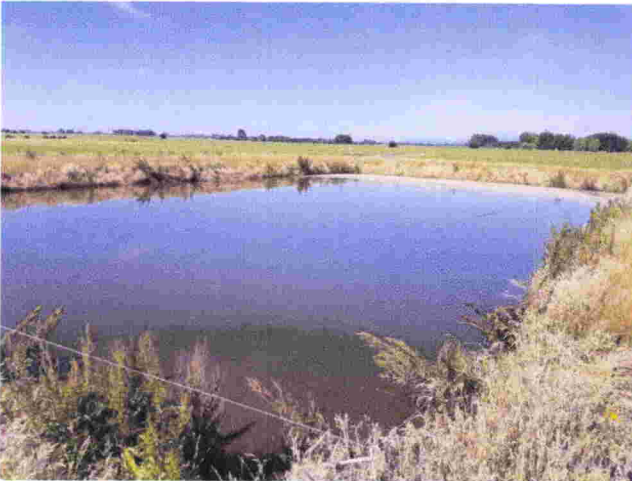
Photograph of pond before test

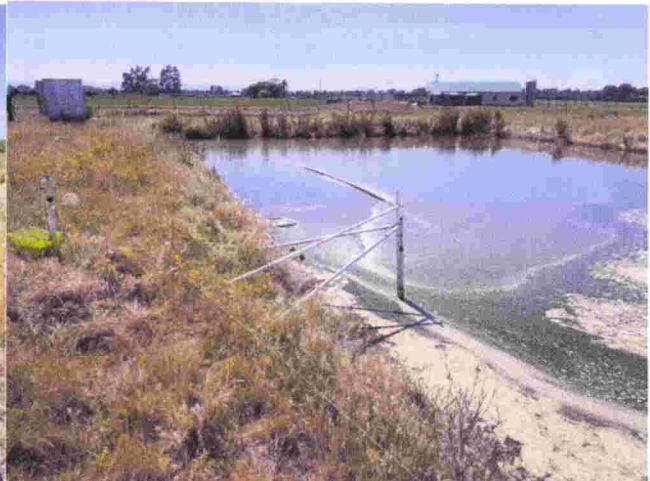
Photograph of pond level logger and evaporation logger

A capacitive water level logger was installed in the pond, to determine the overall change in pond level over time. The logger is protected within a PVC tube covered with filter fabric to prevent fouling of the sensor. Pond level measurements were taken every 10 seconds throughout the test period.

The loggers are both calibrated every time they are used, using effluent from the pond being tested. The precision of pond level measurement is estimated at ± 0.8 mm. The pond level data is shown in the site investigation log.

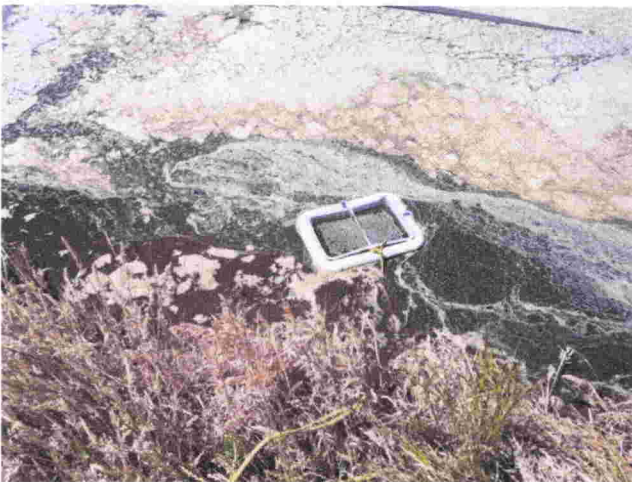
Photograph of floating evaporation tray at start of test.

Two evaporation pans were used for this test. One was placed on the pond embankment in the location shown on the test location plan, the other was floated in the pond as required by IPENZ PN21. The on-shore pan measures 362.5mm long x 240mm wide x 210mm high, while the floating pan measures 410mm long x 270mm wide x 210mm high. We estimate the precision of manual water level measurement in the pans as ± 0.5 mm.

The floating pan is used as the reference for evaporation, as it most closely represents evaporation conditions in the pond. The second pan on the embankment is used as a back-up and to identify trends in level fluctuation, however is less representative of overall evaporation conditions in the pond due to its' different thermal mass.

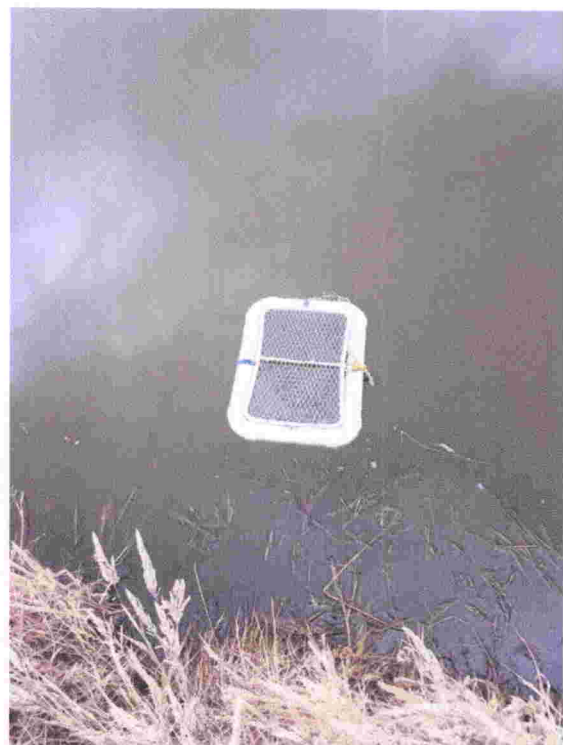
Photograph of the floating evaporation tray at end of test

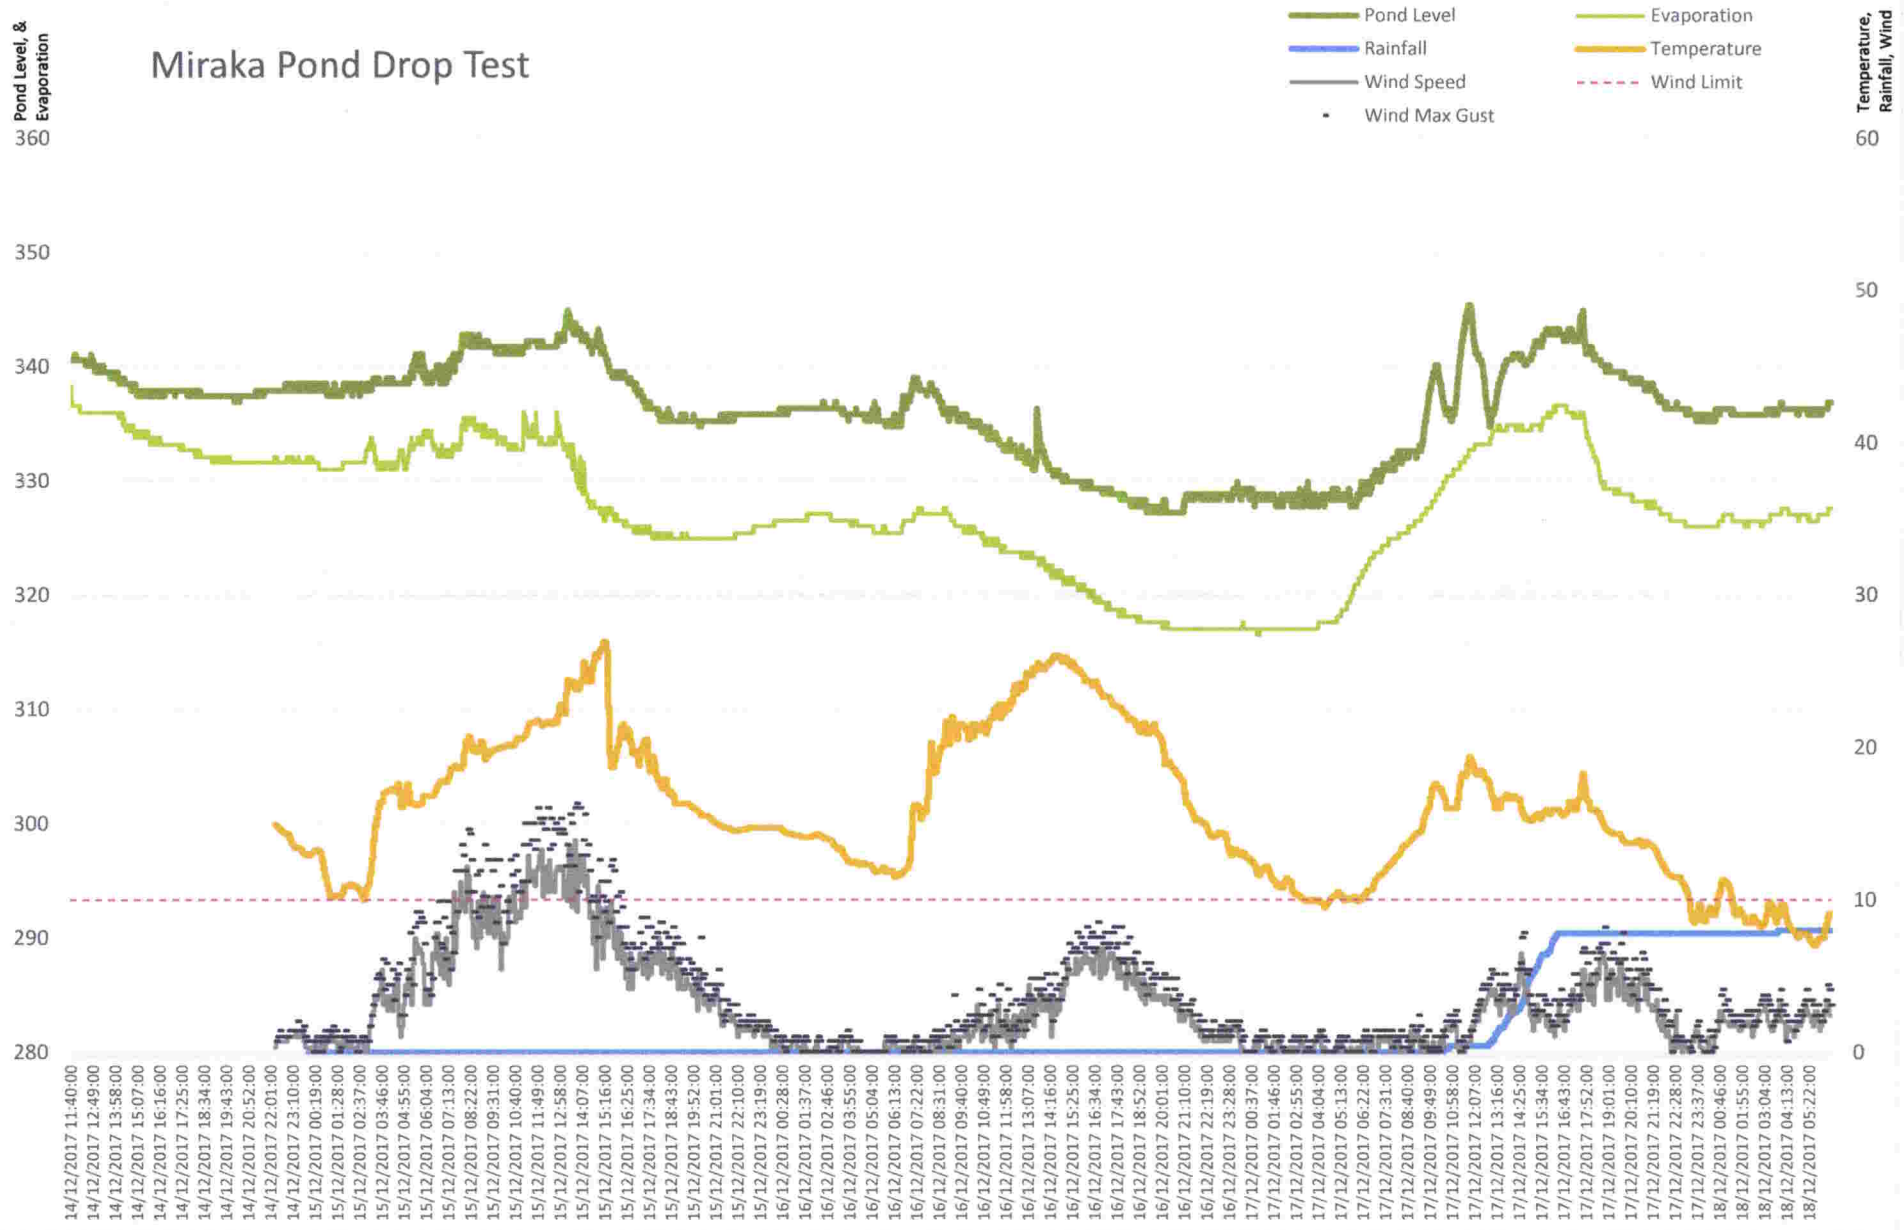
POND LEVEL CHART

This section discusses all changes in pond level during the test. The following events are shown on the charted data.

Between approximately 8:30am and 07:30pm on the 16th of December a significant evaporation event took place, as shown under Event 3 on the charted data. It can be seen that during this event the level in both the pond, and the evaporation tray dropped 10mm. During this event the dominant wind direction was Southerly which turned easterly at approximately 10:00pm, and then turned northerly at approximately 11:20pm.

On the 17th of December, there was a spike in pond level, followed by a drop and then another larger spike, which was then followed by a second drop, and this is shown as Event 4 on the charted data. This event occurred at the same time as two small spikes in temperature and it is suspected that this has caused condensation to build up on the capacitance logger cable which resulted in a false spike occurring.

All rainfall during the test period occurred between 10:30pm on 17th December, and the end of the test, with a total of 8mm recorded in the tipping bucket rain gauge. The rainfall event is shown in the charted data as Event 5, and it can be seen that the pond level increased by approximately 9mm during this period. The rainfall event coincided with moderate to strong Southwest winds which have masked the increase by creating noise in the logged data in both the evaporation tray and the pond. At 10:00pm on the 17th of December the wind speed dropped off and the graphed data shows both the evaporation tray and pond level flattening out.

Miraka Pond Drop Test
