REVIEW OF EFFECTS OF THE FIORDLAND TRAIL ON WETLAND VALUES

Environment Southland have received a retrospective resource consent application (APP-20191150 W4931) from the Fiordland Trails Trust to modify a wetland due to construction of a multi-use trail on the eastern margin of Lake Manapouri. The trail crosses the wetland approximately two kilometres northeast of Manapouri township. Environment Southland required an independent assessment of the likely effects of trail construction on the wetland, which was provided by Wildland Consultants early in 2019 and in response to subsequent developments (Wildland Consultants 2019a; 2019b; 2019c).

All of the previous opinions provided by Wildland Consultants was done so on a desktop basis, without having visited the site, which limited the accuracy of these opinions. A site visit was therefore undertaken on 4 November 2019 to assess the wetland in the field and to assess the effects of the proposed third culvert.

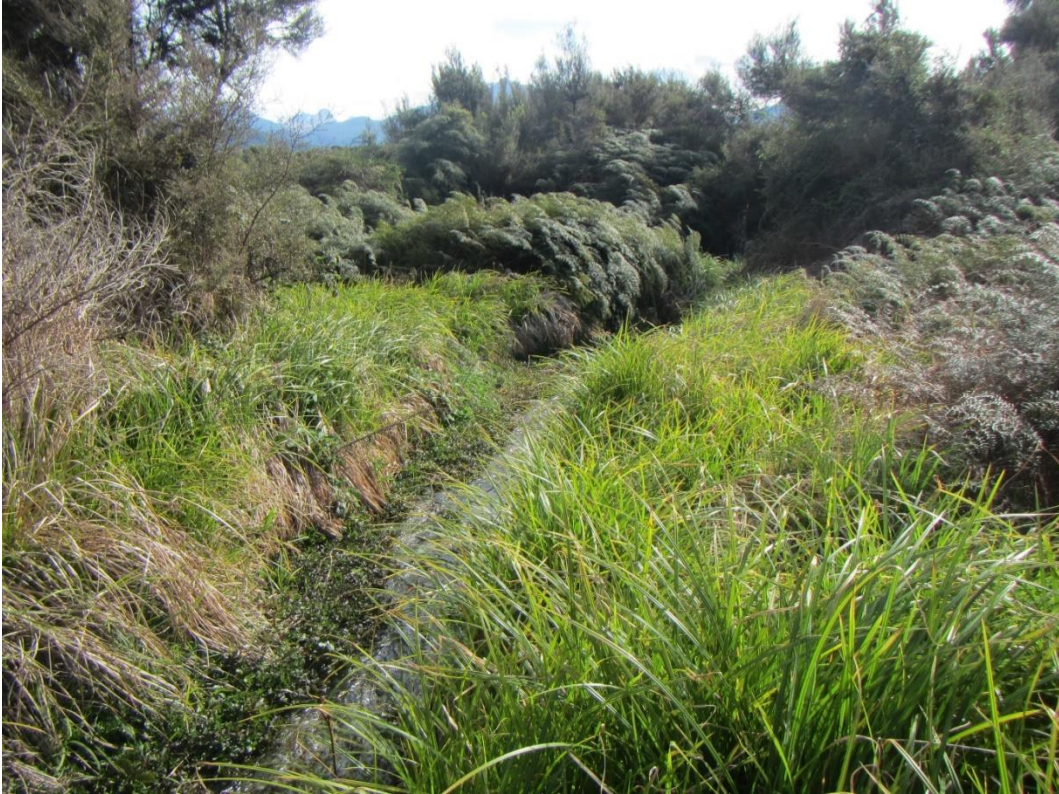
Upstream of the cycle trail, wetland vegetation occupies the floor of a shallow, 30-40 metre wide gully, with wetland sedges dominant on stream sides (Plate 1) but also dispersed through the manuka (*Leptospermum scoparium*) shrubland that occupies much of the gully floor (Plate 2). Mingimingi (*Coprosma propinqua*), weeping mapou (*Myrsine divaricata*), and *Coprosma dumosa* are common shrubs in the mānuka shrubland, with occasional Scotch broom (*Cytisus scoparius*) and blackberry (*Rubus fruticosus*). Rautahi (*Carex geminata*) is the dominant sedge, with pukio (*Carex secta*) on some stream margins. Shield fern (*Polystichum vestitum*) is common

Plate 1: Dense sedgeland beside the northern stream above the cycle trail, with watercress occupying the open stream channel. 4 November 2019.

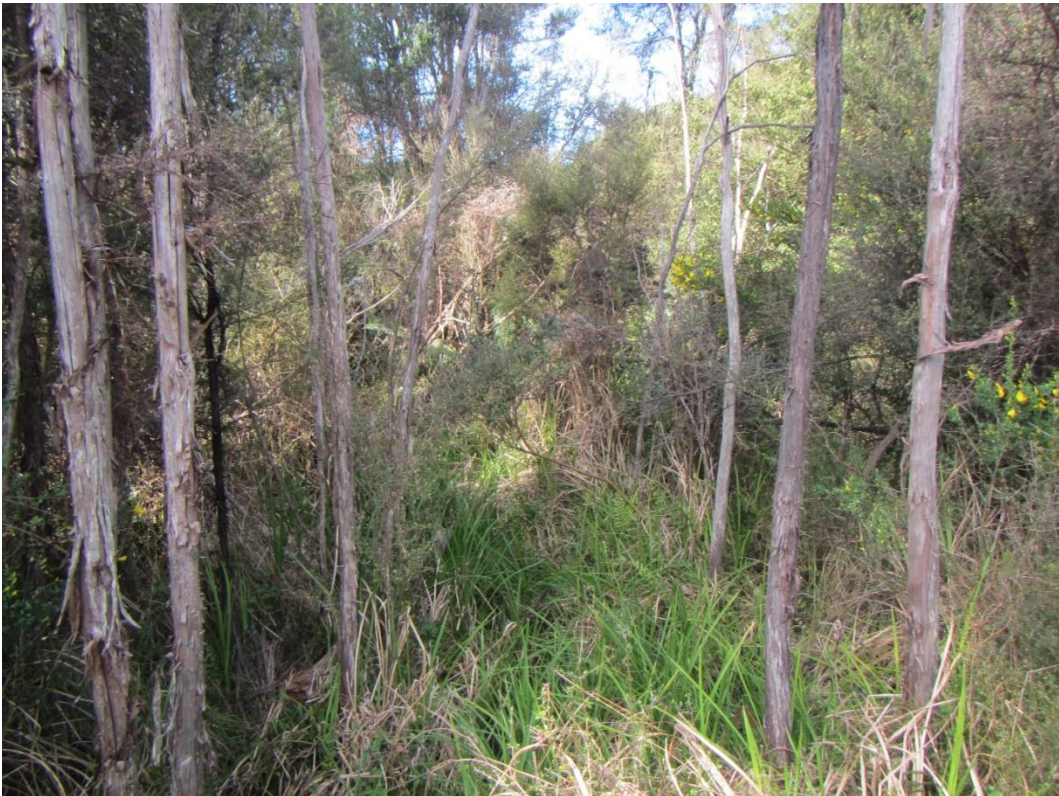
Plate 2: Sedges dispersed through mānuka scrub above the cycle trail, indicating wetland conditions. 4 November 2019.

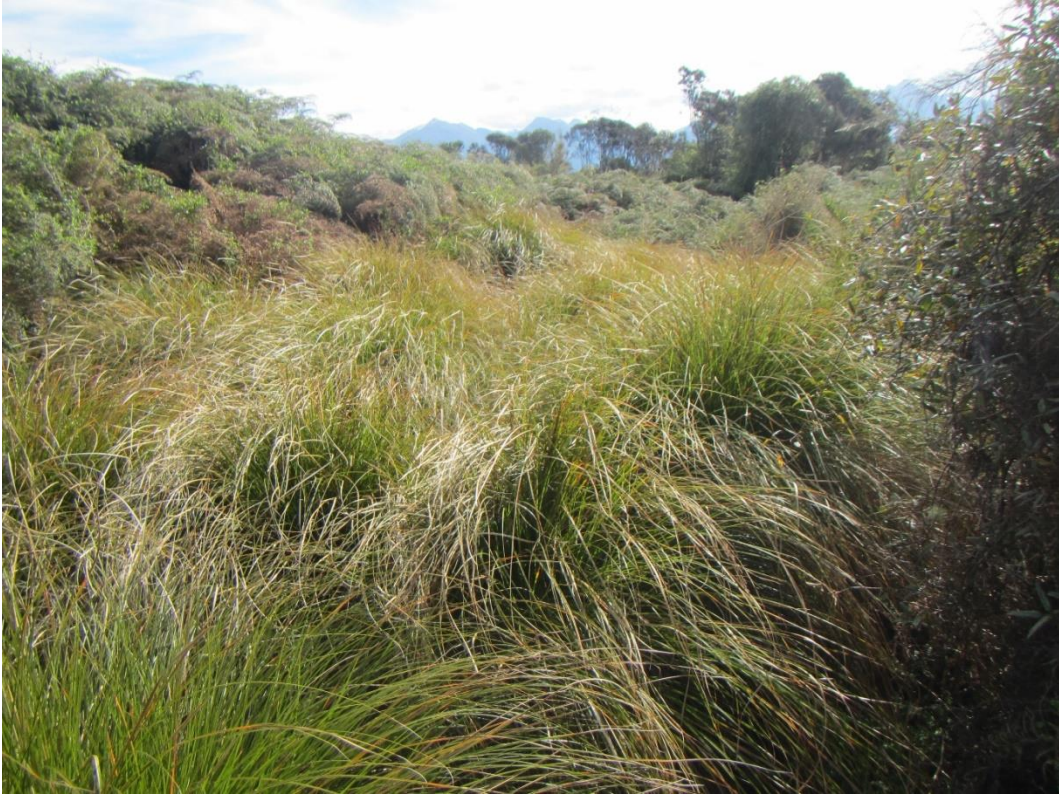
Below the cycle trail, wetland vegetation is largely confined to the margins of the two streams that pass through culverts in the trail. Pukio is the dominant sedge (Plate 3), and water cress (*Nasturtium microphyllum*) is present in the open stream bed.

Plate 3: Dense pukio sedges beside the southern stream below the cycle trail. 4 November 2019.

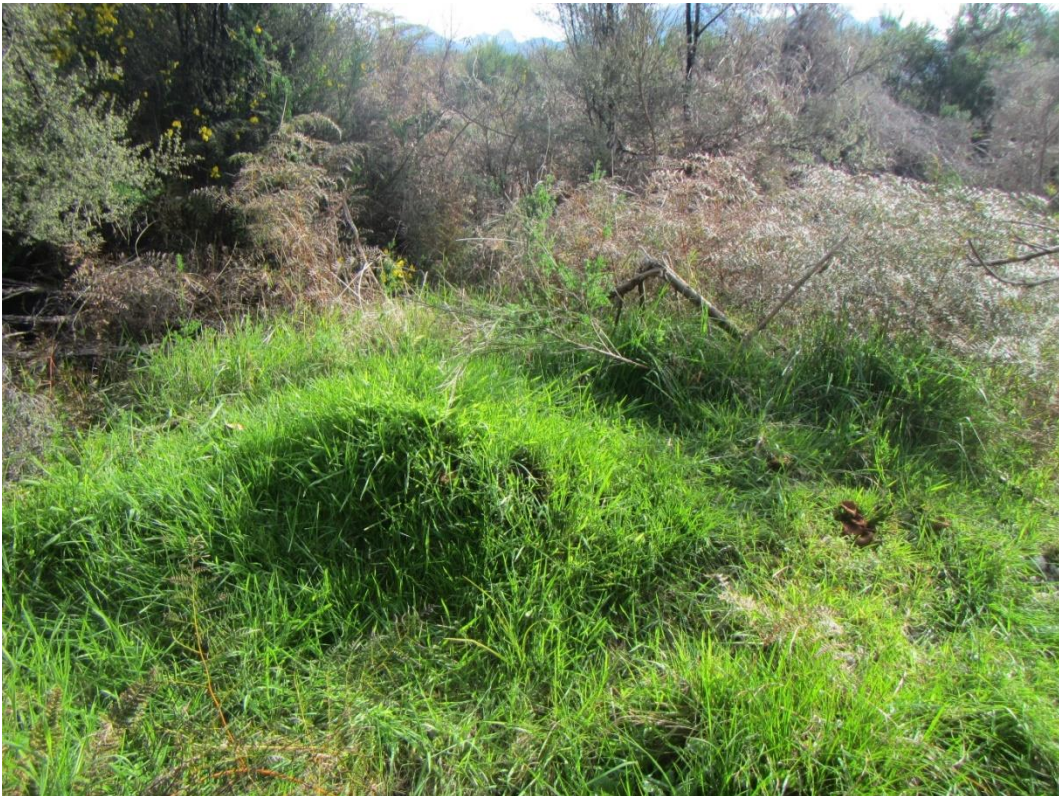
During construction of the trail, excavated substrate has been dumped on either side of the cycle trail, mostly on the downstream side, but in one location on the upstream side (Plate 4). These now form spoil mounds covered by exotic grasses and indigenous fireweed (*Senecio minimus* and *S. glomeratus*).

Plate 4: Exotic grasses dominate a mound created by dumping of spoil in the wetland upstream of the cycle trail. This mound should be removed and the original wetland ground surface restored. 4 November 2019.

In addition to this, we suggest that the spoil mound in the wetland upstream of the cycle trail be removed – it could potentially be used to infill the ditch. Removal of this mound would enable wetland vegetation to re-colonise the area. The mound should be carefully removed to reinstate the original ground level of the wetland, consistent with the adjacent ground surfaces. This will allow the substrate to become wetted, and colonised over time by indigenous wetland vegetation.

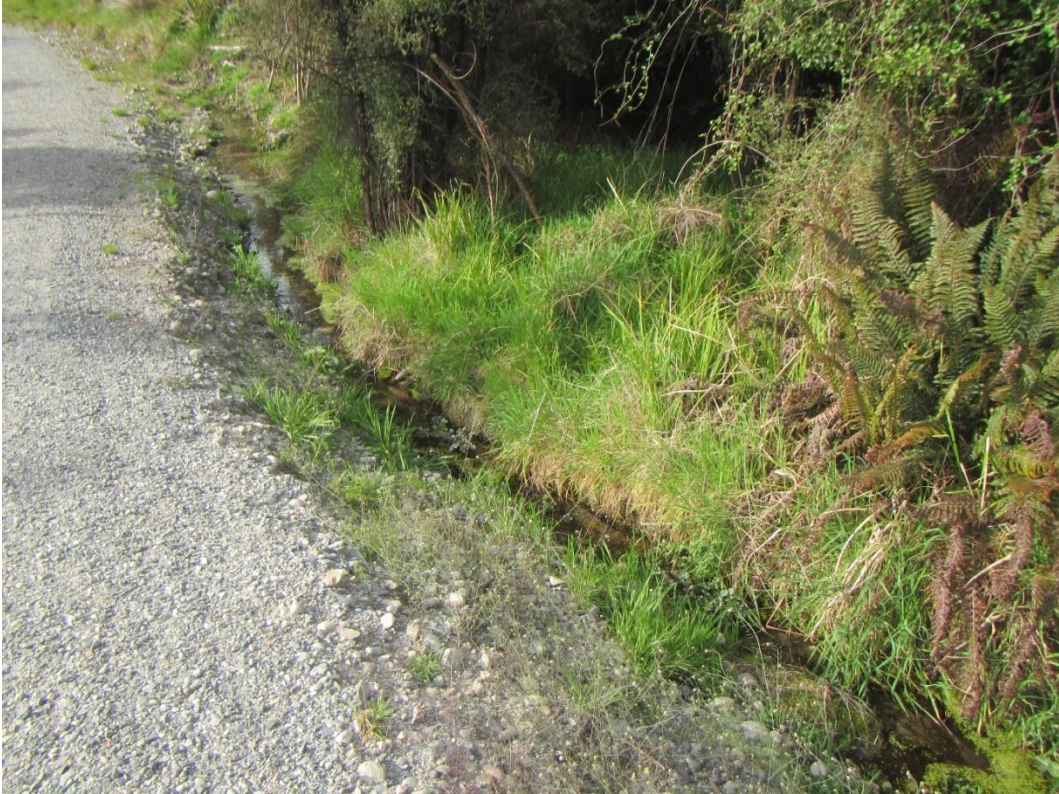
The main effects of cycle trail construction are through loss of indigenous vegetation, including wetland vegetation, beneath the footprint of the trail and associated spoil dumps, and modification to wetland hydrology caused by excavation of a ditch on the upstream side of the trail.

Plate 5: The excavated ditch on the upstream side of the cycle trail that is resulting in adverse hydrological effects on the upstream wetland. 4 November 2019.

The applicant has agreed that the ditch excavated on the upstream side of the formed trail (Plate 5) should be filled in, monitoring of the infilled area should be undertaken to check for settling of the substrate (with re-filling if required), and monitoring of subsequent colonisation by rautahi should be undertaken. The ditch should be filled in to a level consistent with the level of the adjacent upstream wetland surface (Plate 5). This may require raising the height of the cycle trail to prevent water flowing over it.

The applicant has agreed to undertake these works and monitoring. If the infilling work is carried out successfully, this should remedy the adverse hydrological effects on the wetland to the point that they are less than minor (Wildland Consultants 2019c).
