Dairy Green Ltd
Practical Engineering Solutions
Consents, Effluent, Stock water, Irrigation
Design through to Installation
Irrigation NZ Accredited Designer

Drop Test Results: South Pro Maitland Ltd sludge beds, 27 February - 1 March 2019.

The discharge consent for the property is 20146428

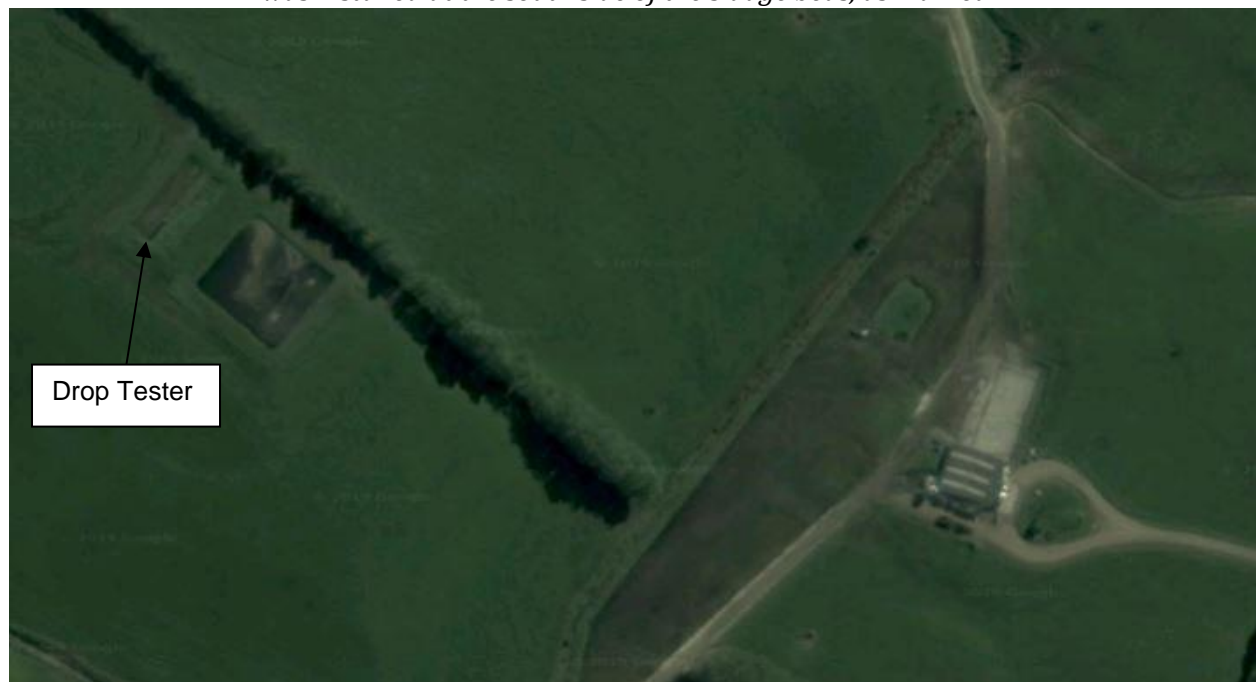
Below is an aerial photo that shows the sludge beds, pond and dairy shed. The laser drop test unit was installed at the south side of the sludge beds, as marked.

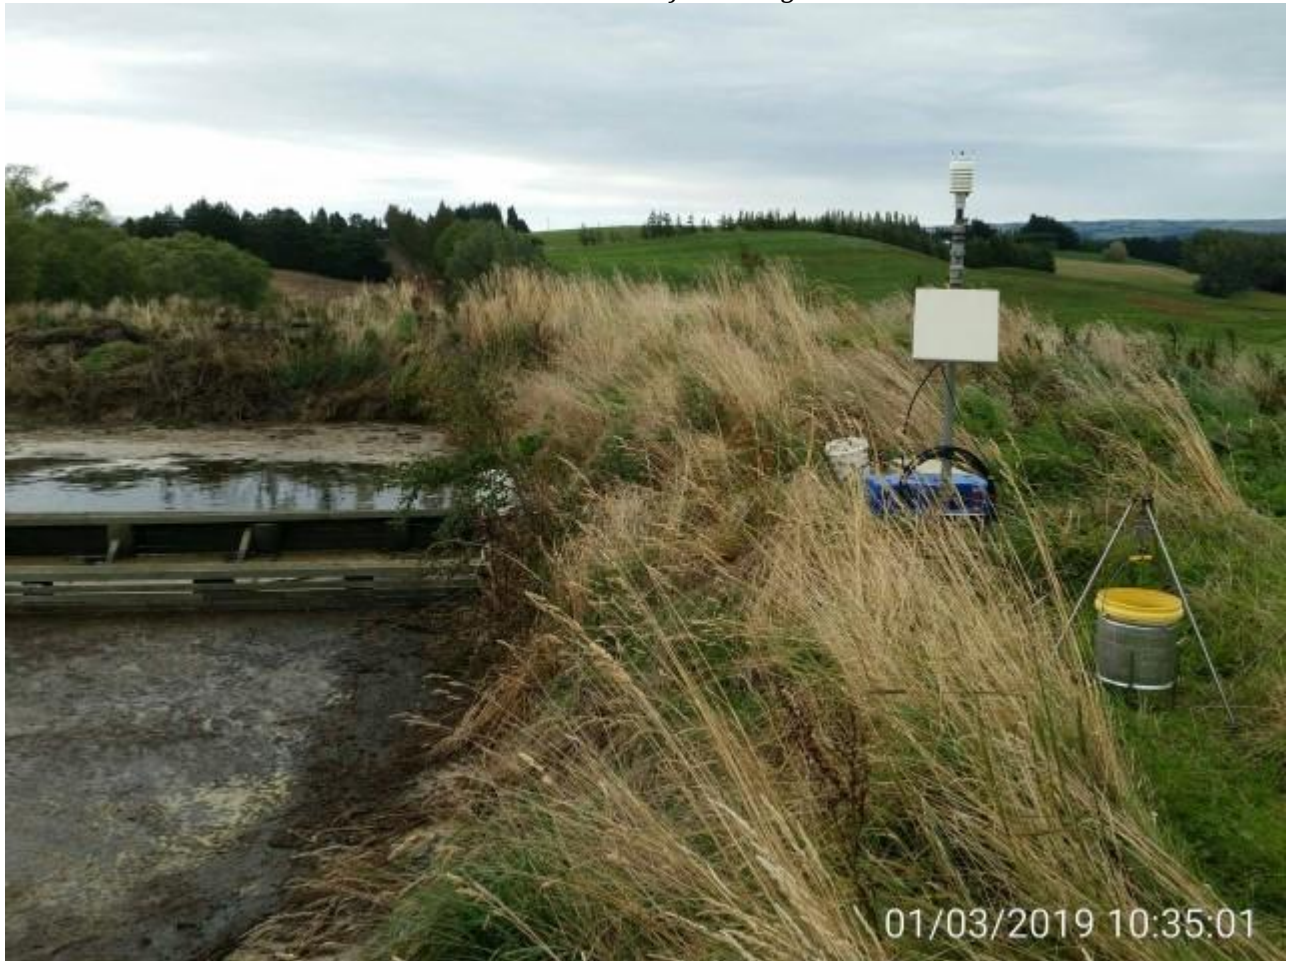
A laser distance measuring unit was set up vertically over the pond surface. A reflective disc was placed on the pond surface to ensure constant, repeatable readings.

The laser was set up within a PVC pipe which acts as a stilling well.

Laser at the south side of the sludge beds.
