PHOSPHORUS MITIGATION PLAN

Woldwide Runoff

**20 Gill Road & 1711 Otautau-
Tuatapere Road**

02 August 2019

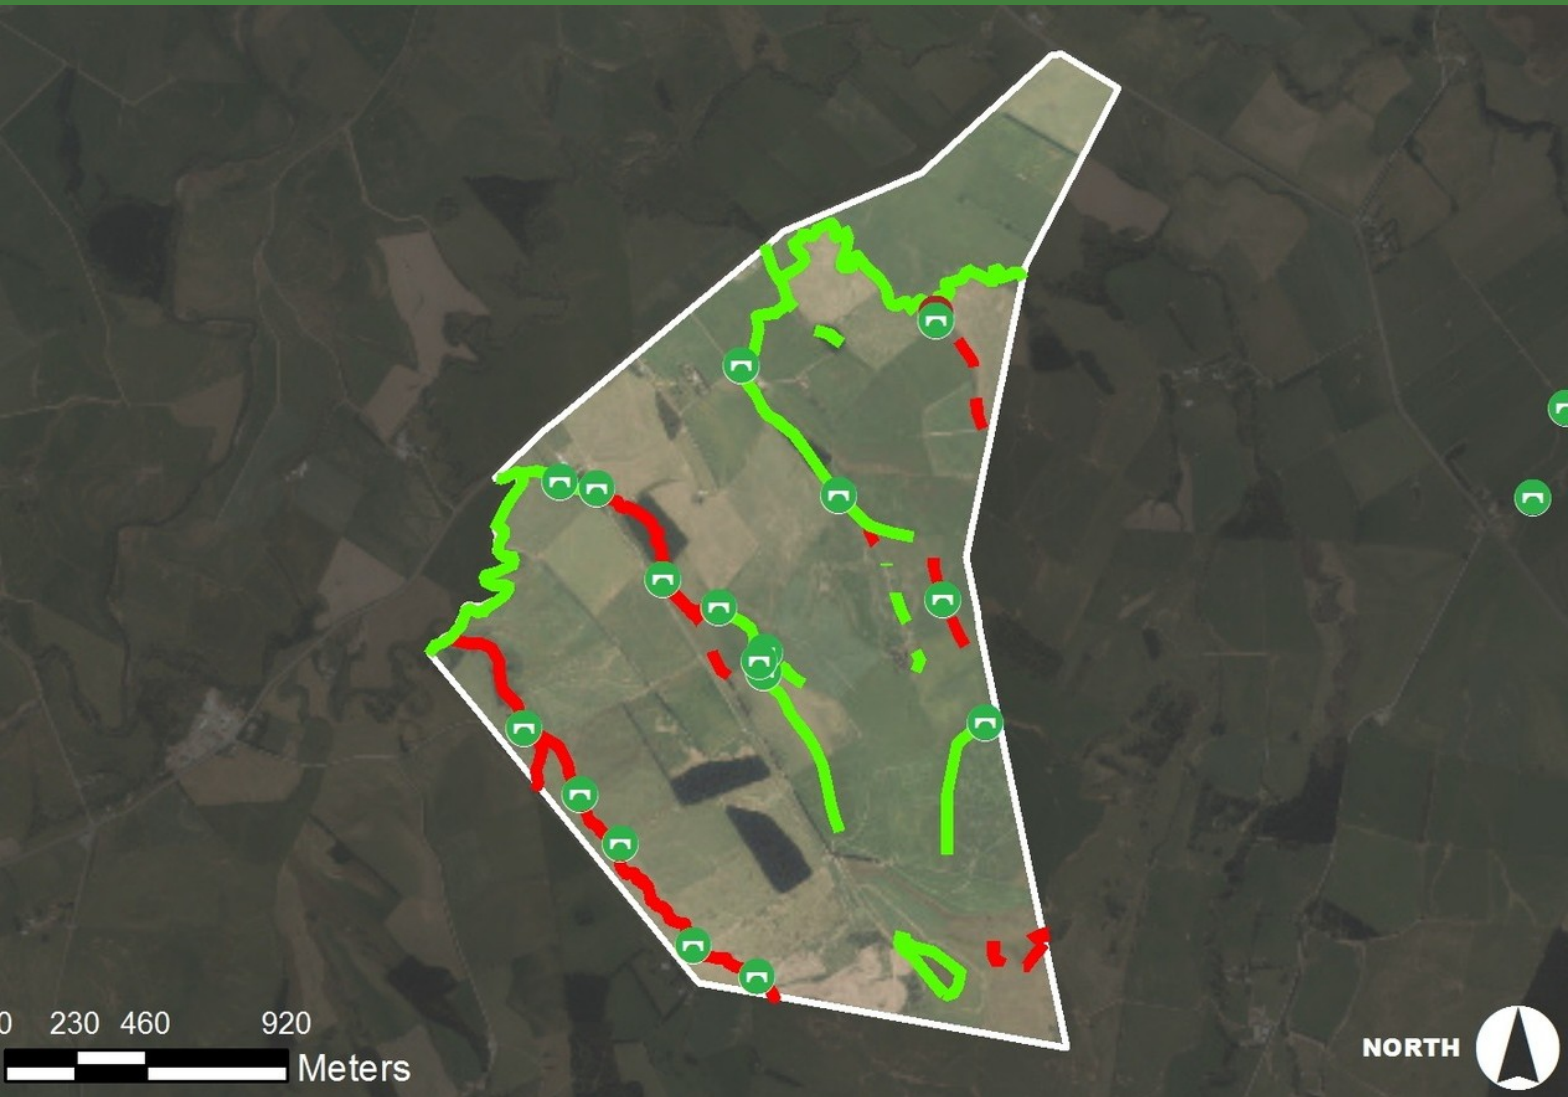
MERRIBURN FARM OVERVIEW MAP

The map below presents the land on which the farming operations covered in this document occur and identifies some key points of interest. More detailed maps looking at specific environmental management topics are contained throughout the document.

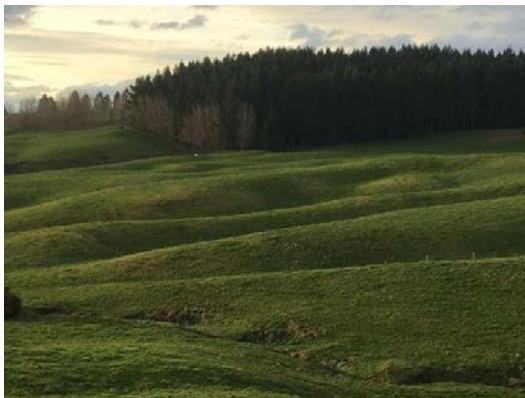
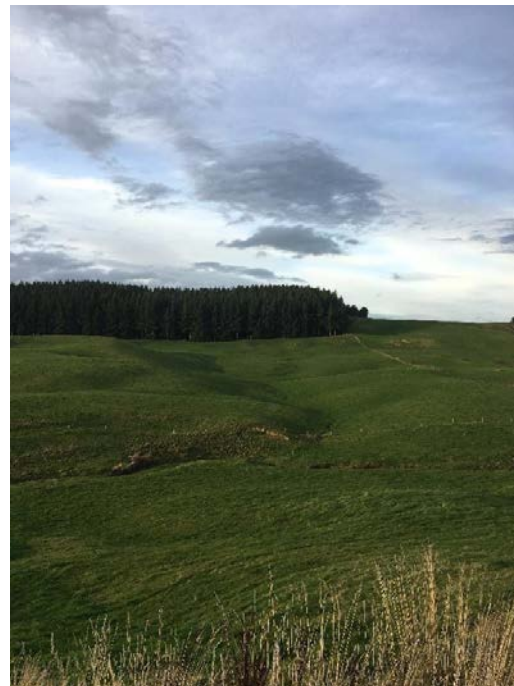
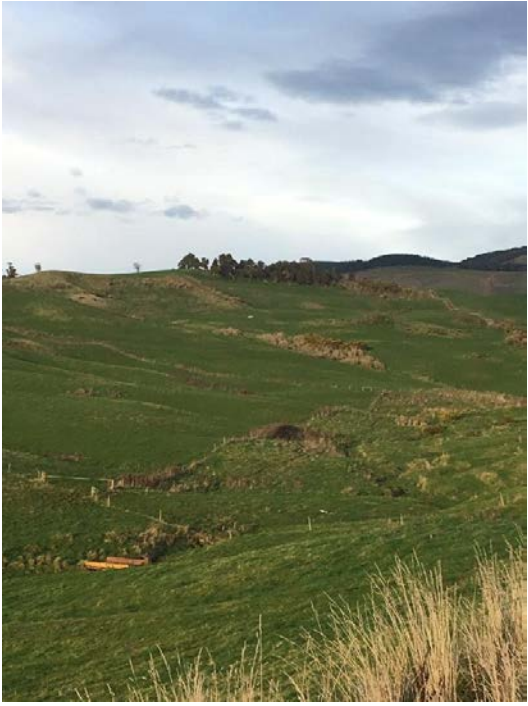
Western Hill Face - Critical Source Areas

The western hill face slopes down from the top of the farm into Foats Stream. There are a multitude of critical source areas along the hill face that will collect overland flow (and associated contaminants) from surrounding paddocks and direct it down to Foats Creek. Mitigations have already been discussed as part of the actions to fence Foats Creek and include having a wider riparian buffer where critical source areas enter Foats Stream. In addition to this, some of the steeper gullies where land is marginal for production purposes could be fenced off and planted in native vegetation.

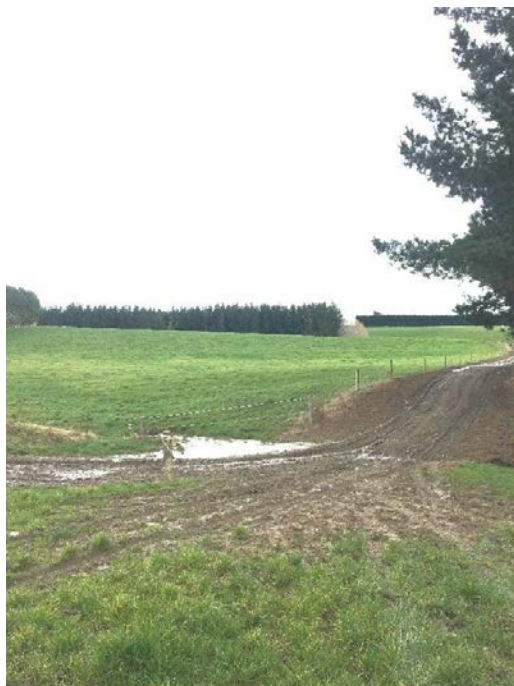
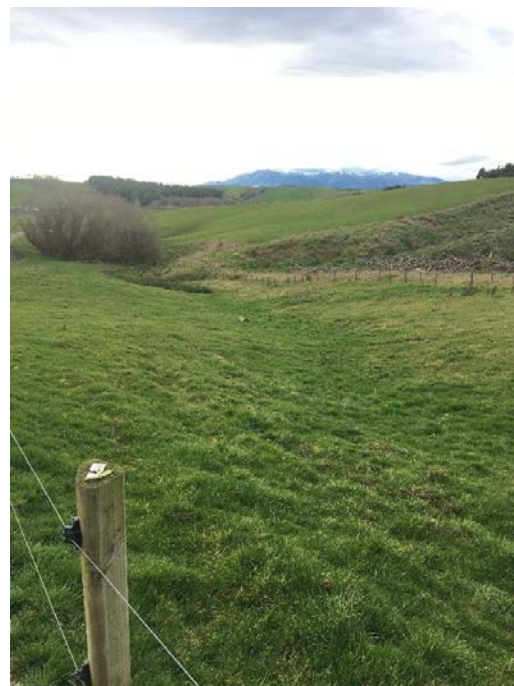
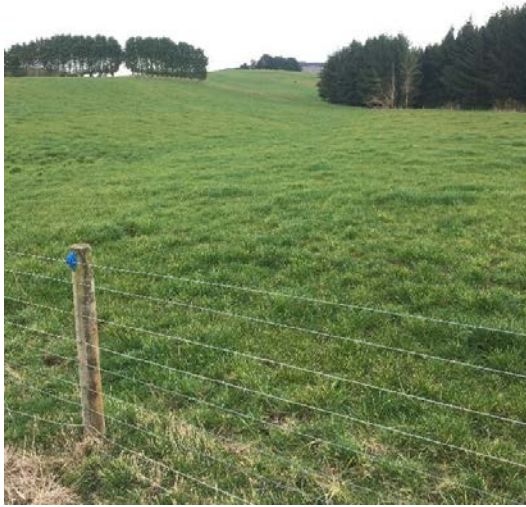
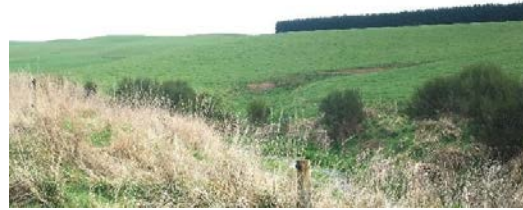
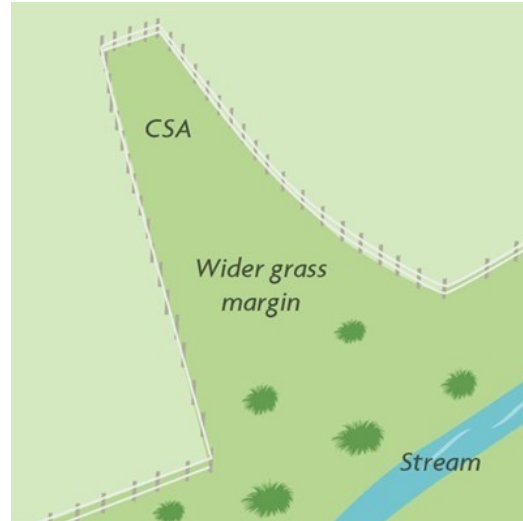
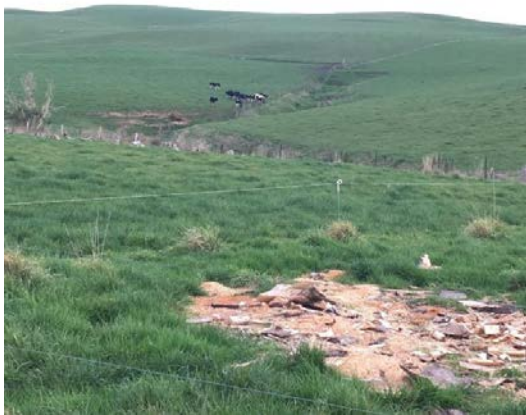
Critical Source Areas - Overland Flow Paths

There are a number of critical source areas (overland flow paths) on the farm as identified on the map at the start of this section. Those shown are not an exhaustive list but form a guide to the areas that should be investigated further. Critical source areas are areas where water and contaminants off surrounding paddocks are concentrated and transported over the land surface to nearby waterways. Where these areas enter waterways a larger riparian buffer should be provided to filter sediment and associated contaminants (such as phosphorus). Buffers should be appropriately sized for the catchment area of the critical source area (normally 5m minimum). The approximate catchment area of the critical source areas identified (not including the western hill face) is 42.3ha.

Extend the riparian buffers where critical source areas such as gullies and swales enter waterways. Buffers should generally be a minimum of 5m or larger depending on the size of the critical source area catchment. Buffer areas should be left in rank grass or planted in native grasses such as carex secta, red tussock and toetoe.

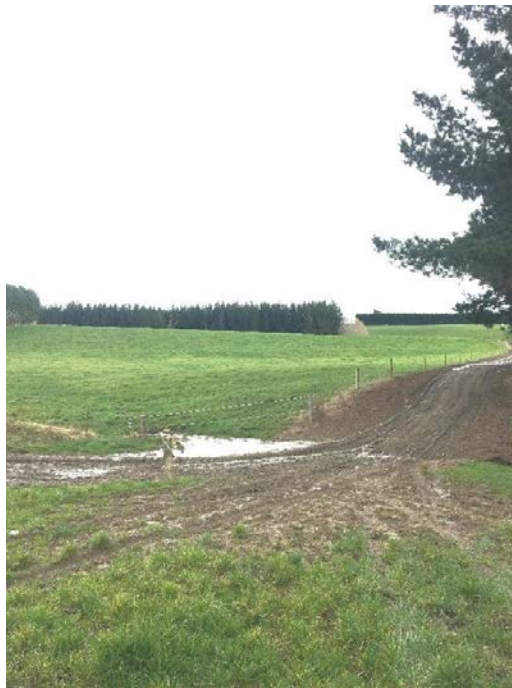
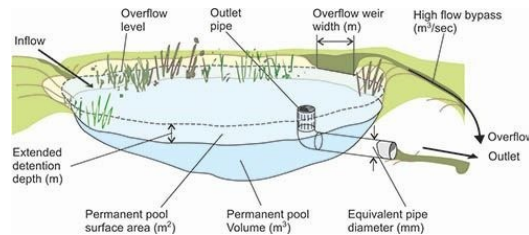
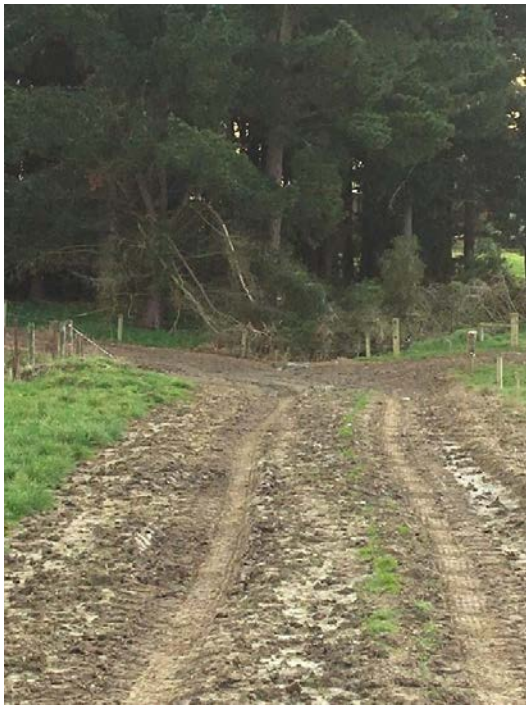
Lane Run-off - Paddock 12

Lane passing between paddocks 12 and 9. The lane slopes down to a stand of pine trees that has a small waterway running through it. Run-off from the lane and paddock 12 flow down to this point. The lane should be built up in this area to avoid run-off flowing into the adjacent creek. The gateway into paddock 12 could be moved out of the low lying area to a location further up the lane and a small bund installed in the low area with a riser and pipe under the lane into the creek. The bund will allow a small amount of water to pond, settling out sediment before discharging into the creek. This will avoid run-off from the paddock flowing across the lane, causing damage and picking up more contaminants.

Build up the lane so it slopes away from the creek and run-off flows into adjacent paddocks. The gateway into paddock 12 could be moved out of the low lying area to a location further up the lane and a small bund installed in the low area with a riser and pipe under the lane into the creek. The bund will allow a small amount of water to pond, settling out sediment before discharging into the creek.

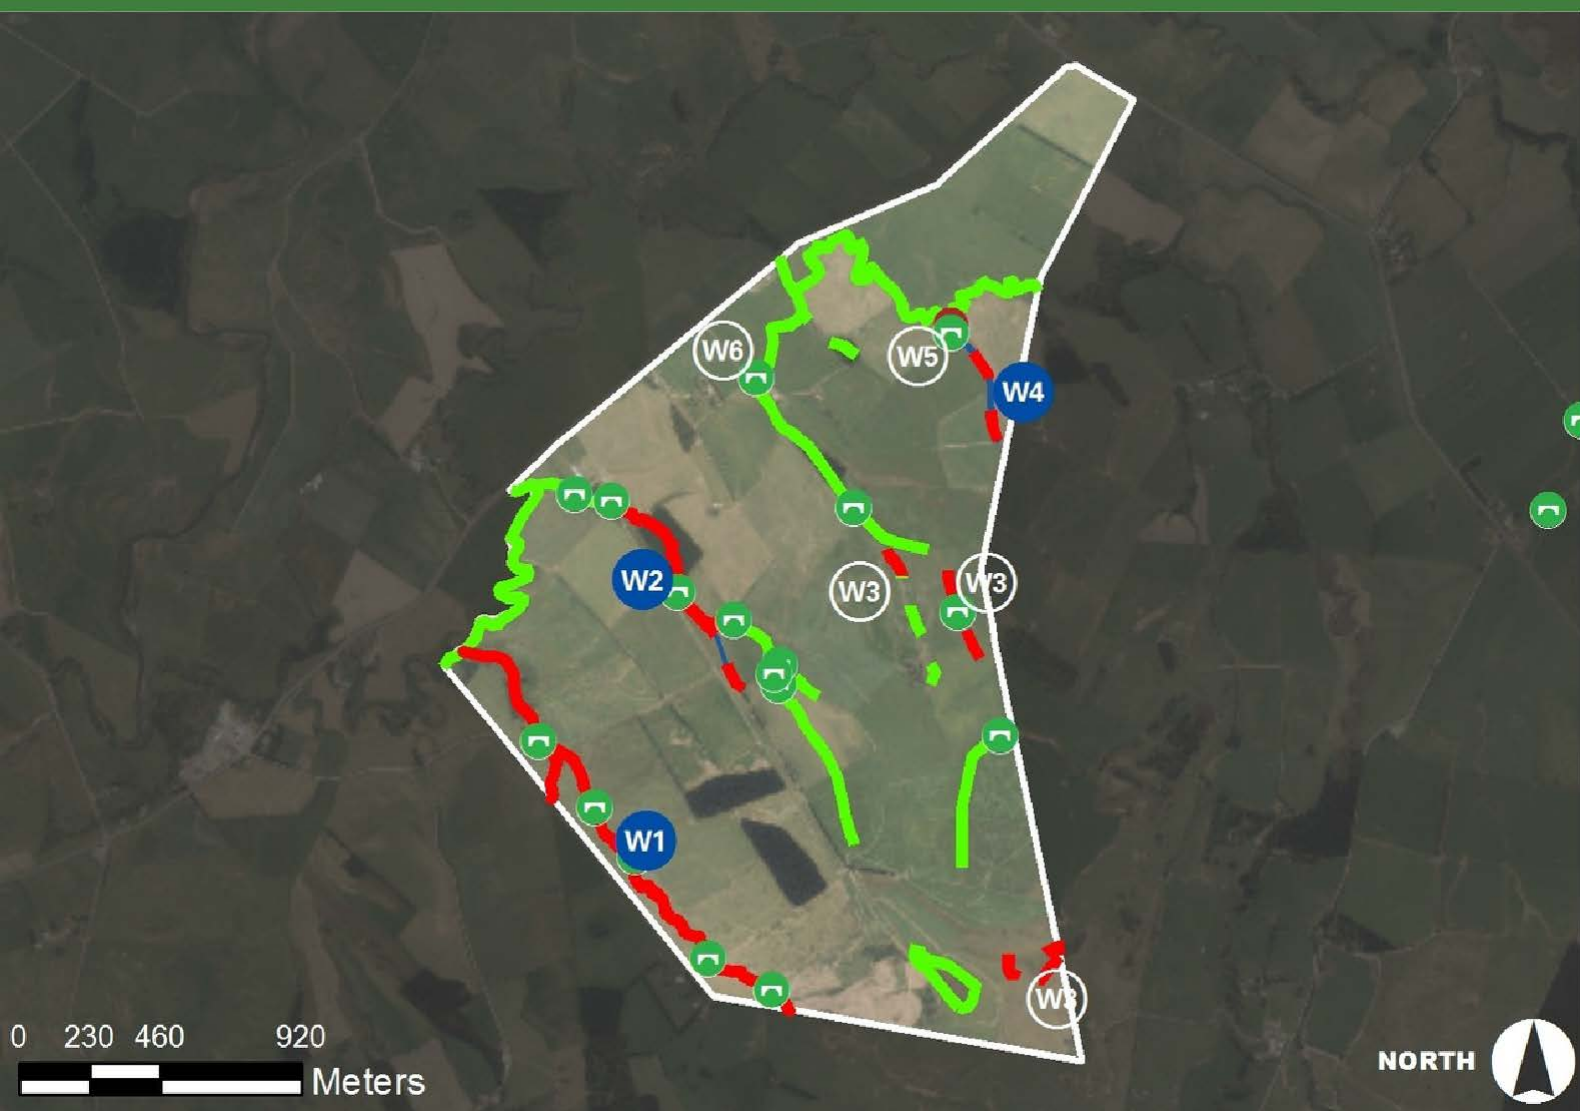
WATERWAYS MANAGEMENT

- W1 Waterway Fencing - Foats Stream - Fencing
- W2 Waterway Fencing - Fenham Creek Tributary Fencing
- W3 Waterway Fencing - Waterway Fencing - Other Areas
- W4 Waterway Fencing - Buckton Creek Tributary Fencing

- W5 Critical Source Area - Stock Ford
- W6 Critical Source Area - Culvert - Lane Between Paddocks 11 & 19
- Accord Defined Stock Excluded Waterway
- Accord Defined Stock Not Excluded Waterway
- Non-Accord Defined Stock Excluded Waterway

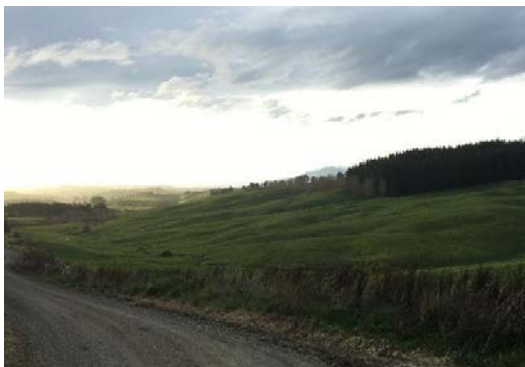
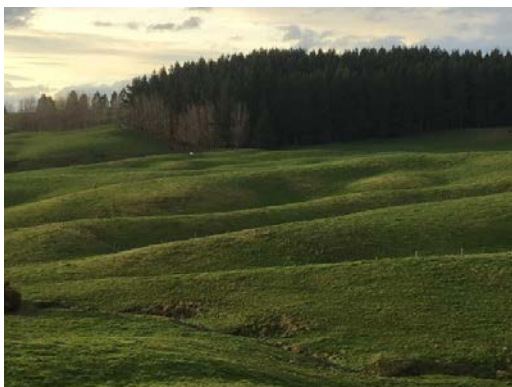
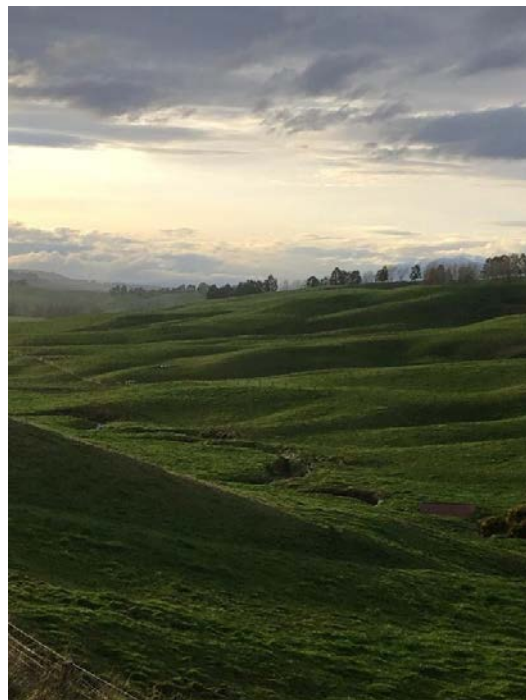
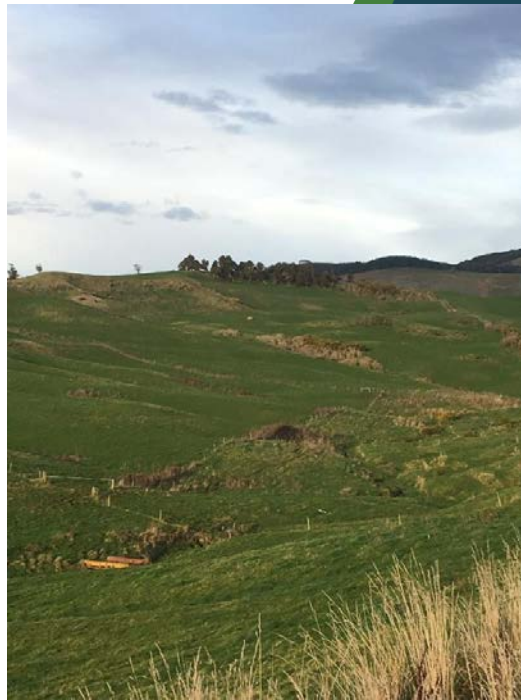
W1 Waterway Fencing
Foats Stream - Fencing

A tributary of Foats Stream flows along the western side of the Merriburn Lease Block adjacent to Sim Road. Run-off from the steeper hill country to the east all flows down into the stream via a multitude of critical source areas. The stream is currently not fenced to exclude stock and there is no vegetated riparian margin. Fencing of the waterway will reduce phosphorus losses from the farm by preventing direct deposition into the stream by stock and filtering run-off from surrounding paddocks. Where critical source areas enter the stream it is recommended the riparian margin is maintained at 5m with a 2m rank grass margin maintained outside of these areas. Foats Stream Tributary has a catchment of approximately 78ha (located on the farm).

Fence off the Foats Stream tributary running along the western side of the farm. It is recommended a 2m riparian buffer be established on both sides of the creek and this is extended to 5m in locations where swales or gullies (critical source areas) enter the stream.

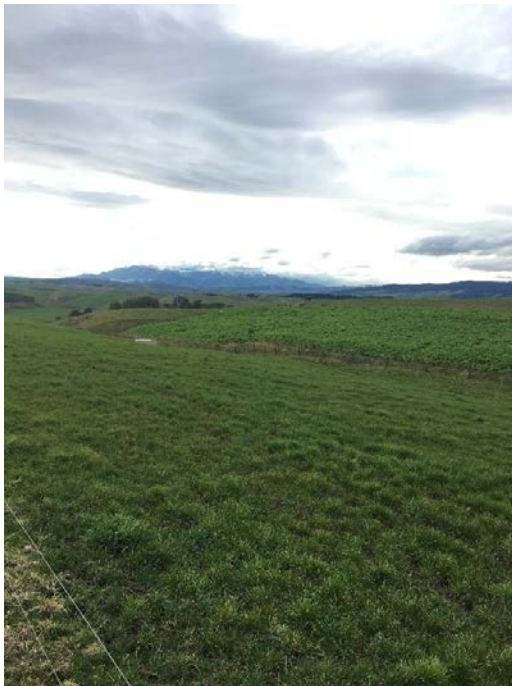
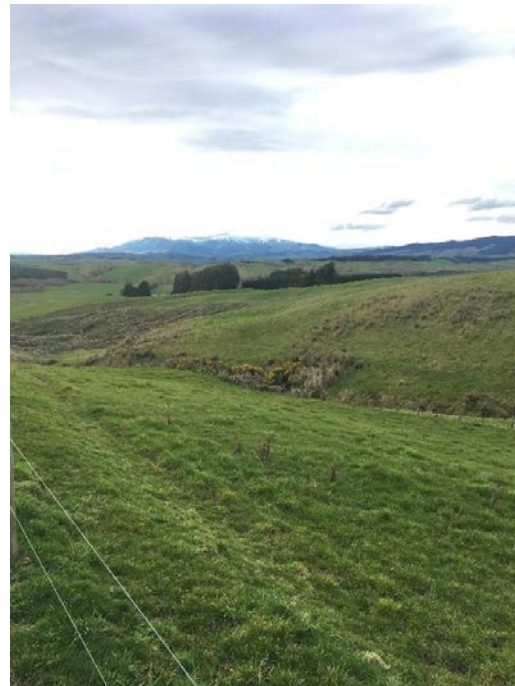
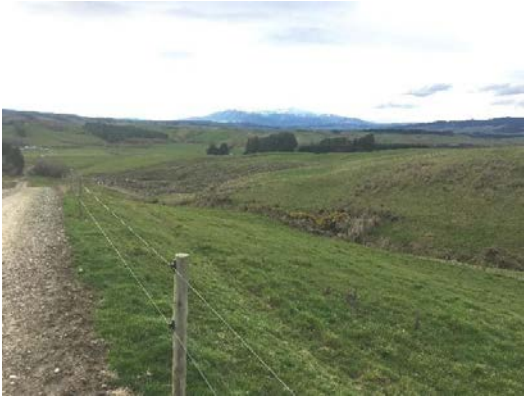
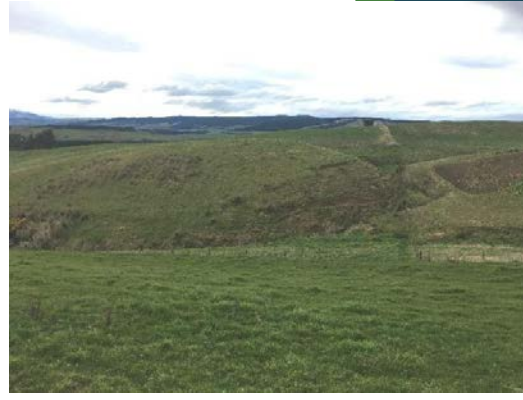
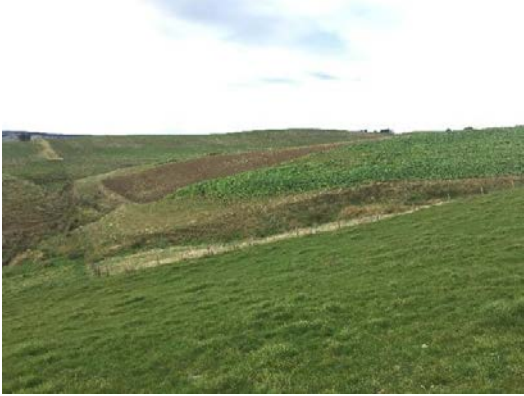
Fenham Creek Tributary Fencing

A tributary of Fenham Creek flows down from the higher elevations of the farm out to Otautau-Tuatapere Road. The upper and lower reaches of the Creek are permanently fenced to exclude stock (although the riparian buffers should be extended when adjacent paddocks are being winter grazed). In the middle section a small forestry block has recently been removed and the creek flows down through a gully to the bottom of the farm. Run-off from surrounding paddocks flows down into the stream via the general topography of the land and critical source areas.

The unfenced section of the Fenham Creek Tributary has a catchment of approximately 10.5ha.

Fence off the central section of the waterway. Where critical source areas enter the stream it is recommended the riparian margin is increased to 5m with a 3m rank grass margin maintained outside of these areas. The steeper sections of the hill could also be fenced off as these have minimal productive value.

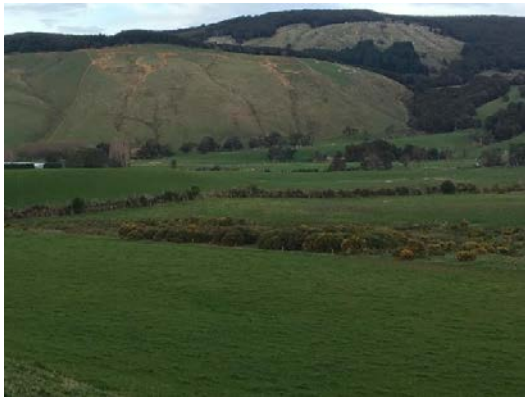
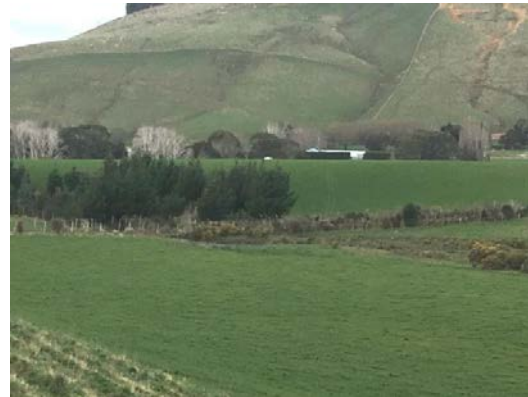
Waterway Fencing - Other Areas

Three additional areas have been identified as requiring fencing to exclude stock. Two of these areas have not been photographed and have been identified from aerial photography. These are small ephemeral waterways or gullies in paddocks 15, 16 and 17. Fencing these areas and maintaining a minimum 2m rank grass buffer will assist with the filtering of run-off from surrounding paddocks, including phosphorus. In addition to this there is a pond and wetland area in paddock 38 that should also be fenced to achieve similar benefits (see photos).

Fence Waterways - Other Areas
<p>Permanently fence off the waterways/gullies in paddocks 15, 16 and 17 as well as the wetland/pond area in paddock 38. A minimum 2m rank grass riparian margin should be established.</p>
<p>TARGET DATE: 1 Aug 2021</p>

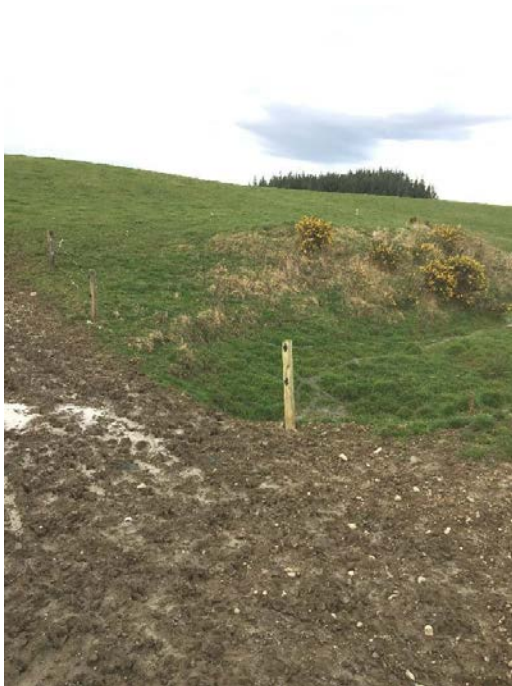
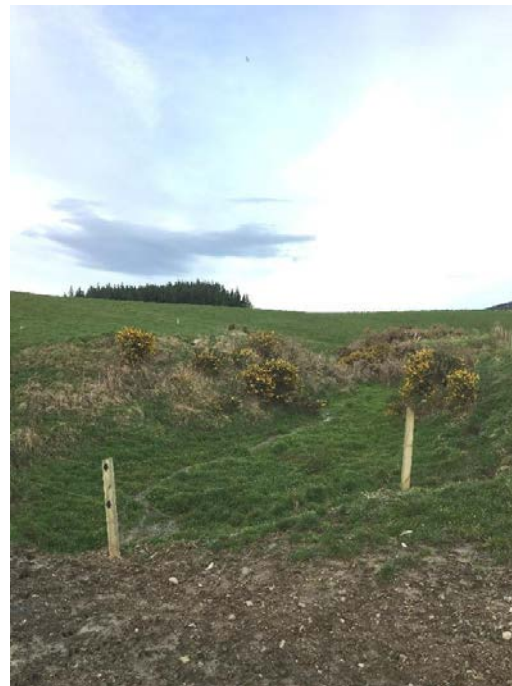
Buckton Creek Tributary Fencing

Small ephemeral waterway that runs between paddocks 6, 7 and 8. The waterway is not currently permanently fenced, however there is a variable riparian margin due to the slope of the bank and the fact the stream flows through a gully. Fencing will prevent stock access and allow rank grass to better establish within the riparian margin, assisting with filtering of run-off. It is recommended a permanent fence be installed at the top of the bank/gully.

Permanently fence off the waterway that runs between paddocks 6, 7 and 8. There is a natural riparian buffer due to the topography of the land of approximately 2-4m. It is recommended the fence line follows this natural contour.

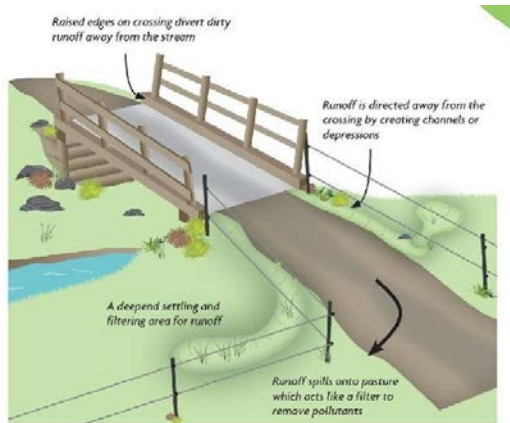
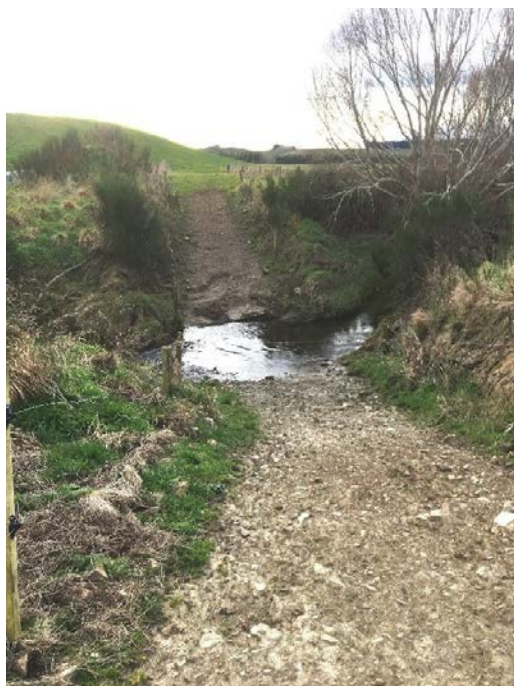
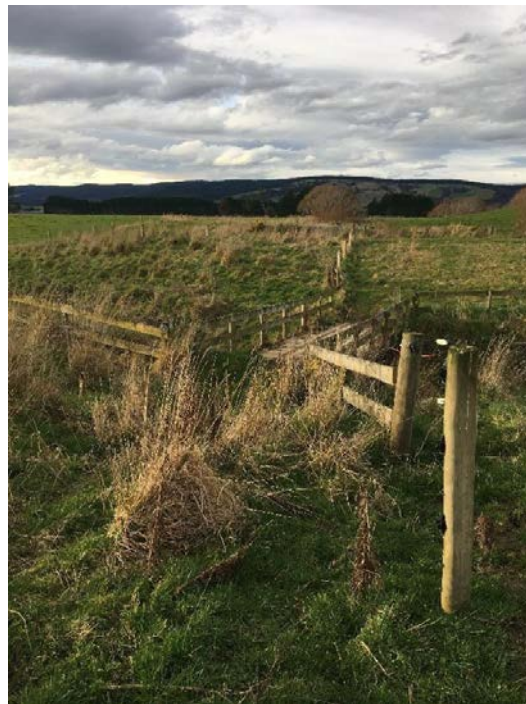
Critical Source Area
Stock Ford

Stock ford between paddocks 5 and 6. The ford is used to access paddocks to the east of the farm and replaces an unsafe bridge. Long term the use of the ford should be discontinued (due to the direct deposition of contaminants into the waterway) and a bridge re-instated.

Long term the use of the ford should be discontinued (due to the direct deposition of contaminants into the waterway) and a bridge re-instated.

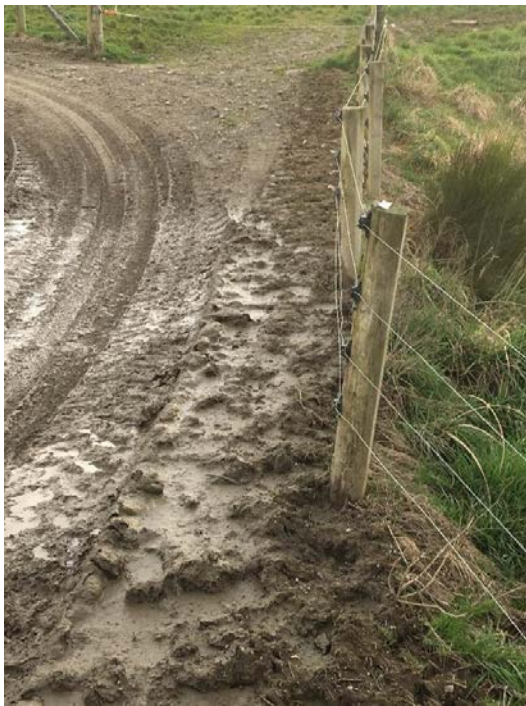
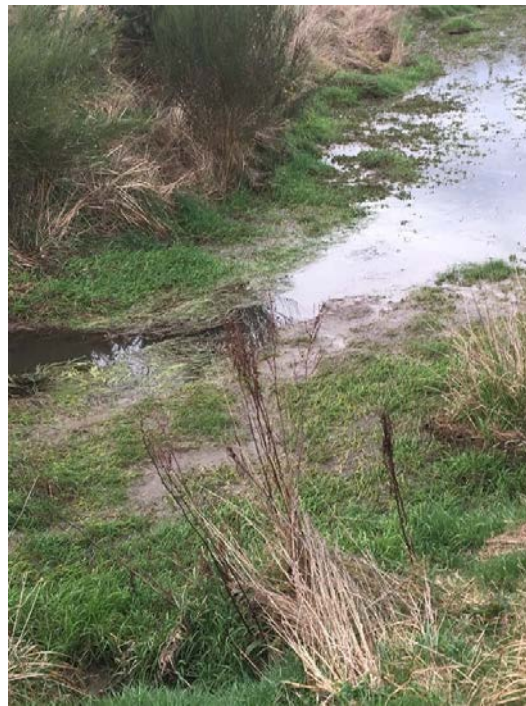
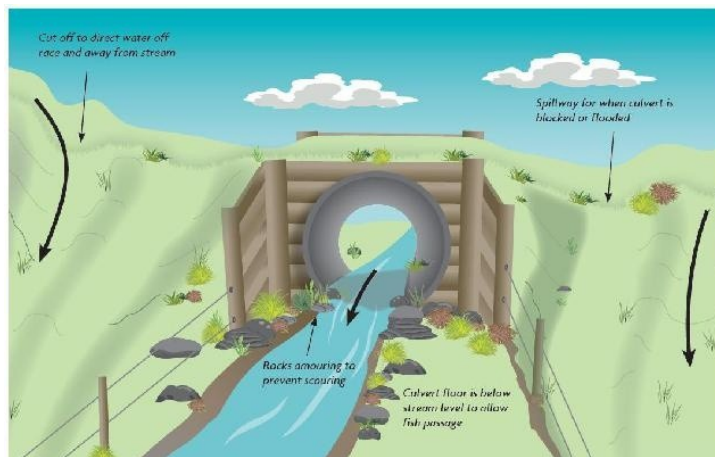
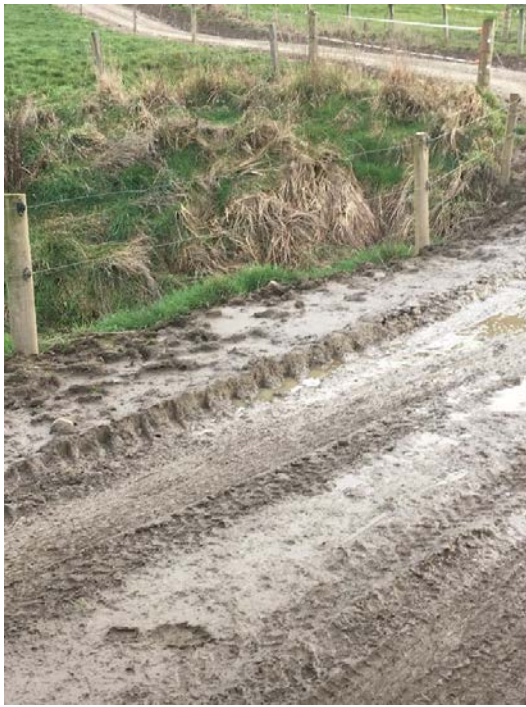
Culvert - Lane between Paddocks 11 & 19

Lane crossing the waterway to the south of paddock 11. The culvert has no raised sides which allows any runoff to flow off the side into the underlying water. Building up the sides of the culvert and directing run-off back into the paddock or at a minimum into a grass riparian area will assist with filtering sediment and associated phosphorus.

Build up the sides of the lane crossing the waterway to the south of paddock 11. This will prevent the direct deposition of sediment and associated phosphorus into the underlying waterway and allow for filtering via a grass buffer.

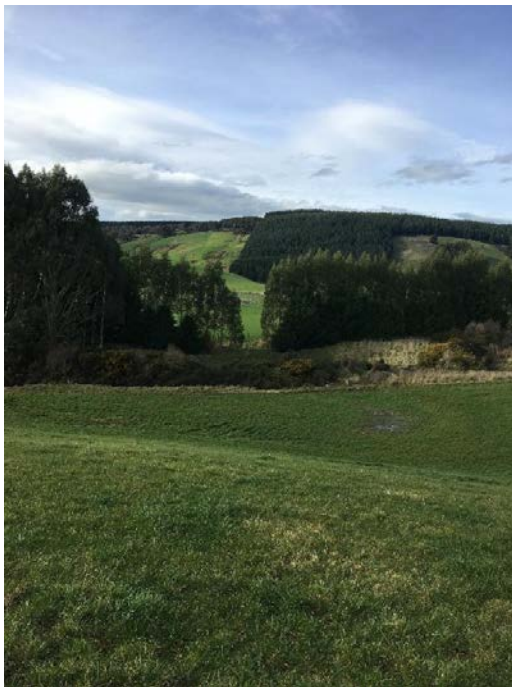
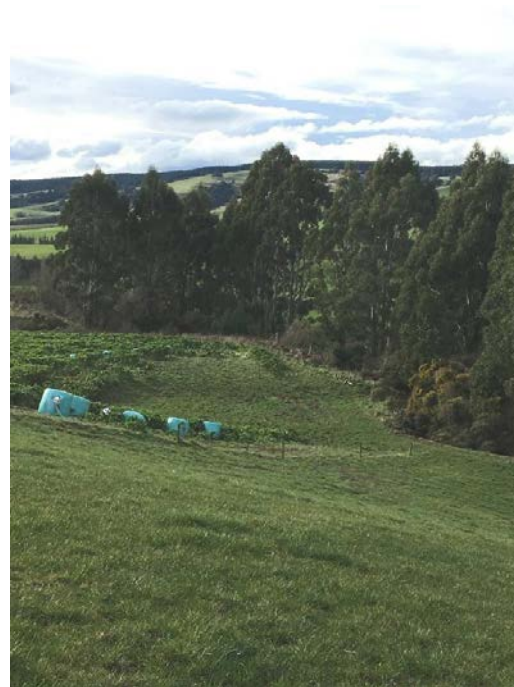
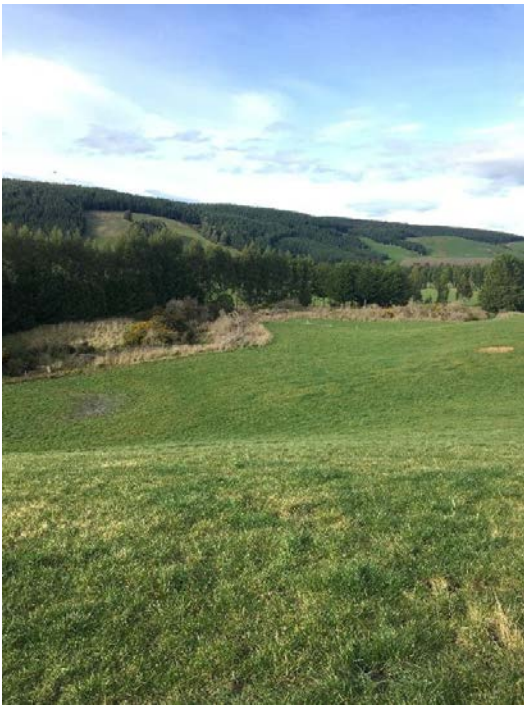
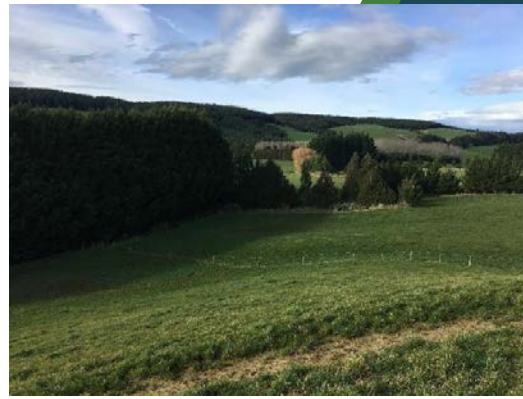
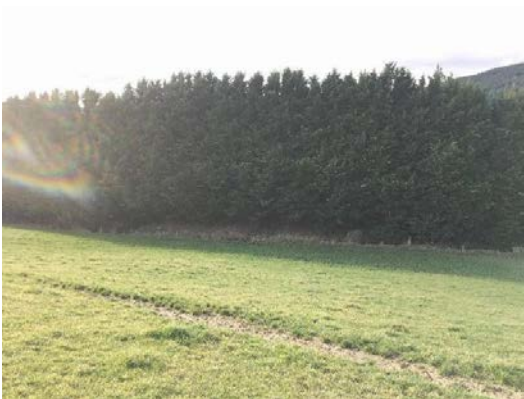
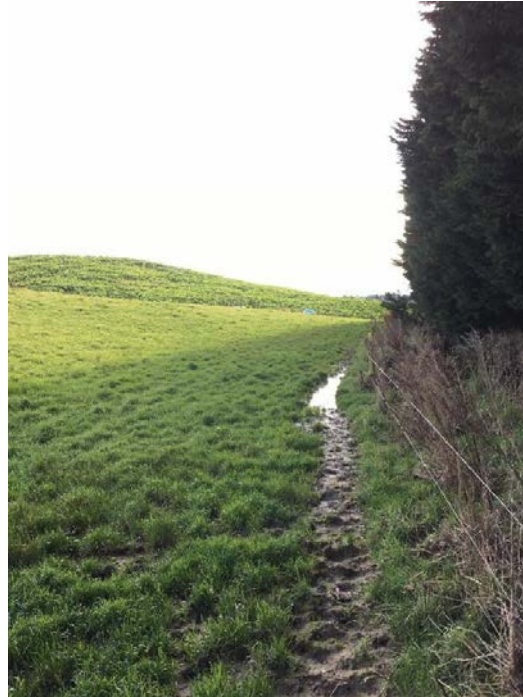
Fenham Creek Tributary (Northern Section)

Northern end of the Fenham Creek Tributary flowing along the bottom of paddocks 88, 90, 92, 94, 96 and 98. The riparian buffer on the western side is approximately 1-1.5m yet there is a significant slope from the adjoining paddocks down to the creek. It is recommended that a 3m grass buffer is fenced off to allow for filtering of overland flow and associated contaminants off the surrounding paddocks. This is especially important when adjacent paddocks are being winter grazed (buffer should be temporarily extended to at least 5m).

The catchment flowing into the riparian buffer is approximately 7 ha over a length of approximately 1km.

It is recommended that the riparian margin of the Fenham Creek Tributary flowing below paddocks 88, 90, 92, 94, 96 and 98 be extended to 3m and maintained in rank grass to.

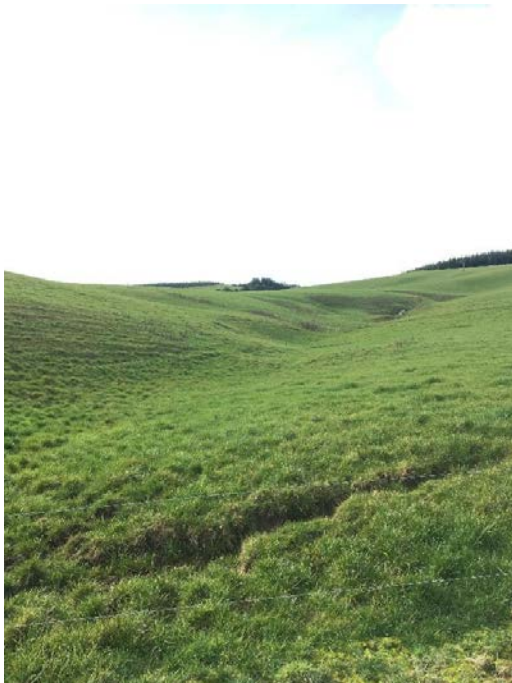
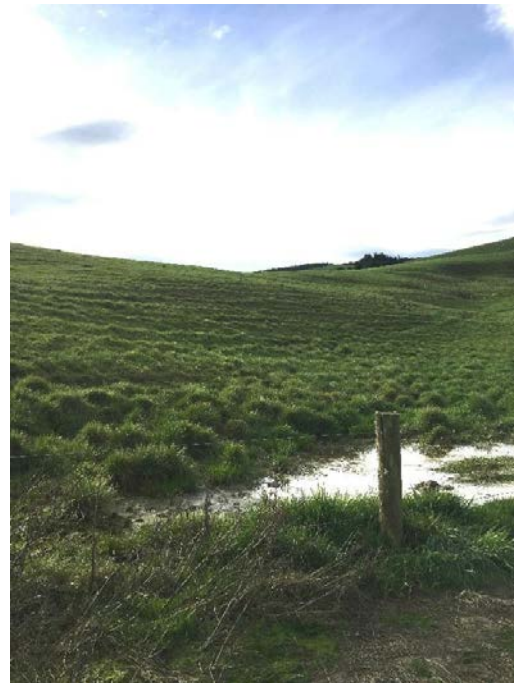
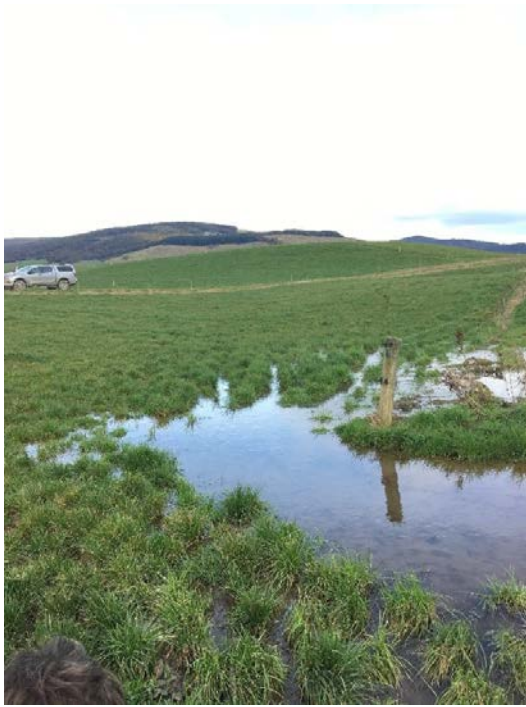
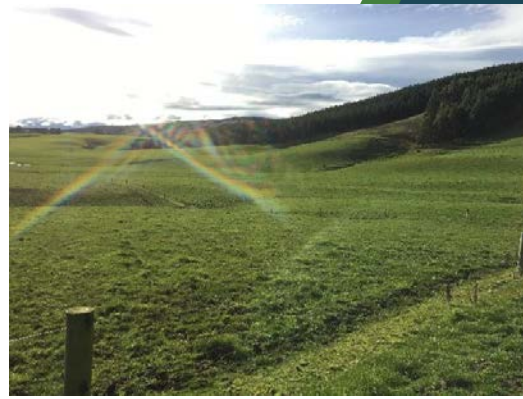
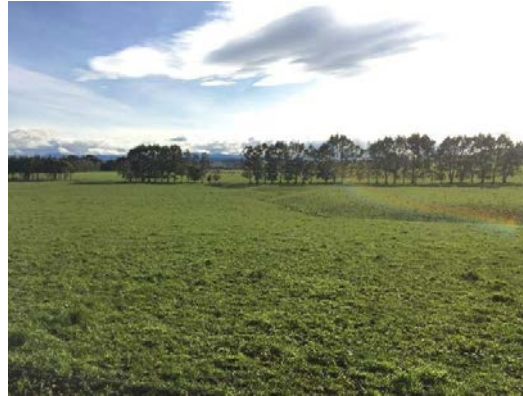
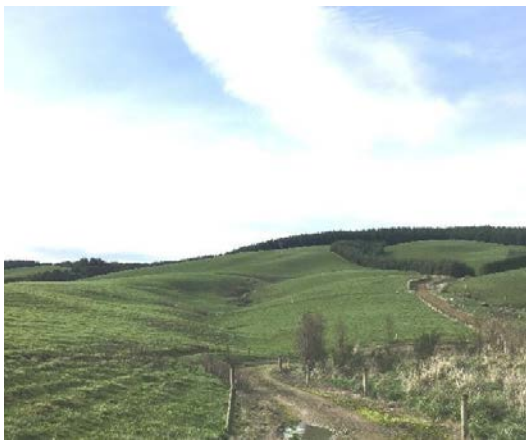
Critical Source Areas - Overland Flow

There are a number of critical source areas (overland flow paths) on the farm as identified on the map at the start of this section. Those shown are not an exhaustive list but form a guide to the areas that should be investigated further. The critical source areas across the farm are areas where water and contaminants off surrounding paddocks are concentrated and transported over the land surface to nearby waterways. Where these areas enter waterways a larger riparian buffer should be provided to filter sediment and associated contaminants (such as phosphorus). Buffers should be appropriately sized for the catchment area of the critical source area (normally 5m minimum).

Extend the riparian buffers where critical source areas such as gullies and swales enter waterways. Buffers should generally be a minimum of 5m or larger depending on the size of the critical source area catchment. Buffer areas should be left in rank grass or planted in native grasses such as carex secta, red tussock and toetoe.

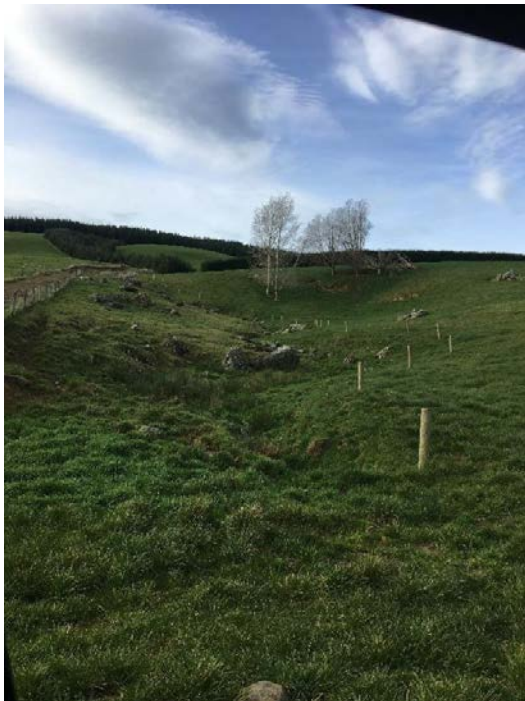
Gully Paddock 9

The gully through paddock 9 has previously been fenced off (posts in place). This should be re-fenced to exclude stock. The area is of low production potential and having stock in this area is likely to cause pugging and sediment (and associated phosphorus) loss to the nearby waterway.

Re-fence Gully - Paddock 10
Reinstate the fence around the gully in Paddock 10.
TARGET DATE: Ongoing

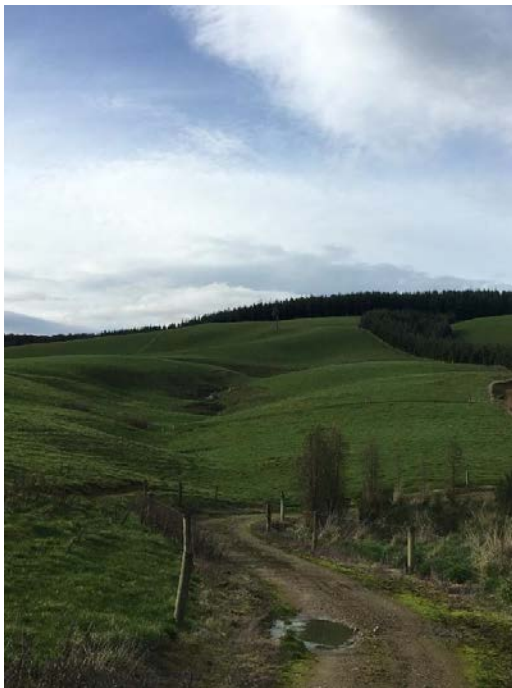
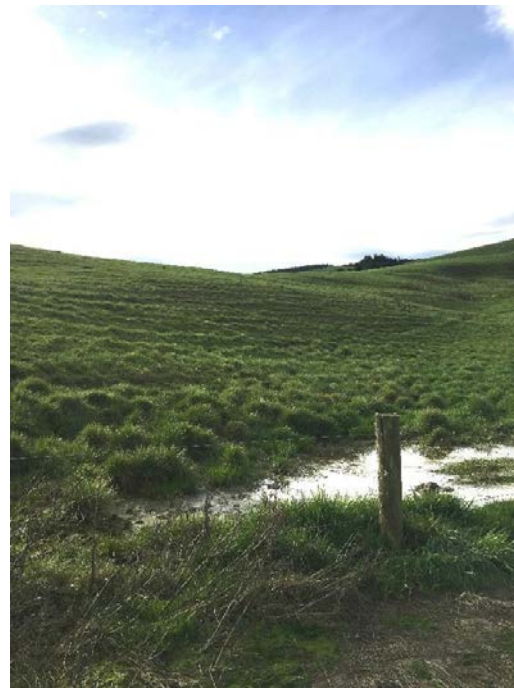
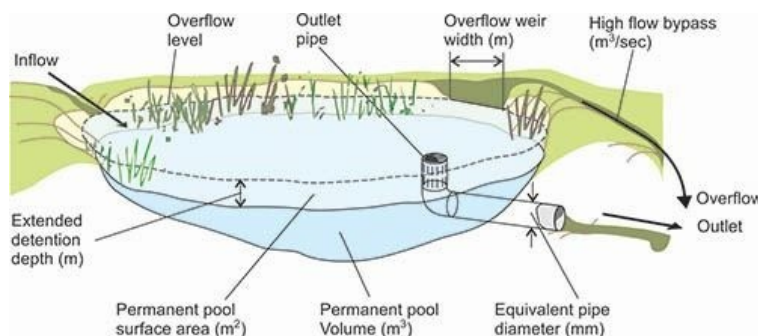
Gully through the center of paddocks 10 and 15. In some places erosion is occurring. These areas should be fenced off to avoid further damage (consider planting with natives to stabilise). In addition to this, the gully is a conduit for overland flow down to the waterway at the bottom. Due to the location of the lane there is minimal opportunity to extend the riparian margin, however long term there is an opportunity to install a sediment trap at the bottom of the gully with an overflow into the creek.

Exclude Stock from Erosion Areas (Pad 10 & 15)
