PHOSPHORUS MITIGATION PLAN

Woldwide 1 & 2

HUNDRED LINE RD, Winton

31 July 2019

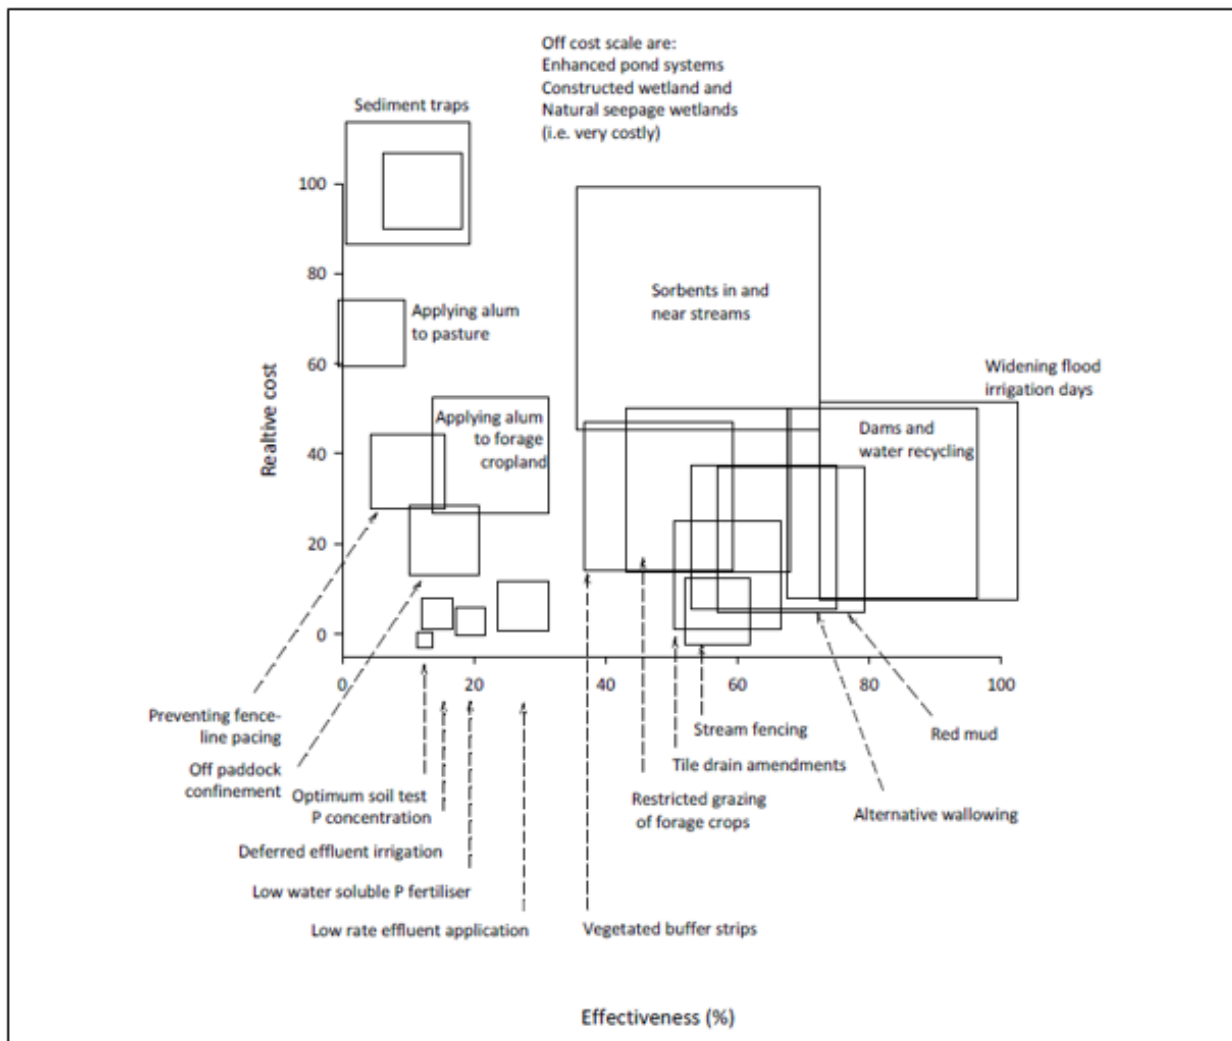
Figure 1 - Cost and effectiveness of strategies to mitigate phosphorus losses (McDowell et al, 2013)

The 50% reduction is based on research that shows management of critical source areas and vegetated buffers can reduce phosphorus loss by 38-59% (Figure 1). A midpoint reduction figure of 50% has been used to account for the likelihood of more phosphorus loss occurring in critical source areas than the rest of the farm and as such, more potential for phosphorus loss reductions.

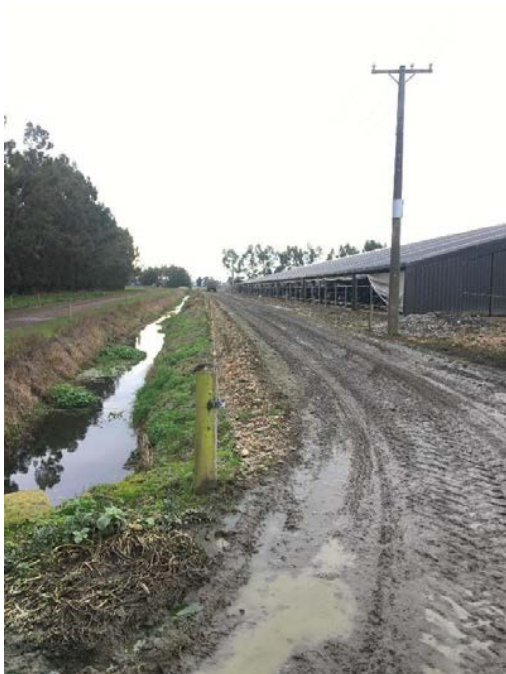
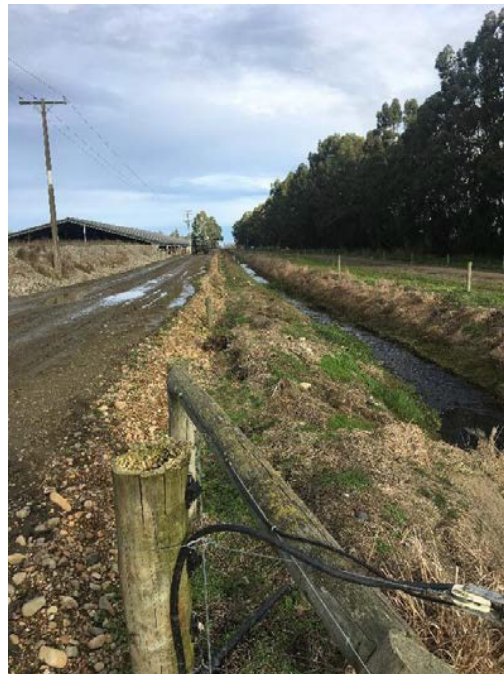
L2

Main lane to the west of the Woldwide One wintering barn running adjacent to a waterway. There is 1-2m riparian buffer, which is wider to the north. Due to the location of farm infrastructure there is minimal opportunity to extend the riparian margin wider. There is minimal vegetation cover in the riparian margin to filter any run-off.

It is recommended this area be planted in low native grasses such as red tussock and carex secta (1m intervals) to filter any run-off and utilise the associated nutrients. As a minimum, the riparian buffer should be maintained in a healthy sward of rank grass. In addition to this, any areas of the lane that slope towards the waterway should be modified to slope in the opposite direction.

The riparian margin between the main dairy lane and the waterway to the west of the Woldwide One wintering barn should be maintained in a healthy vegetative cover. It is recommended native *carex secta* and red tussock are planted (1m spacing's) in the riparian margin to filter run-off and utilise any associated nutrients. As a minimum the riparian margin should be maintained in a healthy sward of rank grass.

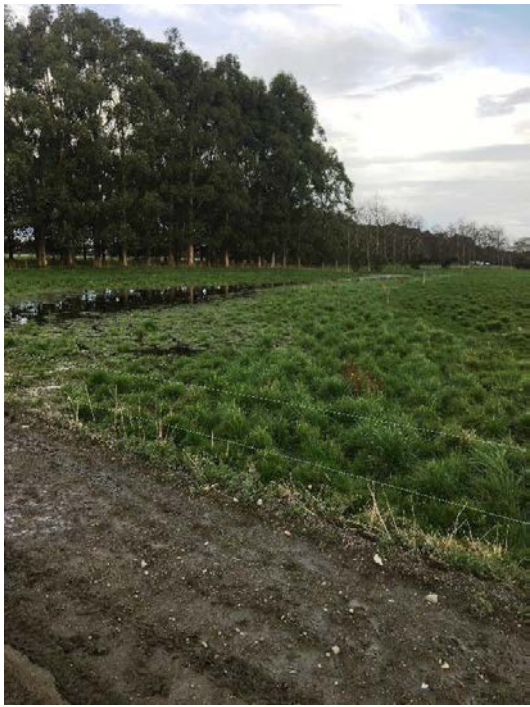
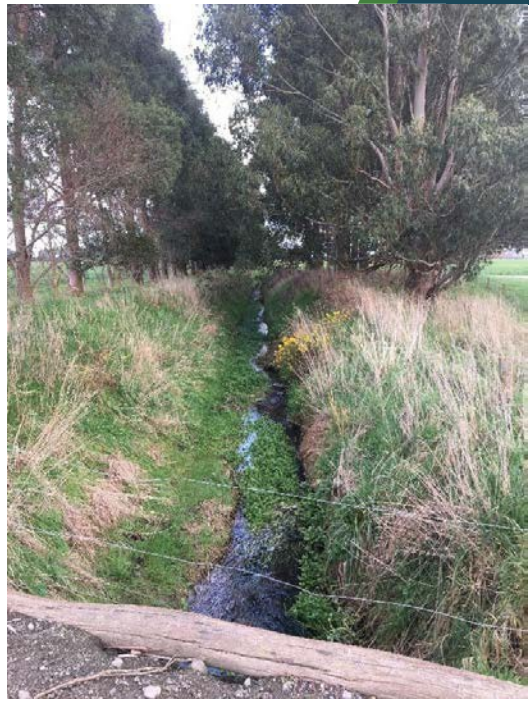
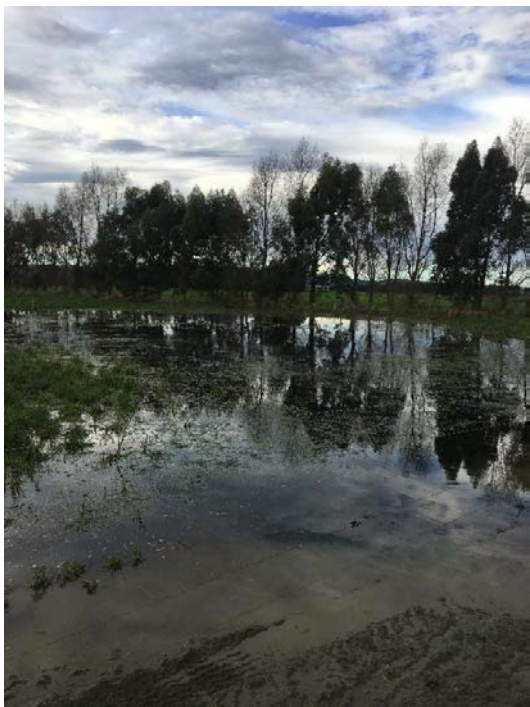
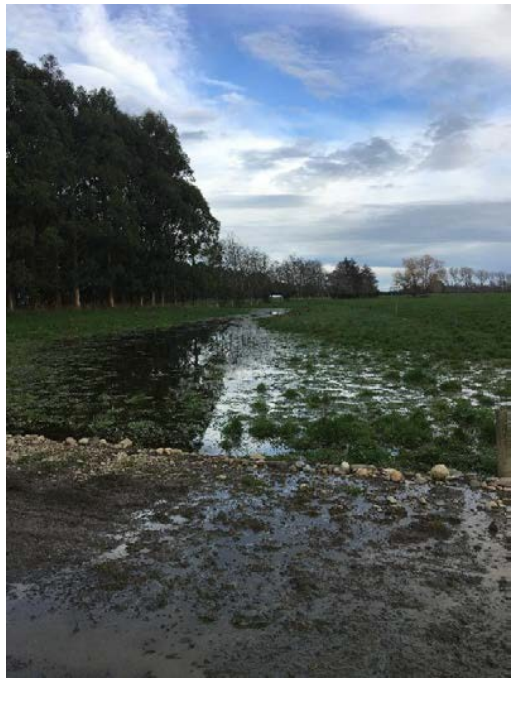
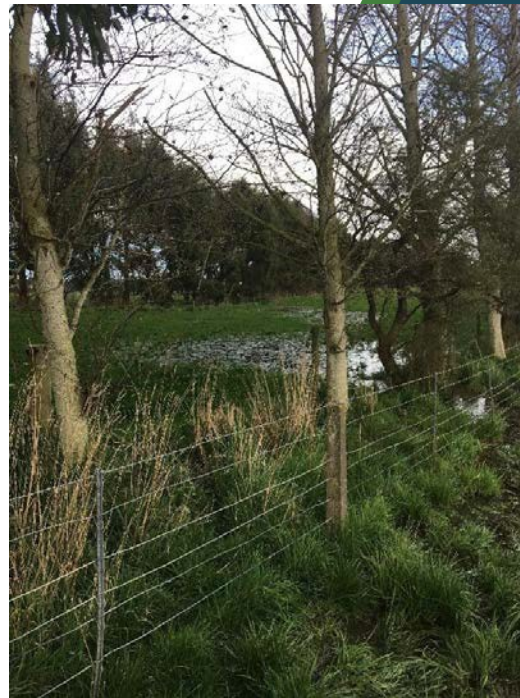
Critical Source Area (Paddocks 14-15)

Low lying area at the eastern end of paddocks 14 and 15 on either side of the dairy lane. At times this area holds water which subsequently enters the creek at either end of the CSA. The area is partly fenced off but is still grazed.

Being one of the few critical source areas on the farm means this area is likely to have a disproportionately high loss of sediment and phosphorus compared to other areas of the farm.

It is recommended that the riparian margin where the gully enters the adjacent waterway should be extended and maintained in rank grass (or planted in native grasses such as carex secta or red tussock) to filter any overland flow that may occur under normal rainfall conditions.

The riparian margin where the gully (Critical Source Area) enters the waterway should be extended and maintained in rank grass (or planted in native grasses such as carex secta or red tussock) to filter any overland flow that may occur under normal rainfall conditions. See photo above.

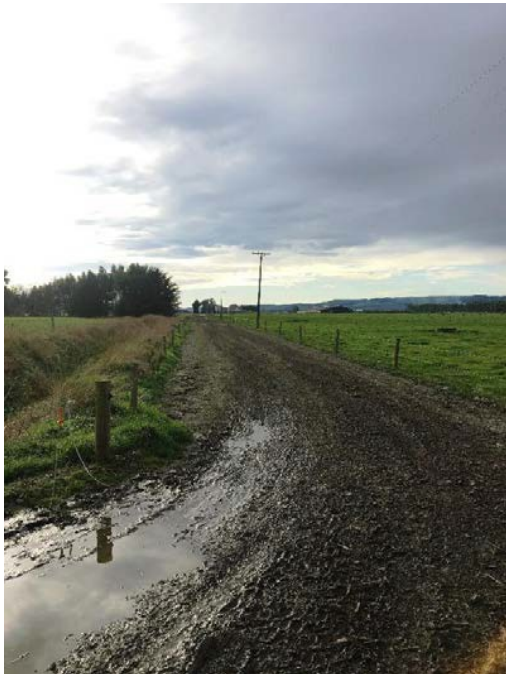
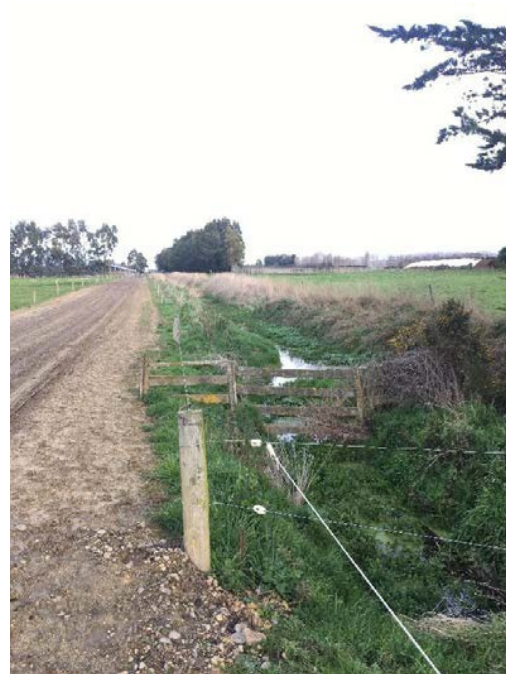
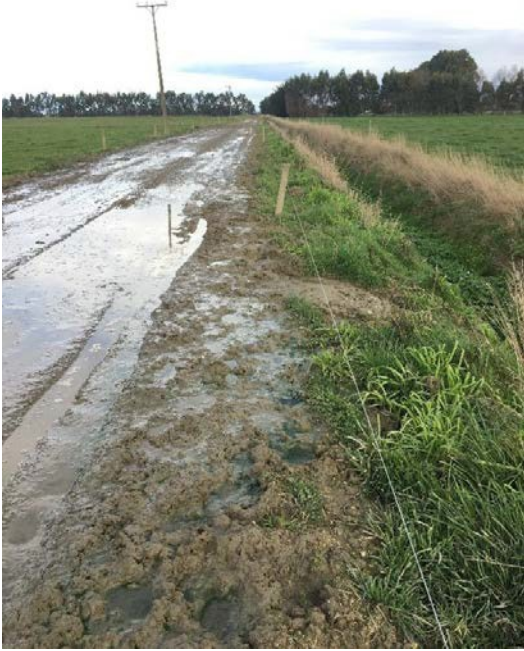
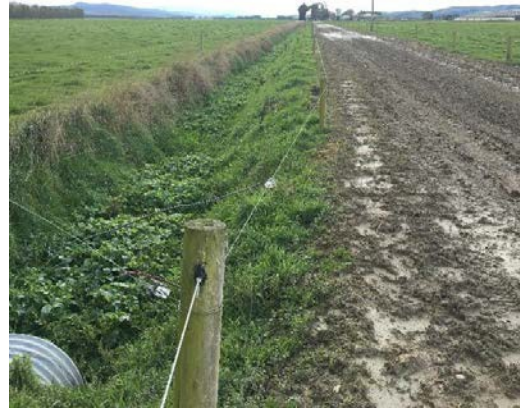
L4

Main dairy lane running between Woldwide One and Woldwide Two. Currently this is used frequently by stock from Woldwide Two to access paddocks to the south, south east and south west of the dairy shed. Changes in the layout of the farms will result in a number of these paddocks being accessed by different lanes. This will significantly reduce the frequency of stock movements along this section of the central lane (minimum of 50% reduction in stock movements) and the corresponding amount of dung (and associated phosphorus) deposited on the lane. In addition to the reduction in lane usage the lane should be sloped away from the adjoining waterway and the riparian buffer extended by 1m and maintained in rank grass (or planted in native grasses such as carex secta or red tussock).

The reduction in use of the central dairy lane between Woldwide One and Woldwide Two will result in a significant reduction in stock movements along this section of laneway and a subsequent reduction in dung (phosphorus) deposited on the lane.

The lane should be sloped away from the adjoining waterway and the riparian buffer extended by 1m and maintained in rank grass (or planted in native grasses such as carex secta or red tussock).

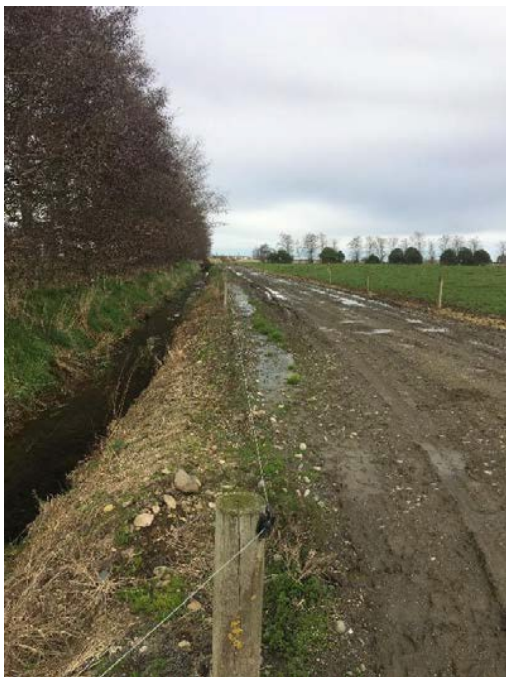
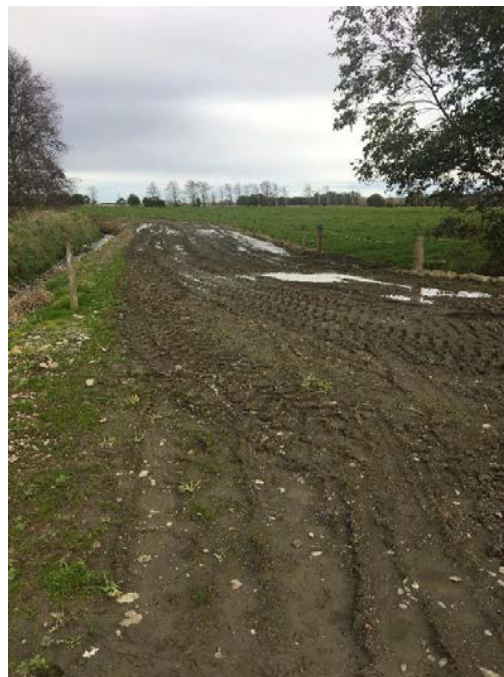
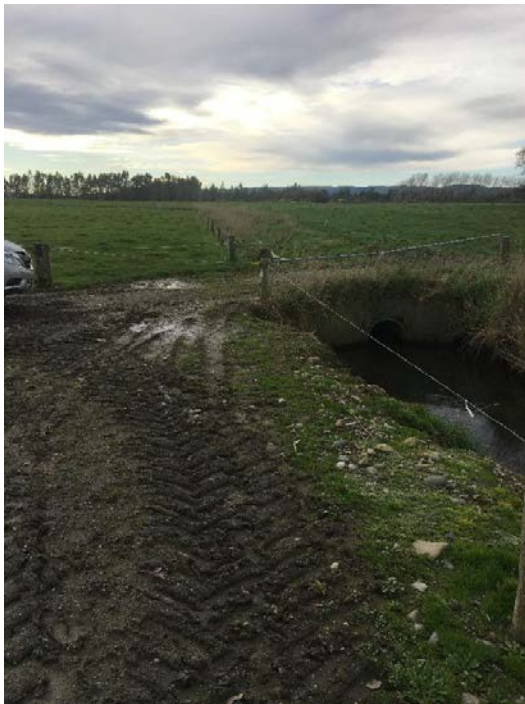
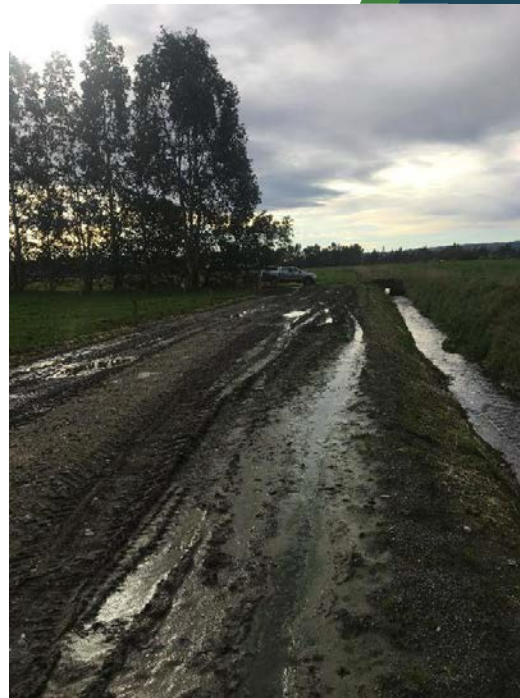
L5

Main dairy lane running adjacent to a waterway. There is a small riparian buffer but this is not well vegetated and provides minimal opportunity for filtering contaminants off the lane. The lane is relatively wide in this area and as such it is recommended the fence be moved out 1m and a rank grass (or native plants such as carex secta and red tussock) be established to assist in filtering any run-off.

In a number of places the lane does slope away from the adjacent waterway but during upcoming lane maintenance the entire lane should be sloped away from the creek.

Extend the riparian margin by a minimum of 1m and establish a good sward of rank grass (or plant native grass such as carex secta and/or red tussock) to assist with filtering run-off from the lane. In addition to this slope the lane away from the waterway.

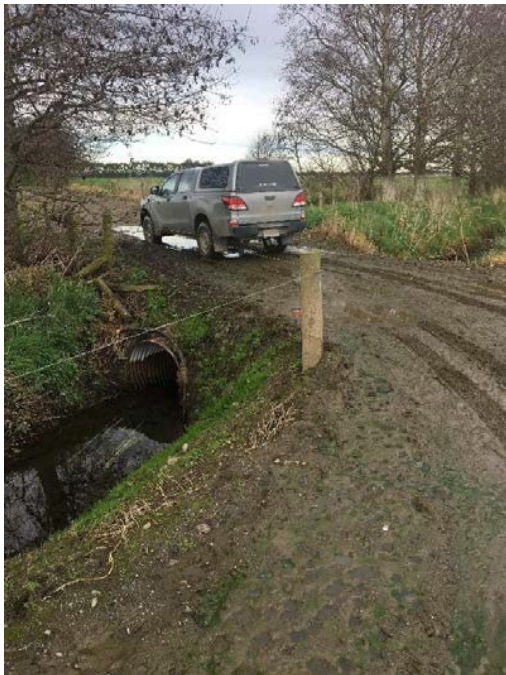
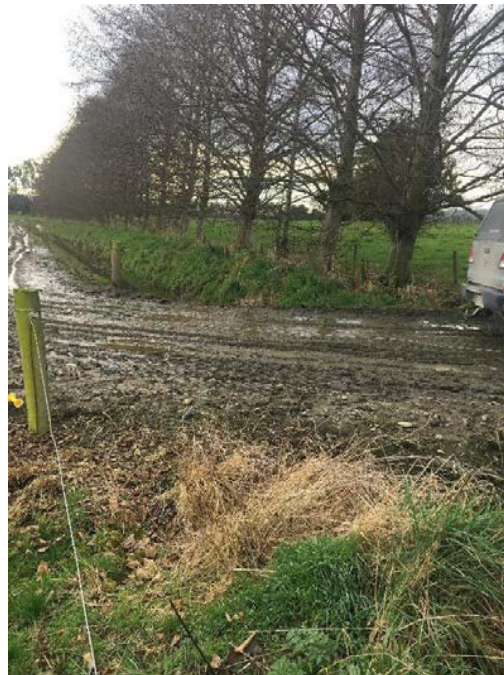
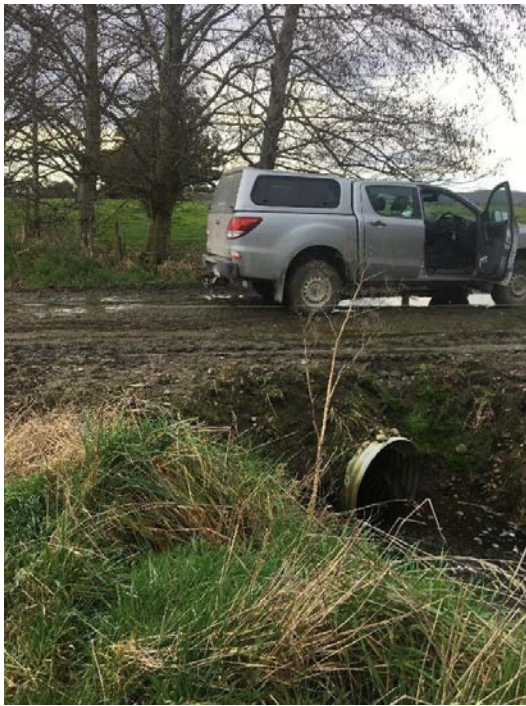
L6 Culvert Management

Culvert crossing the waterway to the south of paddock 34. The culvert has no raised sides which allows any runoff to flow off the side into the underlying water. Building up the sides of the culvert and directing run-off back into the paddock or at a minimum into a grass riparian area will assist with filtering sediment and associated phosphorus.

Build up the sides of the culvert crossing the waterway to the south of paddock 34. This will prevent the direct deposition of sediment and associated phosphorus into the underlying waterway and allow for filtering via a grass buffer.

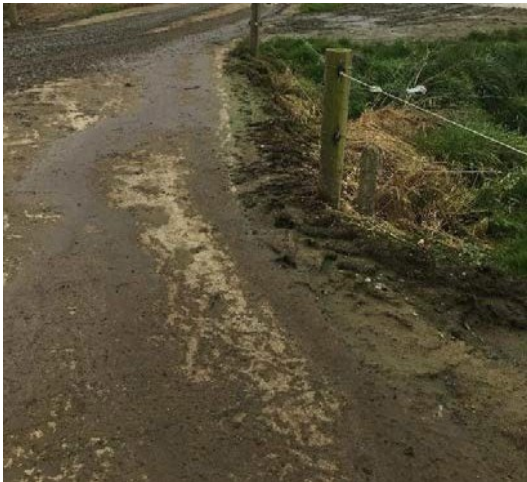
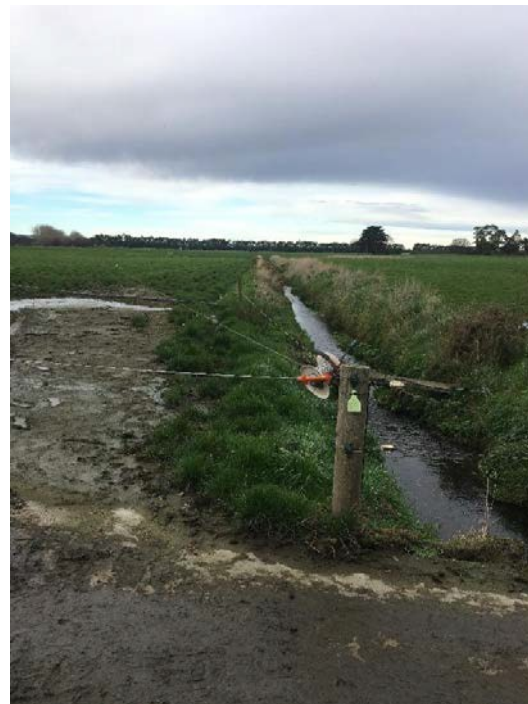
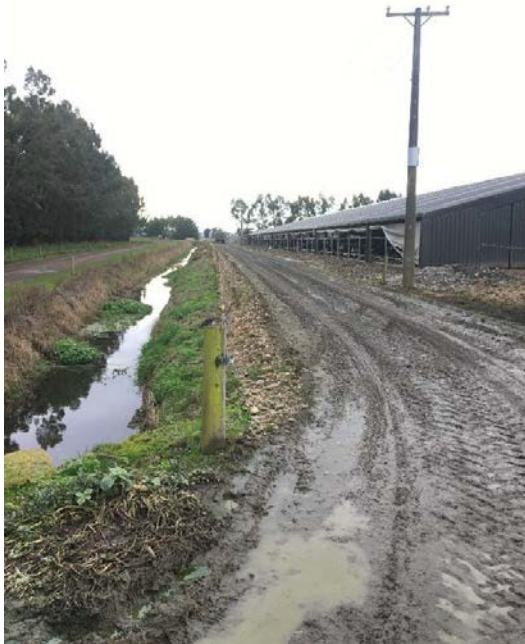
Main Culvert (South of Wintering Barn)

The main lane culvert to the south of the wintering barn on Woldwide One. A kerb should be installed on the sides of the concrete lane going over the culvert to prevent direct run-off into the underlying waterway. The kerb should direct run-off back into the adjacent paddocks. On the western side of the culvert a triangle could be fenced off and left in rank grass.

Install a kerb on the concrete lane at the point it goes over the main culvert. This should direct run-off into the adjacent paddock.

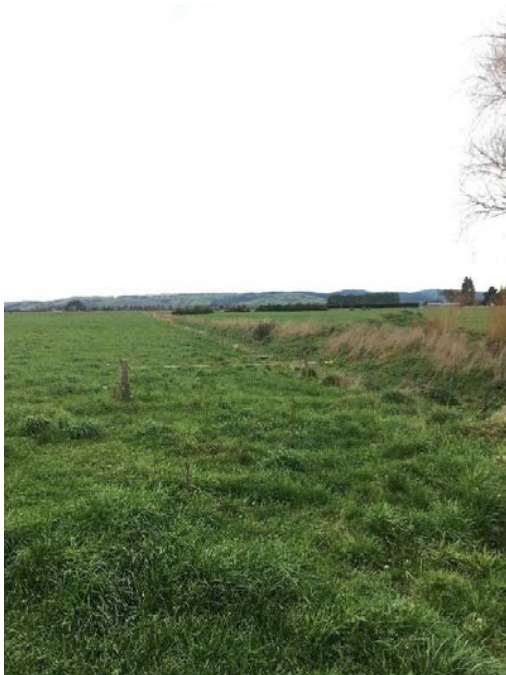
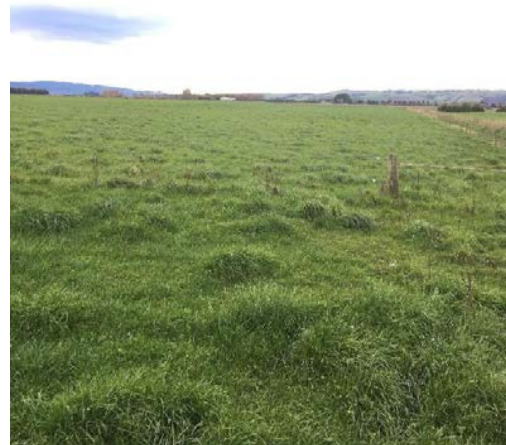
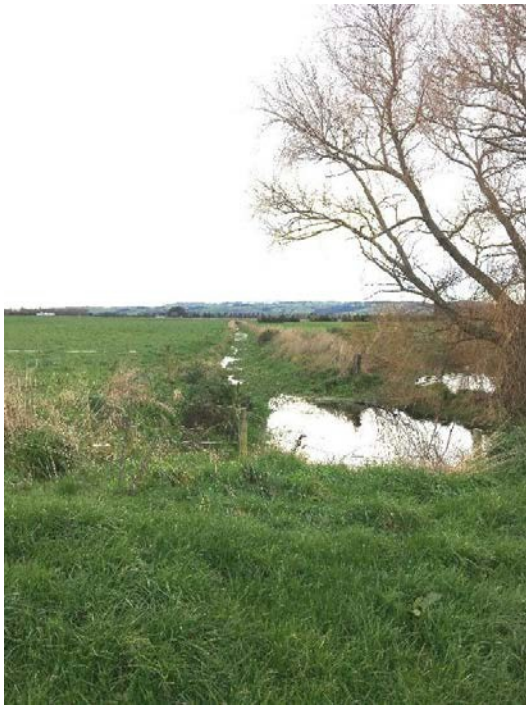
L9

Swale/low area running through Marcel paddock 1. Overland flow will be concentrated in this area following heavy rain and make its way down into the adjacent waterway. The riparian margin should be increased where the swale enters the adjoining waterway and maintained in rank grass or planted in native grasses such as red tussock, carex secta or toetoe.

Extend the riparian margin in Marcel Paddock 1 where the critical source area enters the adjoining waterway. This area should be left in rank grass or planted in native grasses such as carex secta, red tussock or toetoe.

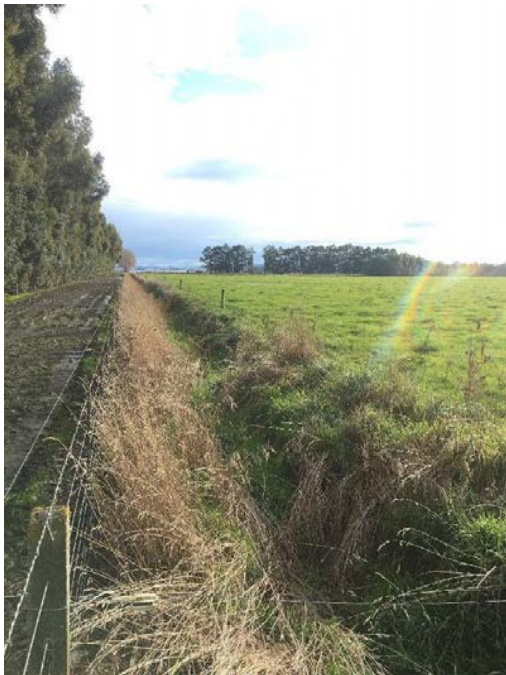
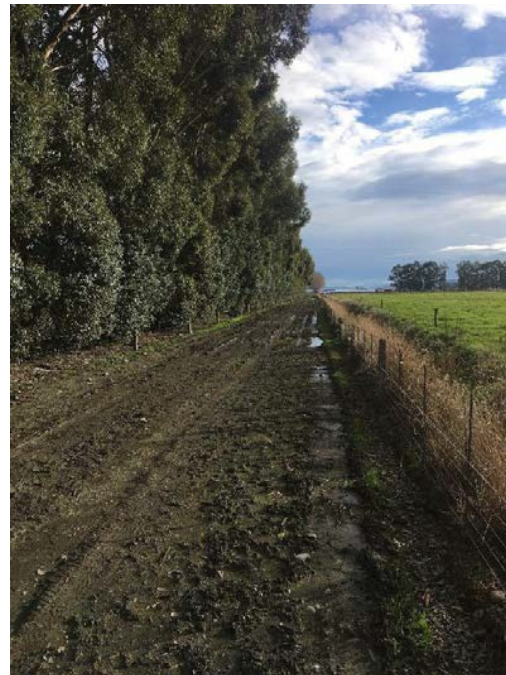
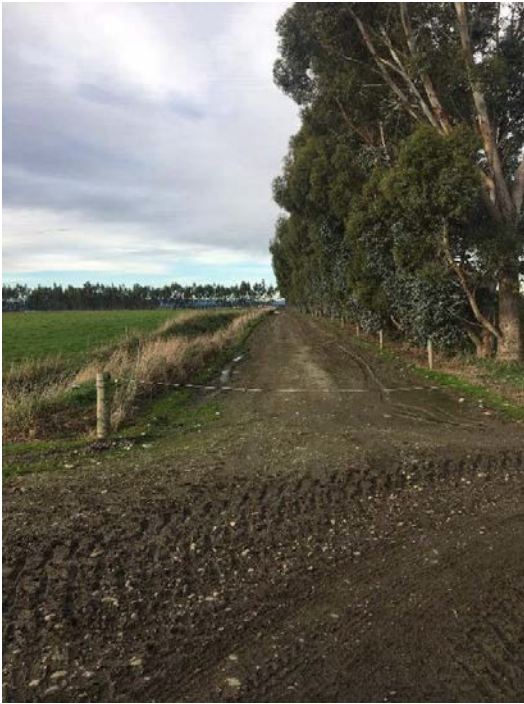
L10

Dairy lane on the boundary of Woldwide One and Woldwide Two, south of paddock 34. The lane is lined on the southern side with a row of tall gum trees, which will impact on the ability of the lane to dry out. There is a 1-1.5m riparian buffer between the lane and the creek, which is maintained in rank grass. Some re-contouring of the lane could occur to ensure it slopes away from the waterway along its full length. In addition to this the large gum trees could be removed and replaced with low growing native plantings such as flax, toetoe and red tussock. This will still provide stock shelter, aesthetic and biodiversity outcomes but not impact on the drying out of the lane.

Re-contour the dairy lane at the southern end of paddock 34 (between Woldwide One and Woldwide Two) so it slopes away from the dairy lane. In addition to this the gum trees could be removed to prevent shading of the lane, allowing it to dry out (reducing the likelihood of water ponding and running off). This area could be replanted in low natives such as flax, toetoe and red tussock to maintain biodiversity and aesthetic values.

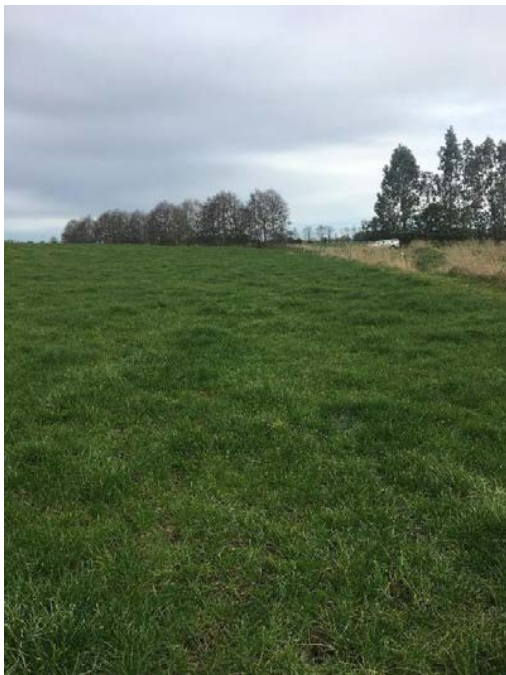
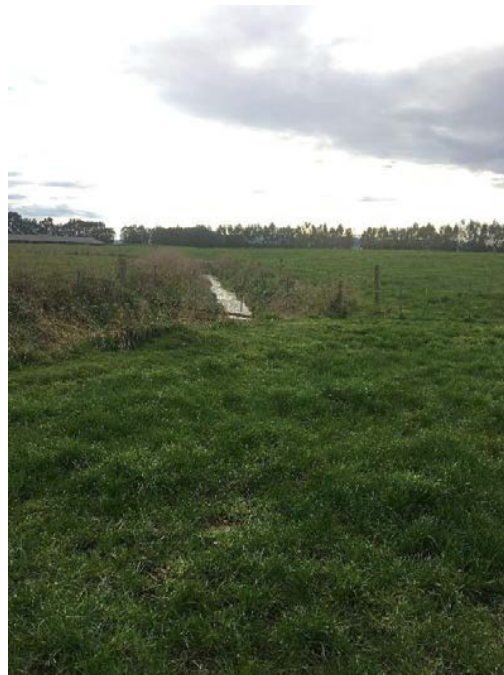
L11

Small gully/swale running through paddock 34. In heavy rainfall events this will collect rainwater and associated contaminants from the surrounding land and direct them down to the waterway. Extending the riparian buffer and maintaining it in rank grass (or plant with native grasses such as Carex Secta or Red Tussock) in the location where the swale enters the creek will assist with filtering sediment and associated phosphorus.

Extend the riparian margin where the small swale in paddock 34 enters the adjacent waterway. Maintain this area in rank grass or plant in native grass species such as red tussock or carex secta.

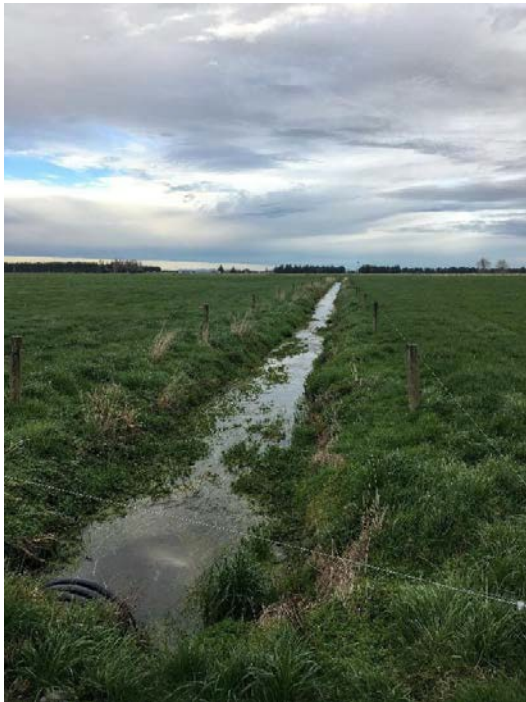
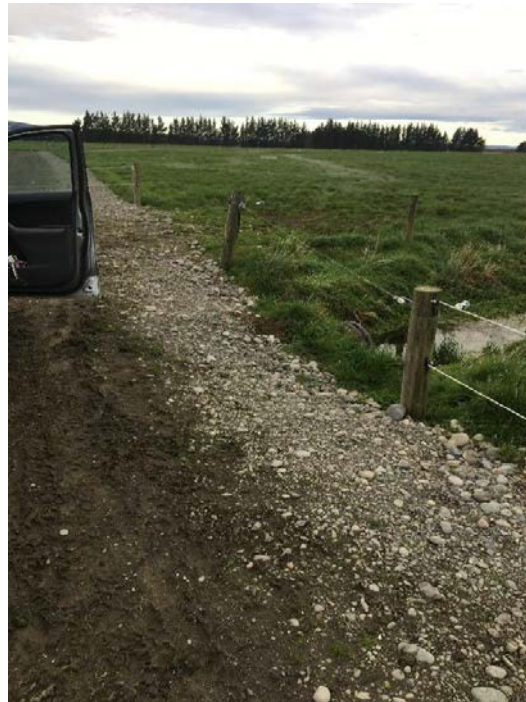
L13

Lane culvert into Marcel Paddock #9. The culvert is in good condition along with the lane overlying it. The sides of the culvert should be raised to prevent contaminants off the lane running directly into the underlying waterway. Run-off should be directed out into the adjacent paddocks.

Raise sides of culvert (Marcel #9)
