Application for Resource Consent (PART A)

Land use consent for an existing effluent storage pond.

Application under pSWLP (2018) Rule 32D (b):

6. Proposal - Existing Effluent Pond – WW2 unit

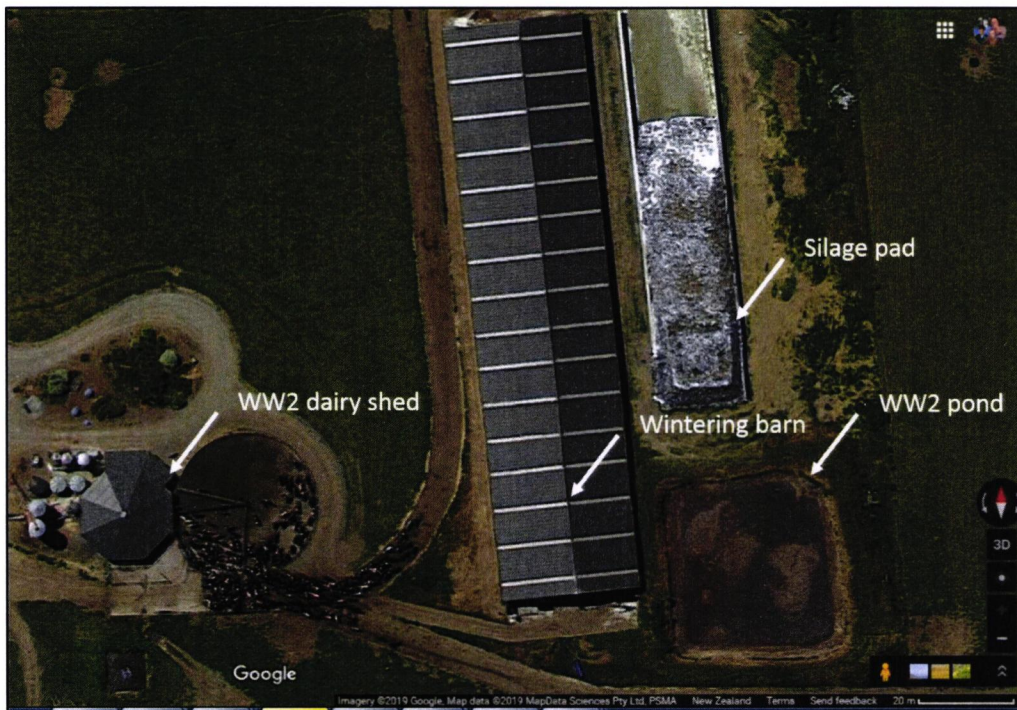
Figure 2. Aerial photo showing key features.

NZTM (2000) Easting	NZTM (2000) Northing
Pond NW corner	1225188	4889704
Pond SW corner	1225197	4889668
Pond NE corner	1225155	4889698
Pond SE corner	1225160	4889662
WW2 dairy shed	1225041	4889687
WW2 wintering barn	1225131	4889710
Bore (E45/0083)	1225017	4889695
Nearest waterway	1225002	4889654

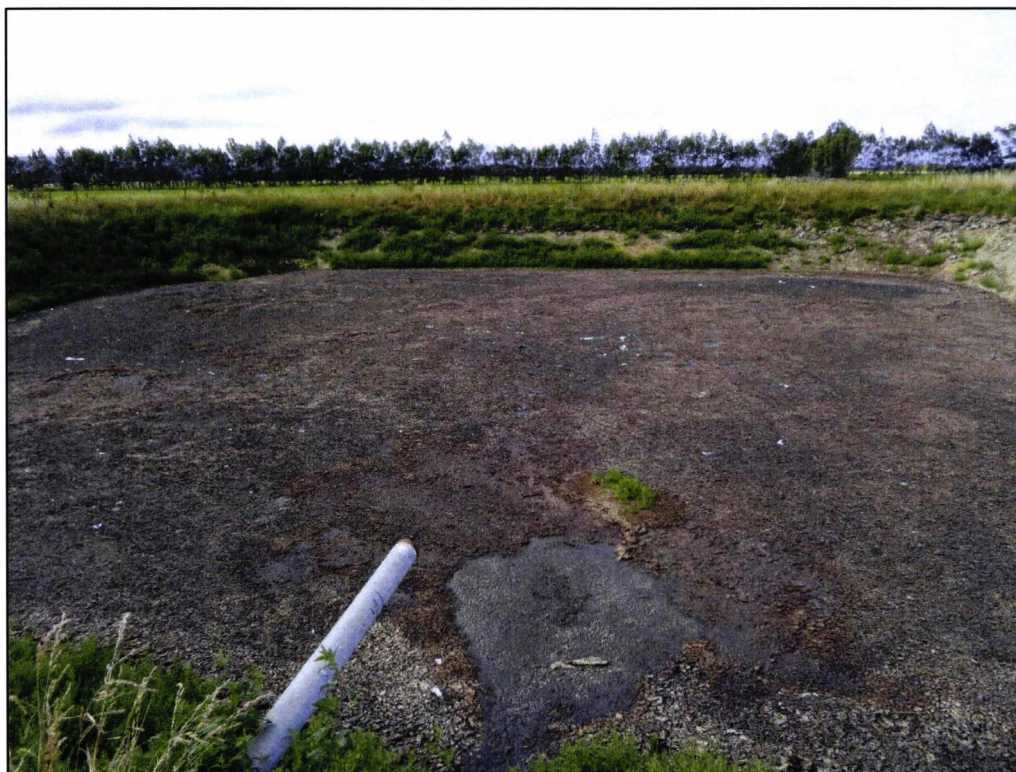
Figure 3. Photo of WW2's effluent storage pond.

As the pond is a pre-existing structure, soil testing for bank construction purposes is not required.

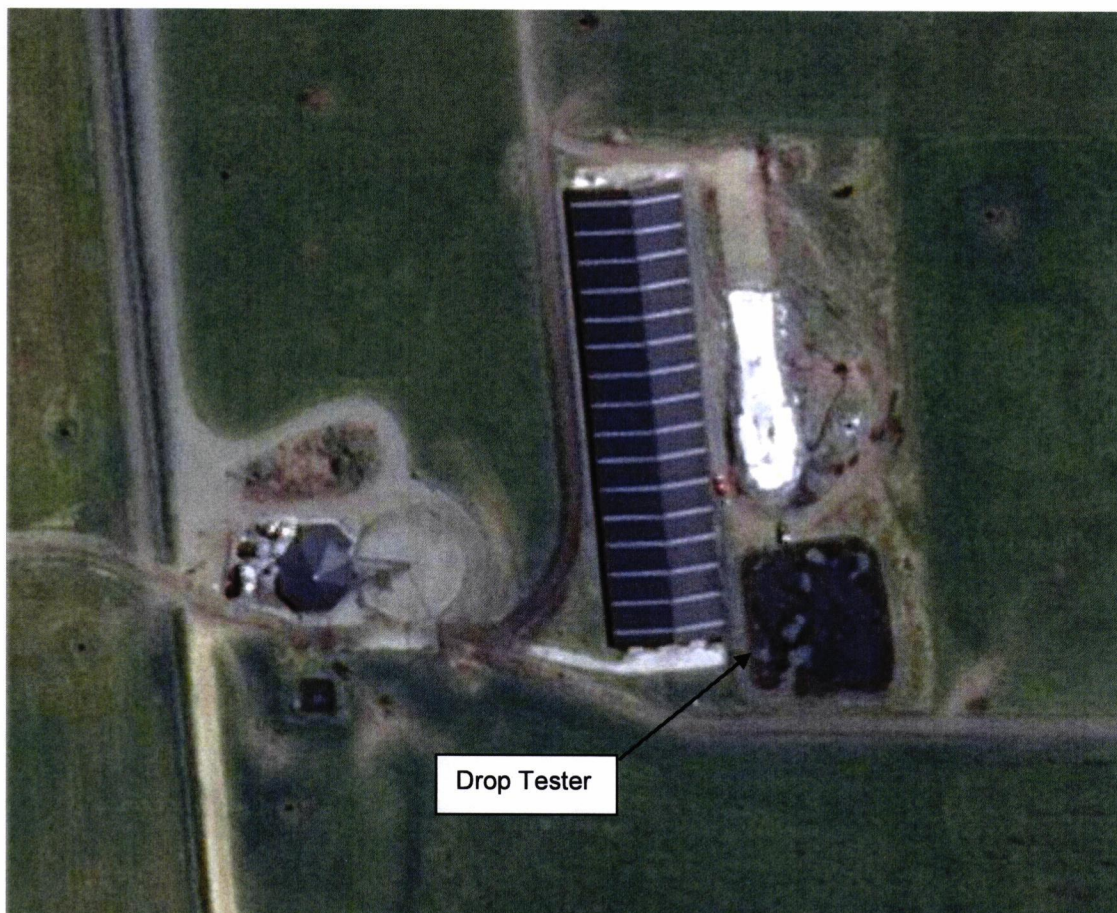
The maximum depth for the pond is 3.2m, this includes 0.5m of freeboard. At the time of the test the liquid level was 1.0m below design height, i.e.81% full.

Below is an aerial photo that shows the pond and dairy shed. The laser drop test unit was installed at the west side of the pond, as marked.

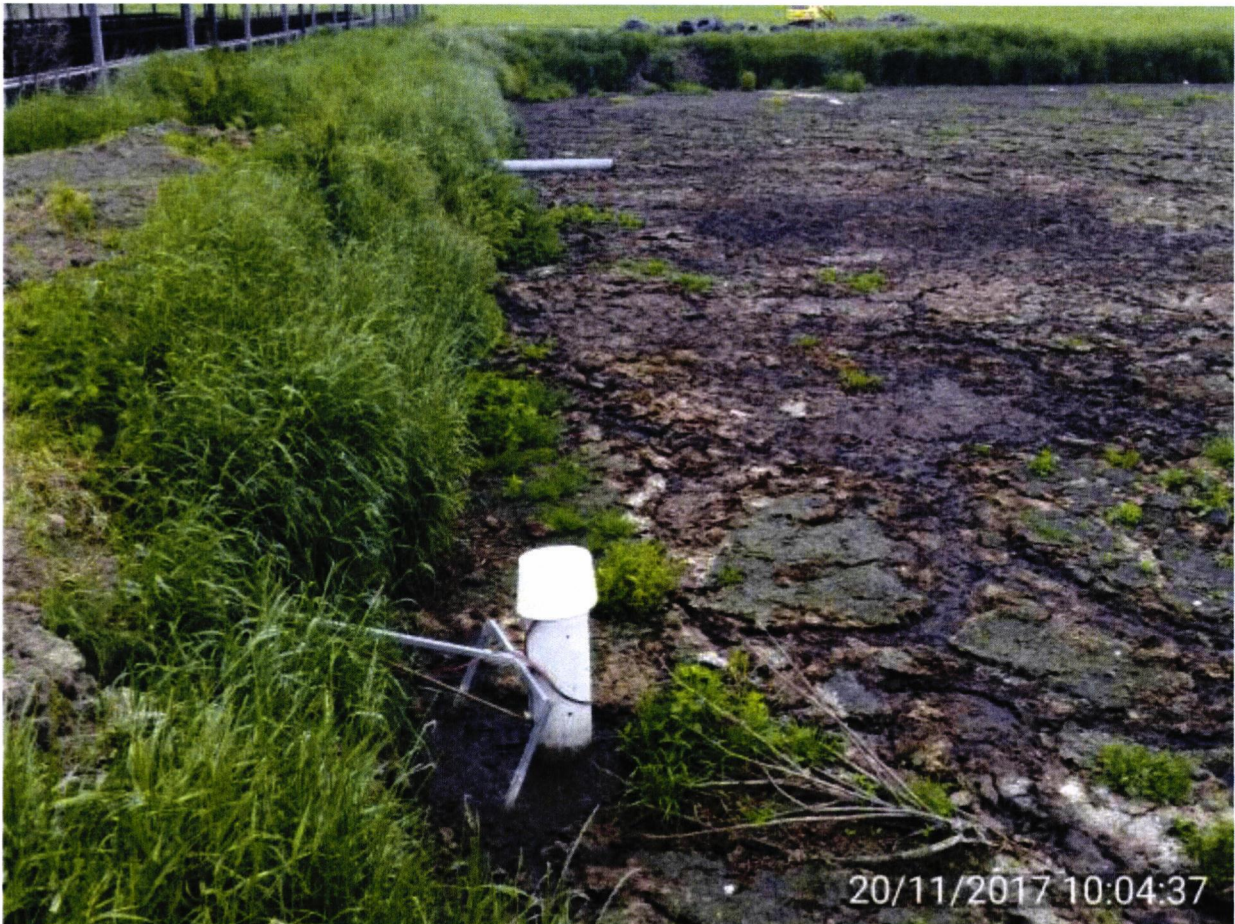
Laser at the west side of the pond.

- Rainfall and the evaporation bucket liquid volume was measured at the start and end of the test period, the measurement cylinder was rinsed prior to the volume being measured.
- When a period of 48 hours or more has elapsed the information is down loaded and the results interpreted.
- The GPS location of the pond and equipment setup is recorded. For this test the equipment was located at E1225159, N4889662, at the west side of the pond.

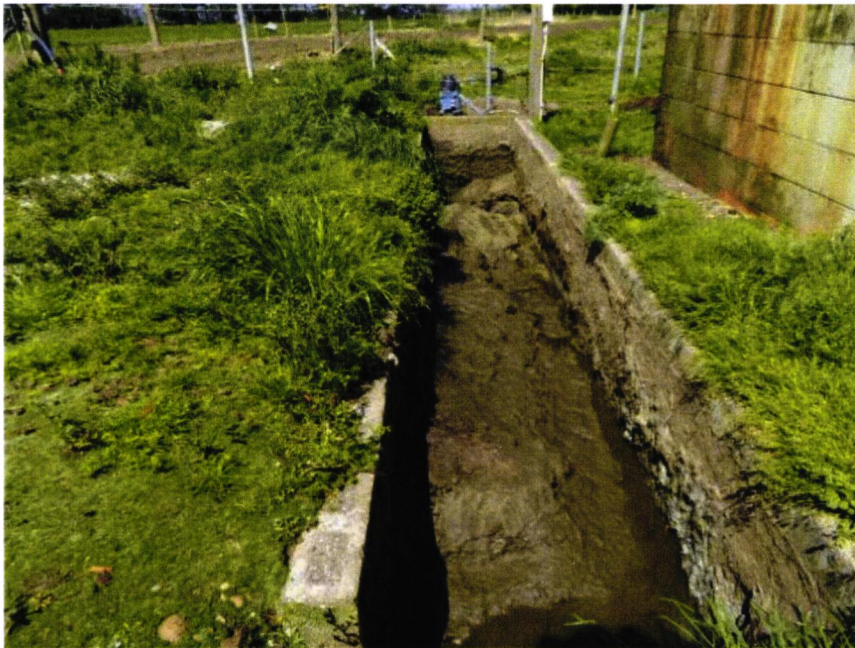
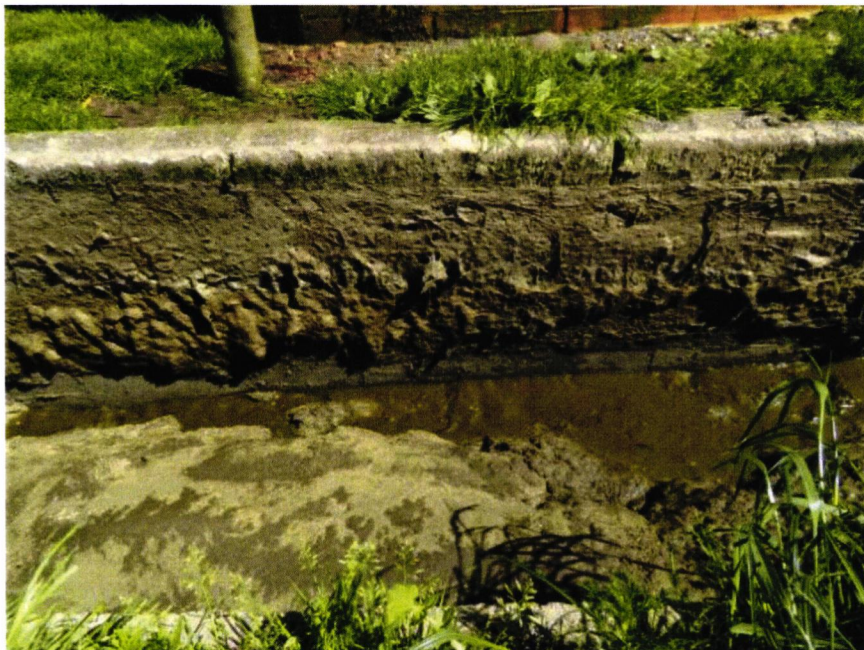
There was no sign of settlement or differential settlement or cracking. Grouted joints that could be observed appeared to be sound although there was one join in the top

The sand trap appeared to meet the criteria of not causing defects that would allow leakage.

Below are photos showing the sand trap lengthwise and looking at the internal concrete block wall.

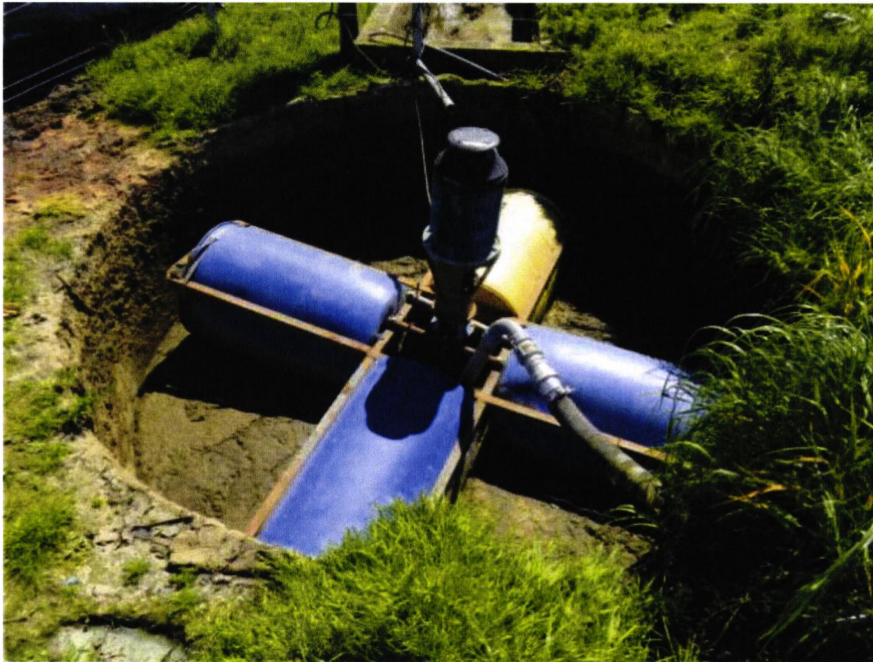
The pump sump at the end of the sand trap is formed from a precast 22.5m³ concrete tank. It has an inlet from the sand trap and one from a pipe crossing a race at a higher level. There were no obvious cracks in the concrete. A small area of concrete had been removed to facilitate the placement of the discharge pipe in a conduit under the race.

The sump appeared to meet the criteria of not causing defects that would allow leakage. It is pictured below with the end of the stone trap in the background.

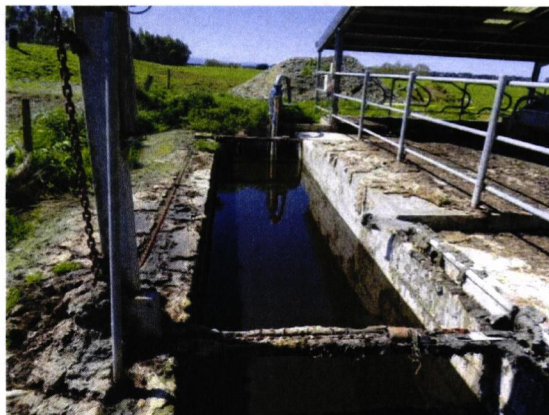
The wintering barn has a collection sump at the north end where scraped effluent is deposited prior to being pumped into the storage pond. The sump is 1.9m wide and 26m long. It appeared to be in sound order with no obvious corrosion of concrete.

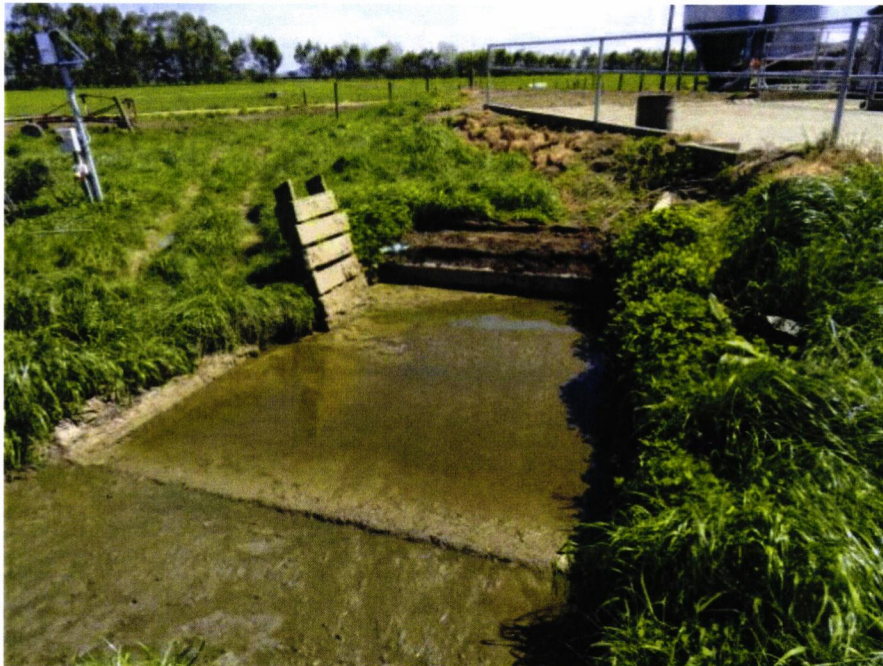
Effluent from the dairy shed and yard flows to a conventional sand trap on the south side of the dairy shed. It is emptied by front end loader. The structure didn't show any visible signs of settling or cracking. There was no cracking of the concrete where tractor tyres enter the trap or along the back wall where the front end loader bucket may contact the wall.

The sand trap appeared to meet the criteria of not causing defects that would allow leakage.

Below is a photograph of the sand trap.

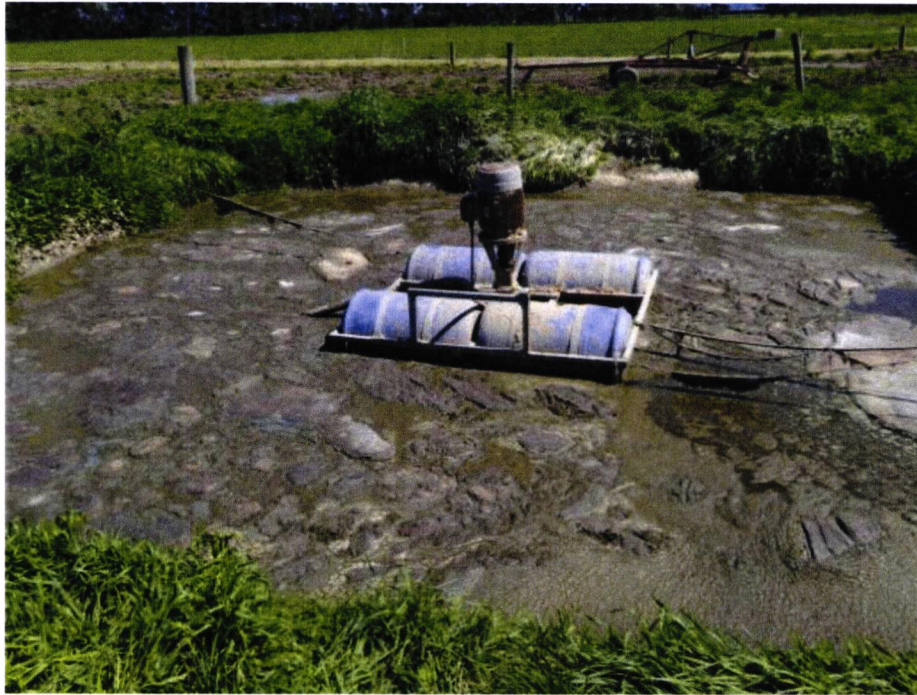
The pump sump adjacent to the sand trap is formed from a shotcrete concrete tank in the order of 9.2 m x 9.2 m. It has an inlet from the sand trap. There were no obvious cracks in the concrete for the area of concrete that was visible.

The pump sump appeared to meet the criteria of not having defects that would allow leakage. It is pictured below with a section of the freeboard batter slope exposed in the background and then close up.

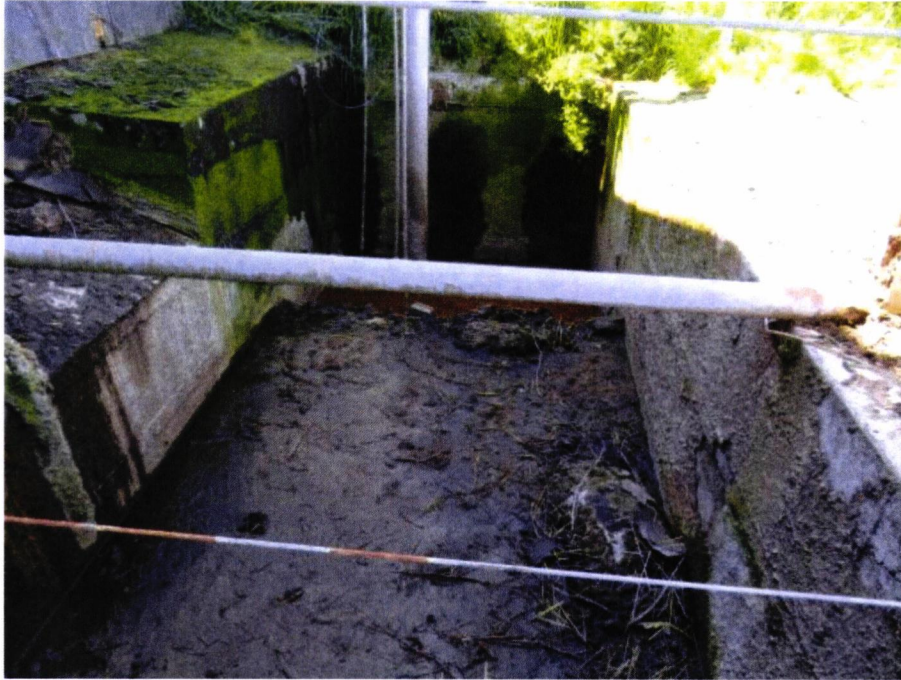
The wintering barn has a collection sump at the south end where scraped effluent is deposited prior to being pumped into the storage pond. The sump is 1.9 m wide and 30 m long. It had been poured in situ. It appeared to be in sound order with no obvious corrosion of concrete.

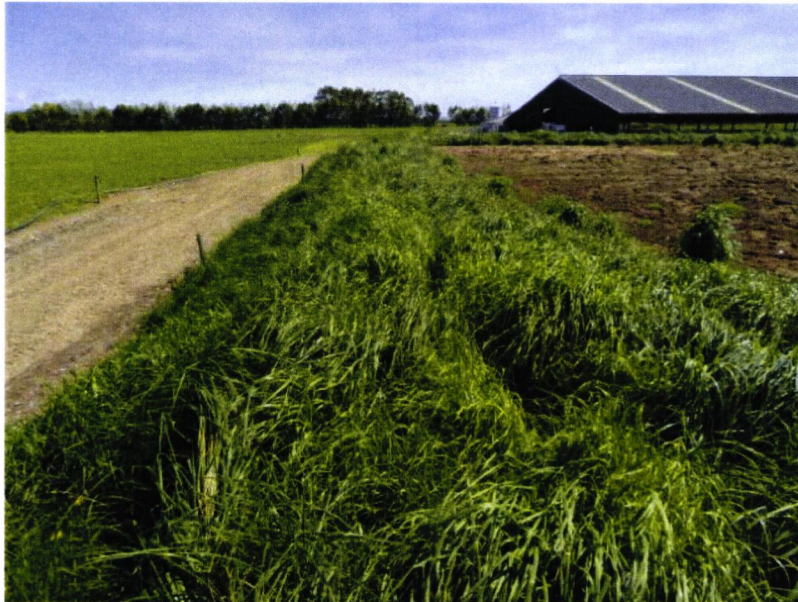
South Bank.

Photos of each bank crest appear below.

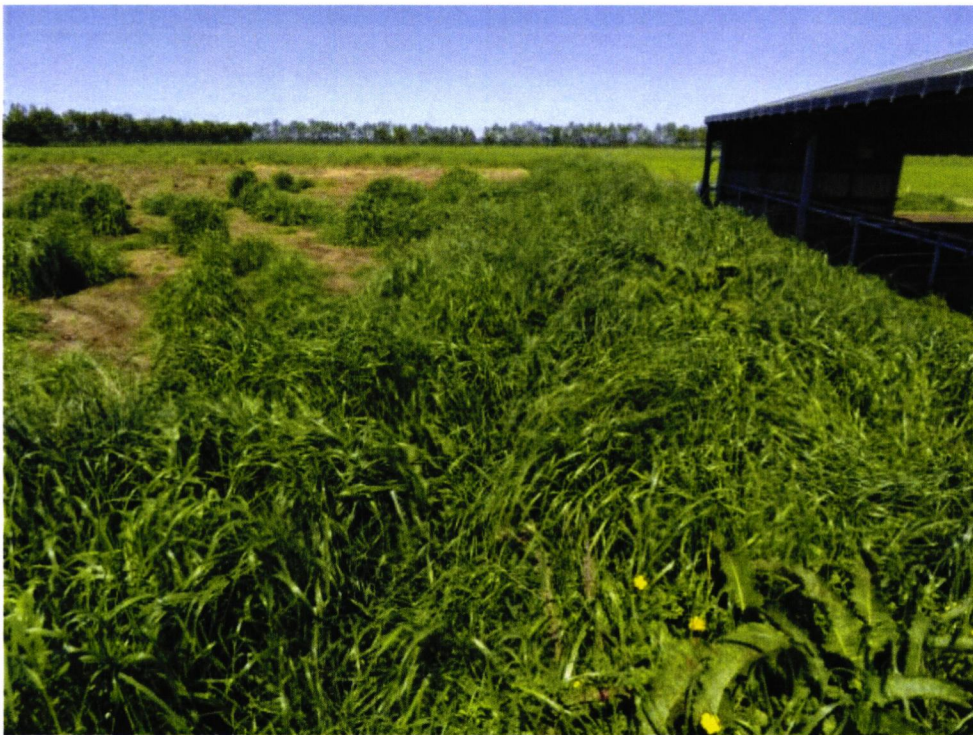
West Bank

In accordance with Rule 32D of the pSWLP, the effluent storage pond at Woldwide Two has been assessed by a SQP and is certified as having no visible cracks, holes or defects that would allow effluent to leak from the effluent storage facility.
