FARM ENVIRONMENT PLAN

Arlake Ltd

23 October 2019

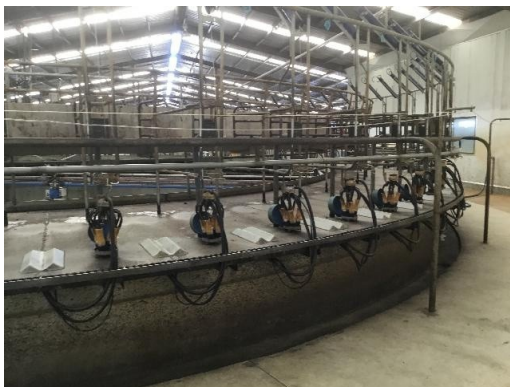
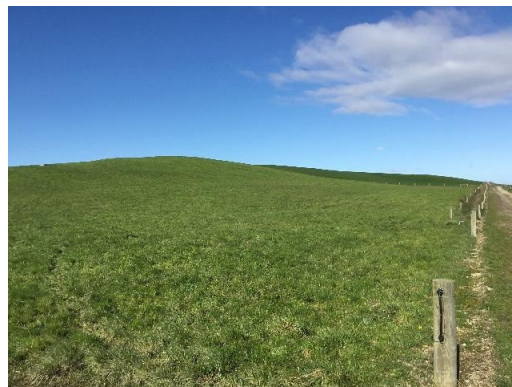
* The physical and biophysical characteristics of the farm system are identified, risk factors to water quality associated with the farm system have been assessed and are managed appropriately

OPEN ACTIONS:**Ensure Accurate and Auditable Records are Kept**

The maintenance of accurate and auditable records of farm inputs, outputs and management practices needs to occur. This is particularly important for supplementary feed, fertiliser use and location of spreading and stock numbers. Without this data an accurate picture of the farms environmental and economic performance cannot be obtained.

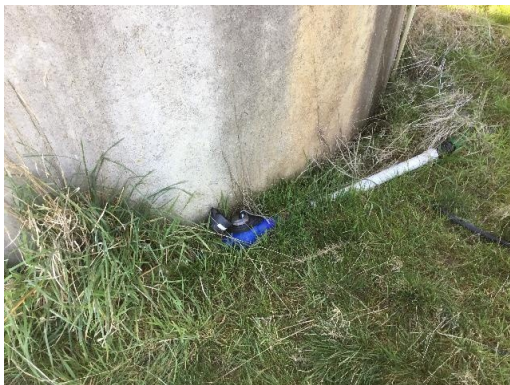
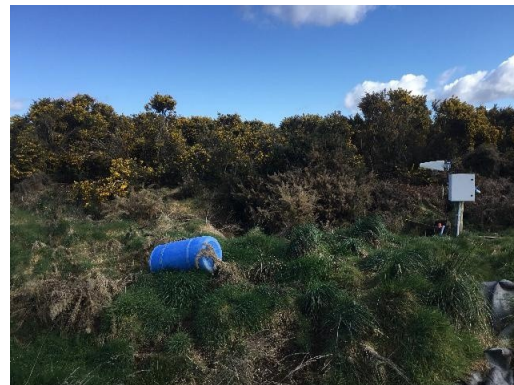
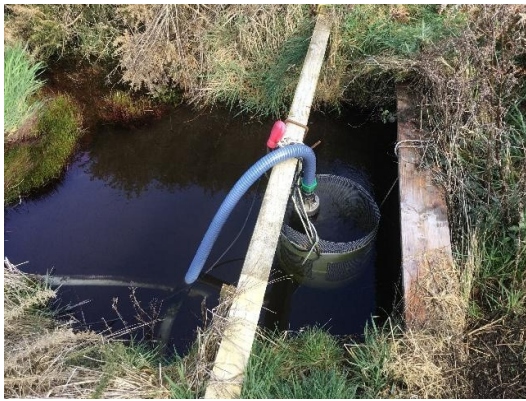
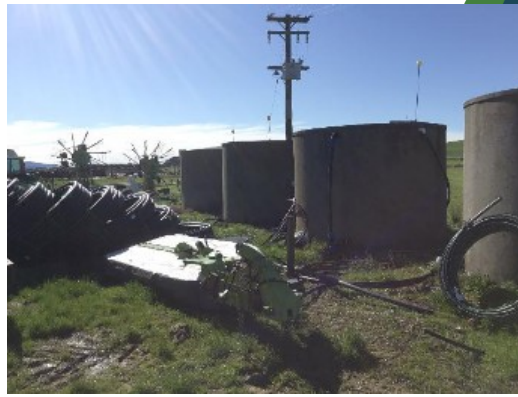
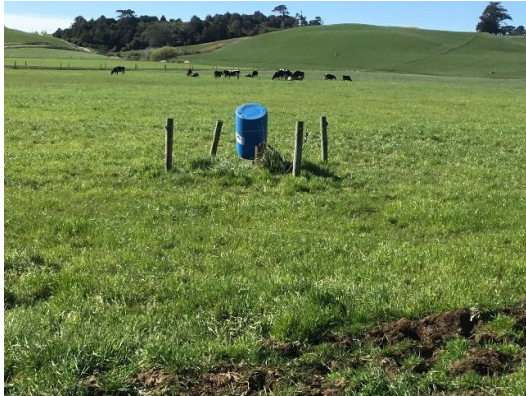
Water use on the farm is generally efficient with yard hosing kept to a minimum. Water troughs are checked daily for leaks where stock are grazing.

- * All water use on farm is measured (water meters)
- * Water wastage is minimised from the dairy shed
- * All leaks are fixed as soon as possible
- * Water troughs are checked daily where animals are grazing

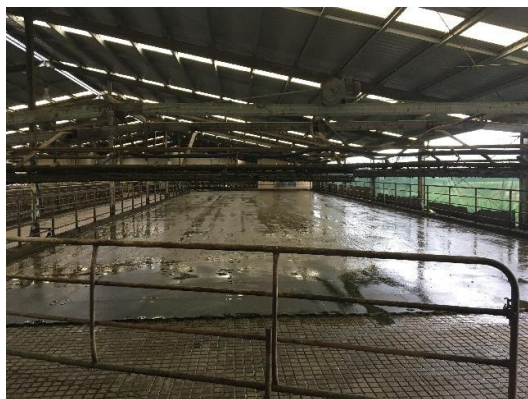
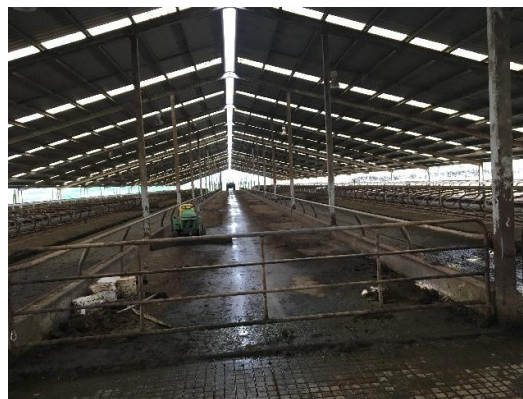
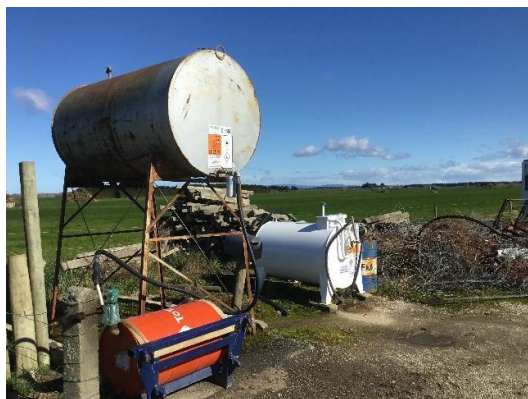
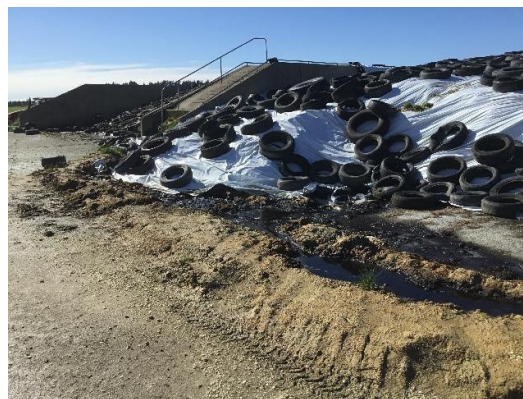
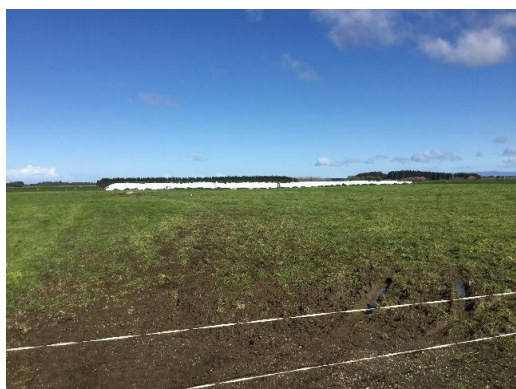
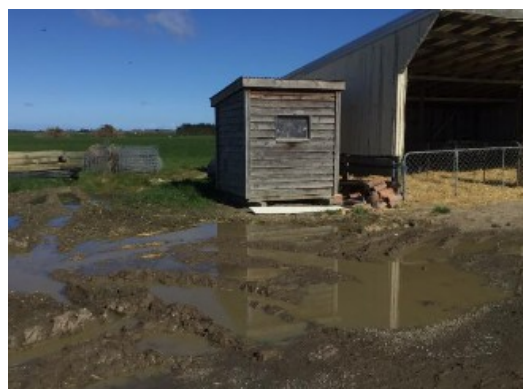
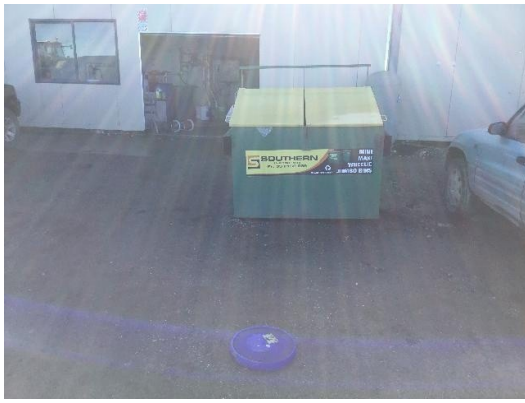
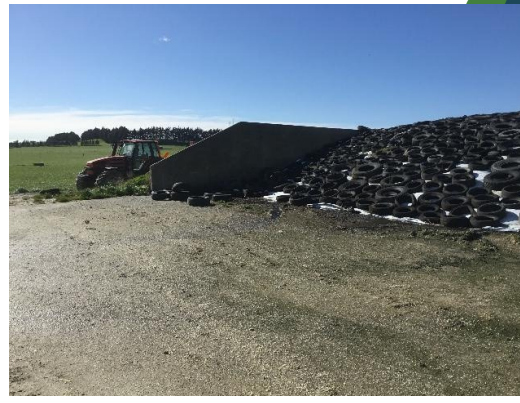
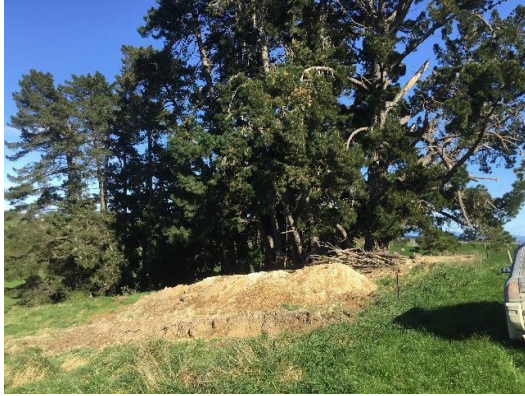
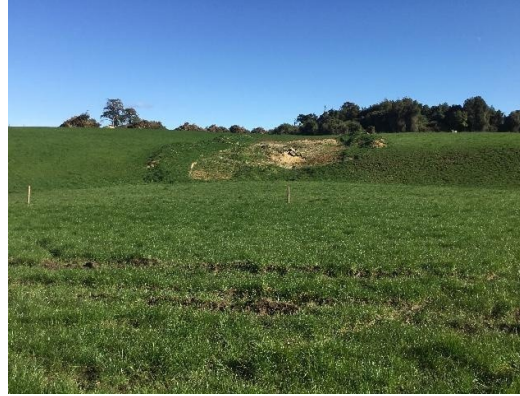
Household and farm rubbish is collected and removed off farm by Southern Skips. The households are active recyclers. Everything on farm that can be recycled is recycled. Dead stock are picked up by Wallace Group and all calves are picked by Slinkskins. There is an offal hole on farm that is only used for anything that cannot be picked up. Items which are able to be burned such as untreated wood and greenery are burnt on farm.

Fuel tanks are located beside the old woolshed/implement shed and are elevated with no signs of significant leakage or spillage around them. There is a 1000 L petrol tank and a 3000 L diesel tank.

Relocate/Retire Offal Hole

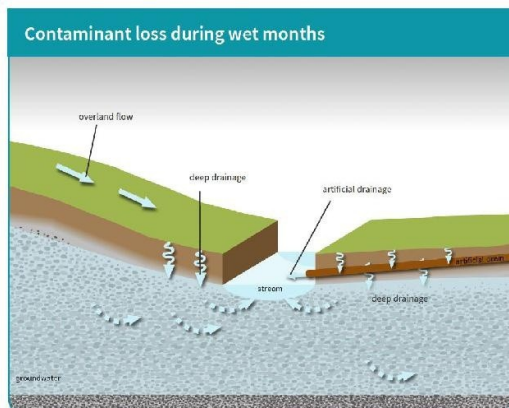
Physiographic Zone: Oxidising

The overland flow variant of this Physiographic Zone is predominately found on the property on the hill areas of the property.

Oxidising Zone - Minimise Grazing

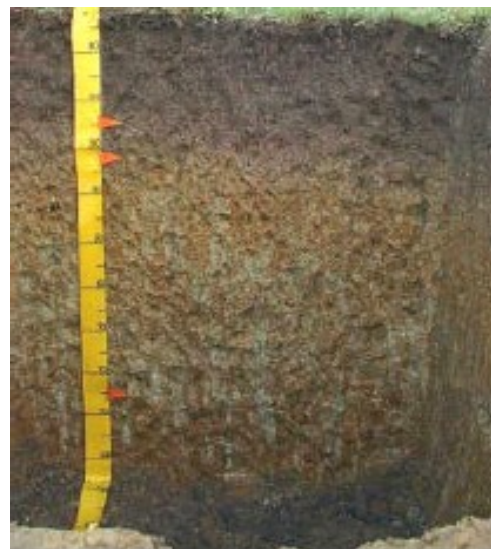
Braxton profile

Braxton soils are moderately deep, poorly drained and have a silty clay to heavy silt loam texture. Due to the slow subsoil permeability and poor drainage these soils only have a slight vulnerability to nutrient leaching when they are well wetted, however they are often artificially drained and prone to cracking during dry conditions. This significantly increases their vulnerability to nutrient losses to nearby surface water and to underlying groundwater.

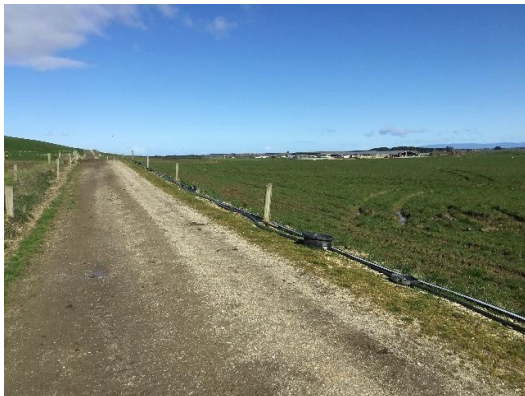
The dairy lanes over the farm are generally wide enough to facilitate good cow flow with a solid base and good surface incorporating an appropriate crown and camber. The lanes are regularly maintained and there were no significant issues noted with poor lane quality. Quality lanes allow for good stock flow, reducing lameness issues and the build-up of effluent on the lane surface and adjacent paddocks.

General condition: Good

Maintenance: Regular

OPEN ACTIONS:**Recamber Lanes Away From Waterways**

Re camber the lanes so that effluent is directed away from the waterways. This can be done when maintenance is undertaken.

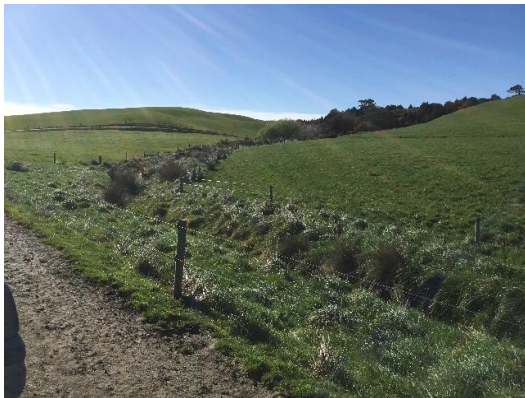
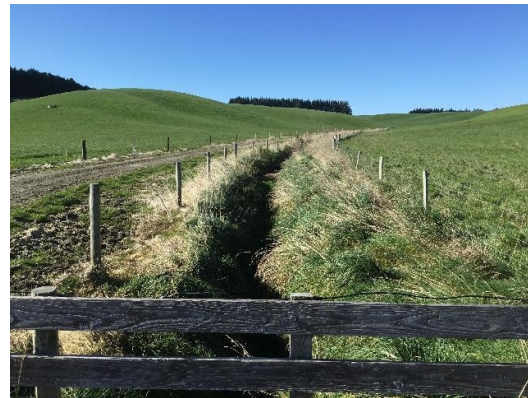
There are a number of small gullies and depressions on the farm that during heavy rain will result in a concentration of water and associated contaminants (sediment, phosphorus and bacteria) from surrounding paddocks being discharged into nearby surface waterways. The photos below show examples of such gullies/depressions (albeit they are difficult to see in the photos). Most of these gullies also have tile drains located under them and thus tile drain treatment options can also be investigated in these areas (where tile drains are significant). Where depressions flow through productive land the riparian margins can be extended where these gullies enter surface waterways, as per the diagram below. This will assist in filtering overland flow from surrounding paddocks.

Extend Riparian Margins (CSA Overland Flow)

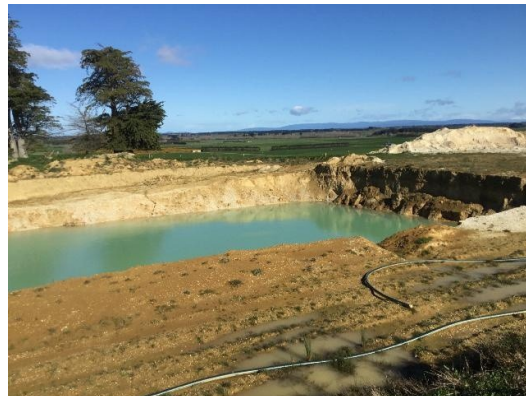
There is currently a 20 million litre irrigation pond being constructed on farm.

Update Farm Environment Plan

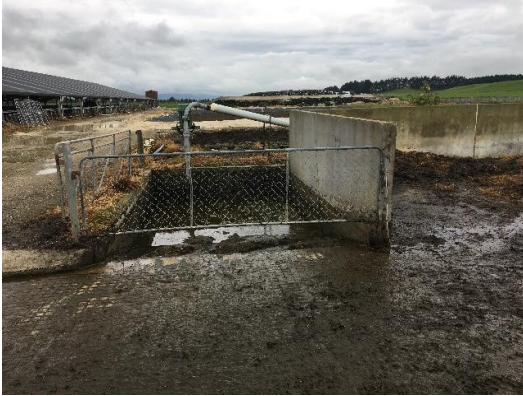
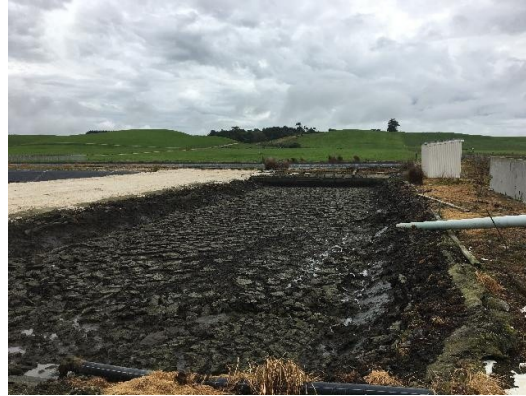
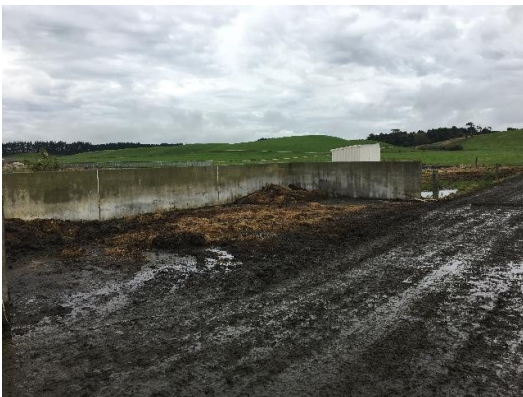
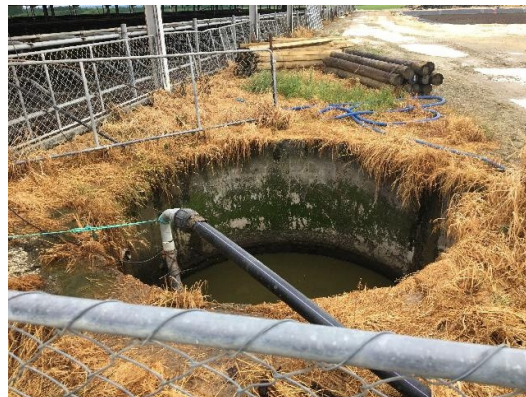
The farms effluent pond size has been assessed using dairy effluent storage calculator and is well in excess of the size required to avoid effluent having to be applied when conditions are unsuitable. The pond was constructed by an accredited effluent designer and is sealed with an HDPE liner. It is not equipped with a leak detection system.

Effluent applications are only carried out when conditions are suitable although scheduling could be improved via on farm soil moisture monitoring and continuing to use data from Environment Southlands soil moisture site at Woodlands.

The locations where effluent can be applied are shown on the farms resource consent and the map in this Farm Environment Plan. Staff are aware of the farms resource consent and the general conditions of that consent.

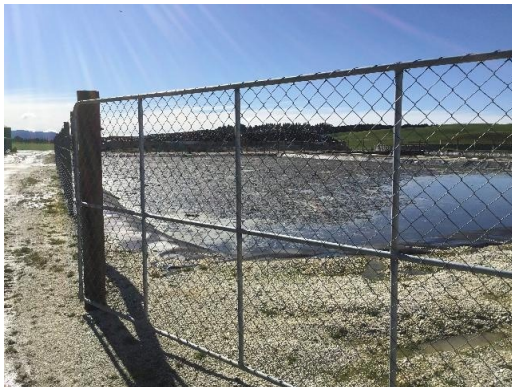
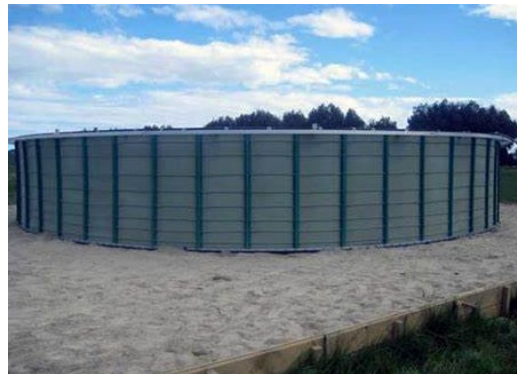
The farms effluent pond size has been assessed using dairy effluent storage calculator and is well in excess of the size required to avoid effluent having to be applied when conditions are unsuitable. The pond was constructed by an accredited effluent designer and is sealed with an HDPE liner. It is not equipped with a leak detection system.

Dairy effluent storage calculator:	Yes
Solids management:	Spread immediately
Pond lining:	lined
Stormwater diversion:	Yes

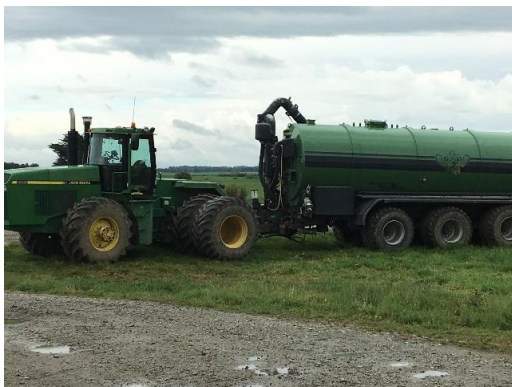
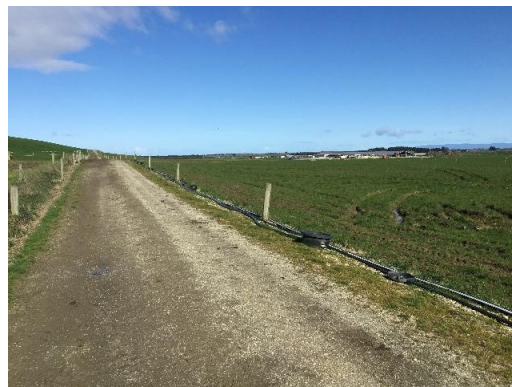
Effluent is spread to category C land via a set of 5 K-line-Max70 pods. The pods are fitted with an electronic failsafe to automatically shut down the pump if there is a sudden pressure drop or increase. The application rate of these pods were tested and are applying at an average rate of 4.8 mm per hour putting out 19.44 m³ of effluent per hour in total over the 5 pods.(appendix 3)

Application Depth (Category C): 10 mm depth, 10 mm rate

OPEN ACTIONS:**Soil Moisture Monitoring**

On farm soil moisture monitoring (i.e. Regen) is the best way to ensure soil moisture conditions are suitable for applying effluent and provide valuable data on available irrigation days to assist with future consent applications and irrigation best practice. In the absence of on farm data the nearest Environment Southland Soil moisture site can be used as a guide (Woodlands).

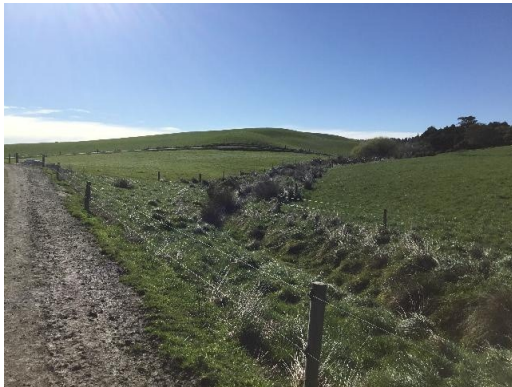
Riparian Management Plan:	Yes
Vegetation status:	Rank Grass
Waterway type:	Stream/Creek
Fencing status:	Permanently Fenced

Riparian Planting

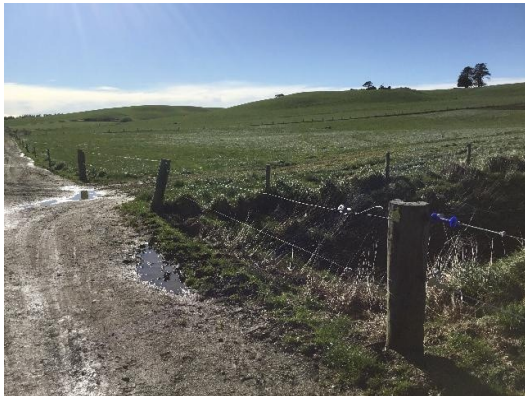
The culvert that crosses the creek between paddocks 40 and 41 has signs of erosion. This should be repaired to prevent damage to lane and the loss of sediment and nutrient off the lane into the water way below. The lane is also tapered so that all water would be directed into the creek.

Type:	Culvert
Condition:	Average
Fish Passage (Culvert):	Yes

Repair Crossing (Paddock 40 & 41)

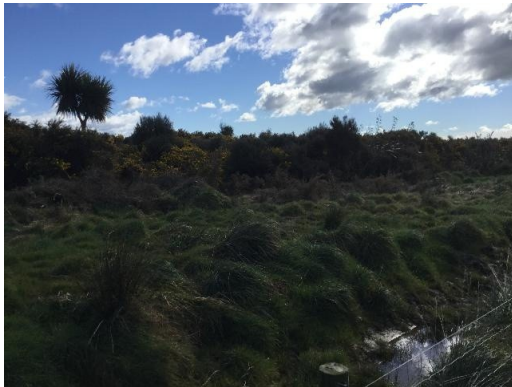
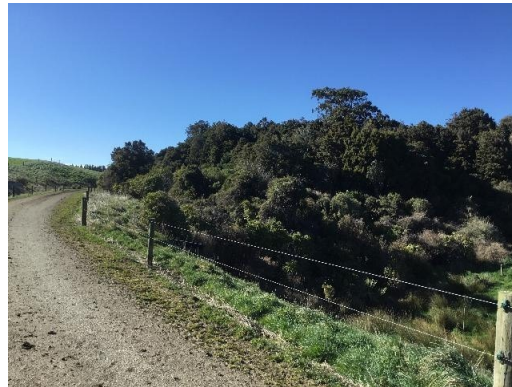
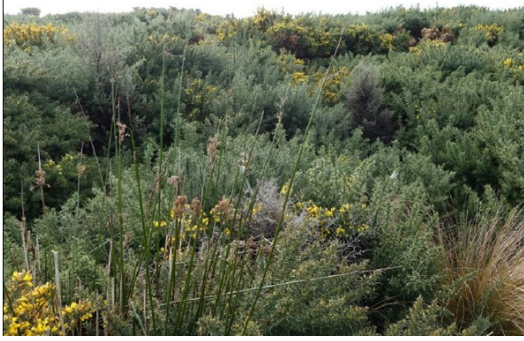
Waterway Type: Wetland

**OPEN ACTIONS:****Wetland Area Weed Control**

Undertake weed and pest control around wetland areas to allow native vegetation and species to re-establish. Consider infill planting some of these areas to enhance the biodiversity values and prevent weeds re-establishing.

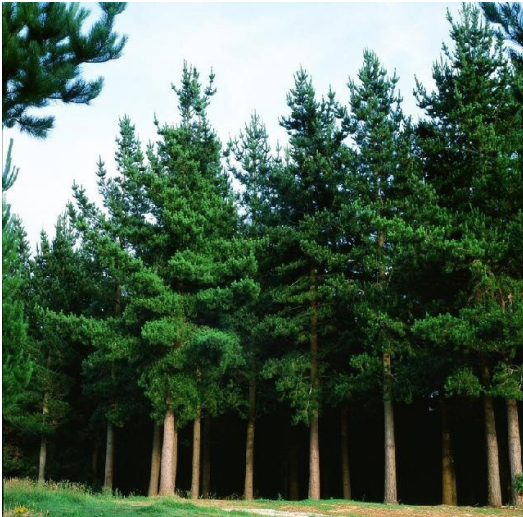
Vegetation status: Exotic

Manage tree harvesting risks

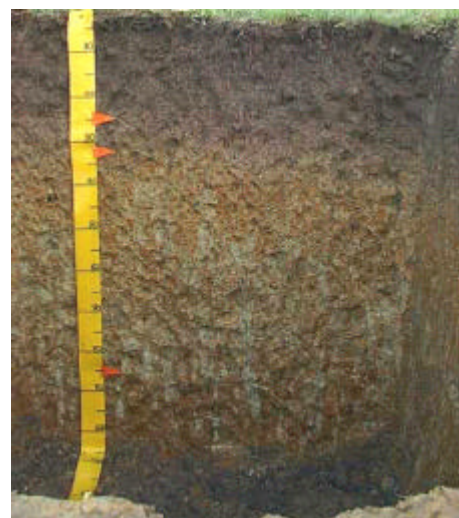
Braxton profile

Braxton soils have a deep rooting depth and high available soil water, although the rooting depth may be limited by poor aeration during wet periods due to the poor drainage and slow subsoil permeability. Mottles occur in all horizons – another indication of poor drainage. Texture varies between heavy silt loam and silty clay in the subsoil, and silt loam topsoil clay content is 22–30%. The soils are typically stone-free, although the moderately deep phase will have gravel between 45 and 90cm depth.

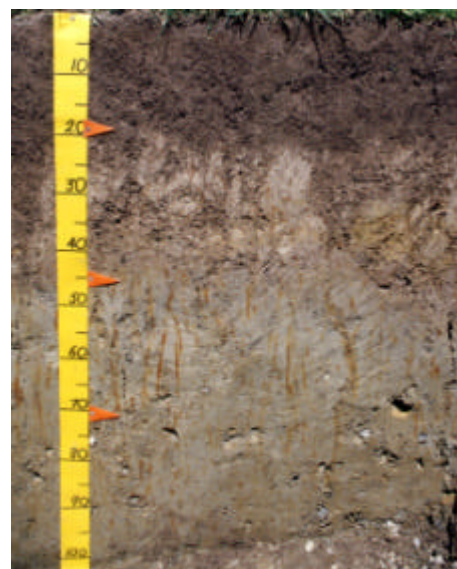
Makarewa profile

Makarewa soils have a deep rooting depth and moderately high available soil water, although the rooting depth may be limited by poor aeration during wet periods due to the poor drainage and slow subsoil permeability. Texture is variable, with layered texture profiles common, but there is always at least one horizon with silty clay texture and topsoil clay content is 30-60%. The soils are typically stone free, although the moderately deep phase will have gravel between 45 and 90cm depth.

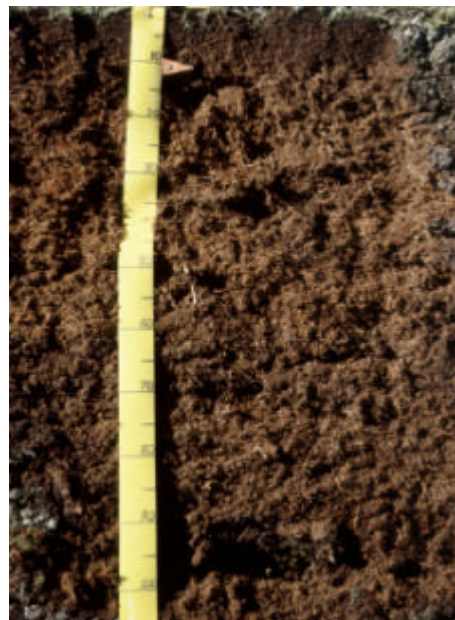
Otanomomo profile

Otanomomo soils occupy about 14,300 ha scattered throughout the lowlands of Southland. They are peat soils formed in weakly to moderately decomposed organic material. Otanomomo soils typically occur as raised bogs (up to 6m deep) overlaying fine alluvium and gravel, and the peat bogs vary in size from a few metres across to hundreds of hectares. The soils have very poor drainage and are extremely acid, which severely restricts the growth of most crops. Many peat swamps have only been developed around the edges, with areas of deeper peat partially or not developed, and are now used for casual pastoral grazing or are included in the conservation estate. Climate varies according to location.

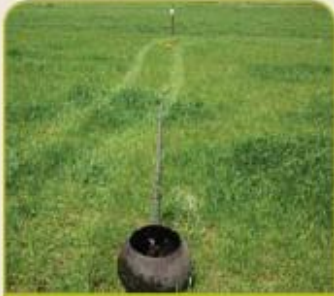
12. Line up

Line up pod line with markers on the fence. If no markers avoid cross over spray approx. 25m

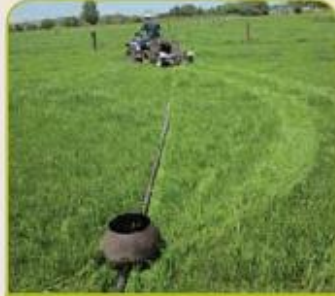
13. Tow hose

Once line is in place unhook and go to next line. Move all lines. Repeat until lines have been moved

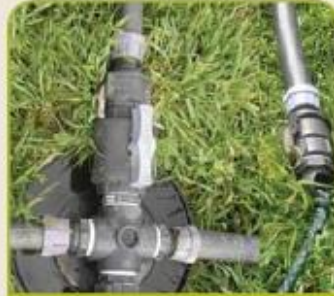
14. Connect cam

Connect cam locks and move caps and towing systems to end of each line if at wrong end.

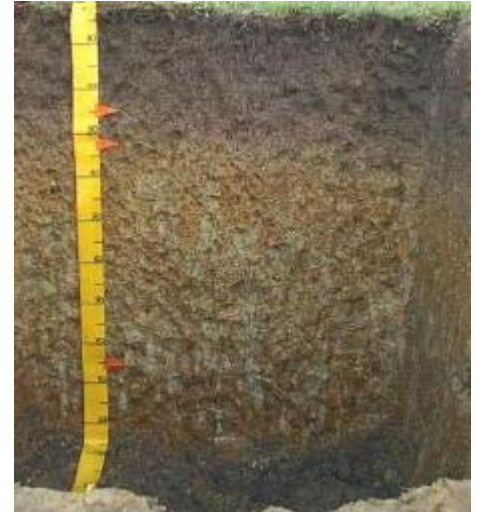
Braxton profile

Braxton soils have a deep rooting depth and high available soil water, although the rooting depth may be limited by poor aeration during wet periods due to the poor drainage and slow subsoil permeability. Mottles occur in all horizons – another indication of poor drainage. Texture varies between heavy silt loam and silty clay in the subsoil, and silt loam topsoil clay

content is 22–30%. The soils are typically stone-free, although the moderately deep phase will have gravel between 45 and 90cm depth.

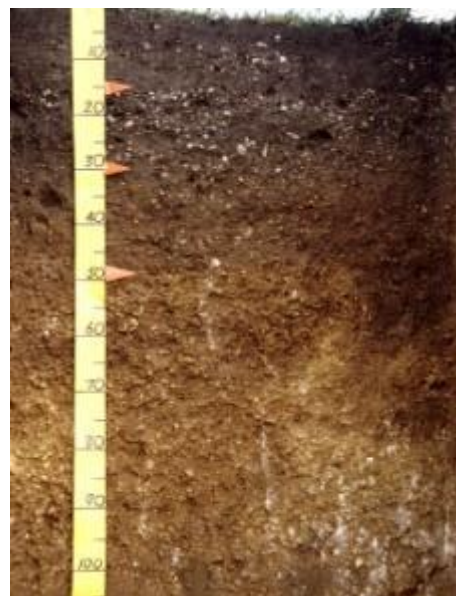
Pebbly Hills profile

Pebbly Hills soils have a slightly deep rooting depth and moderate plant available water, and are limited by the subsoil gravel. The soils are well drained, with good aeration in upper horizons that decreases with depth, and the subsoil is slowly permeable. Textures are silt loams, grading to sandy loams in the gravelly horizons. Topsoil clay content is about 20–30%, and slightly to moderately gravelly. Subsoils are typically very to extremely gravelly.

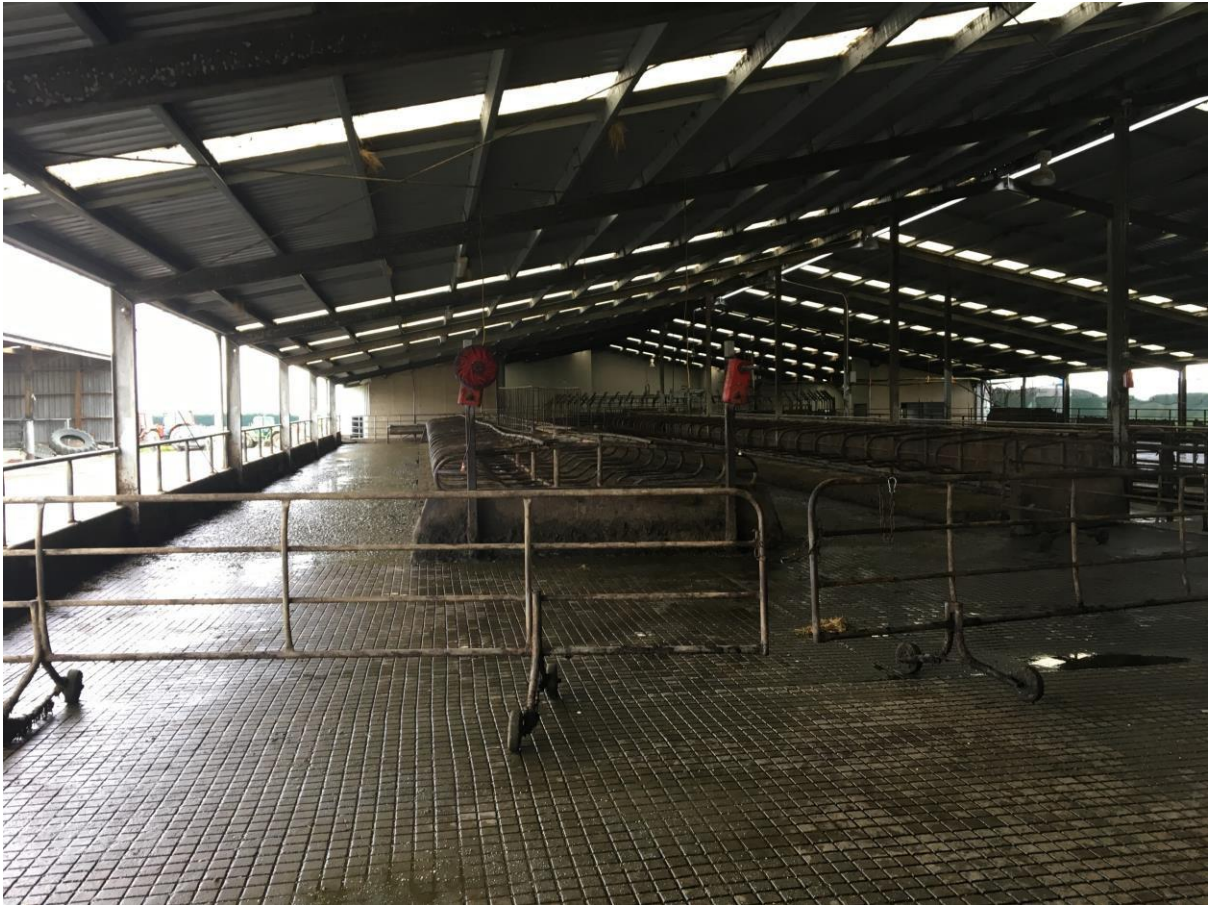
Picture 1: Wintering barn stalls and yard.

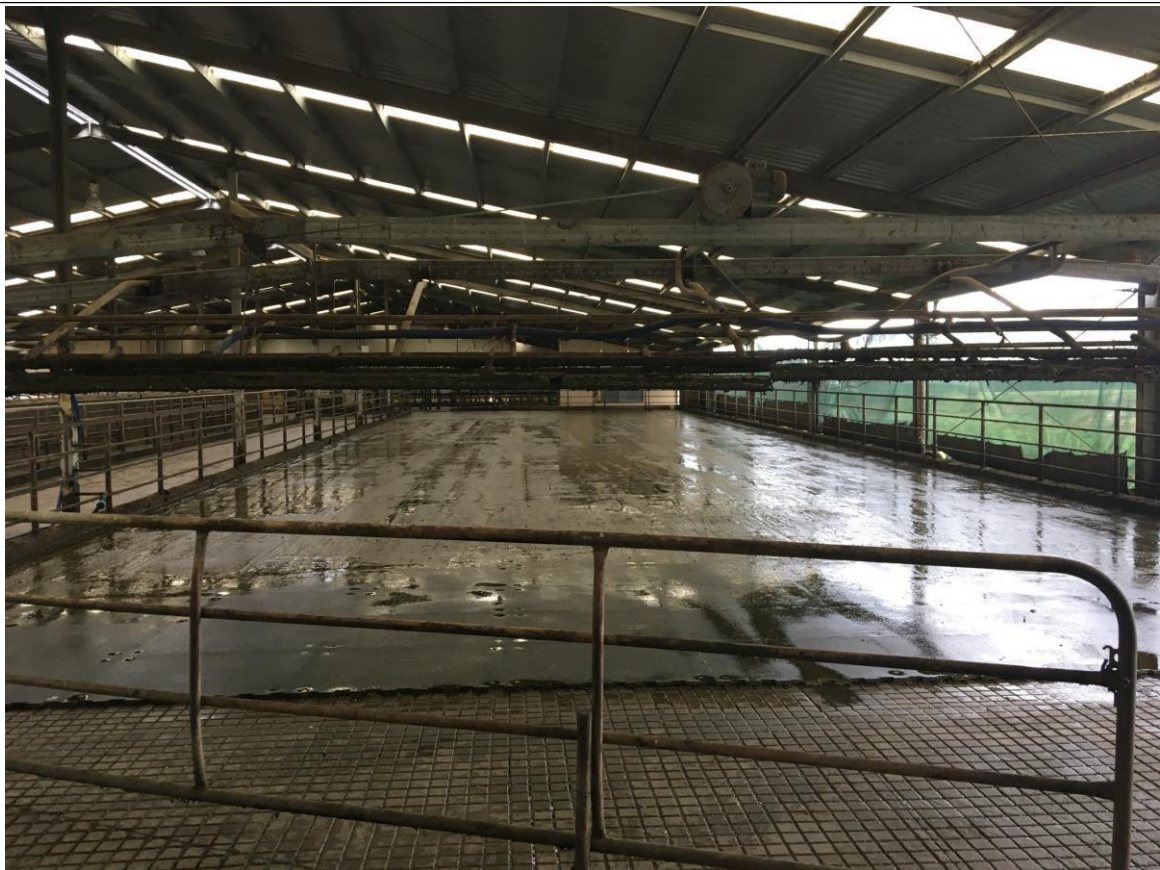
Picture 2: Yard.

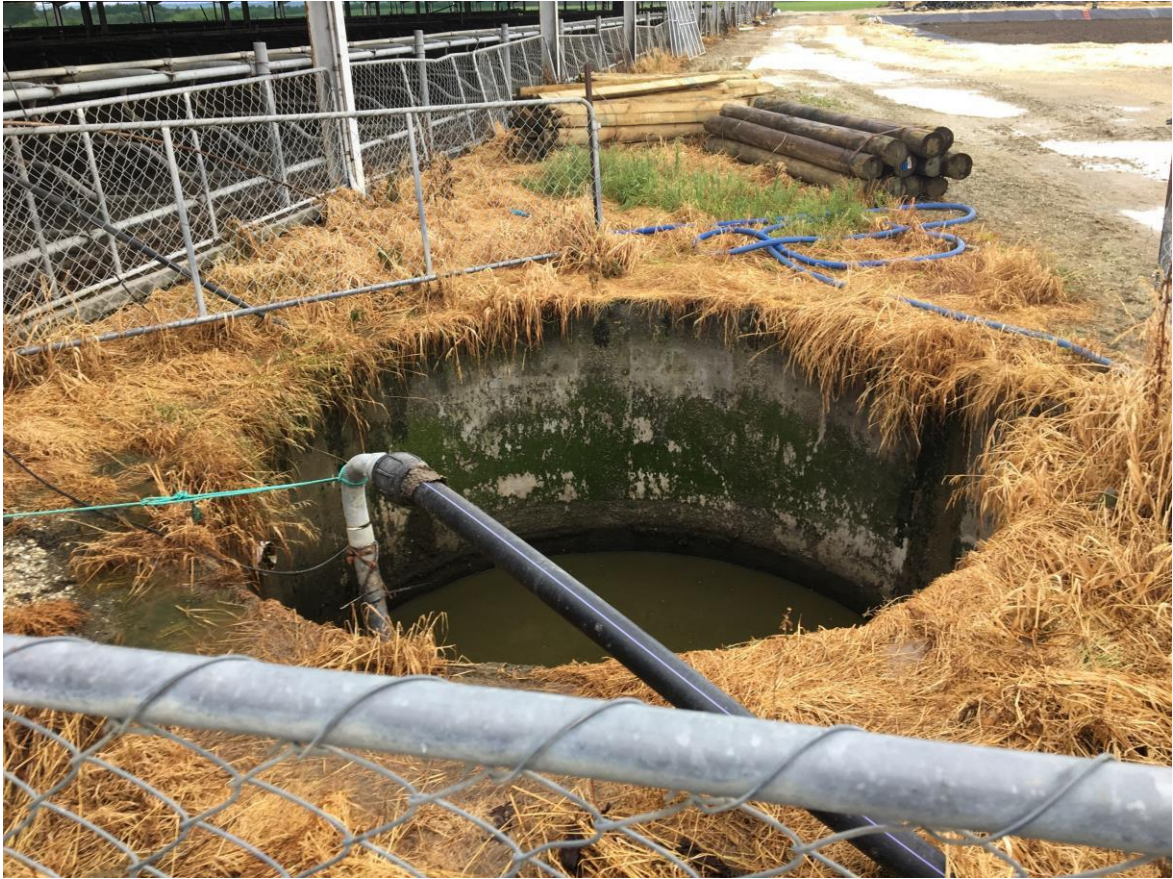
Picture 3: Transfer sump located at the southern entry to the wintering barn.

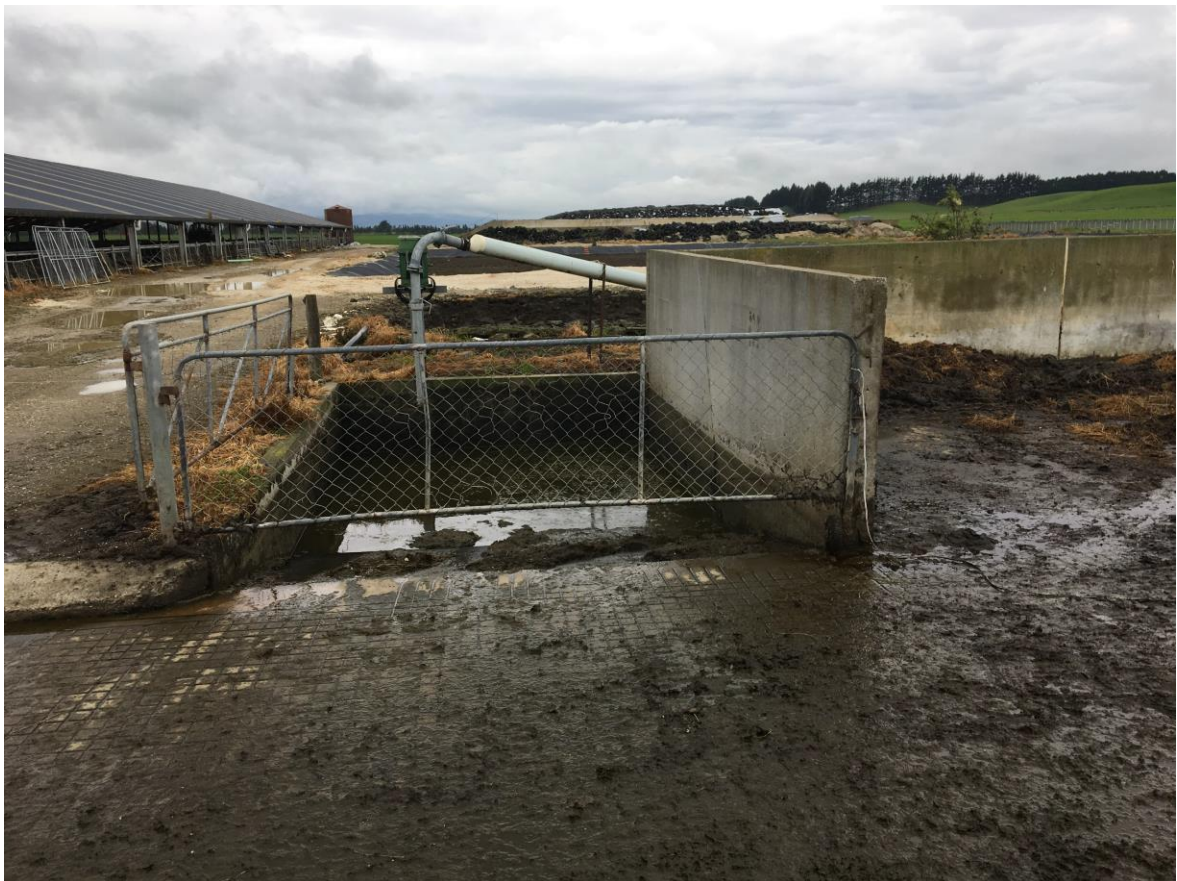
Picture 4: Sand trap located at the southern entry and exit point to the wintering barn.

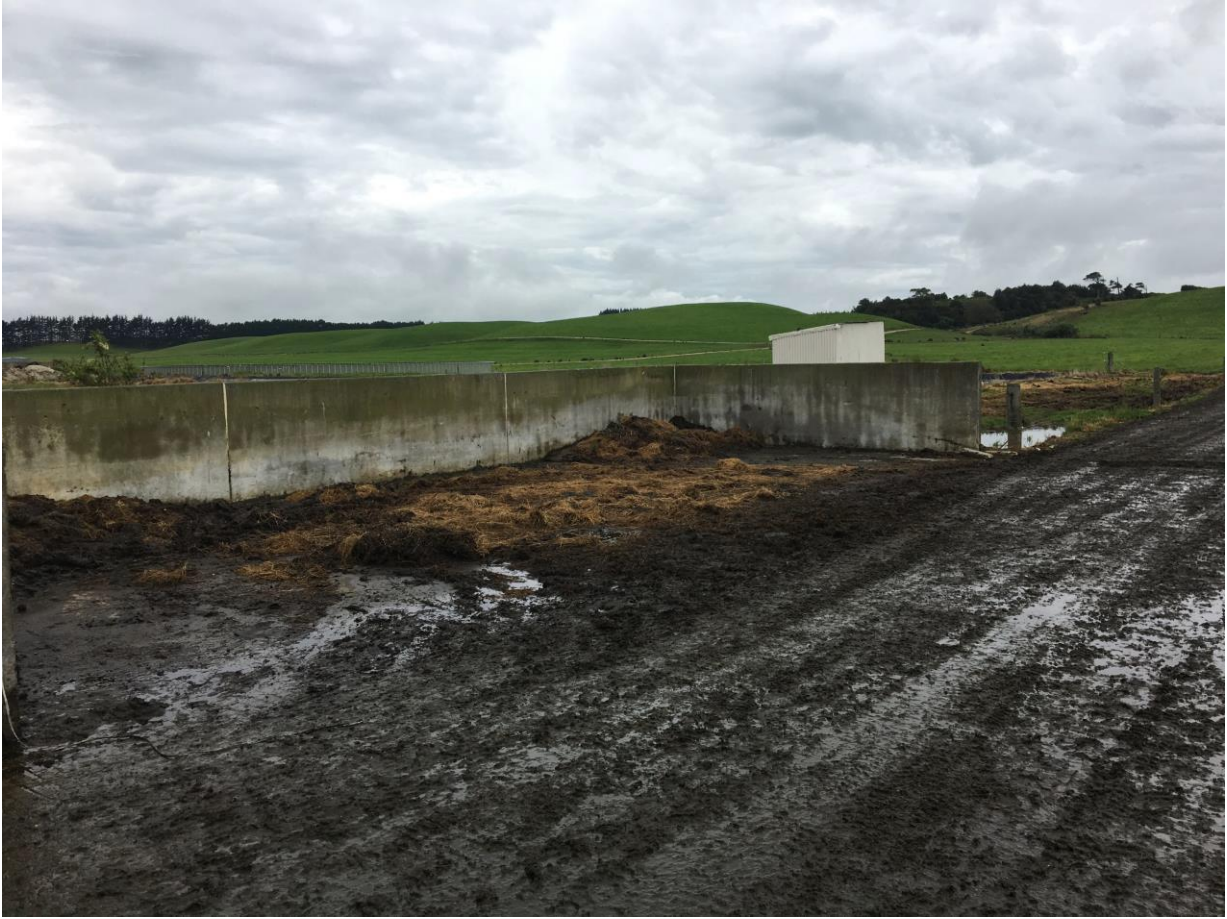
Picture 5: Solids bunker, and liquid effluent flow back into the transfer sump.

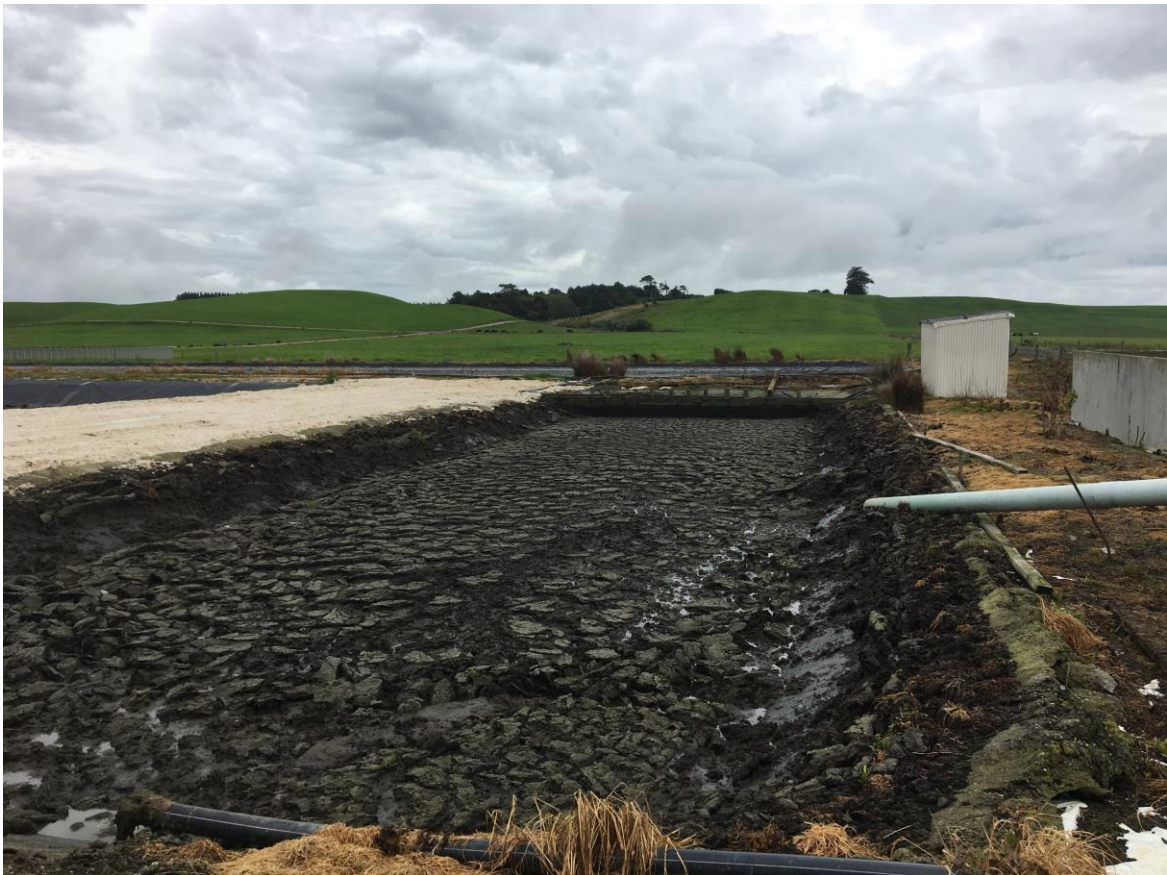
Picture 6: Weeping Wall, solids removed are spread to land as a permitted activity under Rule 38 of the pSWLP.

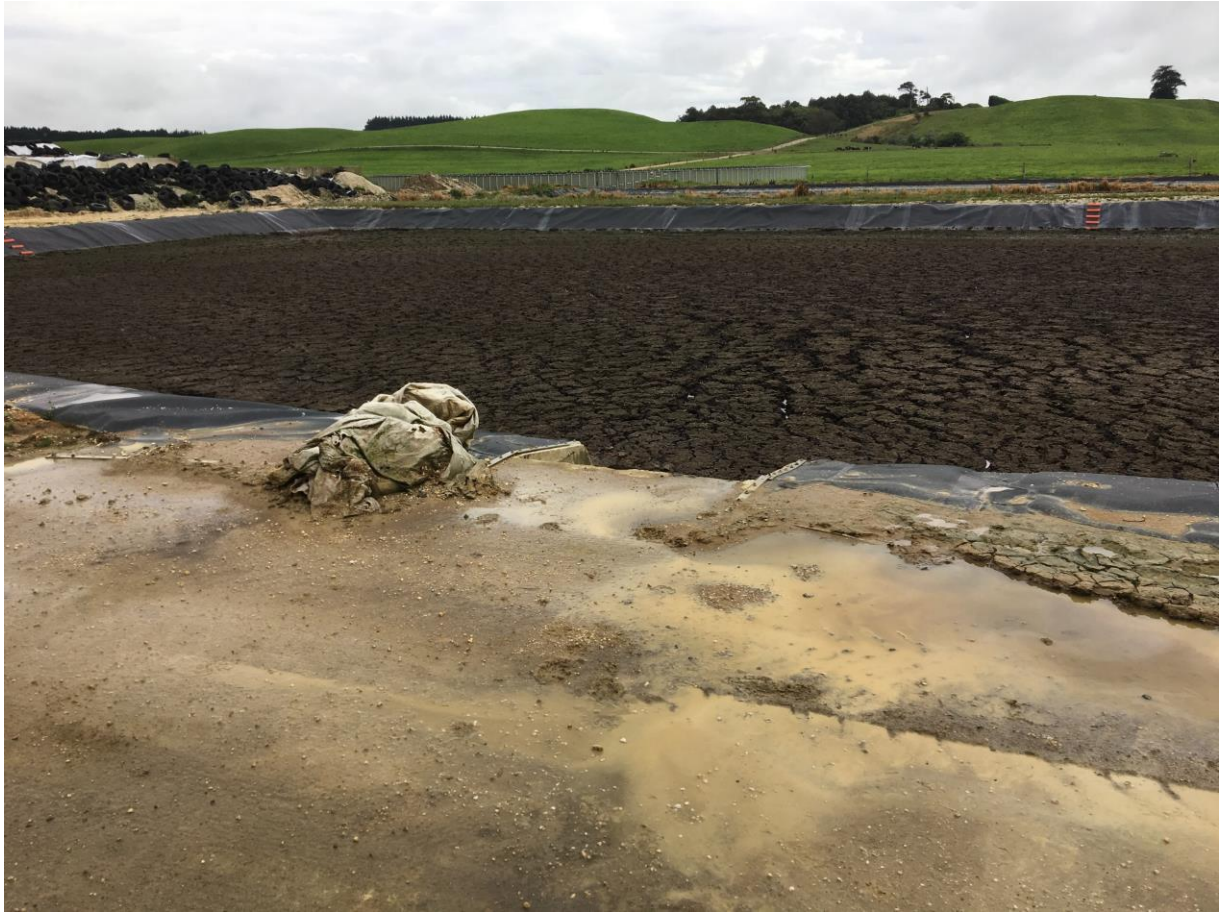
Picture 7: Wintering barn and solid scraping pond, with effluent pond 1 & 2 in the background. Wintering Barn and solids scrapings pond is emptied via slurry tanker.

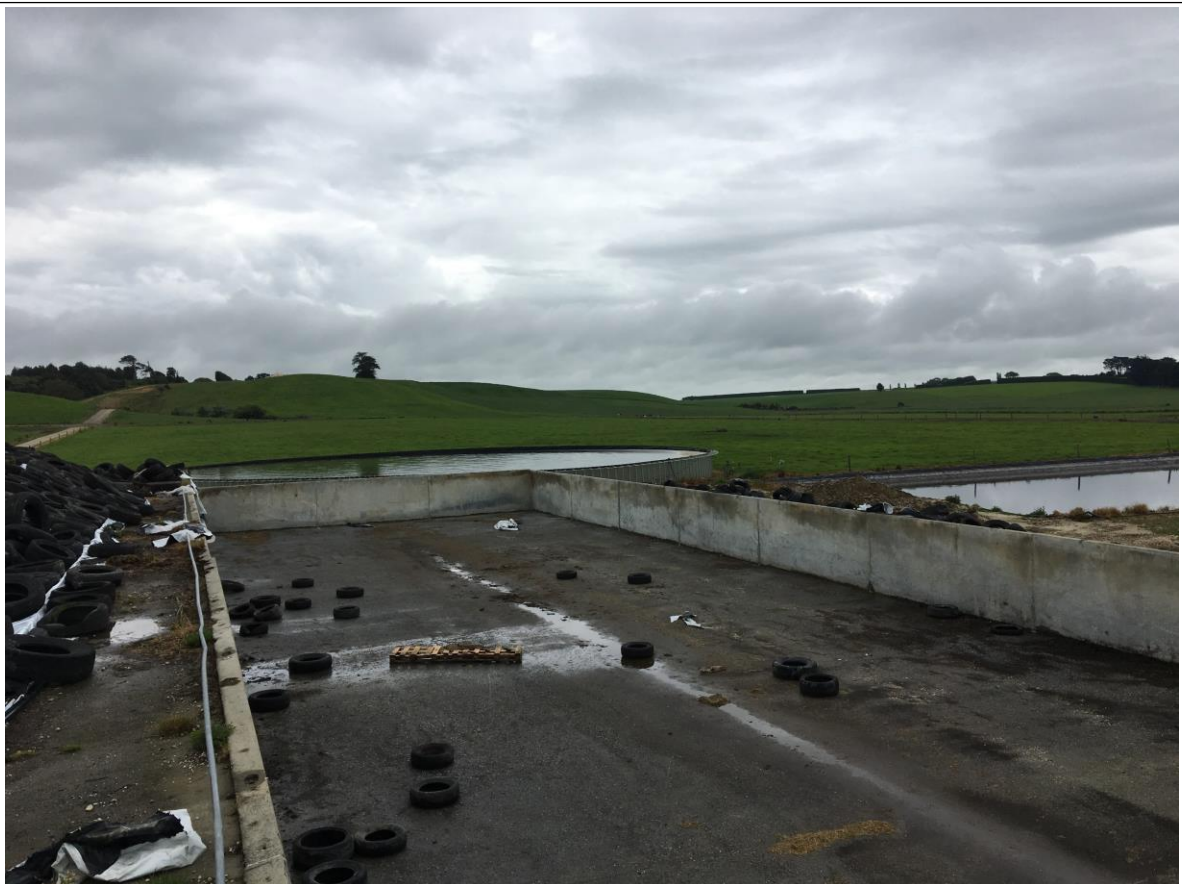
Picture 8: Dual silage pit with drains located throughout which flow to silage leachate sump located on the north eastern end of the shed. Silage leachate is discharge to land as a permitted activity under rule 41 of the pSWLP.

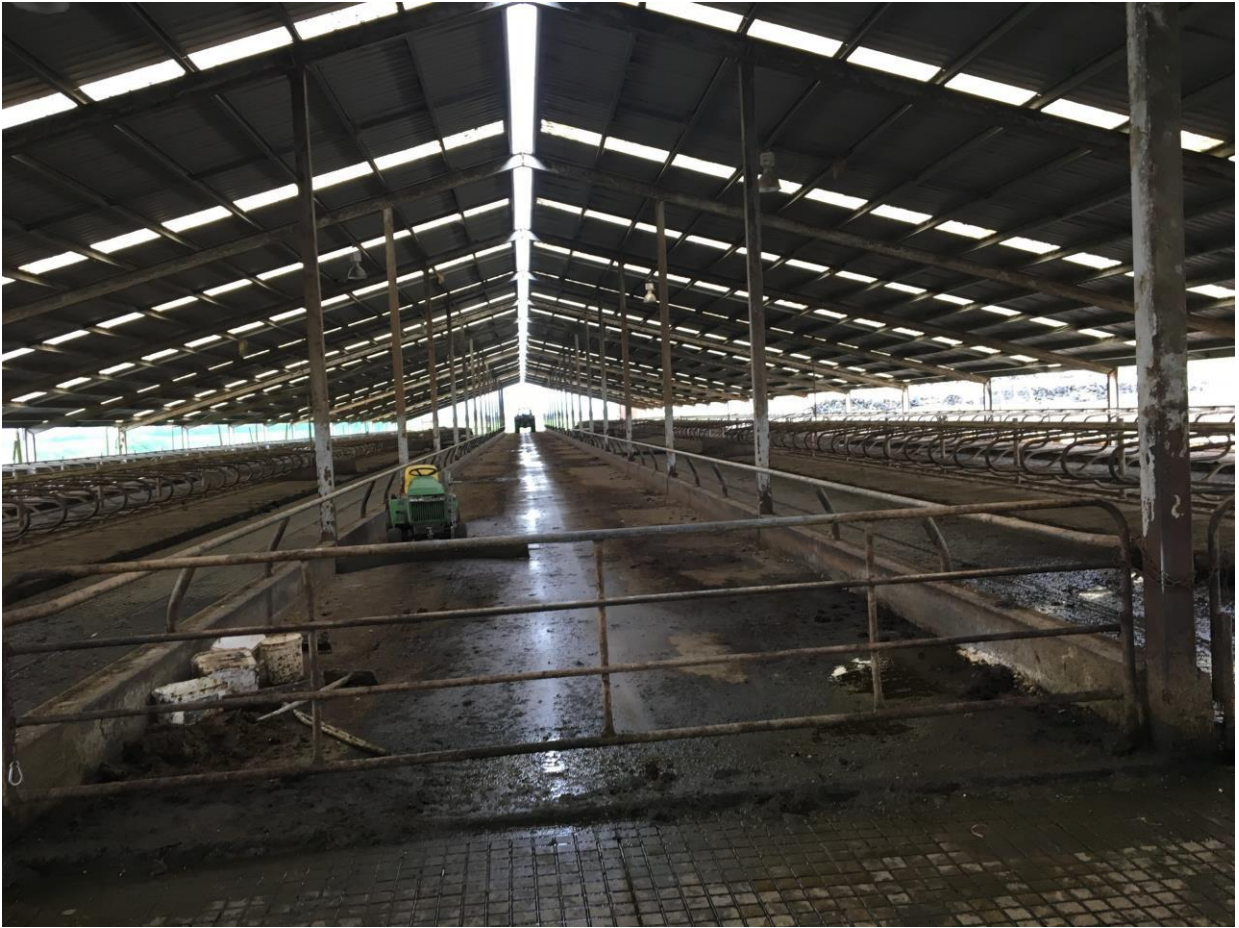
Picture 9: Feeding land and wintering barn stalls.

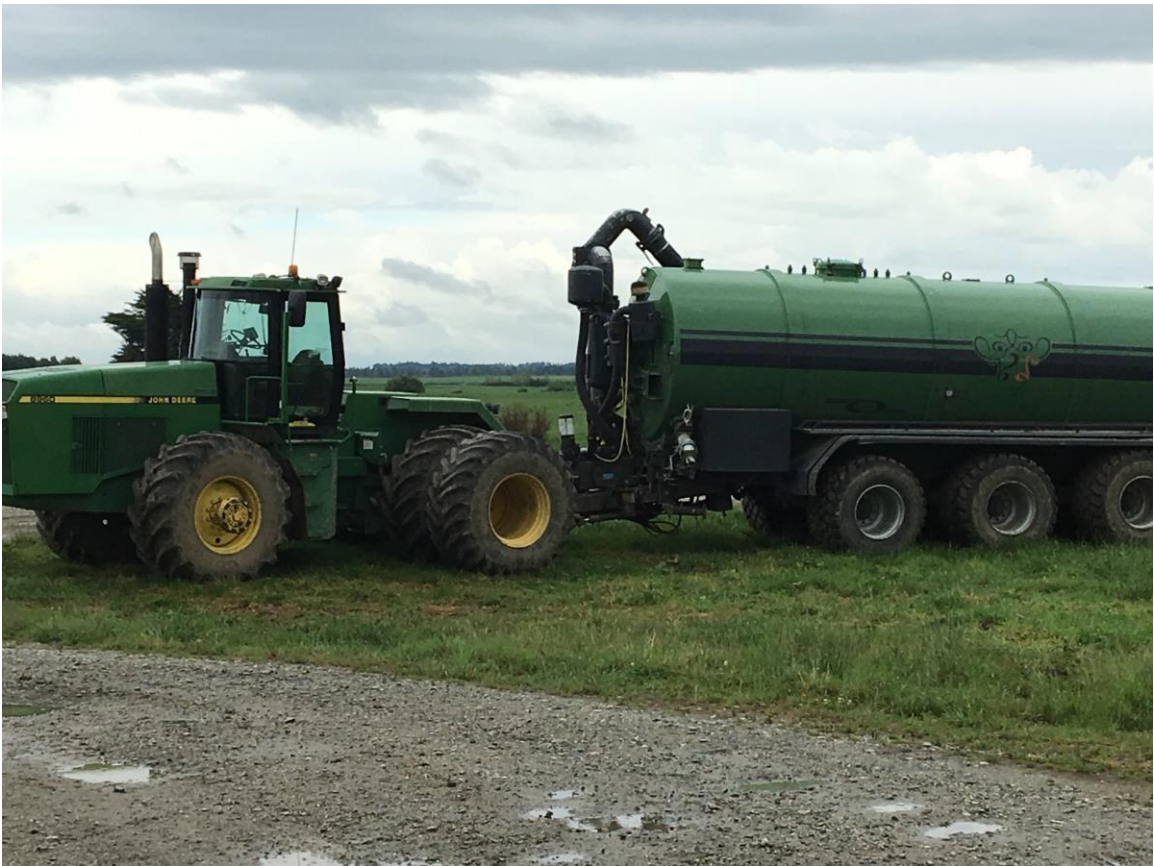
Picture 10: Slurry tanker used on farm.
