Waimatuku Estuary 2018

Fine Scale Monitoring and Macrophyte Mapping

Prepared
for
**Environment
Southland**
June
2018

Ben Robertson and Barry Robertson

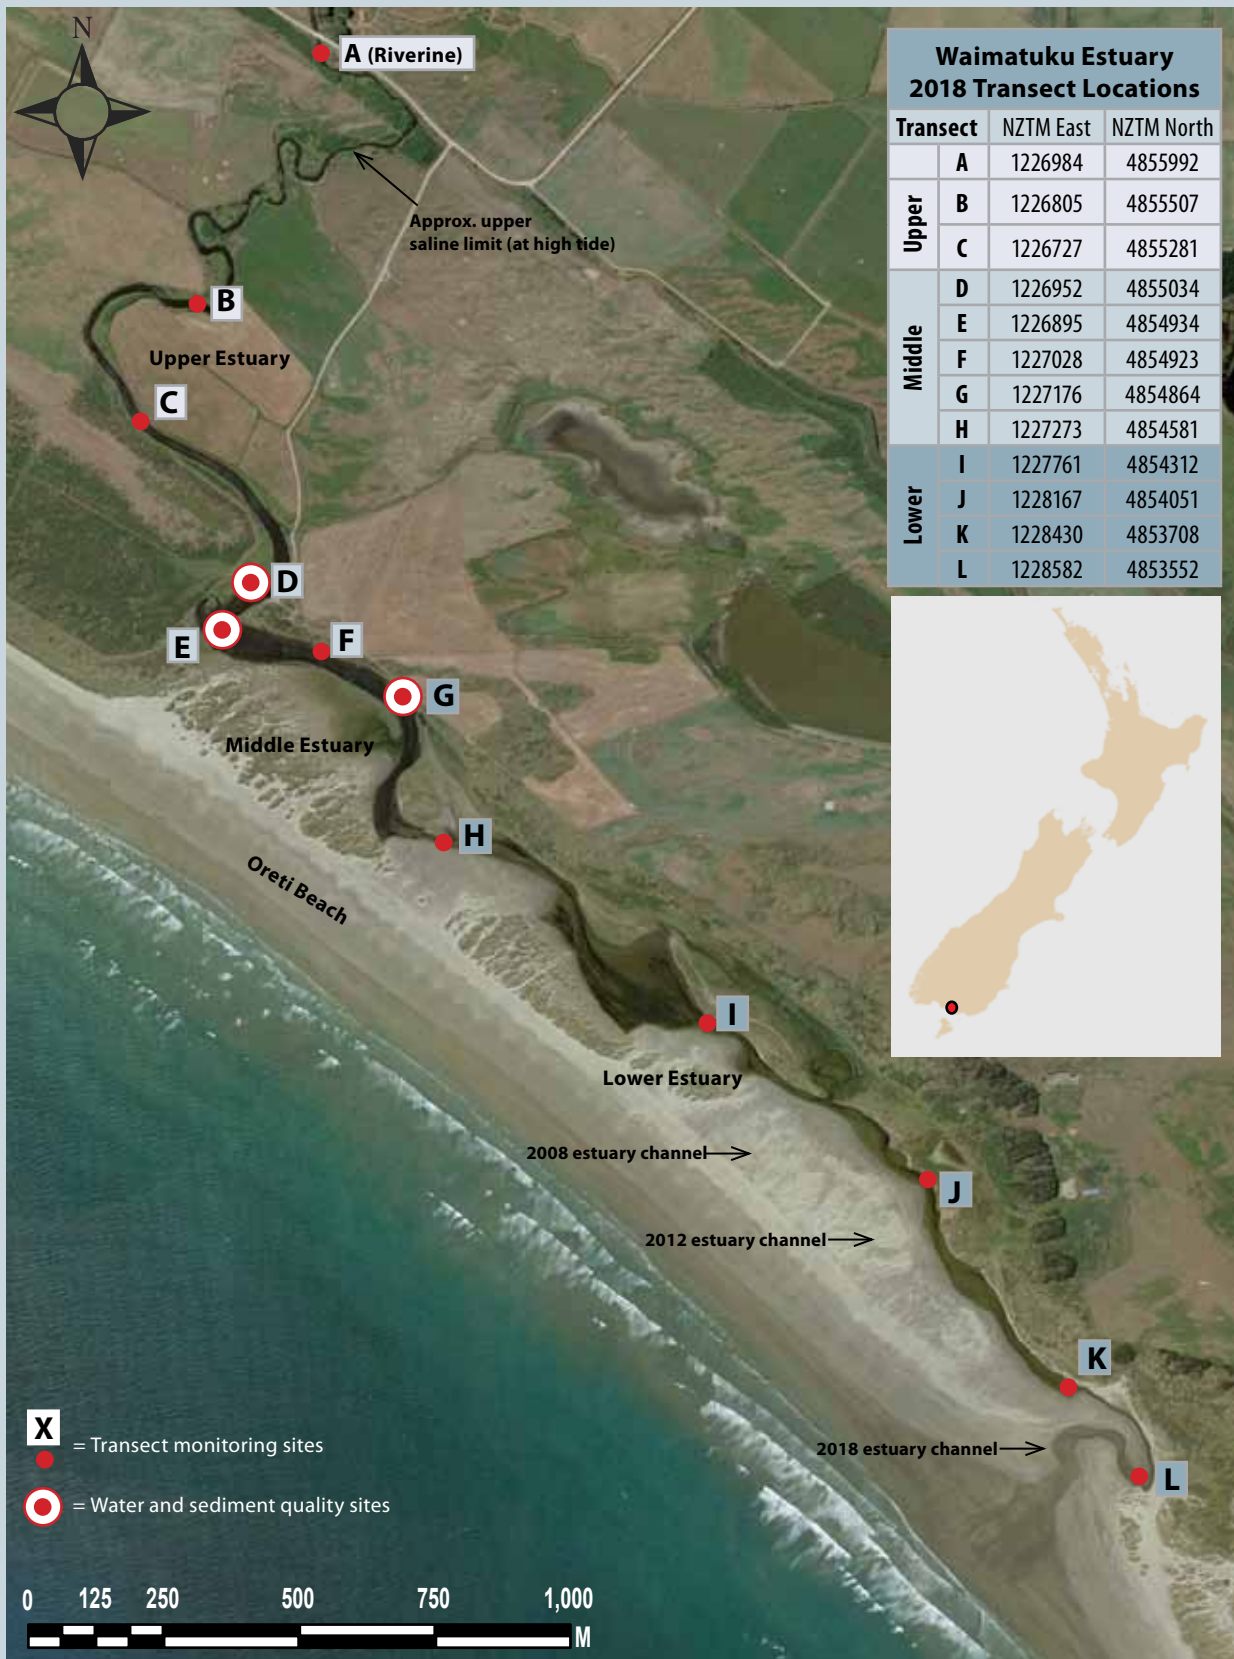
Figure 1. Sampling sites in the Waimatuku Estuary, February 2018. Image source: Google Earth Pro (dated 13 January 2018). Note: Lower estuary sites I, J, K and L were relocated eastward in 2018 to account for estuary mouth migration since 2012.

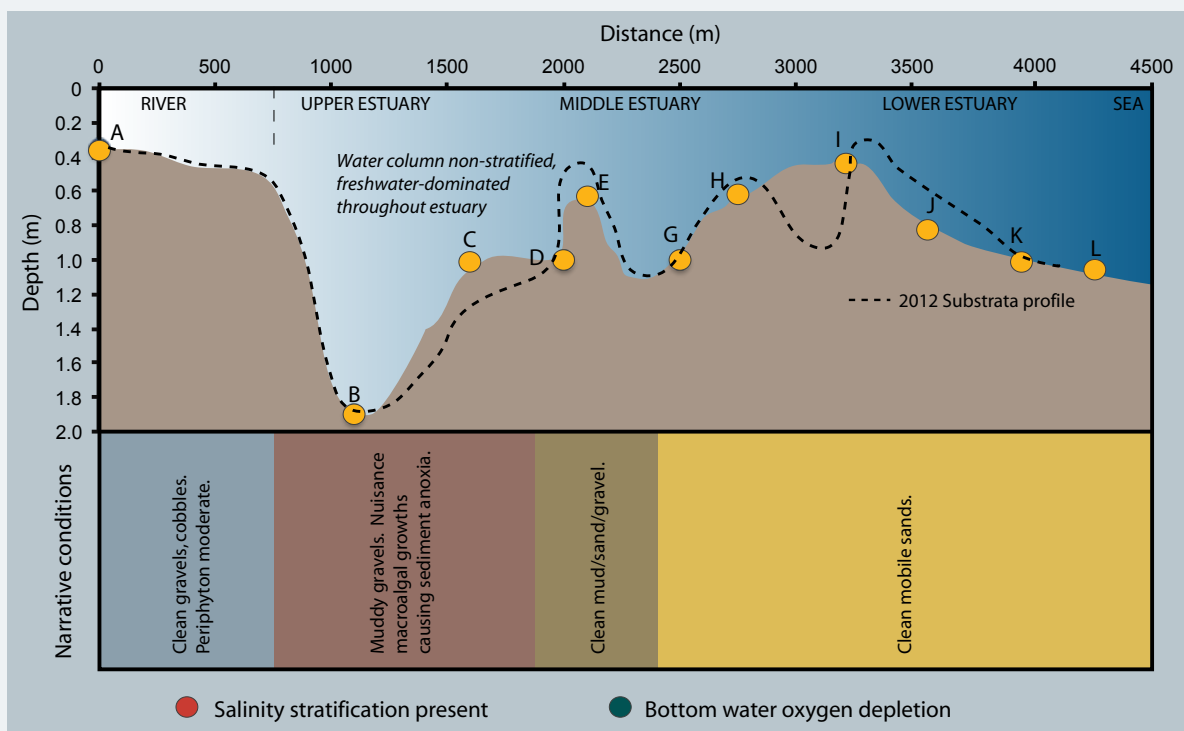
Figure 3. Longitudinal profile (river to sea) of maximum water depth (at high water) and substrate type, 14 February 2018. 2012 substrata profile superimposed to allow for temporal comparison.

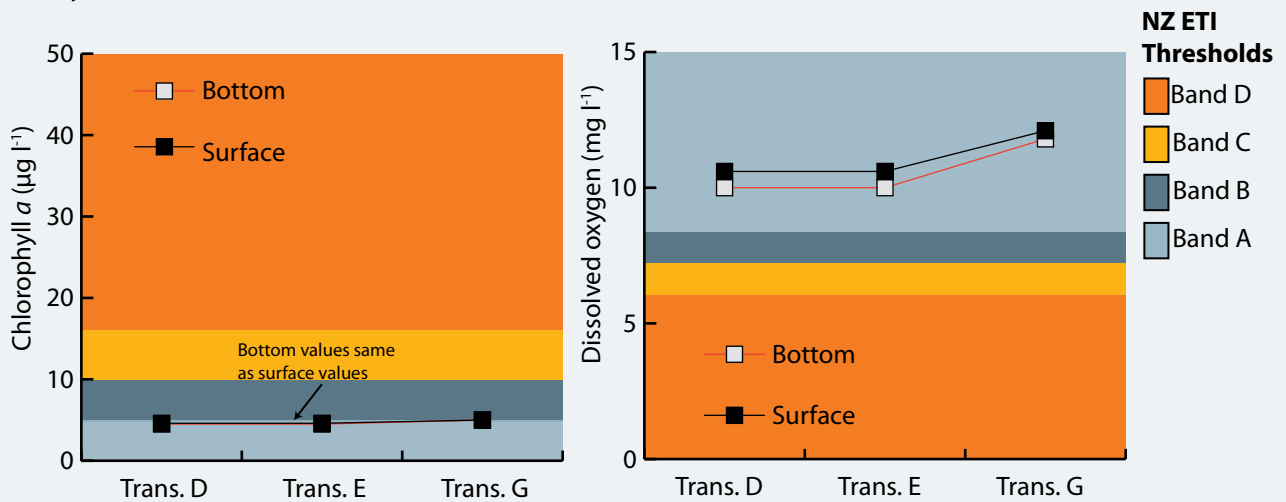
Figure 5. Chlorophyll a and dissolved oxygen concentrations in surface and bottom water ($n = 1$) at three subtidal channel sites, Waimatuku Estuary, 14 February 2018.

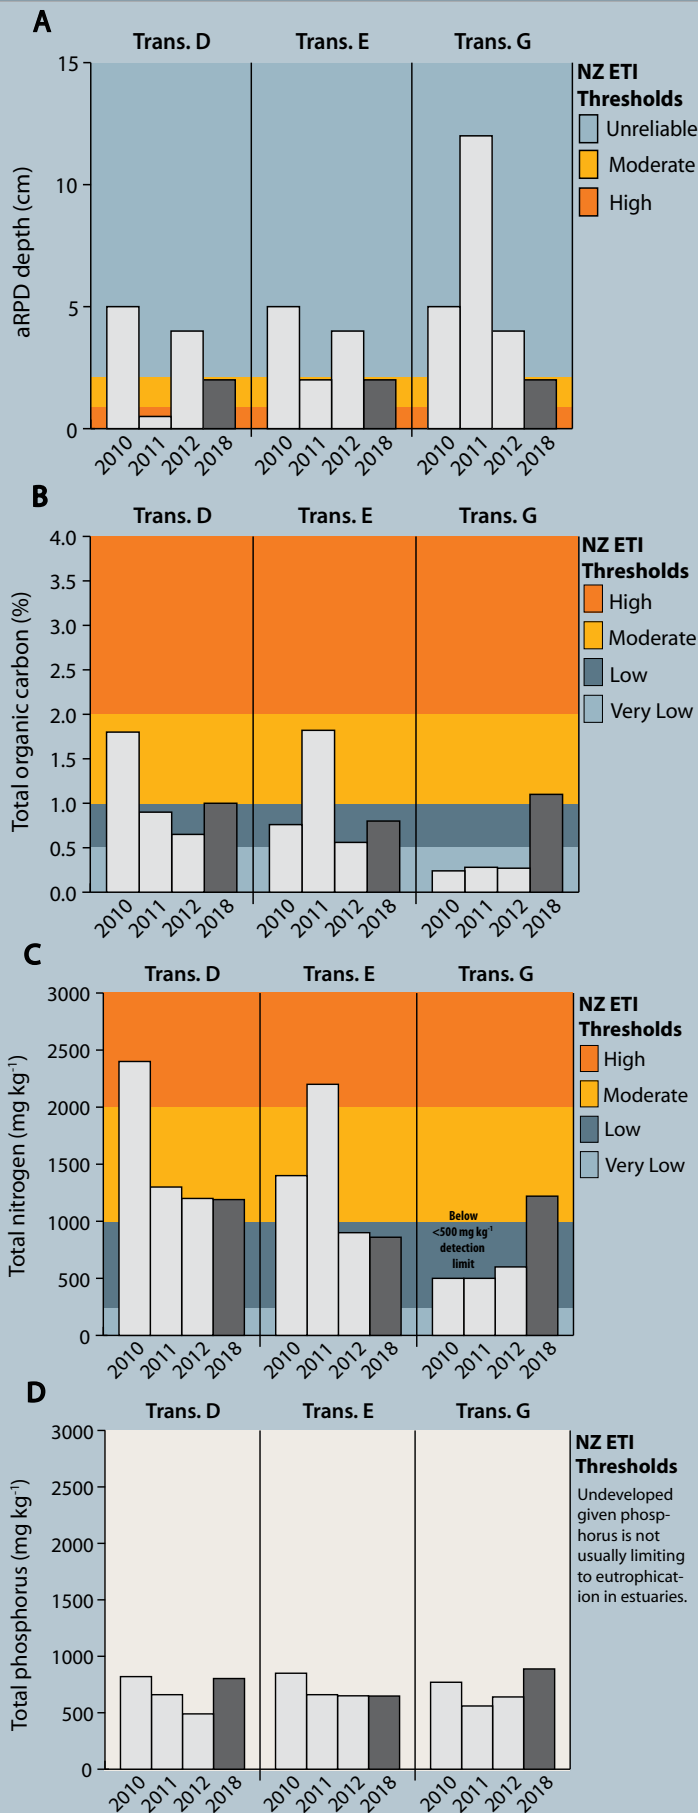
Figure 7. Sediment apparent Redox Potential Discontinuity (aRPD) (A), total organic carbon (B), total nitrogen (C), and total phosphorus (D) at three proximate mid-estuary transect stations (composite sample, $n = 1$), Waimatuku Estuary, Feb 2010, 2011, Jan 2012 and Feb 2018.

Apparent Redox Potential Discontinuity (aRPD) The depth of the aRPD zone provides a coarse indication of the level of sediment oxygenation. The results (Figure 7A, Table 3), showed that the 2018 aRPD depth at the Waimatuku sites was ~1-3 cm at all sites, and therefore the sediments in the mid-estuary were likely to be moderately oxygenated. Although variable through time, there was no significant difference between 2018 aRPD ratings and those measured in previous baseline years (ANOVA $p > 0.05$; Appendix 4). Such temporal variability in aRPD values indicate the changeable conditions often experienced in tidal river estuaries where both river flow and tidal intrusion have a major influence on estuary condition. As a result, the benthic community in the middle estuary was likely to be transitional and dominated by organisms and plants tolerant of moderate organic enrichment.

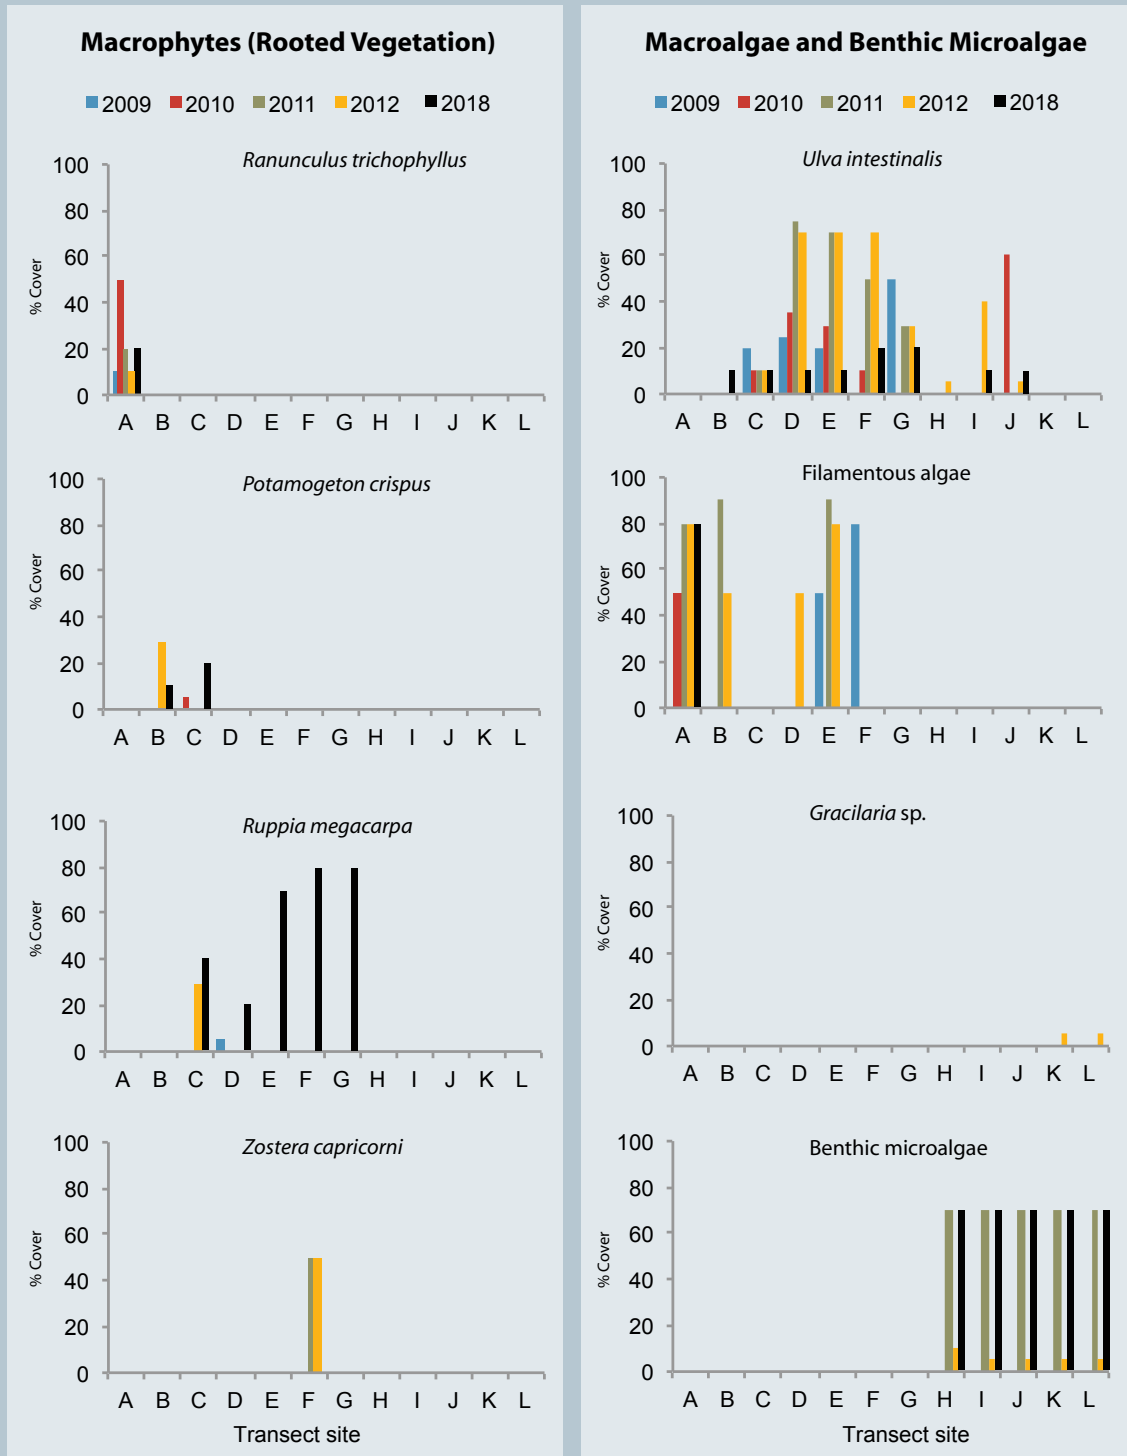
Based on representative benthic sampling at each transect site on 14 February 2018, as in baseline years (including 2009), the lower Waimatuku Stream and the upper-middle Waimatuku Estuary supported growths of rooted aquatic macrophytes (Figure 8). *Ranunculus trichophyllus* (water buttercup, see Figure 9) was relatively abundant (20 % cover) in the clear, 0-0.5 m deep, flowing freshwater of the lower Waimatuku Stream Site A, growing in 1 m long strands in the filamentous algal-dominated gravel bed, while *Mimulus guttatus* (monkey musk) was common along the margins.

Figure 8. Percent cover of aquatic vegetation at 12 discrete Waimatuku estuary transects 2009-2012 and 2018.

Ruppia was present throughout the upper and middle estuary as occasional dense patches in the 0-1 m depth range, indicating expansion into middle estuary sites (D, E, F and G) since 2012. This expansion is likely to continue given what occurs in similar situations (e.g. Wilson Inlet, an Australian ICOLL type estuary; Boardman 1994). That is, brackish conditions favour germination and once established abundant and potentially nuisance growths occur favoured by low turbidity and elevated external nutrient levels. In some situations (e.g. Waiau Lagoon, Southland) other brackish tolerant macrophytes can also become highly abundant (e.g. *P. crispus*). *P. crispus*, present at 0-1 m depths (10-20 % cover at Sites B and C), was also highly abundant (80-100 % cover) in upper-middle Waimatuku Estuary margins (i.e. adjacent to discrete monitoring sites) where it was often associated with surface growths of *Azolla* sp. (5 % cover) and the nuisance macroalgae *Ulva intestinalis* (60-70 % cover) (see top photo overleaf). It is important to note that while rooted macrophytes are highly beneficial at low-moderate densities (i.e. through stabilising/oxygenating sediments, providing food and habitat for other biota, buffering catchment nutrients, limiting production of ecologically less functional algae), nuisance-level growth can result in negative impacts on the amenity of the estuary (i.e. primarily through reduced oxygenation of sediments and overlying waters driven by plant respiration and/or decomposition processes, and limiting boat use through motor snagging) (Boardman 1994). Seagrass (*Zostera capricornia*) was not observed in the estuary in 2018 (Figure 8).

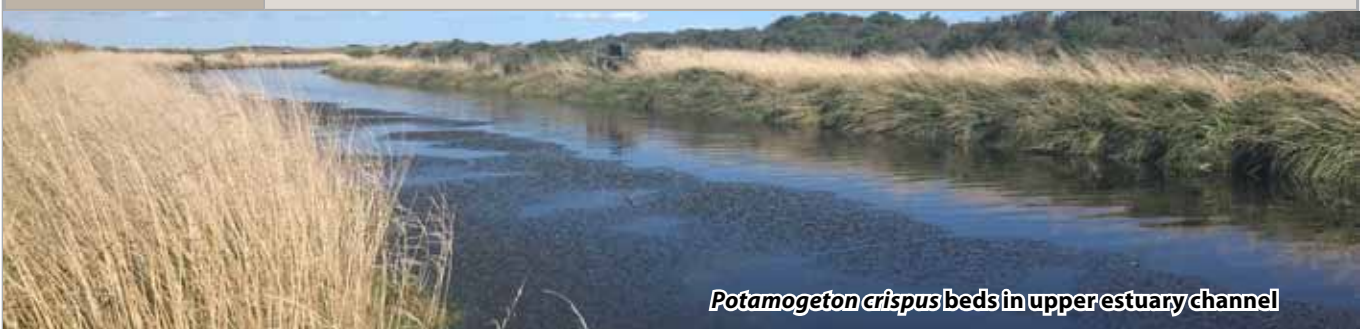
***Potamogeton crispus* (Curly pondweed)** is an introduced species that is tolerant of slightly brackish as well as freshwater. It can survive in low light and low temperatures, and prefers high nutrient water. It spreads mostly by means of vegetative buds (turions) that germinate in autumn, grow vigorously in spring, and die off in the summer. The decaying plant matter can make the water extremely enriched, encourage nuisance algal mats near the sediment surface, inhibit the growth of native aquatics, and can interfere with boating and other water recreation. These plants germinate in autumn, grow vigorously in spring, and die off in the summer.

Potamogeton crispus beds in upper estuary channel

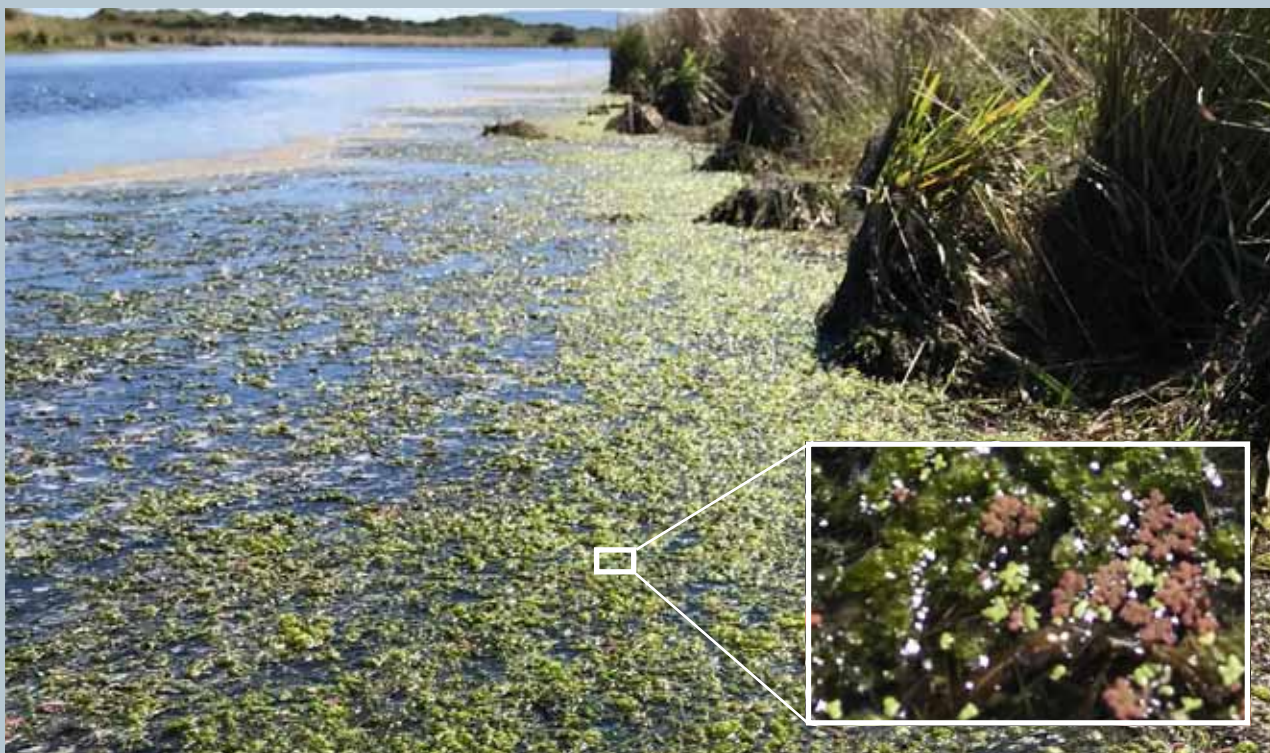
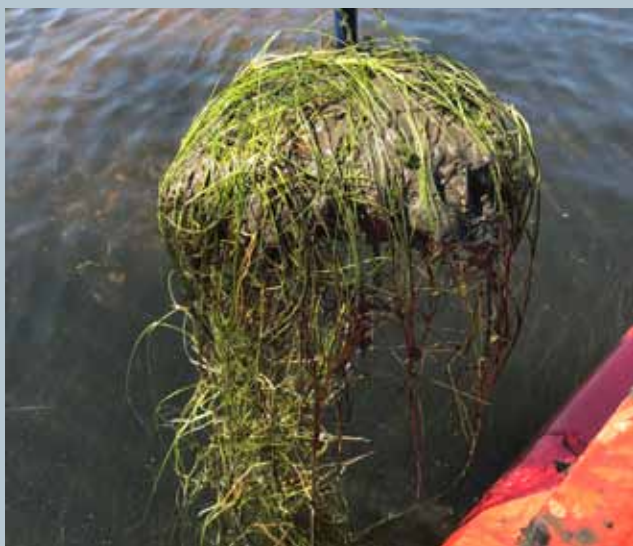
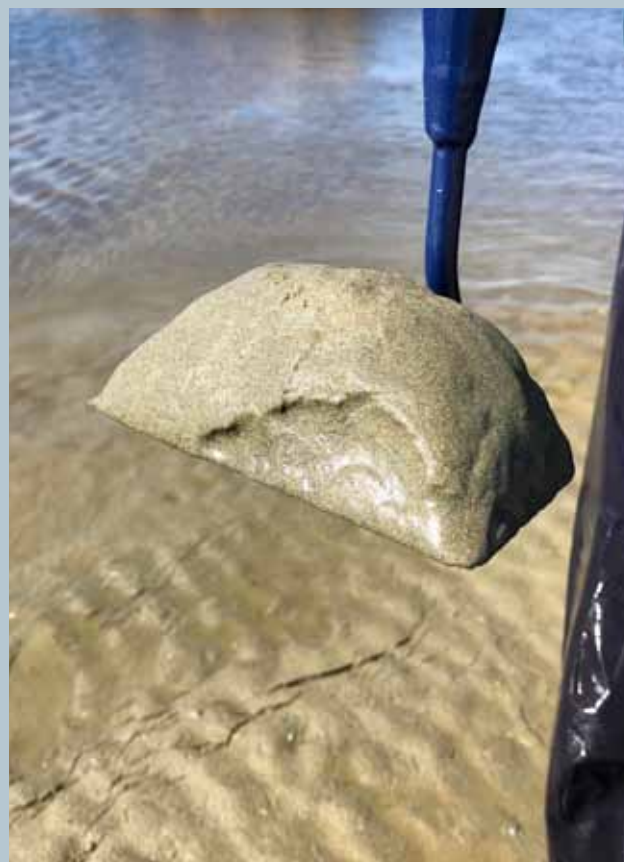
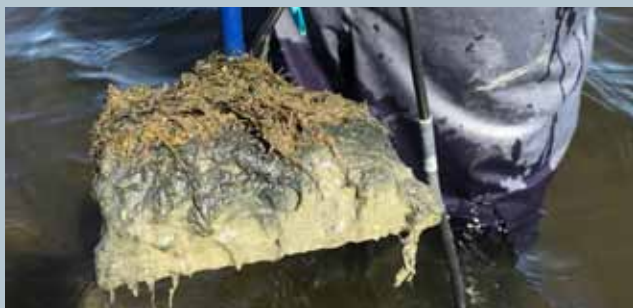
Figure 10. Examples of thick *Potamogeton crispus* beds associated with *Azolla* sp. and *Ulva intestinalis* in middle estuary margins (top), *Ruppia megacarpa* from the middle estuary channel (middle left), and decomposing macrophyte beds underlain by locally anoxic sands (bottom left) and benthic microalgae on sands (right) in the lower Waimatuku Estuary, 14 February 2018.

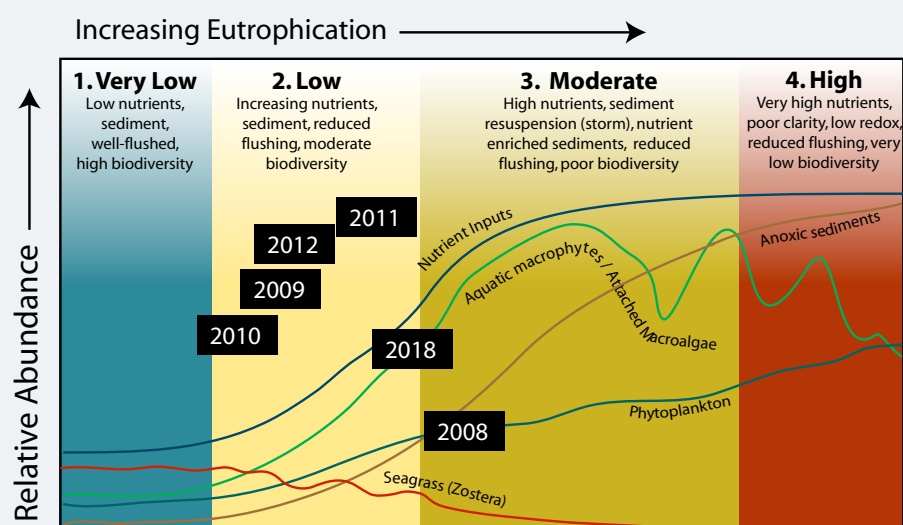
Conceptual representation of response of tidal river estuary with constricted mouth to increased nutrients. 2018 trophic status had deteriorated slightly since 2012, but remained within the range of previous monitoring years.

Figure 11. Waimatuku Estuary - subtidal channel condition and trophic state (2008, 2008, 2010, 2011, 2012 and 2018).
