# Fortrose (Toetoes) Estuary

Broad Scale Habitat Mapping 2012/13

Prepared for  
Environment  
Southland  
October  
2013

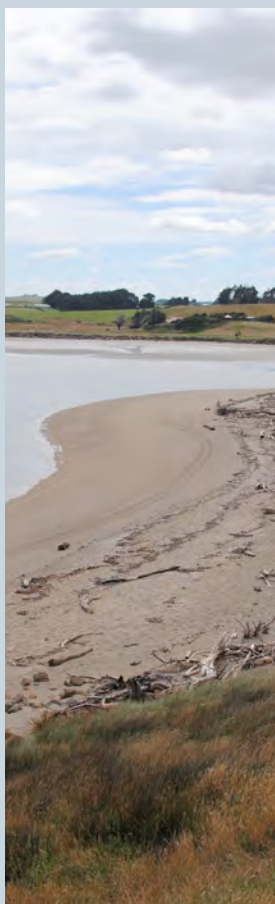
Firm sand near the estuary entrance.

Soft muds on previously sandy tidal flats in the east of the estuary.

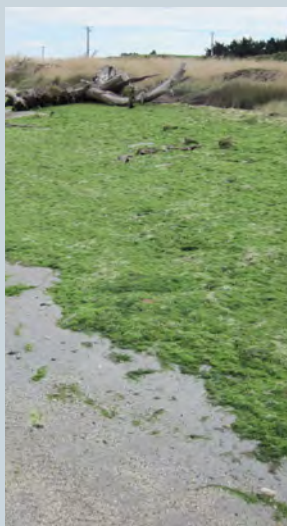
Wind blown accumulation of *Ulva* in front of rushland on the eastern shoreline.

Extensive dense macroalgal cover on the lower intertidal flats near the eastern shoreline.

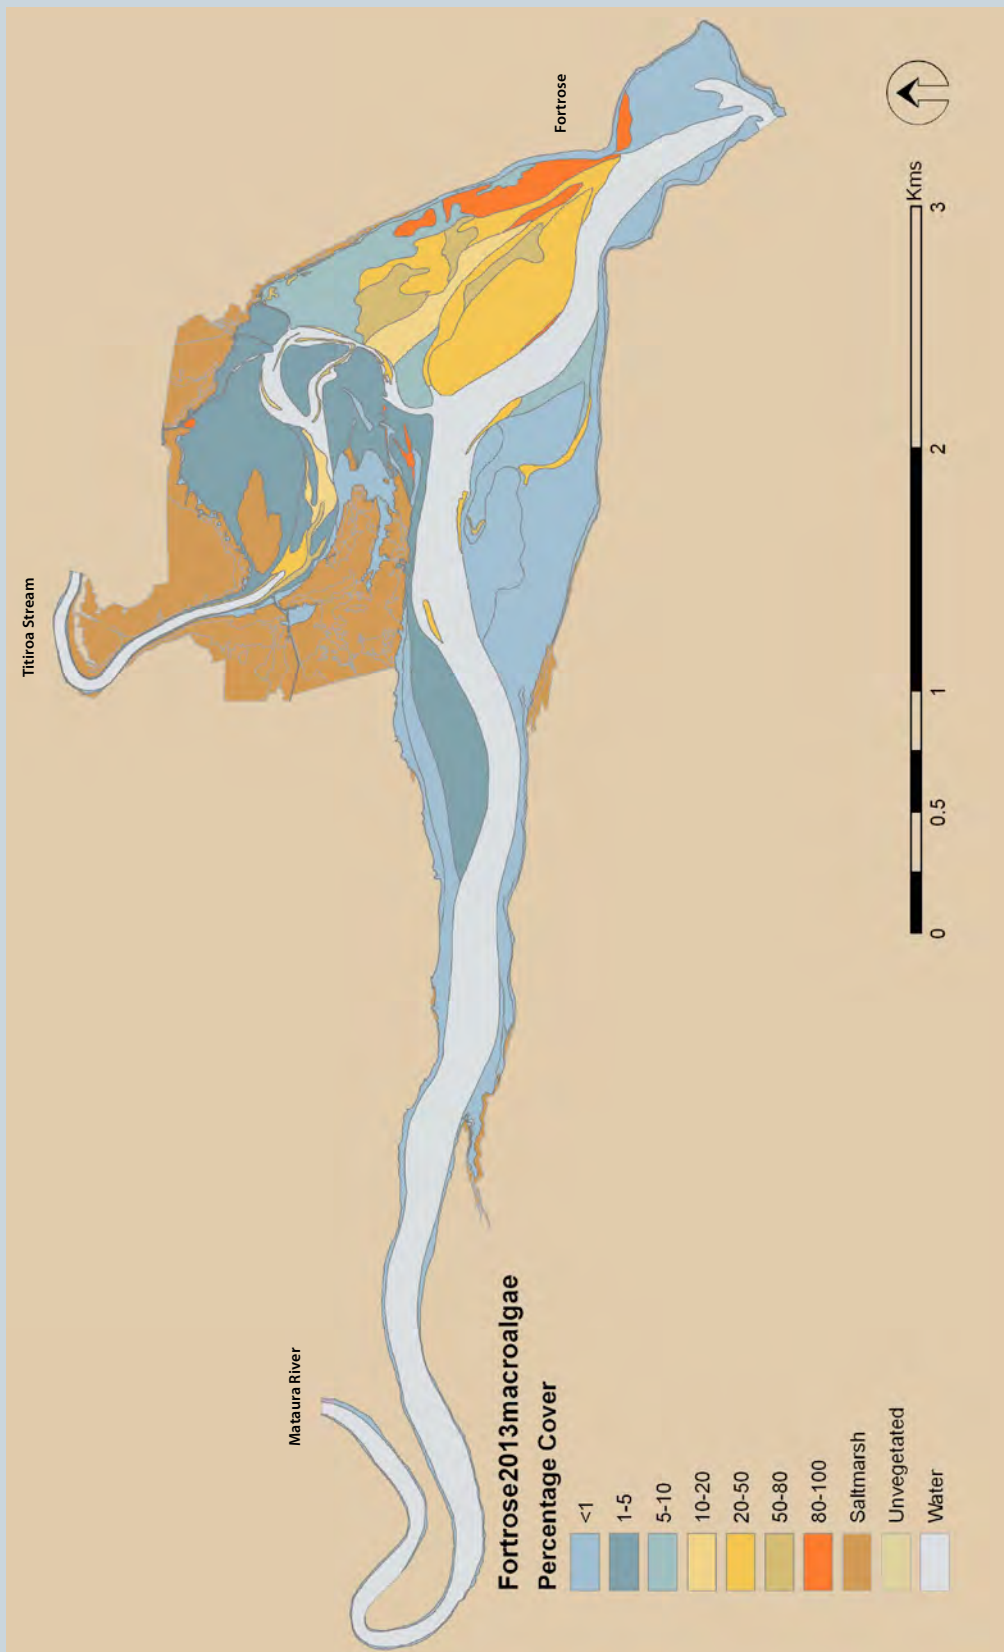
Figure 6. Map of macroalgal cover - Fortrose (Toetoes) Estuary, February 2013.

The Macroalgal Coefficient (MC) for low density cover within the estuary in 2013 was 1.5 (Table 7). This fits a condition rating of "moderate", reflecting widespread low growth across much of the estuary. The high density macroalgal cover was rated as "moderate" with 8% of the estuary experiencing dense (>50%) macroalgal growths.

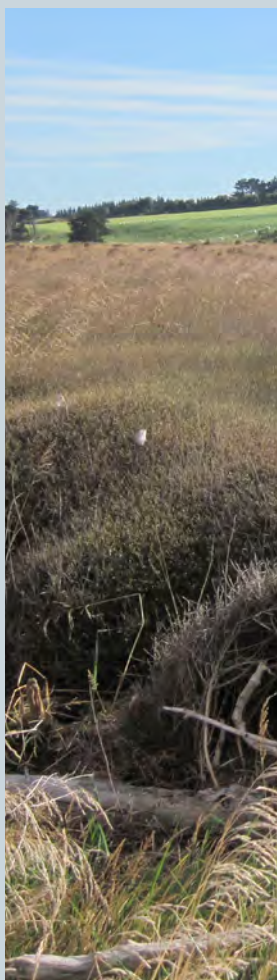
Saltmarsh ribbonwood and tall fescue between the estuary and surrounding pasture near Titiroa Stream.

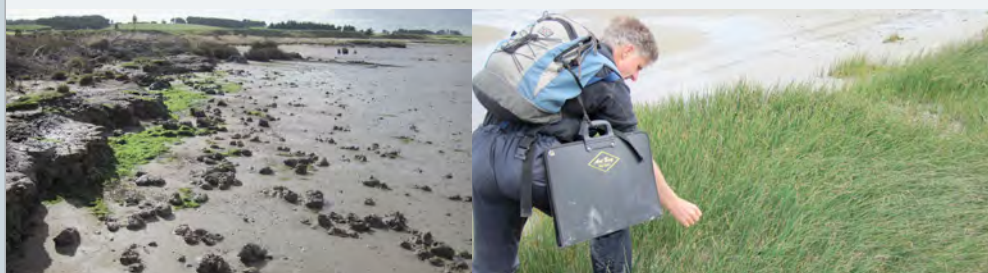
Eroding rushland (left) and sedge beds (right) along the east side of the estuary.

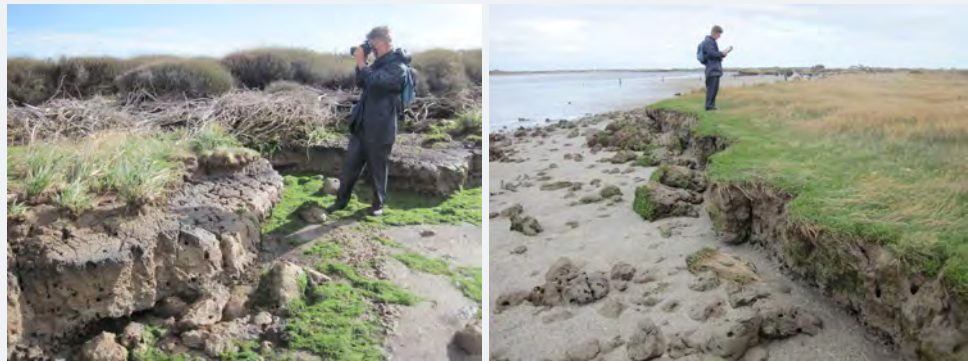
Bank erosion in the east (above left) and west (above right) contributing to minor saltmarsh losses.

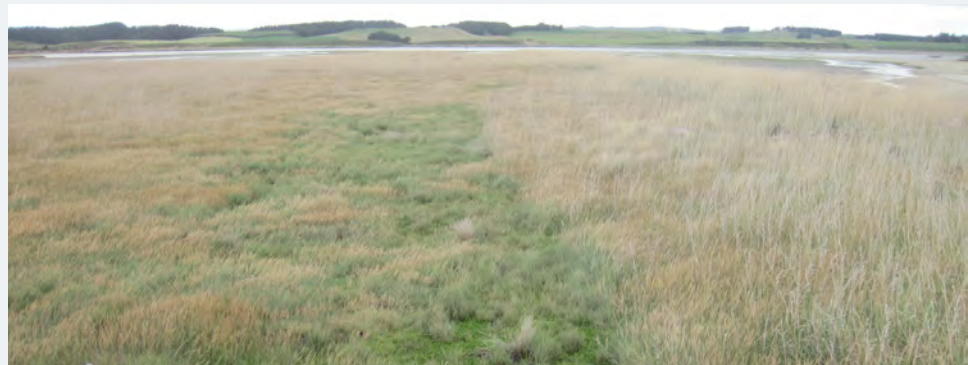
Grassland containing herbfield in the west of the estuary adjacent to the Matura River re-classified from intertidal saltmarsh in 2003 to terrestrial margin grassland in 2013 as it is not tidally inundated.

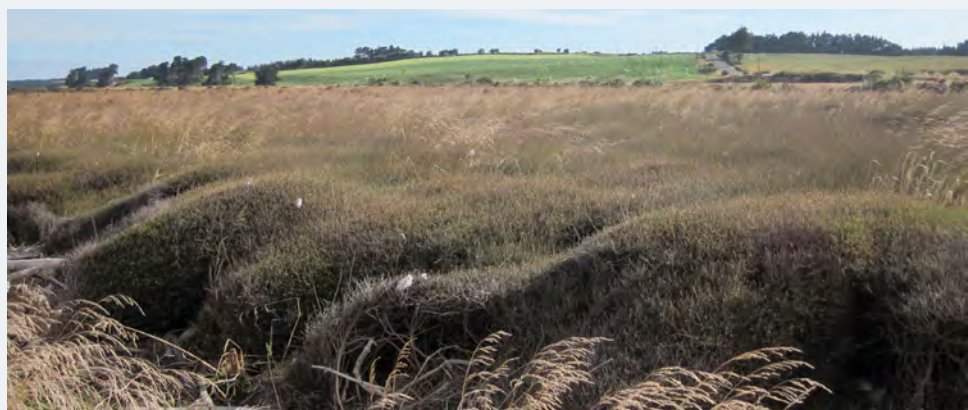
Saltmarsh in the north of the estuary representative of similar areas adjacent to Titiroa Stream added in the 2013 mapping.
