Freshwater Estuary

Broad Scale Habitat Mapping 2007/08

Environment
Southland

December
2008

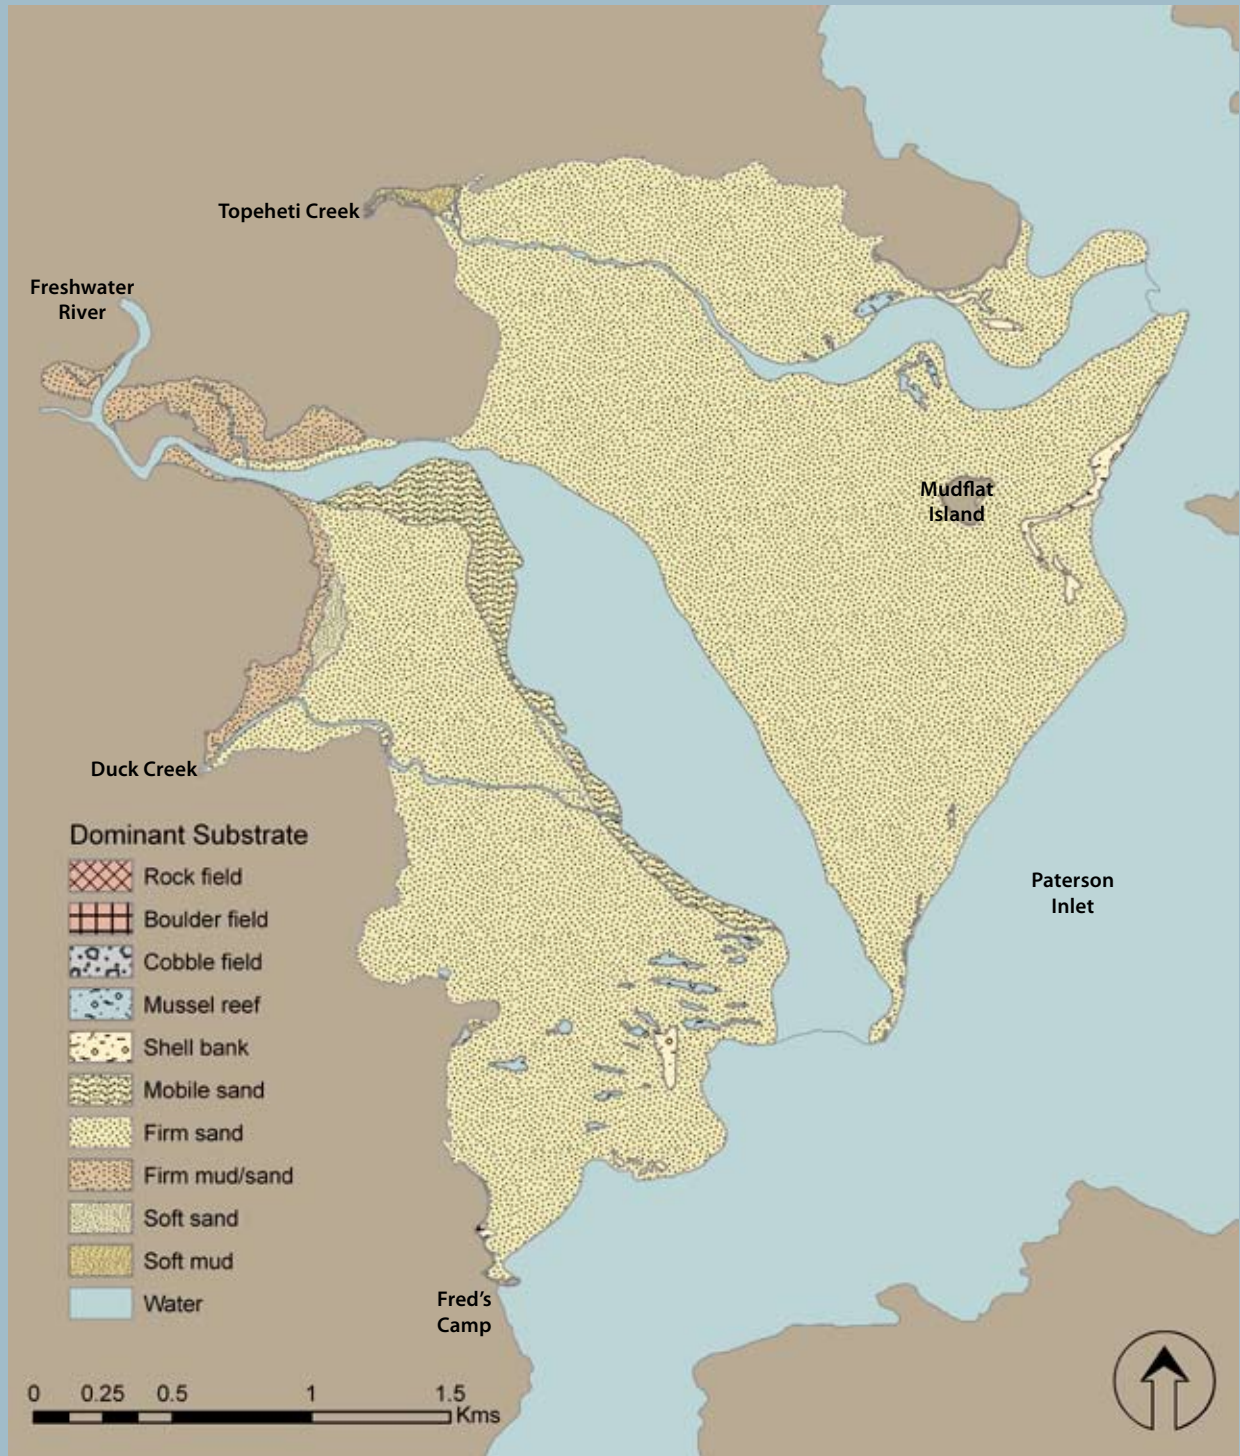
Figure 1. Map of Dominant Substrate - Freshwater Estuary, February 2008

The findings of the broad scale mapping confirmed this, in that the estuary was dominated by firm sand (90%, 596ha) and mobile sand (3.5%, 22.9ha) extending across most of the intertidal delta area (Table 6, Figure 1). Soft mud was uncommon, with only one small area present in the northwest where Topeheti Creek enters the estuary. The soft mud condition rating placed the estuary in the “very good” category (<2% of the estuary is soft mud).

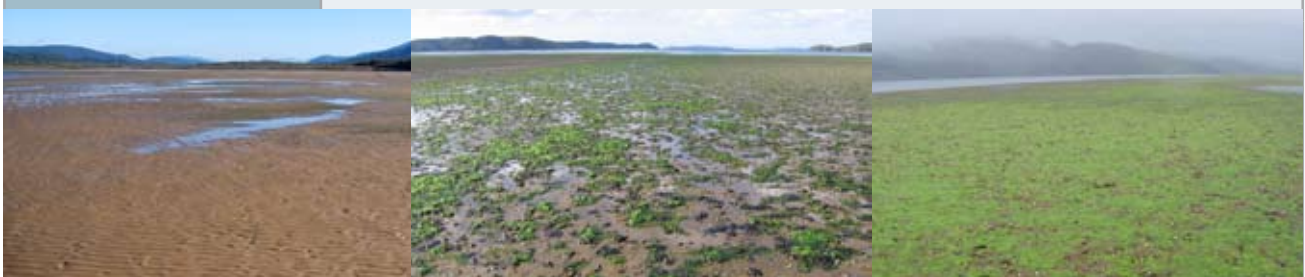
Figure 2. Map of Macroalgae Percentage Cover - Freshwater Estuary, February 2008

Macroalgal blooms are a symptom of estuary eutrophication. These can deprive seagrass areas of light causing their eventual decline, while decaying macroalgae can accumulate on shorelines causing depletion of sediment dissolved oxygen and nuisance odours. Figure 2 and Table 7 summarise the results of macroalgal mapping within Freshwater Estuary. Overall, 530ha (85% of the intertidal area) had a macroalgal cover >5%. Cover was dominated by the red alga *Gracilaria chilensis* and, to a lesser extent, by the green alga *Enteromorpha* which was most common along the edges of the main river channels. Sea lettuce (*Ulva*) was a common sub-dominant species and was also present in the highest percentage cover along the seaward edge of the estuary.

At present it is unclear as to the source of the nutrients supporting the relatively high cover of macroalgae in the estuary. However, ultrabasic rock in the catchment can cause drainage waters to become alkaline and such alkalisation has the potential to increase nitrogen inputs to the streams draining these catchments through increased organic matter turnover (Biggs and Gerbeaux 1993).

It is also possible that nitrogen fixing bacteria associated with the seagrass beds are supporting macroalgal growth within the estuary. Environment Southland are looking to collect additional data on catchment inputs while fine scale monitoring proposed for 2009 will measure sediment nutrients to better understand the source.

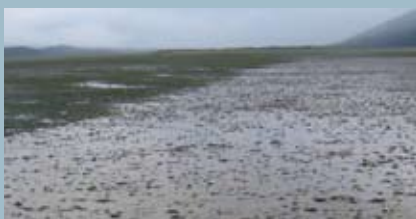
Figure 3. Map of Seagrass Percentage Cover - Freshwater Estuary, February 2008

Within Freshwater Estuary, seagrass was predominantly located in firm sand in the upper reaches of the delta (Figure 3), with the highest density cover between Mudflat Island and Freshwater River. The beds appeared healthy, often with a clearly distinct edge between seagrass and adjacent sandflats (see the aerial photo in Figure 4 and photo below left). Within the seagrass, macroalgae growths were common, and at times thick.

Seagrass (*Zostera capricorni*) is highly valued ecologically for its multiple roles in primary production, nutrient cycling, sediment stabilisation, and as a feeding and nursery area for fish and invertebrates. Seagrass meadows are also a major source of detrital material, and the bacteria and fungi that decompose this material contribute significantly to the sediment nitrogen pool and provide a food source for zooplankton, worms, etc., which are the base of the predatory food web. Seagrass is also an important forerunner to the establishment of saltmarsh on tidal flats, and grows subtidally where water clarity allows light to penetrate to it. Table 8 and Figure 3 summarise the results of seagrass mapping in Freshwater Estuary.

Like macroalgae, the source of nutrients supporting these dense seagrass beds are likely to originate mainly from catchment inputs and nitrogen fixation in the seagrass root zone.

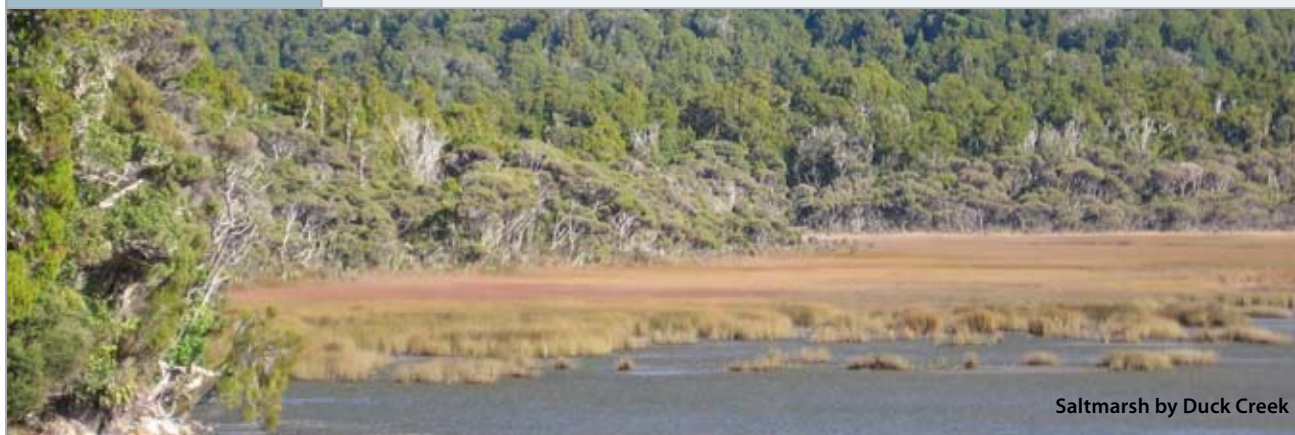
Figure 4. Map of Saltmarsh Vegetation - Freshwater Estuary, February 2008

Saltmarsh vegetation (able to tolerate saline conditions and where terrestrial plants are unable to survive) is highly productive, provides important habitat for a variety of species, naturally filters sediments and nutrients, and acts as an important buffer that protects against introduced weeds and grasses. Results are summarised in Figure 4 with the broad vegetation class and species composition shown in Table 9.

Class	Dominant Species	Primary subdominant species	Ha	%
Estuarine Shrubs			0.5	1.3
	<i>Plagianthus divaricatus</i> (Saltmarsh ribbonwood)		0.2	0.5
		<i>Phormium tenax</i> (New Zealand flax)	0.3	0.8
Rushland			39.3	98.7
	<i>Apodasima similis</i> (Jointed wirerush)		32.0	80.4
		<i>Plagianthus divaricatus</i> (Saltmarsh ribbonwood)	3.5	8.8
		<i>Phormium tenax</i> (New Zealand flax)	2.6	6.6
		<i>Festuca arundinacea</i> (Tall fescue)	1.1	2.8
Total			39.8	100

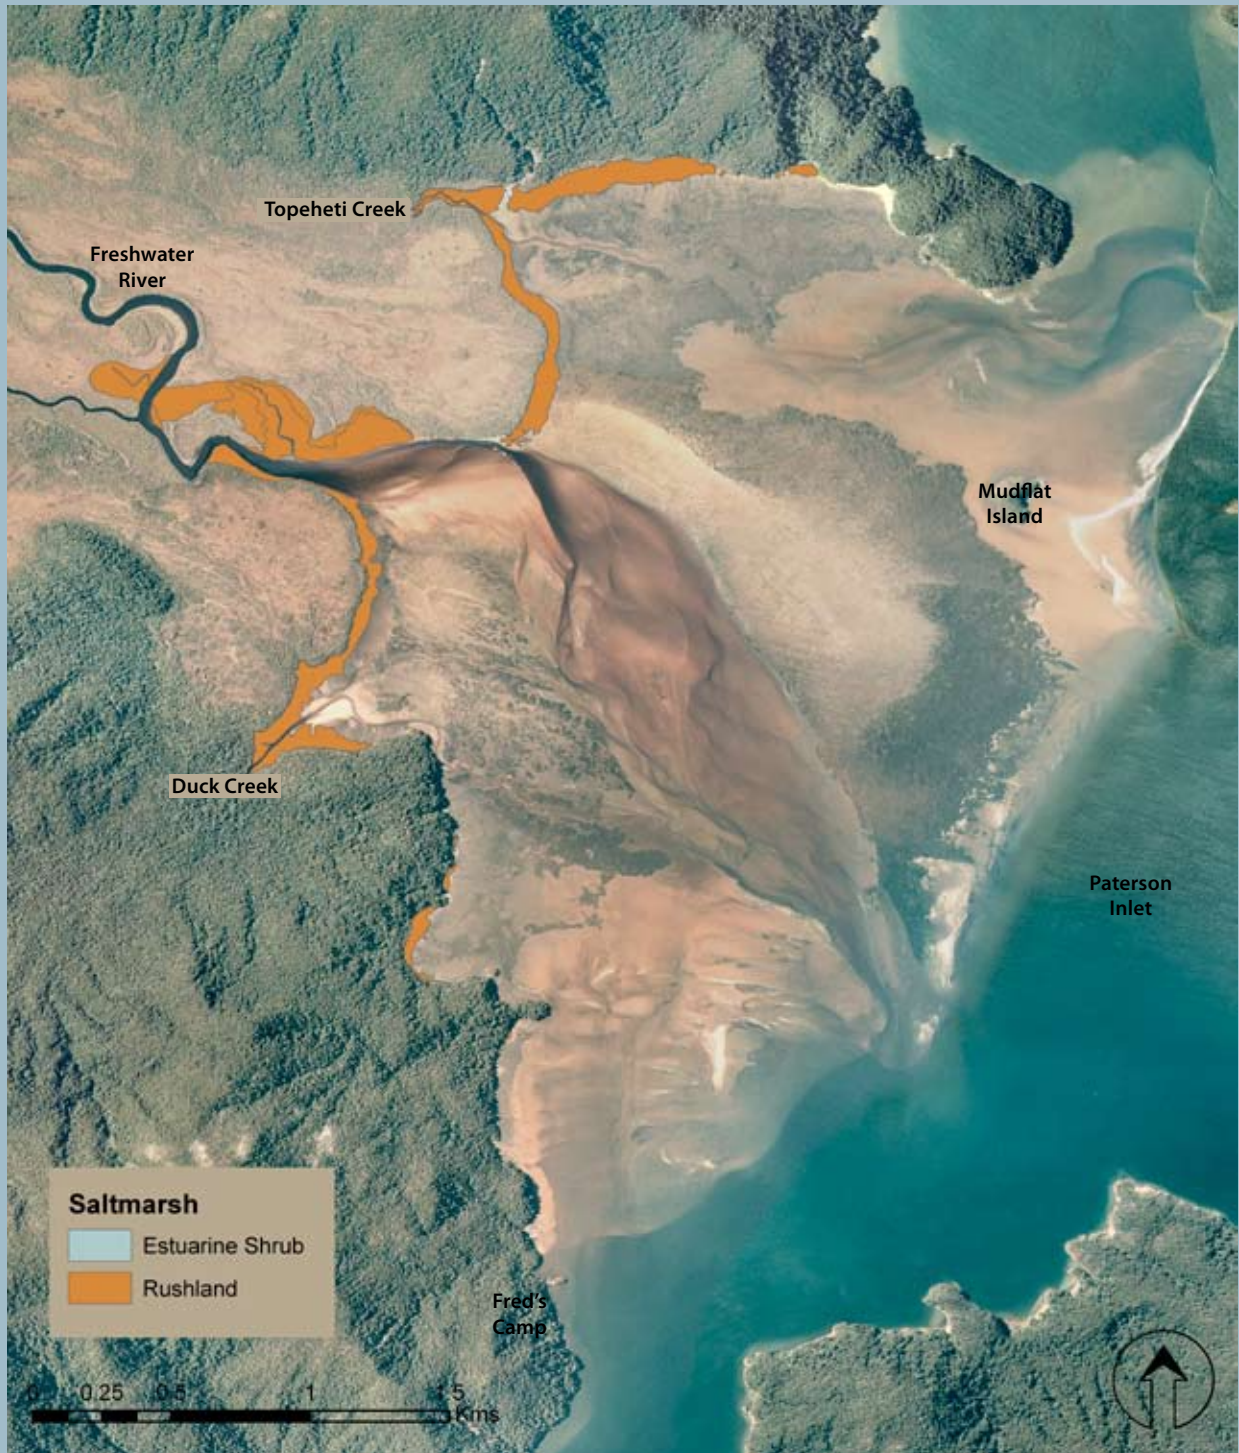
Overall, saltmarsh covered 5% of the estuary (condition rating = “moderate”). While this may appear to be low for a largely unmodified estuary, it reflects that Freshwater Estuary has limited suitable habitat available for saltmarsh growth because of the open nature of the delta, the generally steep surrounding hills, and the confined nature of the upper river estuary contained within incised river banks.

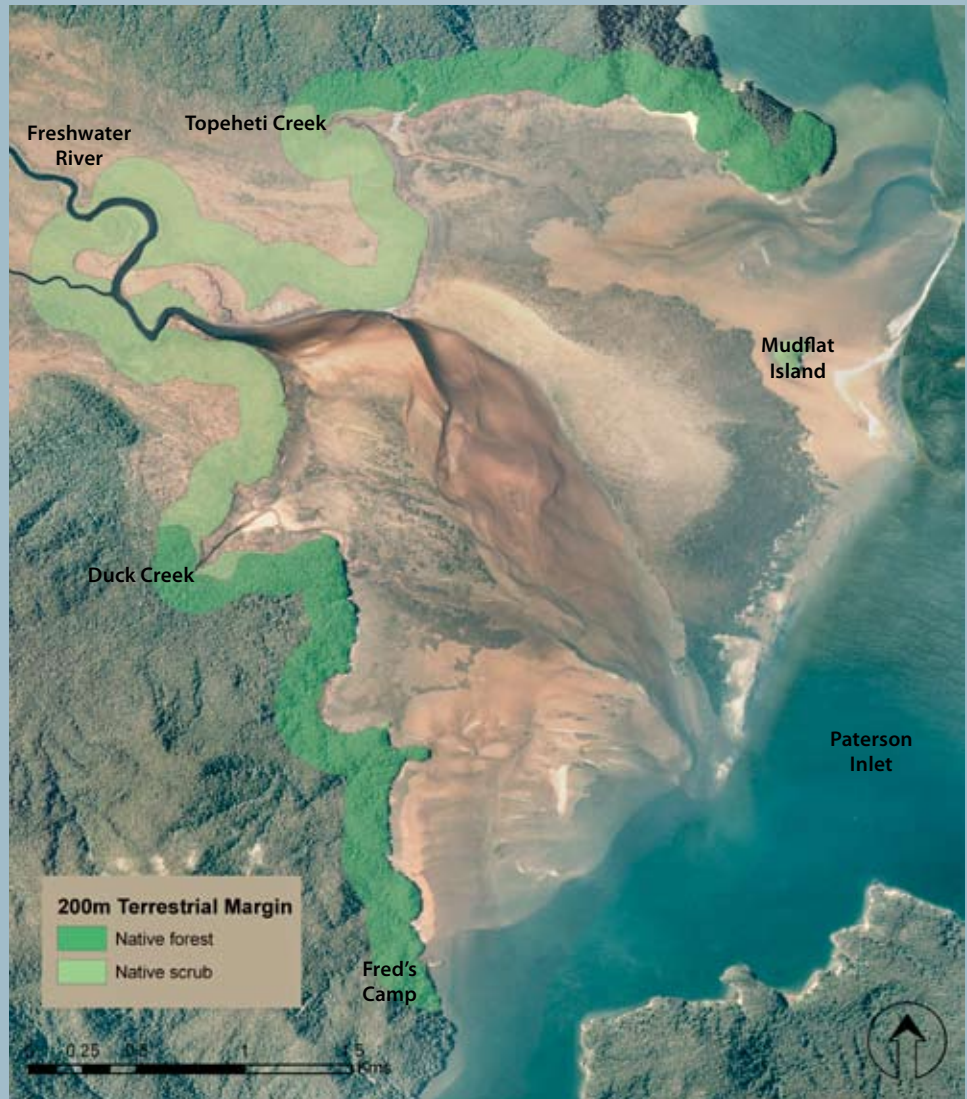
Figure 5. Map of 200m Terrestrial Margin Features - Freshwater Estuary, February 2008

All of the 200m terrestrial margin was covered by a dense assemblage of native scrub/shrub (50%) and mature native forest (50%), a condition rating of “very good”.

Native scrub (particularly manuka - *Leptospermum scoparium* and inaka - *Dracophyllum longifolium*) dominated the valley floor adjacent to Freshwater River, and was perched a couple of metres above the river level. Native podocarp forest (rimu, kamahi, miro and rata all prominent) covered the hillsides to the north and south and either extended directly to the estuary or bordering saltmarsh, or in many instances, ended in a low cliff between 1-4 metres high.

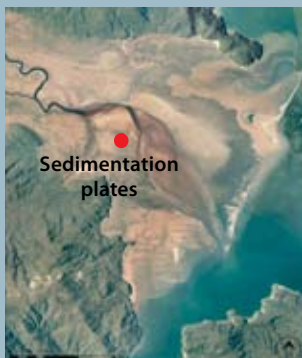
In order to enable the sedimentation rate from now into the future to be measured, four plates (20cm square concrete blocks) were buried approximately 20m apart in a square configuration deep in the sediments where substrate was stable. The site was located in unvegetated firm sand where sediment from Freshwater River was considered most likely to deposit. It is proposed to add a second site on the northern site of the delta in 2009.

The position of each plate was marked with wooden stakes, their GPS positions logged, and the depth from the undisturbed mud surface to the top of the sediment plate was recorded (Table 10). Following establishment of this baseline, ongoing monitoring results can be used to determine the sedimentation rate in the estuary, with a sediment condition rating developed and used to assess any changes.
