# Freshwater Estuary

Broad Scale Habitat Mapping 2012/13

Prepared for  
Environment  
Southland  
November  
2013

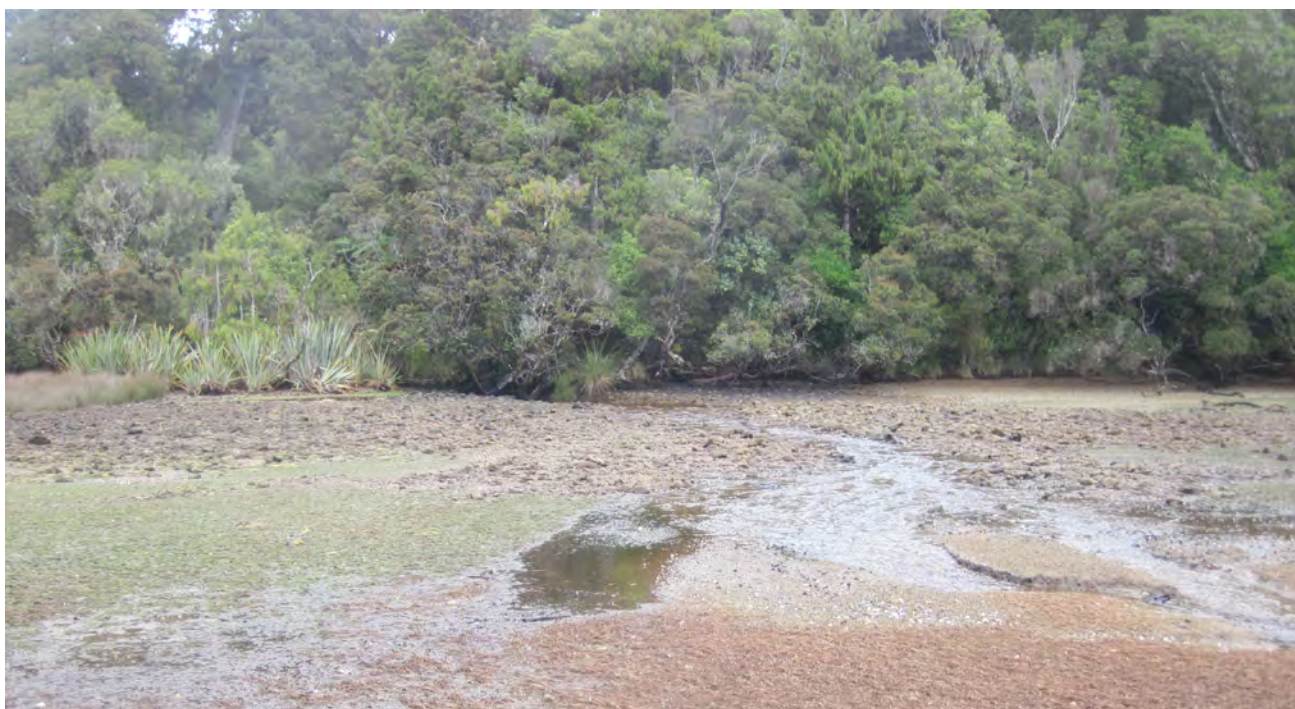
Unmodified terrestrial margin, Freshwater Estuary, February 2013

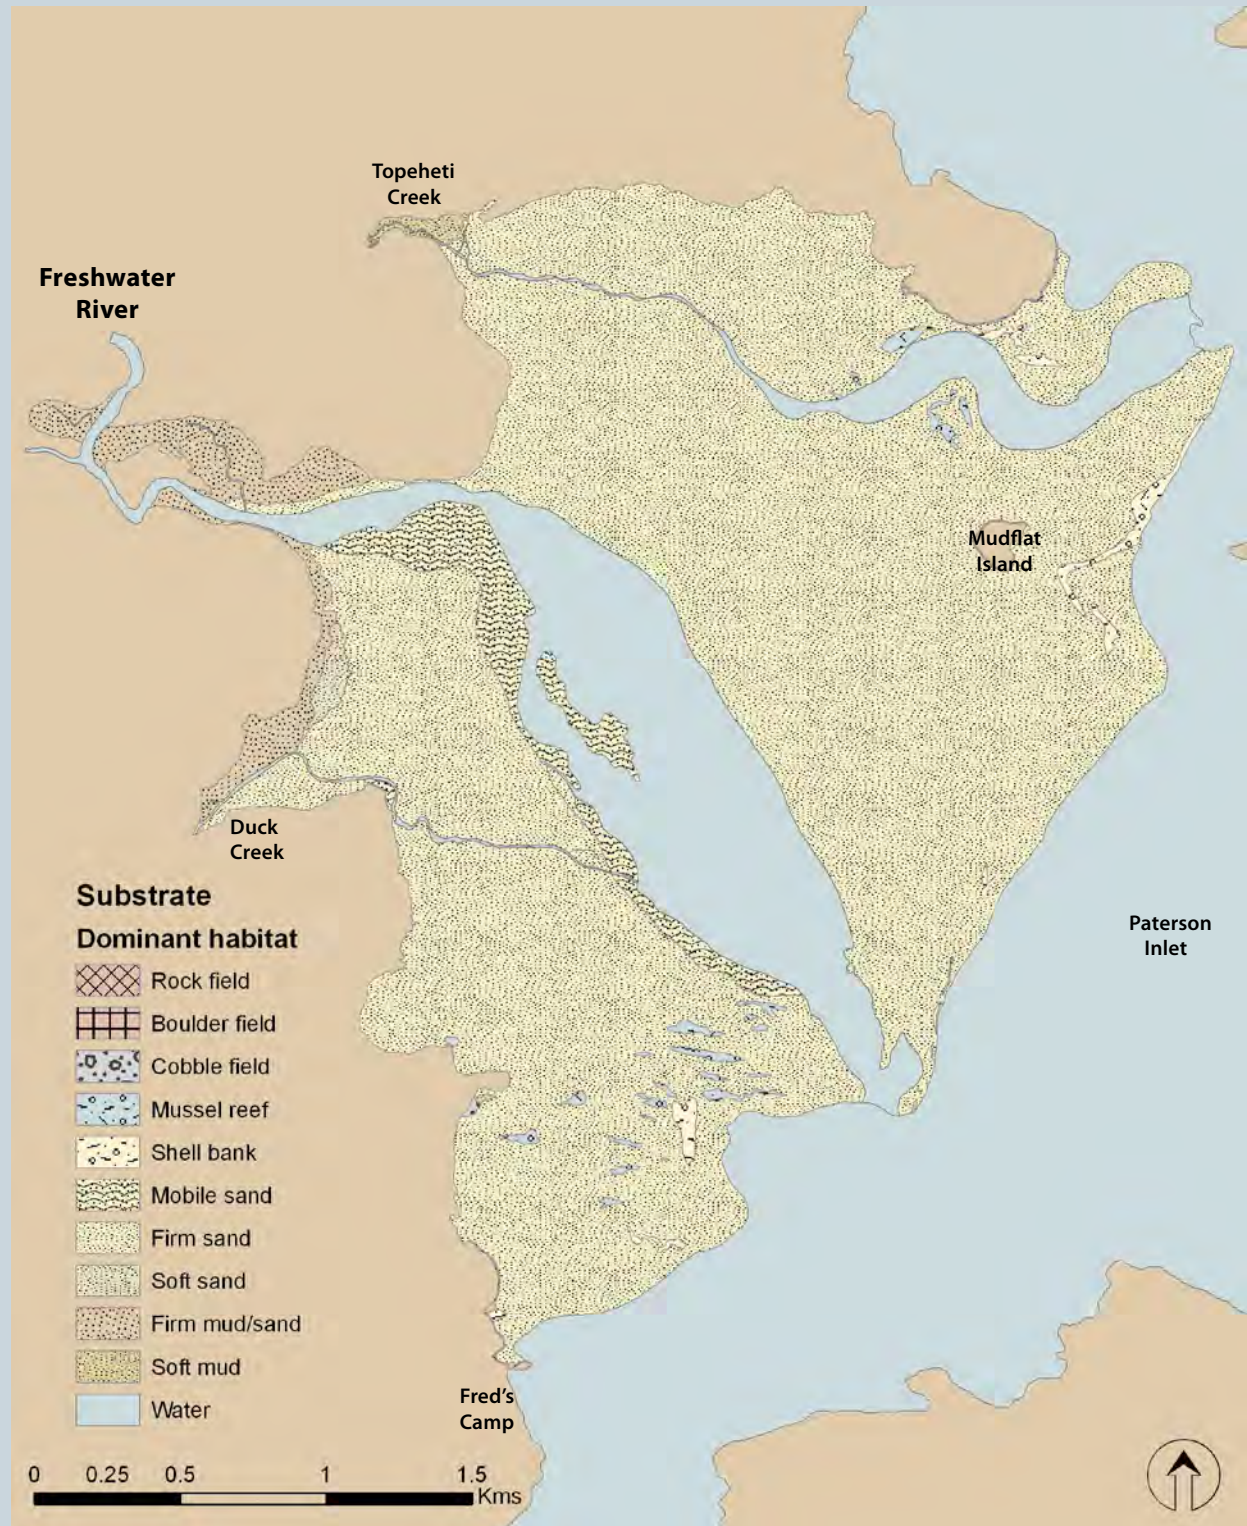
Figure 3. Map of dominant intertidal substrate types - Freshwater Estuary, February 2013.

Figure 3 and Table 4 summarise the unvegetated intertidal substrate of Freshwater Estuary. The primary indicator of sediment impacts is the area of the estuary dominated by soft and very soft muds, with estuaries with an area >5% mud exceeding the early warning trigger for management action. Freshwater Estuary had very little soft mud (2ha, 0.3% present in the northwest where Topeheti Creek enters the estuary), with the vast majority (99.5%) firm sand or shell, or rock/boulder/cobble (0.2%). Such conditions place the estuary in the “very good” condition rating and all of the habitats appeared to be in good (healthy) ecological condition.

There was no change in the soft mud extent from 2008-2013, indicating estuary sediment composition remained in very good condition.

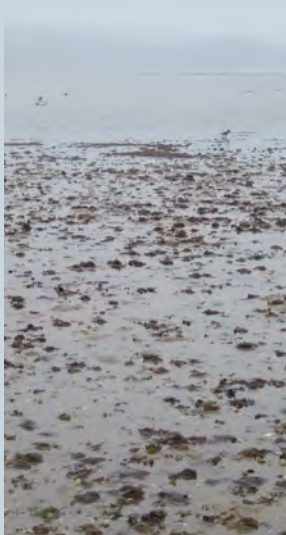
Dense macroalgal growth on firm intertidal sand flats near Freshwater River.

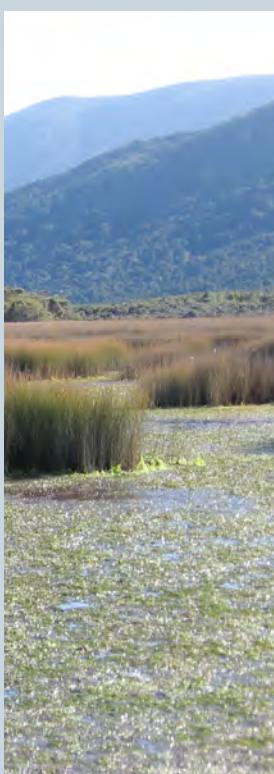
Dense seagrass bed growing among rushland near Freshwater River.

Of particular interest was dense seagrass growing in rushland (see sidebar photo). This is very seldom observed in estuaries with modified catchments, probably because saltmarsh traps and concentrates fine muds lowering water clarity, reducing sediment oxygenation and creating unfavourable growing conditions. Its presence in Freshwater most likely reflects the very low sediment mud content in the estuary.

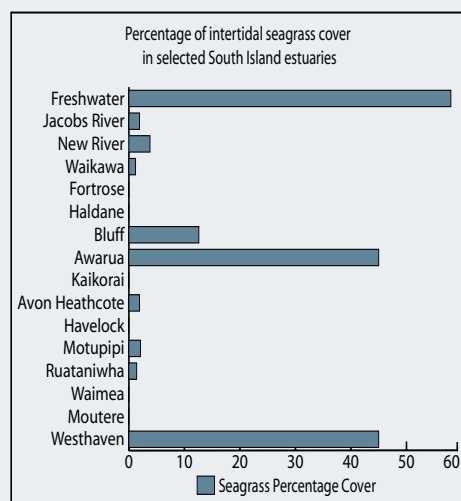
**Figure 5. Percentage of seagrass cover in selected South Island estuaries.**

The 2013 Seagrass Coefficient (SC) was “very high” (7.3), a condition rating of “very good” (the same rating as in 2008), reflecting the presence of dense seagrass beds over nearly half of the estuary. This high cover (present only in estuaries with relatively intact terrestrial margins and low suspended sediment inputs e.g. Awarua, Westhaven, Bluff), is well above the <5% intertidal cover commonly remaining in most other NZ estuaries (see Figure 5 for South Island examples).

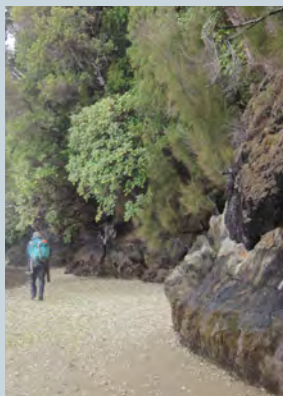
Rushland (top photos) and forest (lower photo) along the upper estuary margins.

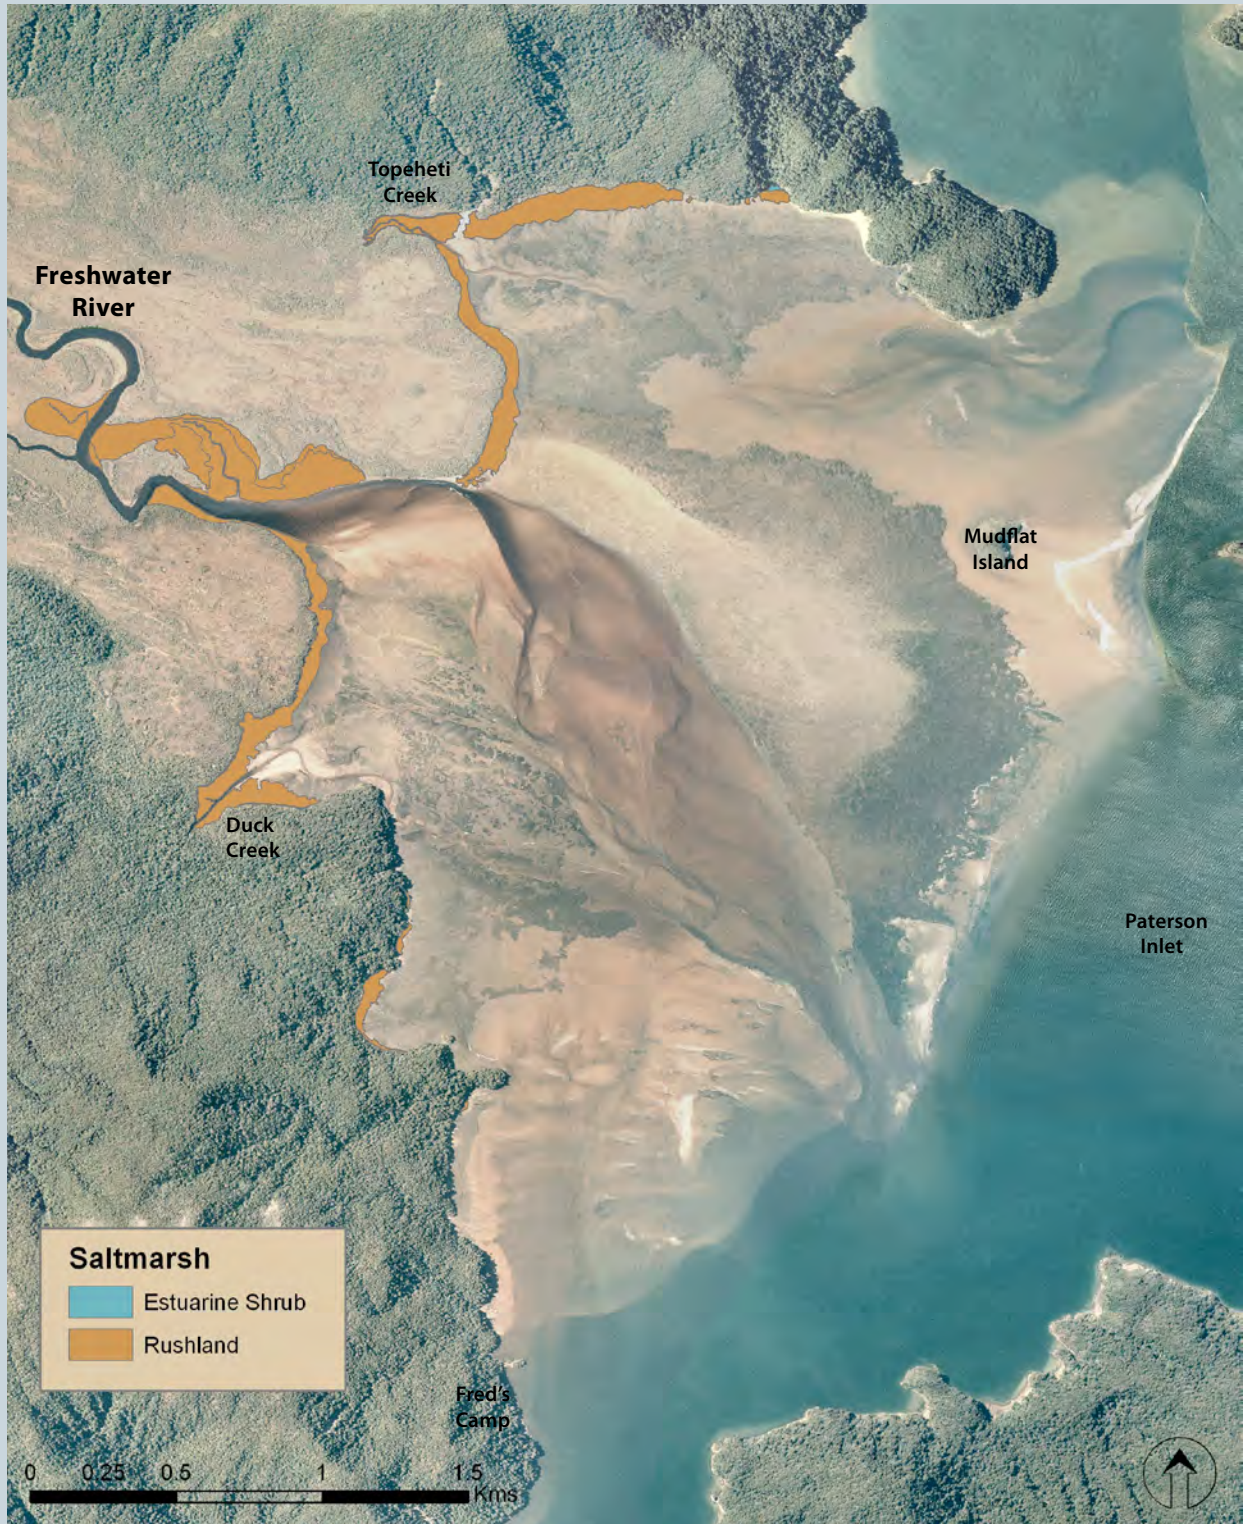
Figure 7. Map of saltmarsh vegetation - Freshwater Estuary, February 2013.

The condition rating for saltmarsh measures a percentage change from an established baseline. Based on the summary information in Table 9, and using 2008 data as a baseline, the 2013 saltmarsh condition rating is rated as “no decrease”. This reflects the pristine and protected nature of the estuary and surrounding catchment.

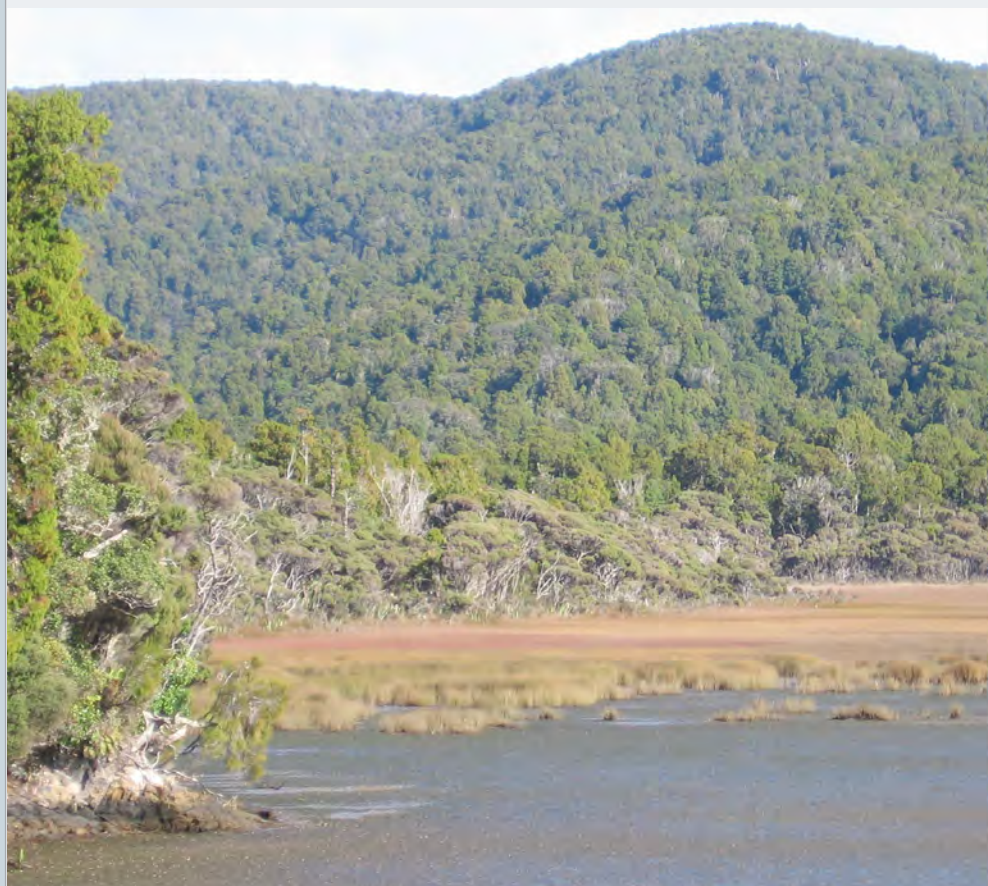
Native forest catchment behind saltmarsh at Duck Creek.

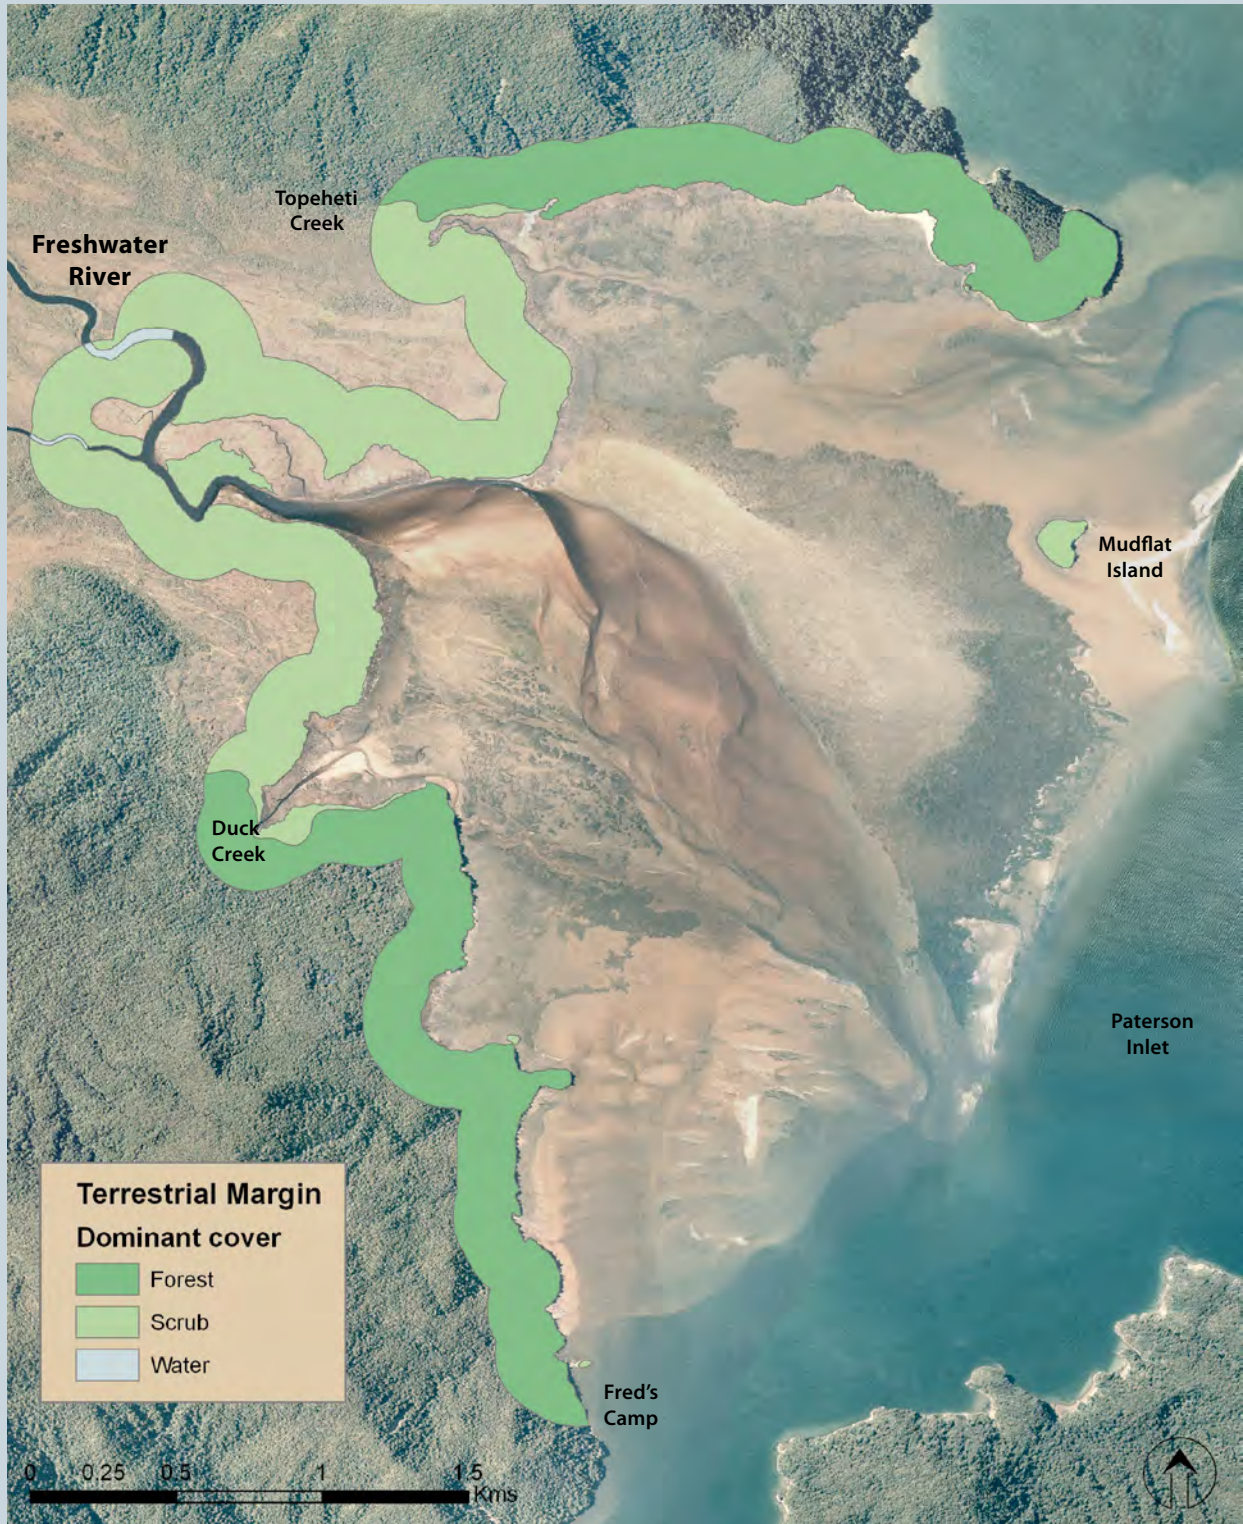
Figure 8. Map of 200m terrestrial margin vegetation - Freshwater Estuary, February 2013.

The 2013 200m terrestrial margin condition rating is rated as "no decrease". This reflects the pristine and protected nature of the estuary and surrounding catchment.
