# Jacobs River Estuary

Broad Scale Habitat Mapping 2007/08

Prepared  
for  
Environment  
Southland  
September  
2008

**Leigh Stevens and Barry Robertson**

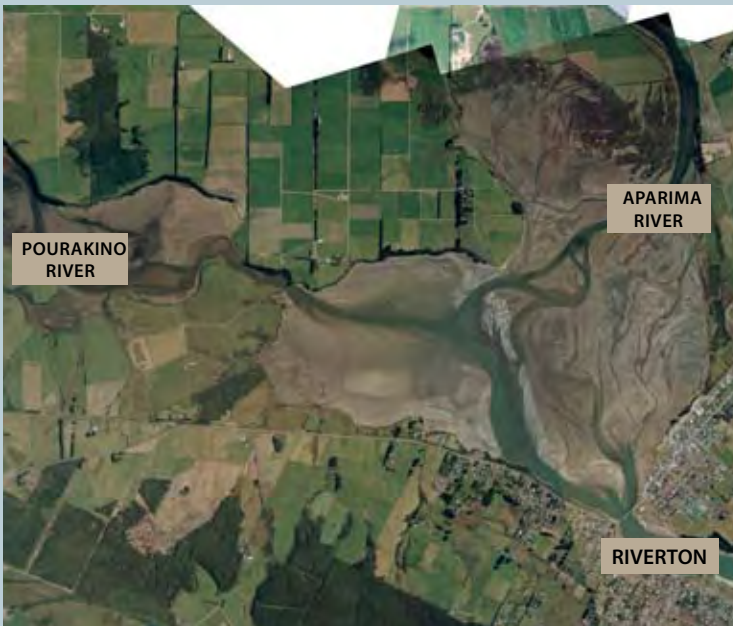
Jacobs River Estuary - Photo Environment Southland, 2008

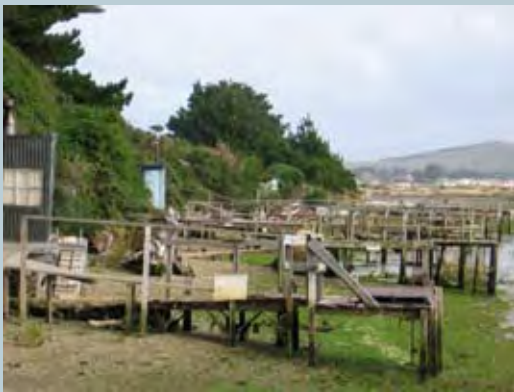
Jacobs River Estuary - whitebait stands and macroalgal blooms in Aparima Arm.

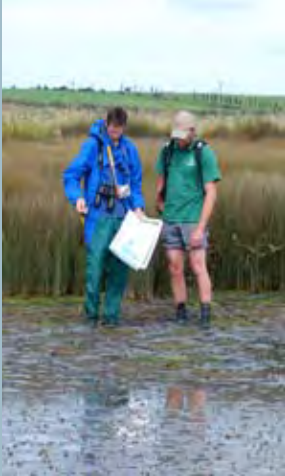
>1 %
1-5%
5-10 %
10-20 %
20-50 %
50-80 %
80-100 %

Broad-scale mapping is a method for describing habitat types based on the dominant surface features present (e.g. substrate: mud, sand, cobble, rock; or vegetation: macrophyte, macroalgae, rushland, etc). It follows the EMP approach originally described for use in NZ estuaries by Robertson et al. (2002) with a combination of aerial photography, detailed ground-truthing, and GIS-based digital mapping used to record the primary habitat features present. Very simply, the method involves three key steps:

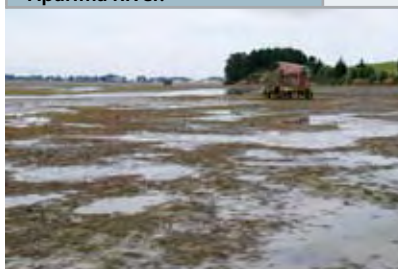
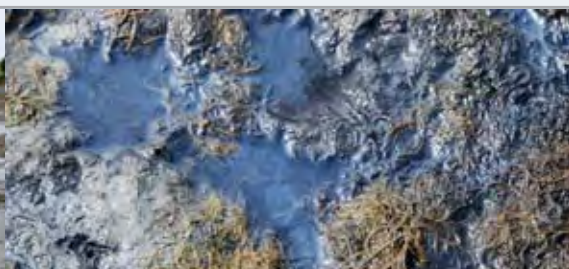
*Gracilaria* (50-80% cover) in the upper Pourakino Arm.

Extensive *Enteromorpha* and *Gracilaria* cover (80-100%) and anoxic sediment north of the Aparima River.

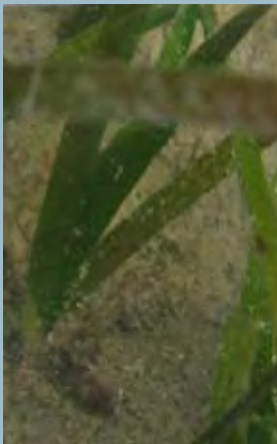
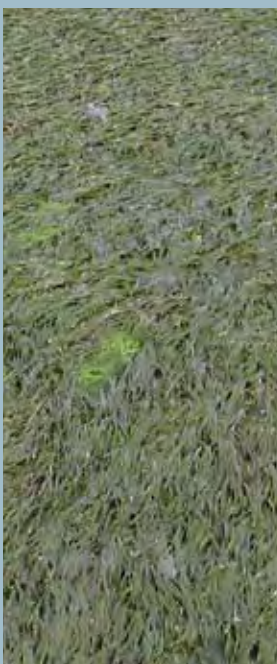
Seagrass (*Zostera muelleri*) is highly valued ecologically for its multiple roles in primary production, nutrient cycling, sediment stabilisation, and as a feeding and nursery area for fish and invertebrates. Seagrass meadows are also a major source of detrital material, and the bacteria and fungi that decompose this material provide a food source for zooplankton, worms, etc. which are the base of the predatory food web. Seagrass is also an important forerunner to the establishment of saltmarsh on tidal flats, and grows subtidally where water clarity allows light to penetrate to it. Table 8 and Figure 3 summarise the results of seagrass mapping within Jacobs River Estuary.

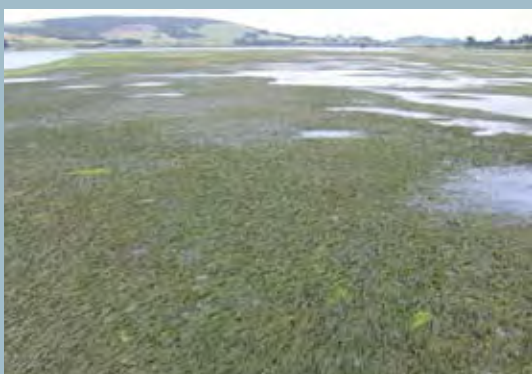
Example of extensive (80-100%) cover of *Zostera* in northern Jacobs River Estuary.

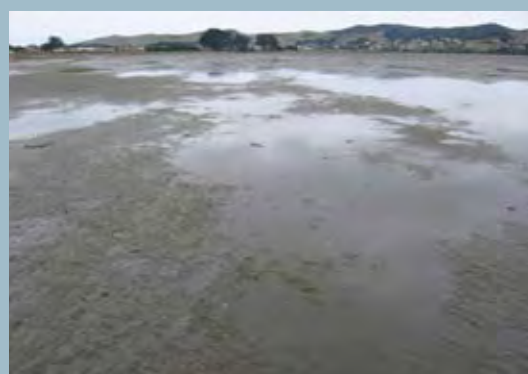
Example of sparse (5-10%) cover of *Zostera* in southern Jacobs River Estuary.

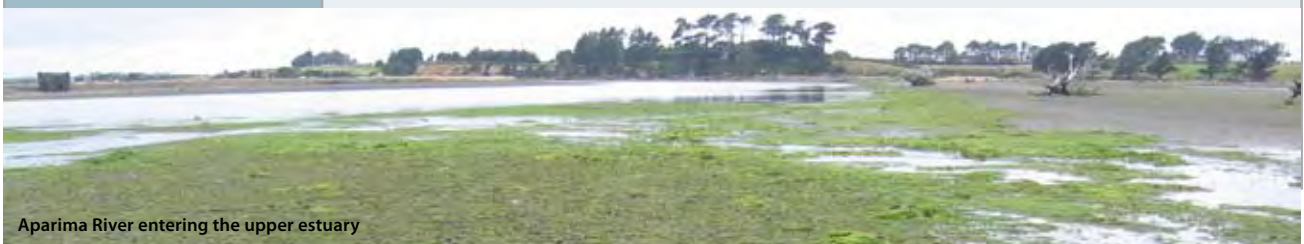
Aparima River entering the upper estuary
