New River Estuary 2012

Broad Scale Habitat Mapping

Prepared
for
**Environment
Southland**
November
2012

Leigh Stevens and Barry Robertson

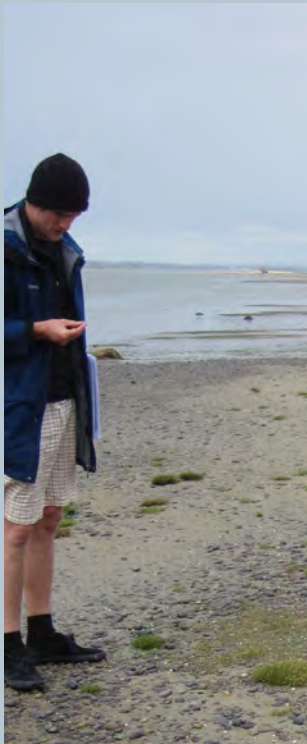
Broad scale mapping in the Oreti Arm.

Broad-scale mapping is a method for describing habitat types based on the dominant surface features present (e.g. substrate: mud, sand, cobble, rock; or vegetation: macrophyte, macroalgae, rushland, etc). It follows the NEMP approach originally described for use in NZ estuaries by Robertson et al. (2002) with a combination of aerial photography, detailed ground-truthing, and GIS-based digital mapping used to record the primary habitat features present. Very simply, the method involves three key steps:

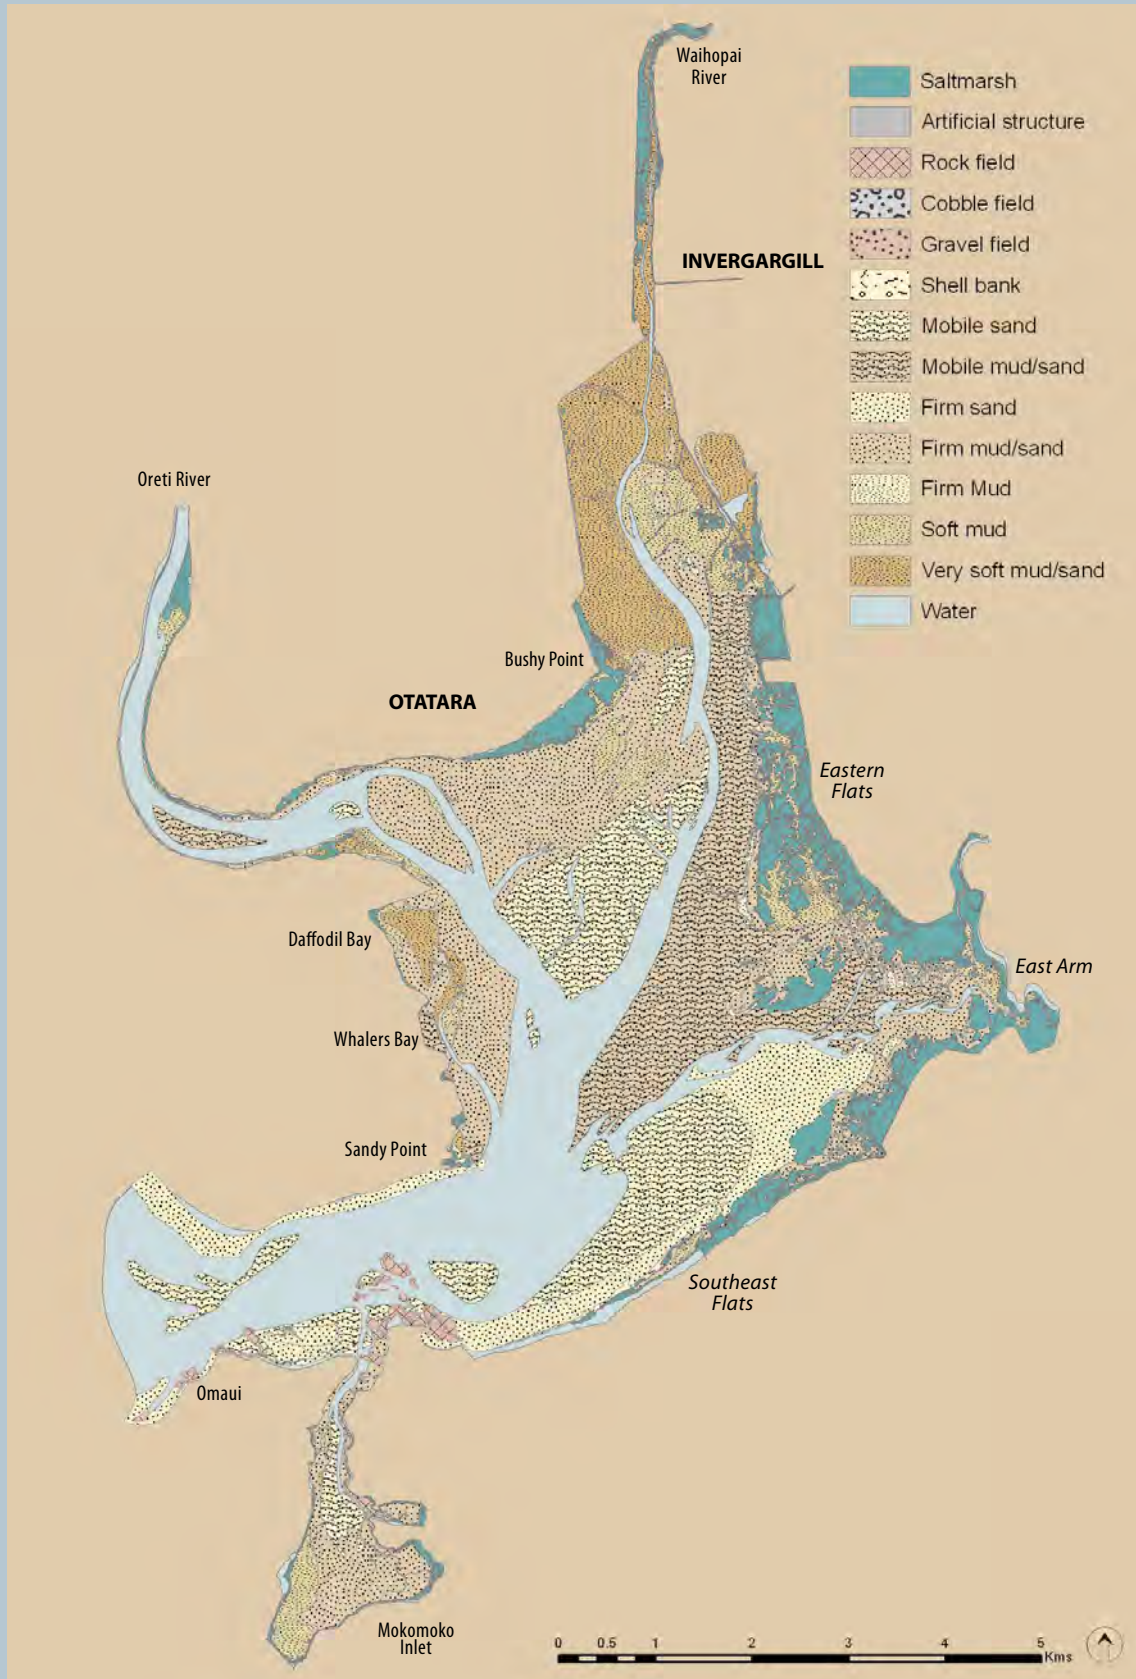
Figure 3. Map of Substrate Types - New River Estuary, Jan. 2012.

Outside of the muddy areas, firm sands dominant throughout the central basin and near the mouth of the estuary, with rock, cobble, and gravel fields located near Omaui. These habitats were in good condition.

Firm Mud	23.2	0.8%	Concentrated in the east - mostly old Spartina beds or areas of eroding rushland.
Soft mud	296.6	10.0%	Present throughout the estuary - mainly among rushland in the upper tidal reaches.
Very soft mud/sand	372.4	12.6%	Concentrated in Waihopai Arm and Daffodil Bay, and in localised settling areas.
TOTAL	2952	100

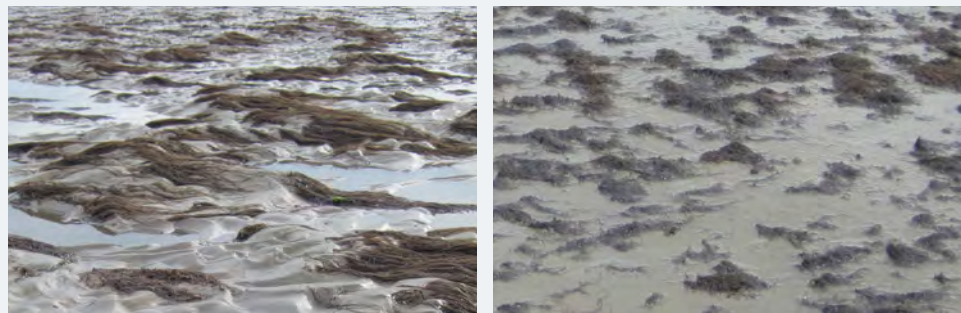
The increased mud at Bushy Point is particularly concerning as it is settling among dense *Gracilaria* beds where it is likely to lead to an increase in gross nuisance conditions if inputs continue and sediment oxygenation declines (see photos below).

Examples of the rapid change in sediment among macroalgal beds at Bushy Point: clean mobile sand (above left) in 2011, and soft mud in 2012 (above right).

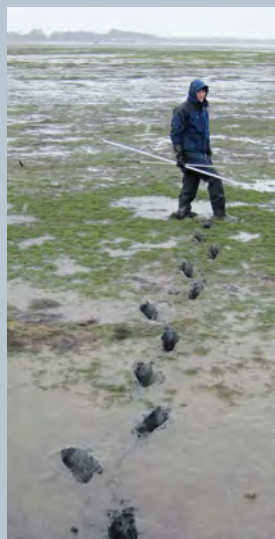
Extensive macroalgal cover along the western side of the Waihopai Arm.

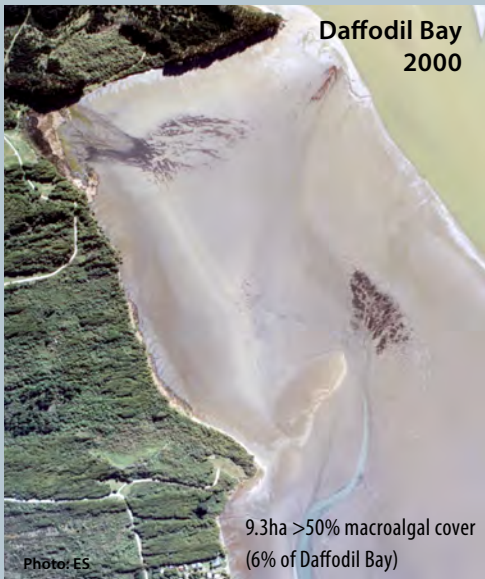
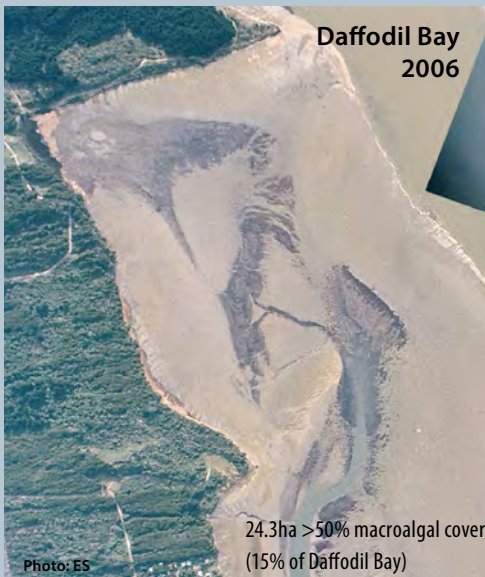
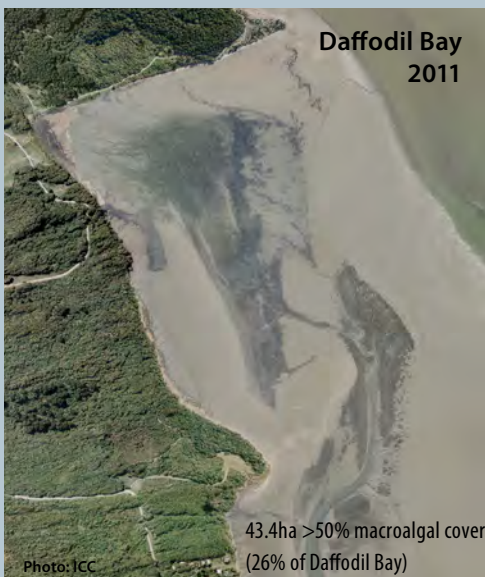
Figure 5. Aerial photos showing changes in macroalgal cover in Daffodil Bay, 2000, 2006 and 2011.

The sidebar photos illustrate the increase in the cover of nuisance macroalgae in Daffodil Bay since 2001. Areas with thick macroalgal cover (i.e. the dark areas in the photos) are generally in very poor condition, with smothering macroalgal growths trapping fine muds at a rapid rate. At the same time the growths are limiting the natural removal of mud from the exposed flats by reducing the re-suspension of sediment by wind-generated waves. As a consequence, the sediments are becoming deeper, softer, and muddier. Further, when the macroalgae dies, it rots and releases organic matter and nutrients into the sediments, reducing oxygenation and fuelling ongoing growths. Where sediment oxygen is depleted, sulphide bacteria grow at the surface (see photo below) reflecting toxic conditions in which few animals can survive.

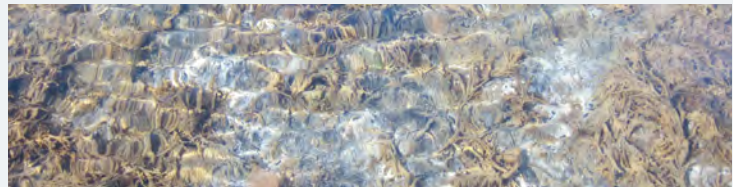
Surface sulphides in Daffodil Bay, Jan. 2012.

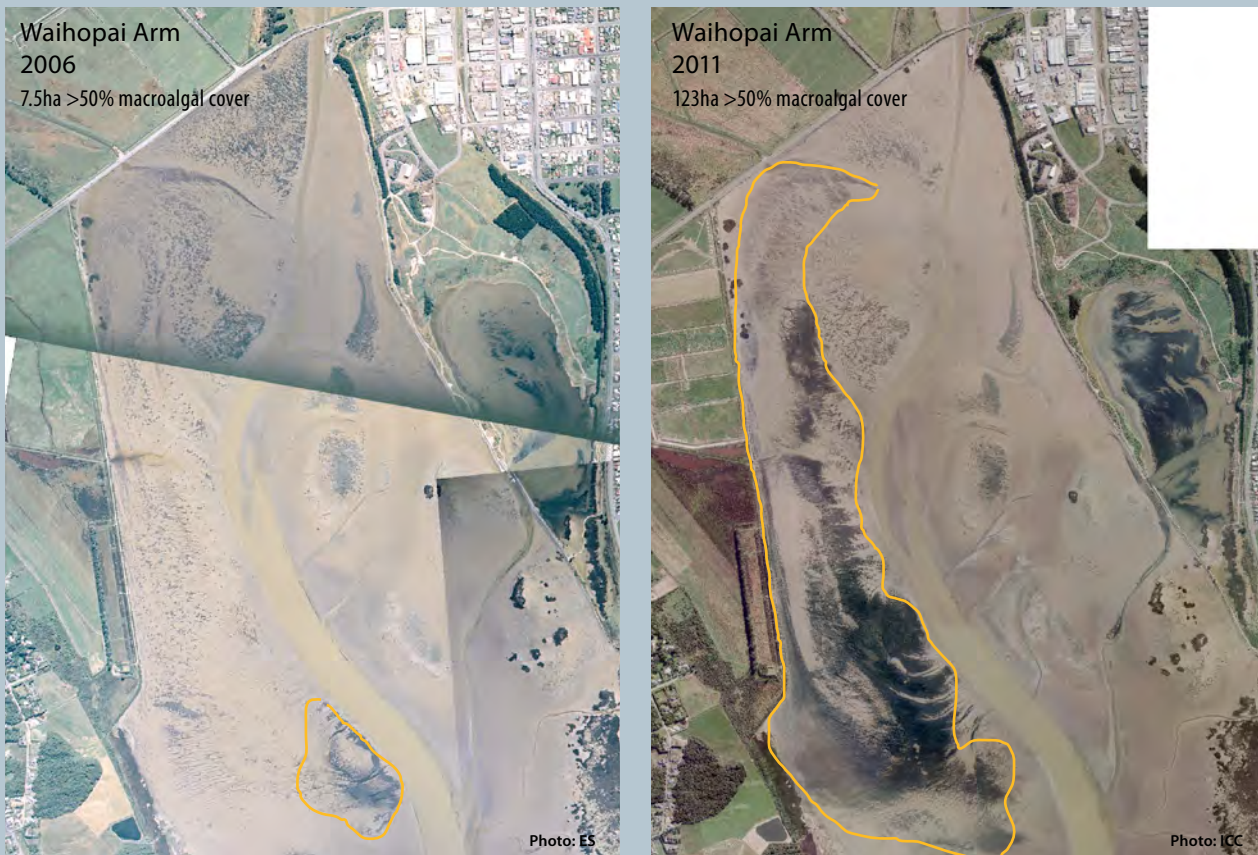
Figure 6. Aerial photos showing changes in macroalgal cover in the Waihopai Arm, 2006 and 2011. General coverage of nuisance macroalgae indicated by the yellow line.

The Waihopai Arm is the worst impacted, with sediment conditions so degraded that nuisance macroalgae are now dying off due to the over-enriched sediment conditions present. The photos in Figure 6 indicate the very rapid changes from 2006-2011 in the Waihopai Arm, and the increase of macroalgal cover in this part of the estuary. Figure 7 illustrates conditions in 2012.

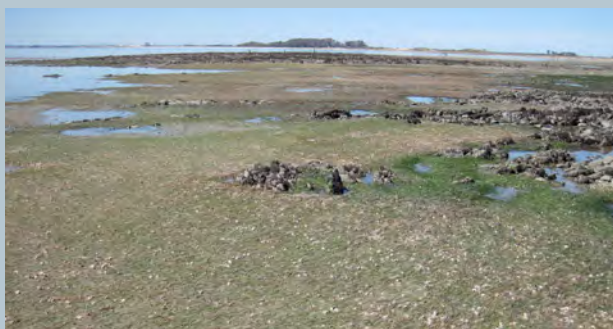
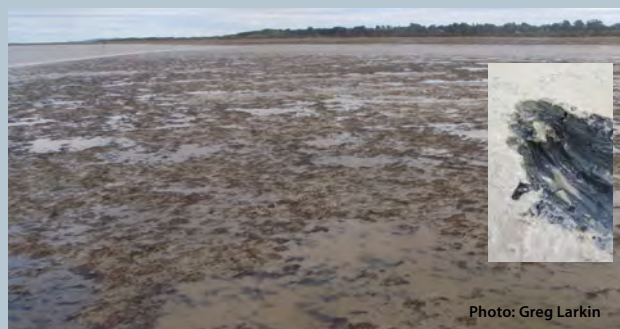
The most extensive areas of seagrass were in the Waihopai arm. However, these beds were very clearly in a state of stress with extensive seagrass beds on the western side of the arm being covered in fine muds, often in combination with smothering by macroalgae. Rotting macroalgae was also creating degraded sediment conditions with black, sulphide rich and anoxic muds dominating the surface sediments (Figure 9).

Figure 9. Contrasting condition of *Zostera* in New River Estuary - healthy beds near Omaui (above left), and severely impacted beds in the Waihopai Arm (above right) which have suffered large areas of die off due to burial in soft muds, smothering by dense macroalgal growths, and toxic (high sulphide/low oxygen) sediment conditions caused by rotting macroalgae.

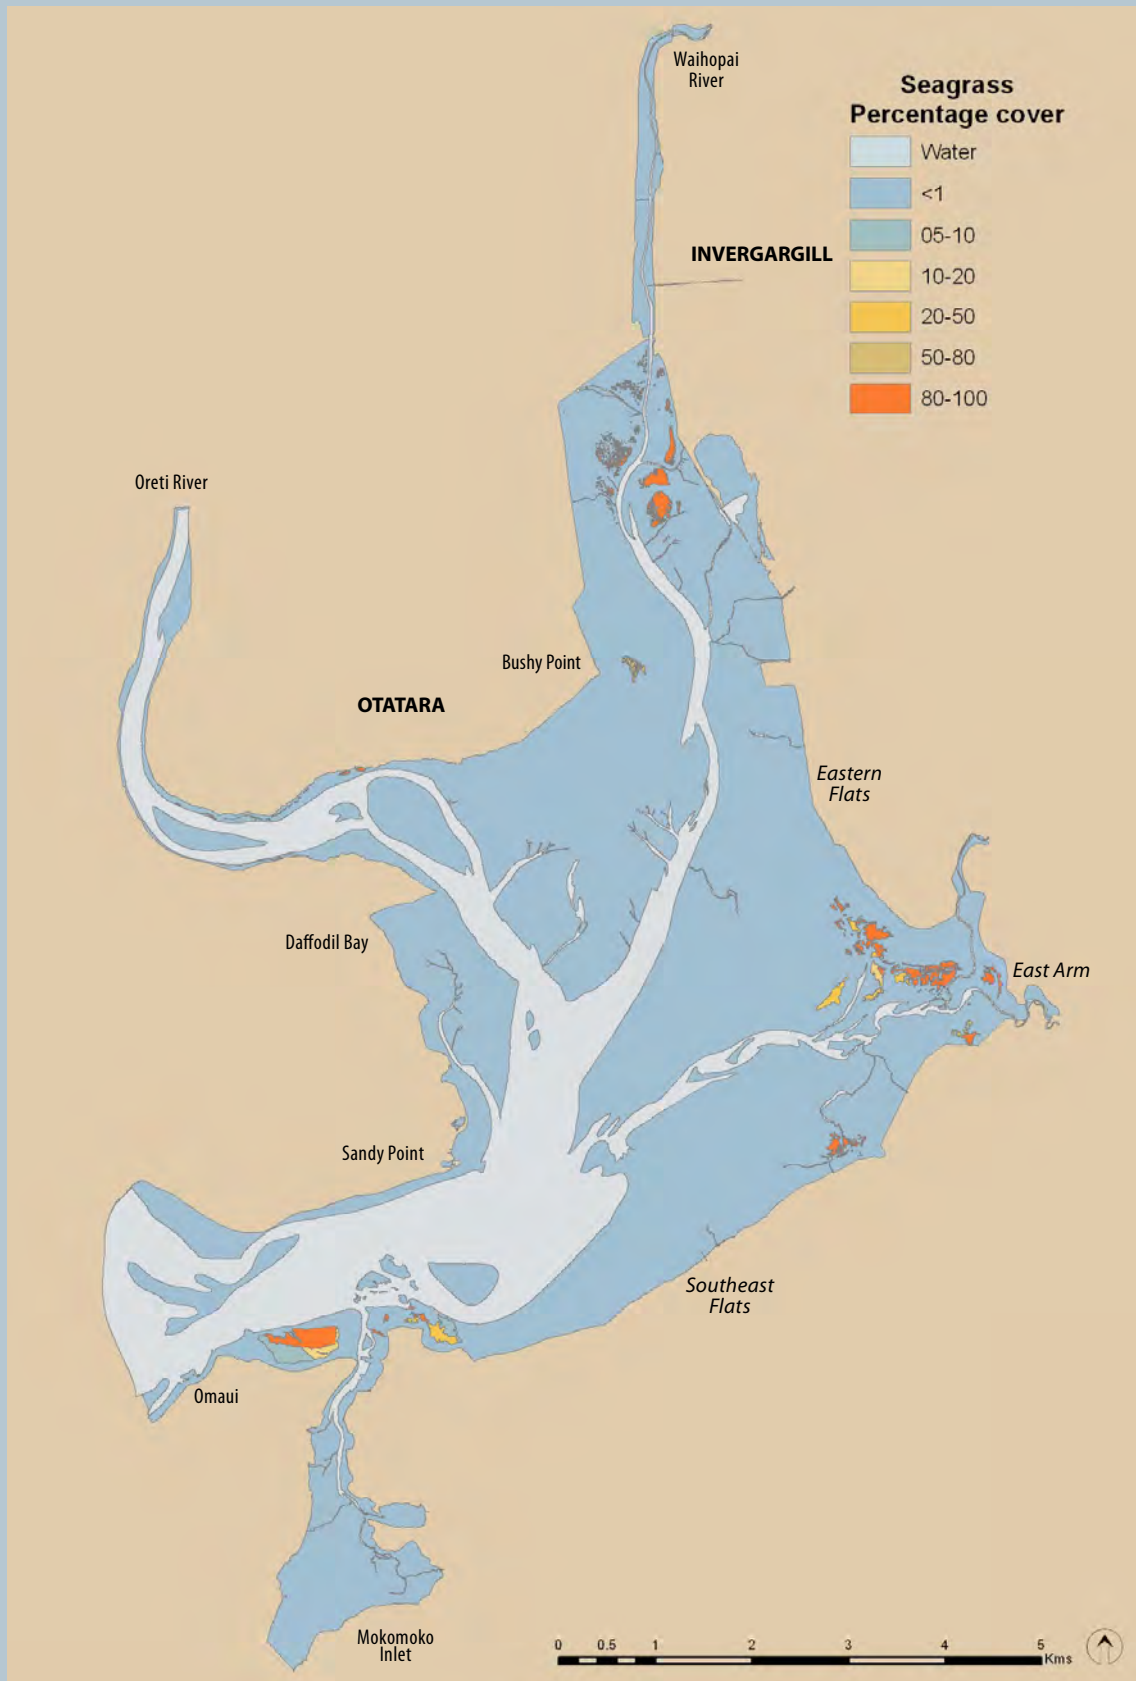
Figure 10. Map of Seagrass Cover - New River Estuary, Jan. 2012.

The Seagrass Coefficient (SC) was "very low" (0.2), a condition rating of "poor". Dense seagrass beds in the lower estuary near Omaui, in the Eastern arm, and near the Oreti River mouth all appeared in relatively good condition with luscious growths, little fine mud, and no obvious macroalgal smothering (Figure 9). To the east, seagrass was primarily in sandier sediments and beds tended to be less dense than in the north. *Zostera* shoots with a <1% cover were observed throughout the eastern side of the estuary. Subtidal beds (not mapped) were present in the lower Oreti River.

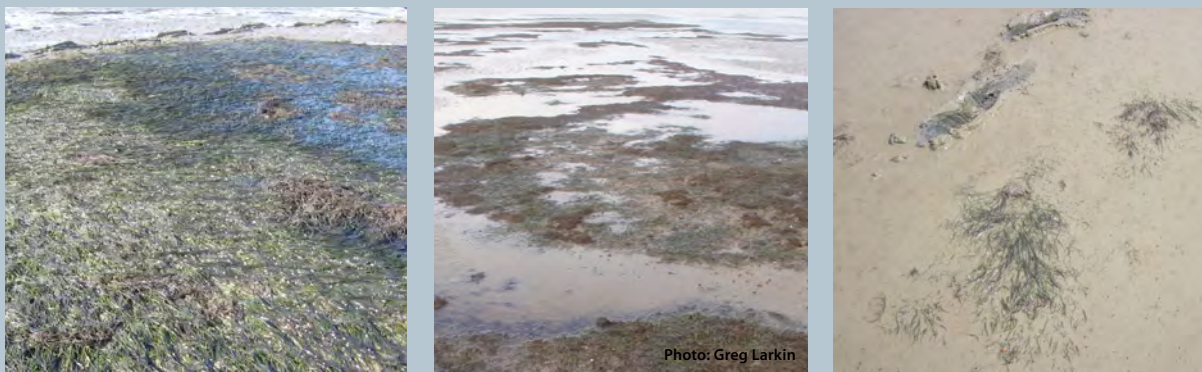
Figure 12. Representative examples of seagrass in good condition in the western Waihopai Arm in 2007 (left) and impacted by sediment and macroalgal smothering in 2012 (centre and right).

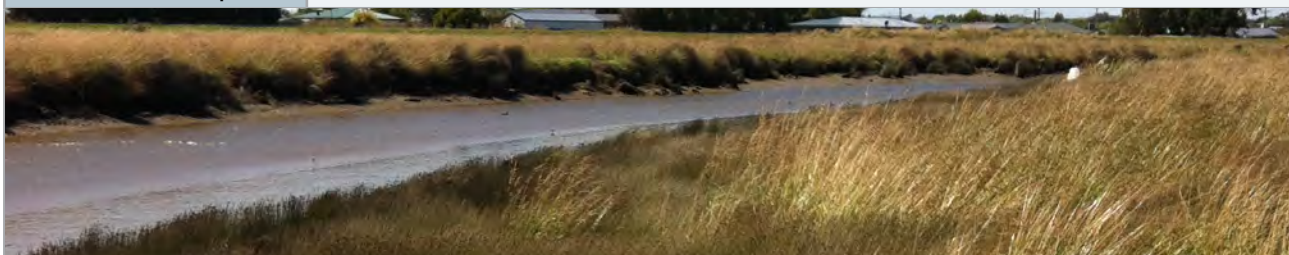
Tall fescue growing through rushland in the Waihopai Arm.

The increasing presence of grassland among areas previously dominated by rushland (photo left) suggests a shift to more terrestrial conditions, possibly because the input of sediment is elevating areas so that there is reduced saline influence. If so, there is likely to be a continued increase or terrestrial weeds and grasses establishing in saltmarsh areas.

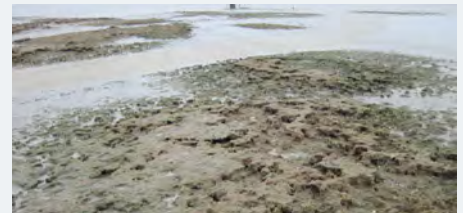
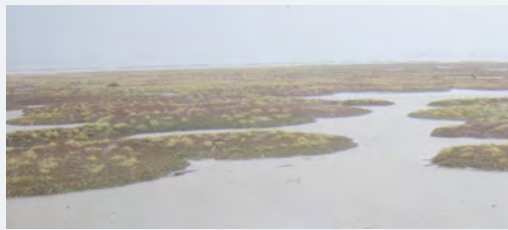
Residual root systems of the invasive cord grass *Spartina* in the east of the estuary (photo right) were predominantly unvegetated and continuing to slowly erode. Relatively extensive herbfields were often growing in sheltered areas adjacent to the root beds (photo below).

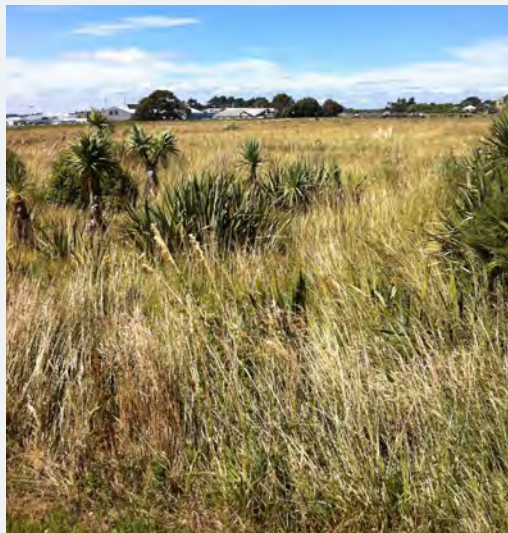
Stabilised duneland remained a notable feature near Omaui where steep marram grass dunes flank the estuary (see photo below), as well as at the back of Oreti Beach, and on the east bank of the Oreti River.

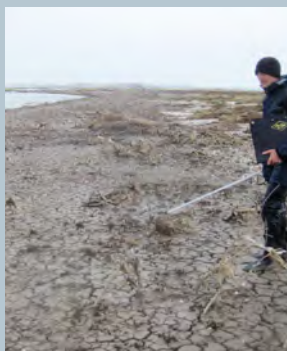
Ten metre wide band of rushland eroded by wind driven waves in the eastern arm.

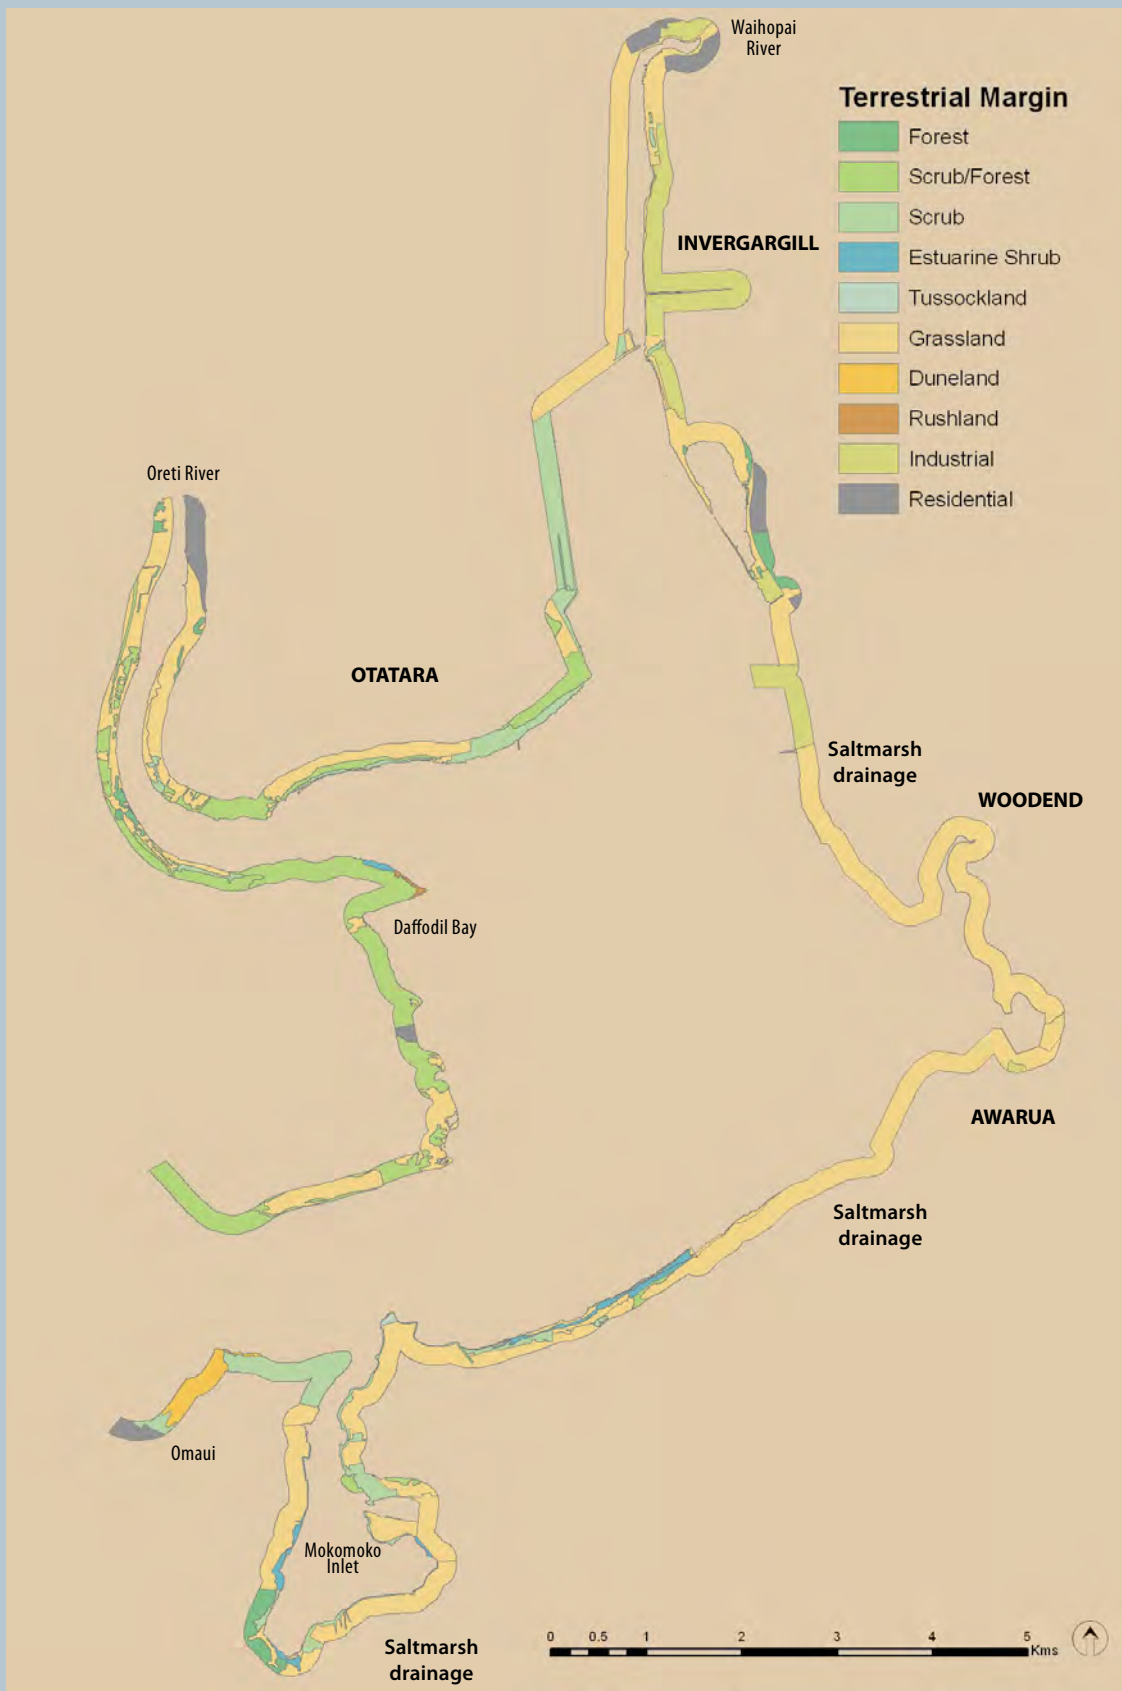
Figure 14. Map of 200m Terrestrial Margin Vegetation - New River Estuary, Jan. 2012.

TERRESTRIAL MARGIN	2007	2012
Percentage densely vegetated	31%	31%
