# New River Estuary

## Macroalgal Monitoring 2012/13

Environment  
Southland

July  
2013

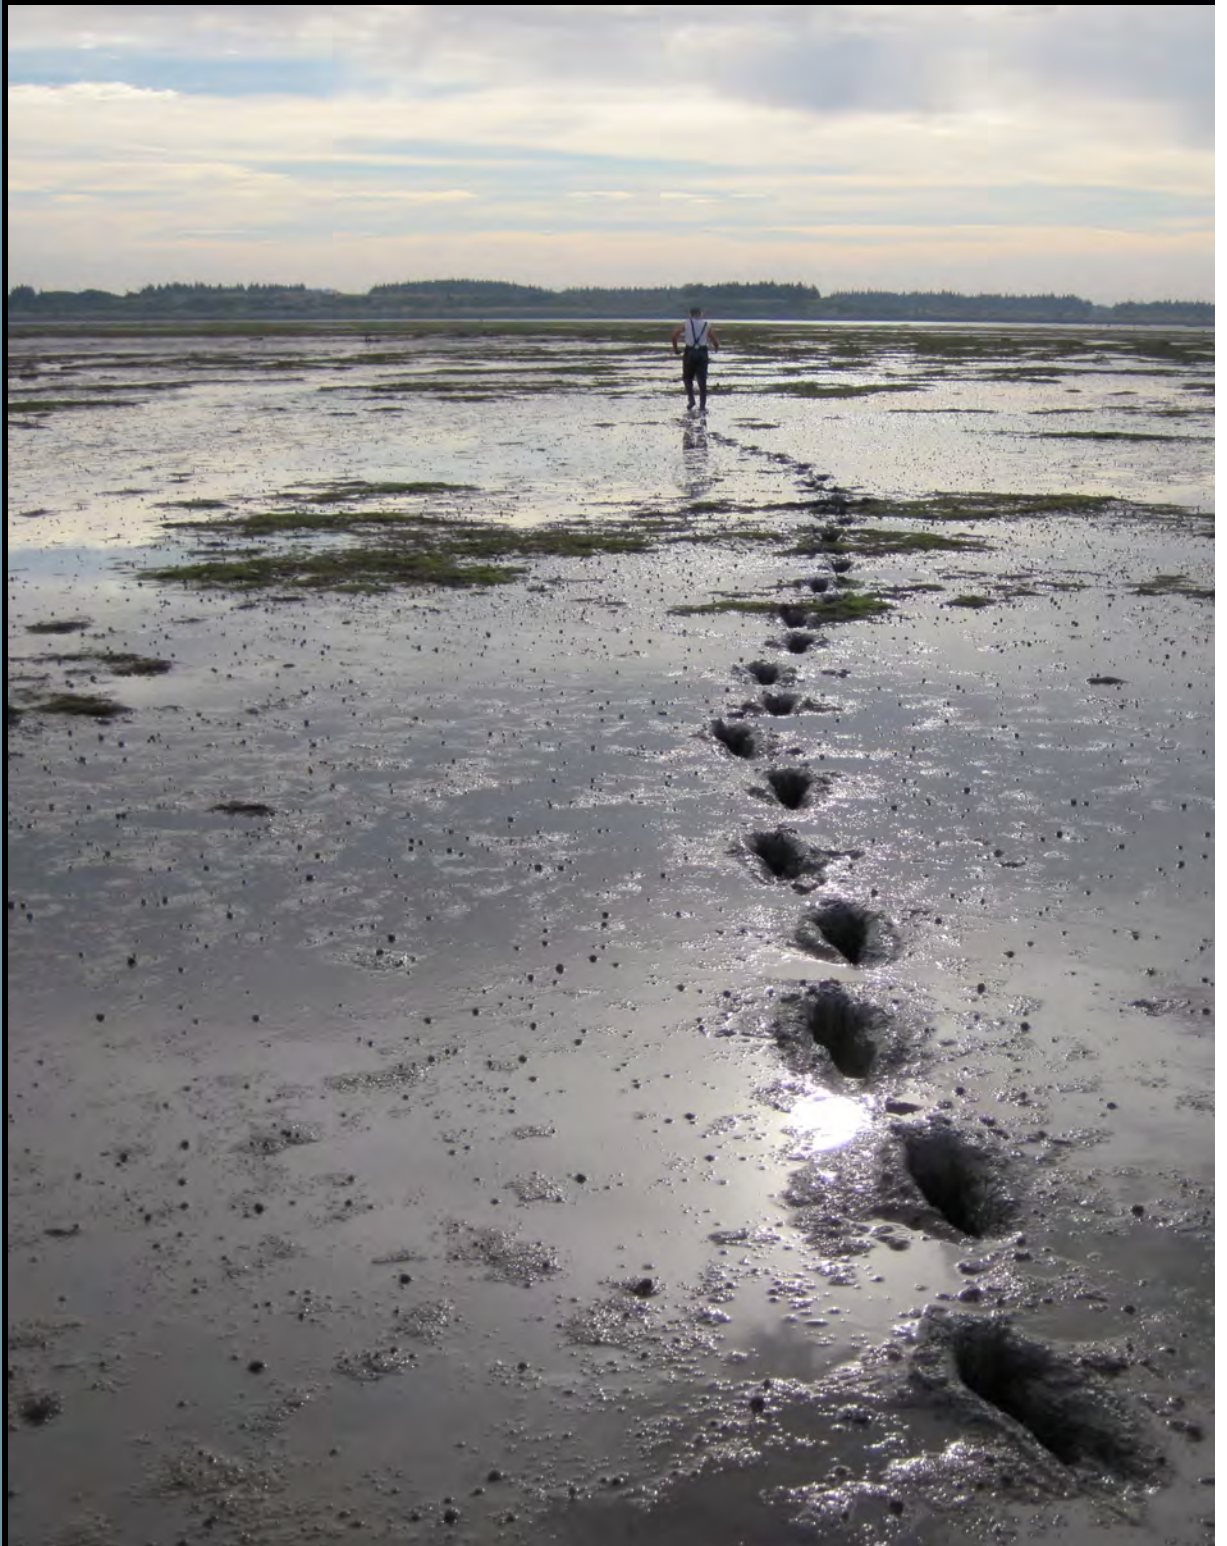
Cover Photo: *Gracilaria* and excessive soft mud deposition on intertidal flats in the Waihopai Arm.

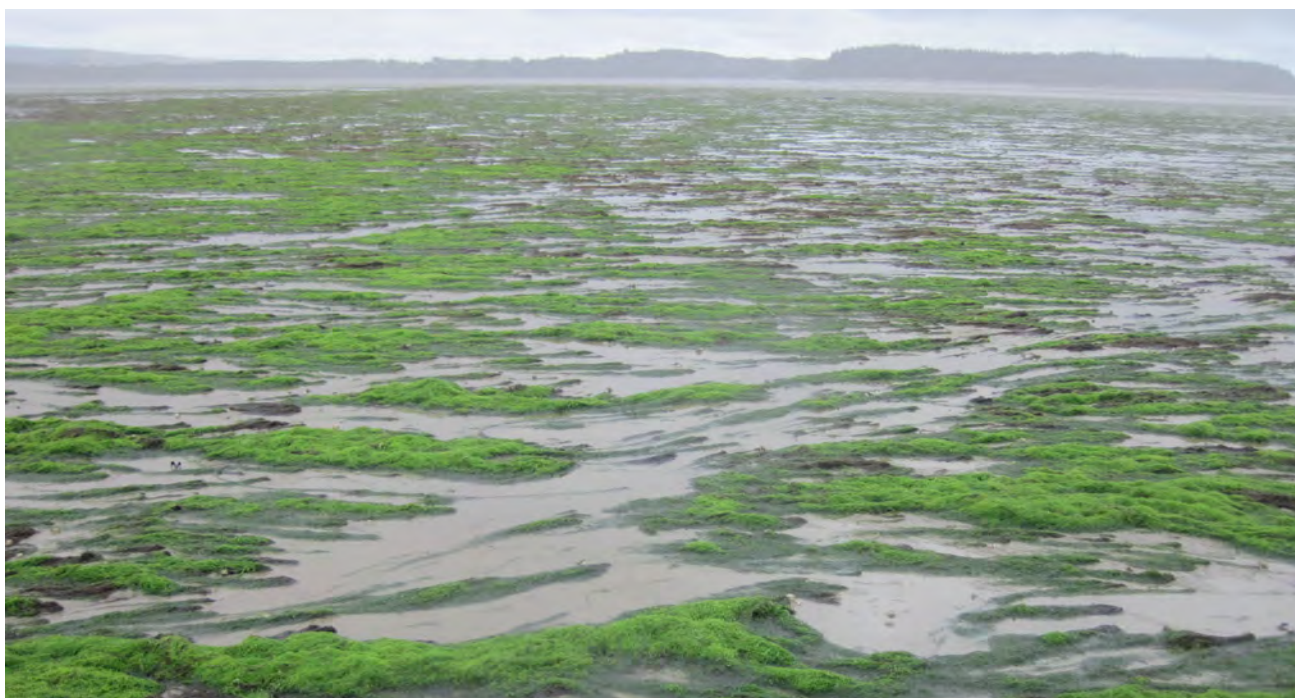
Extensive growths of *Ulva* (*Enteromorpha*) and *Gracilaria* on intertidal flats near the Oreti River mouth.

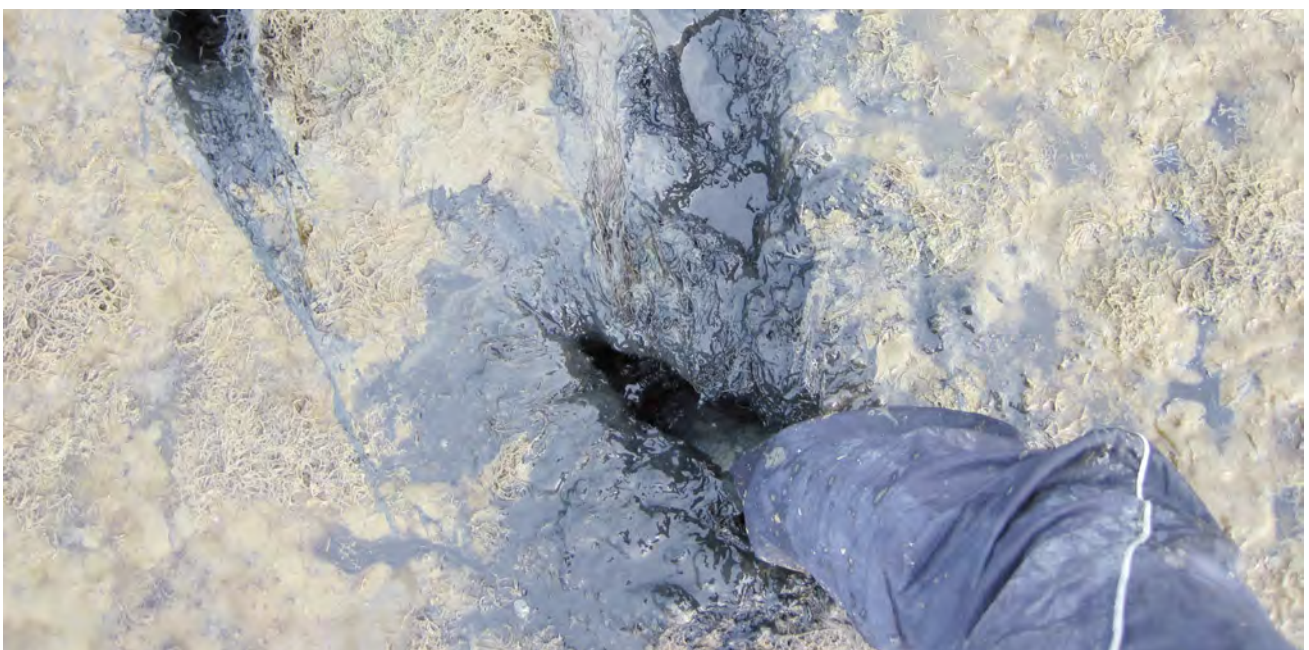
Rotting *Gracilaria* and sulphide rich sediment in the Waihopai Arm.

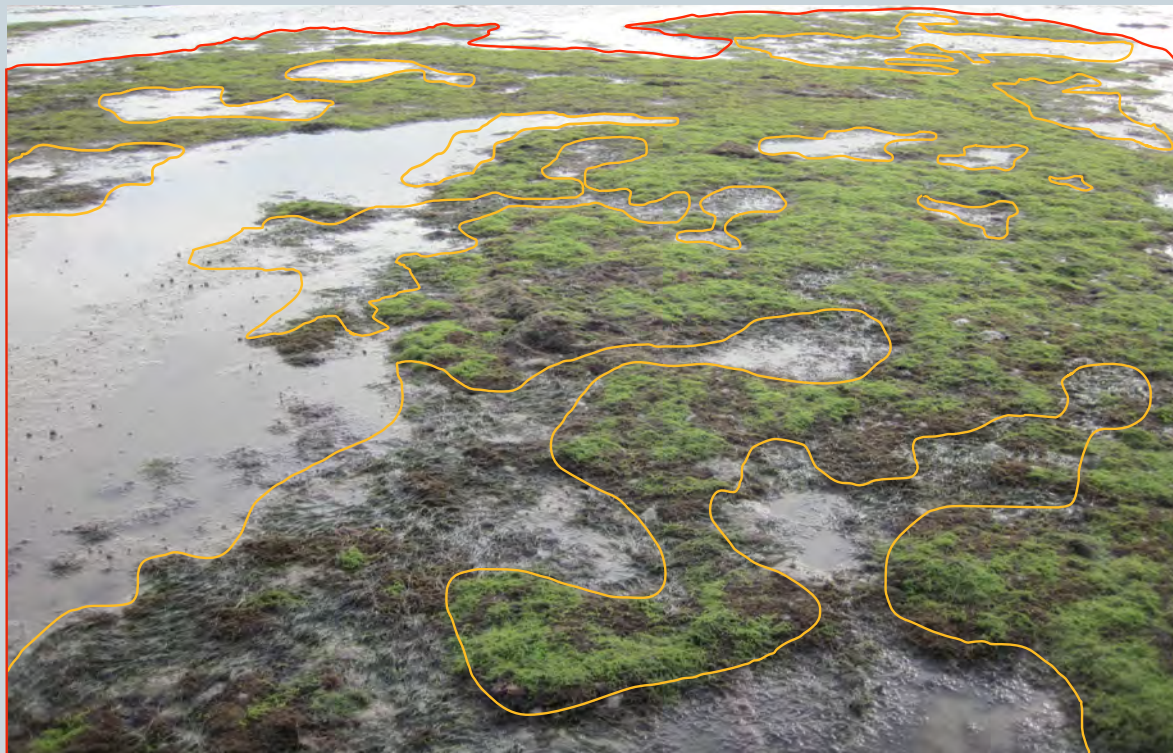
In the western side of the Waihopai Arm there was an 85% loss of seagrass (a reduction from 46ha to 7ha) from 2001 to 2012 (Stevens and Robertson 2012), with the remaining seagrass beds in a state of stress from smothering with fine muds and dense macroalgae. Changes in seagrass cover from 2012 to 2013 were assessed directly in the field using an ipad showing digital boundaries of the seagrass beds mapped in 2012, and real-time GPS tracking to highlight where change had occurred. This clearly showed the extent of losses, and that smothering of seagrass with fine muds and dense macroalgae was likely to be the primary cause of loss. Losses from 2012 to 2013, assessed in representative areas, were estimated at 50% (~3.5ha), with a typical change indicated in Figure 5 below.

In most areas where macroalgal cover exceeded 80%, underlying seagrass was dead or highly stressed, while mud deposition had completely buried many beds. Consequently, unless macroalgal and sediment deposition rapidly declines in the upper Waihopai Arm, the remaining seagrass beds, previously the most extensive in the estuary, are likely to be lost in the very near future.

Figure 5. Representative example of seagrass bed smothered by macroalgal growth and soft mud, Waihopai Arm, Feb. 2013. The 2012 seagrass boundary is indicated by the red line and the 2013 seagrass boundary indicated by yellow lines, indicating ~50% loss from smothering by macroalgae or soft mud.

- Continue with the programme of annual broad scale mapping of macroalgae. Next monitoring due in February 2014. In addition, in order to assess changes in seagrass cover (particularly in the Waihopai Arm), it is recommended that seagrass cover in key locations be monitored annually in tandem with the macroalgal monitoring.

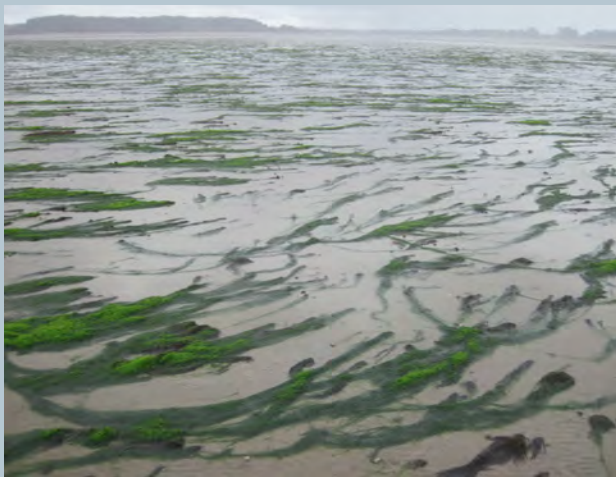
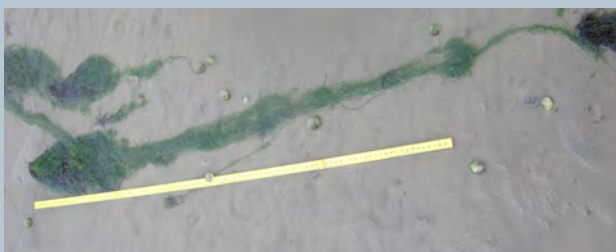
Extensive parts (72%) of the estuary also had a low (<5%) macroalgal cover with no nuisance conditions. These areas were located predominantly in the well-flushed lower estuary and central basin, and the northeastern and eastern flats. However, it was notable in 2013 that the growths were often long (>1m) indicating very favourable growing conditions (Figure 7).

Figure 7. *Ulva* and *Gracilaria* growth near the Oreti River mouth (1m ruler shown).

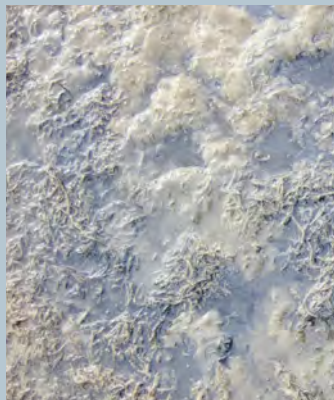
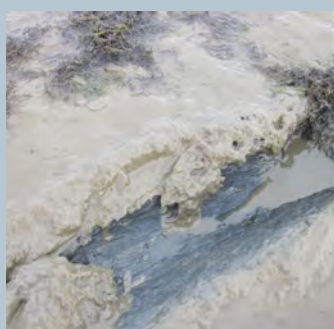
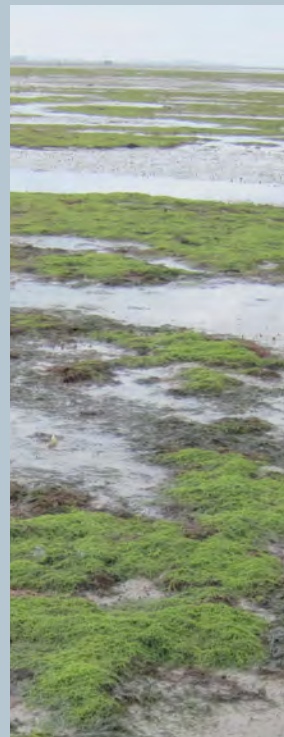
The worst impacted area in the estuary is on the northwestern flats between Bushy Point and the Waihopai River channel (Figures 8 and 9), but there are two other areas in the estuary where *Gracilaria*-dominated macroalgal growth is also excessive - Daffodil Bay and Bushy Point. Degraded sediment conditions in Daffodil Bay, while not as extensive as in the Waihopai Arm, show low oxygen levels, elevated organic enrichment, high and increasing dense macroalgal cover, and the presence of soft muds - a clear indication of deteriorating conditions.

Figure 8. Examples of anoxic sediment and extensive macroalgal cover in the Waihopai Arm in 2013.

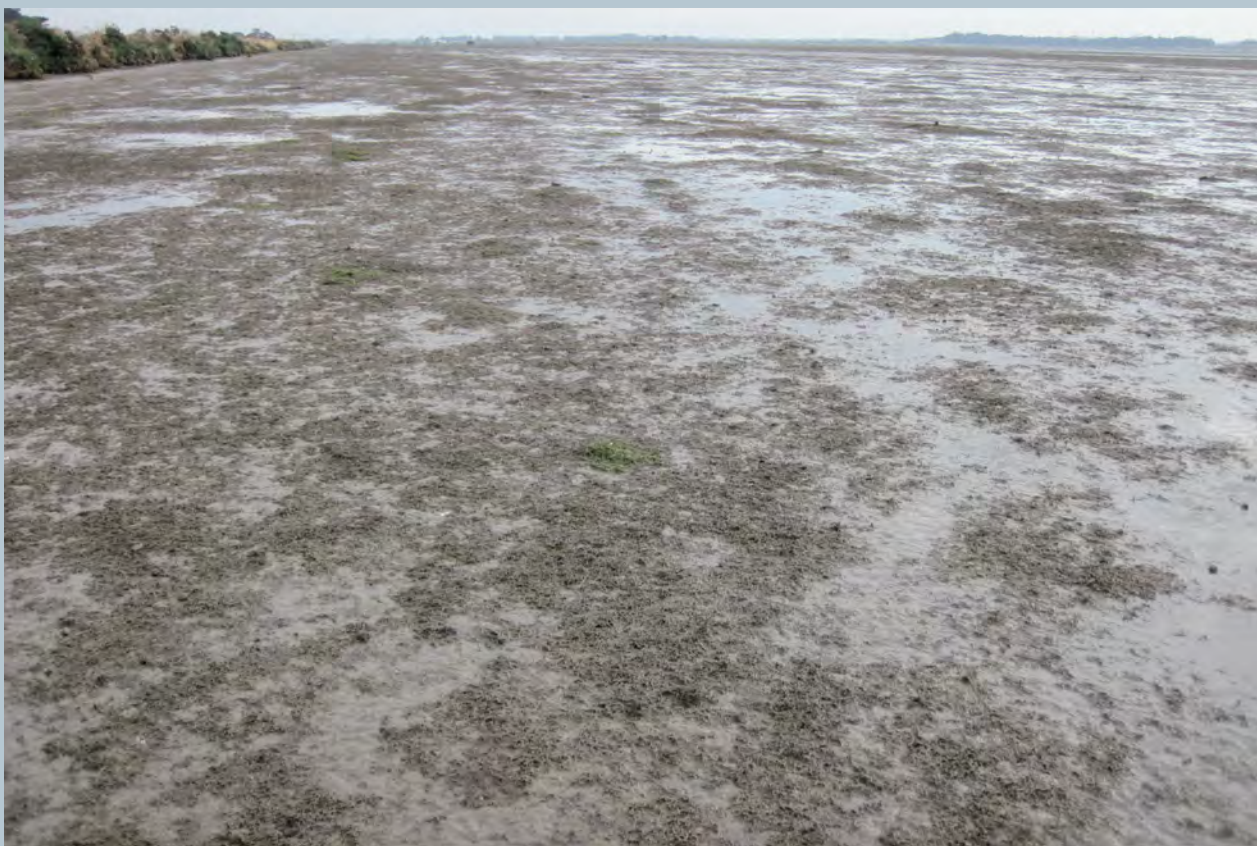
Figure 9. *Gracilaria* beds in the Waihopai Arm, 2013. Seagrass beds dominated this area in 2001.
