# Southland Coast

## Te Waewae Bay to the Catlins

Habitat Mapping, Risk Assessment and Monitoring Recommendations

Prepared  
for  
Environment  
Southland

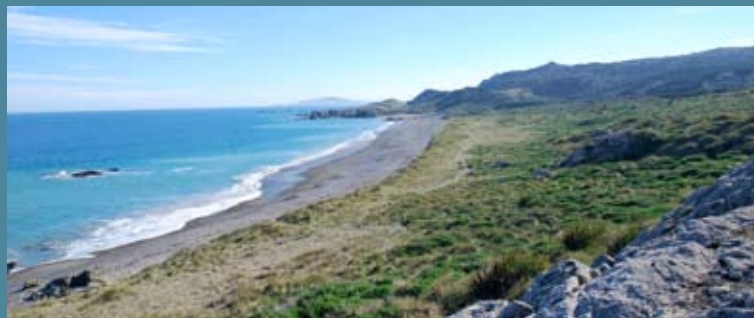
Wastewater plume - Howells Point near Riverton.

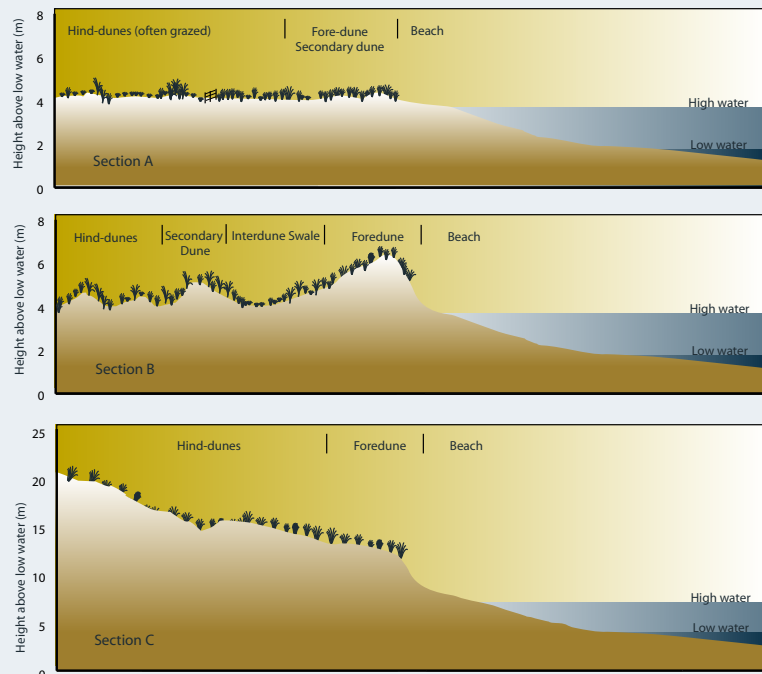
Figure 1. Cross sections of 3 typical Southland dune systems.

The structure and vegetation cover on coastal dune systems vary markedly, dependent on location and exposure. Figure 1 provides cross sections of 3 typical Southland dune systems and the general zones found within them.

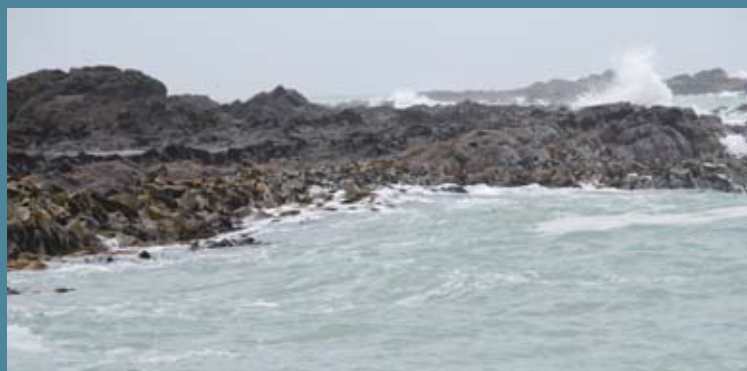
Platform reef near Dummys Beach - such low lying reefs will lose intertidal communities with sea level rise.

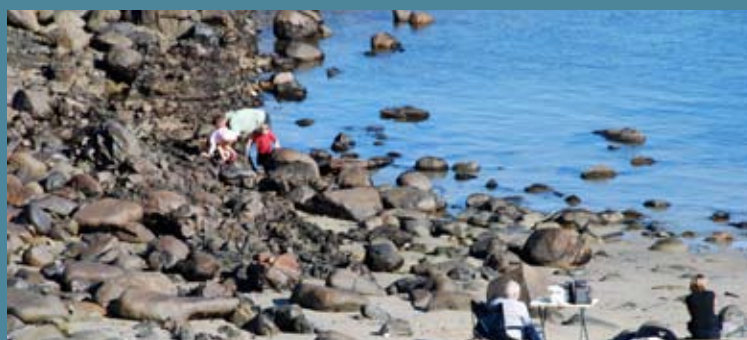
Collecting rocky shore animals at Cosy Nook - damage can occur if too many plants or animals are taken or trampled.

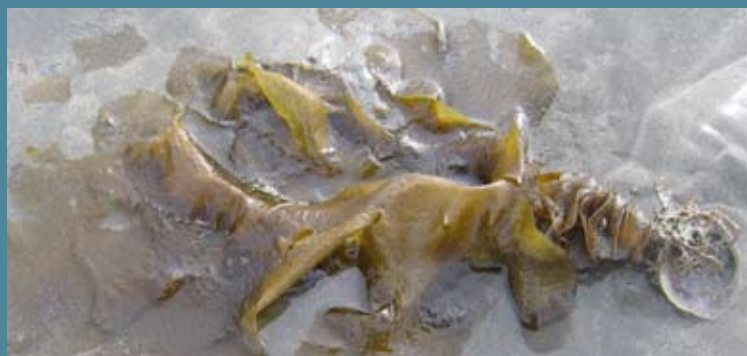
Example of the invasive seaweed *Undaria*.

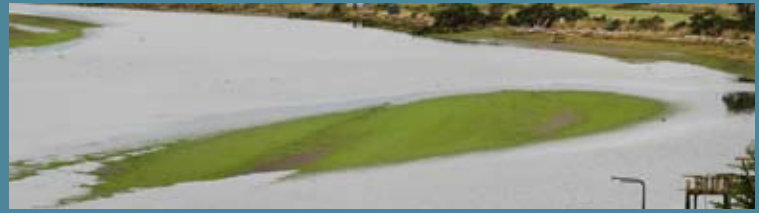
Jacobs River Estuary - Green algal bloom caused by excessive nutrients in Aparima River.

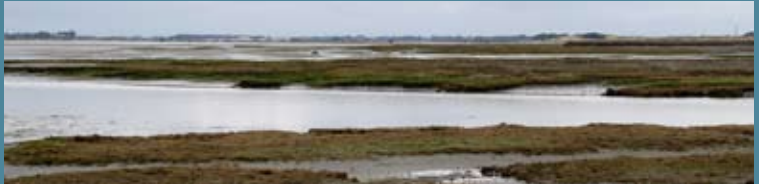
Invercargill City point source discharge of treated wastewater to New River Estuary.

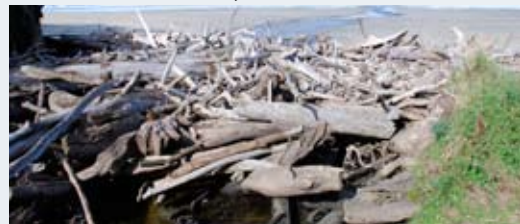
Grove Burn Estuary, mouth constricted with wood debris

Issues	Monitoring	Management
Mouth constricting. Natural cycle of low to high water quality as degree of mouth restriction varies. Estuary margin deterioration.	<ul style="list-style-type: none"> <li>Map intensive landuse - 5 yearly.</li> <li>Habitat map estuary every 10 years.</li> </ul>	<ul style="list-style-type: none"> <li>Limit intensive landuse development and/or manage to ensure low WQ impacts.</li> <li>Encourage margin vegetation maintenance.</li> <li>Assess possibility of artificial mouth opening.</li> </ul>

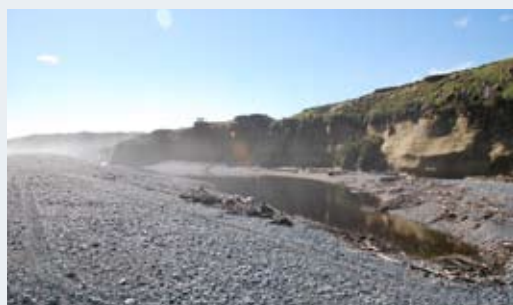
Waimeamea Estuary, mouth closed

Issues	Monitoring	Management
Mouth constricting. Natural cycle of low to high water quality as degree of mouth restriction varies.	<ul style="list-style-type: none"> <li>• Map intensive landuse - 5 yearly.</li> <li>• Habitat map estuary every 10 years.</li> </ul>	<ul style="list-style-type: none"> <li>• Limit intensive landuse development and/or manage to ensure low WQ impacts.</li> <li>• Encourage margin vegetation maintenance.</li> <li>• Assess possibility of artificial mouth opening.</li> </ul>

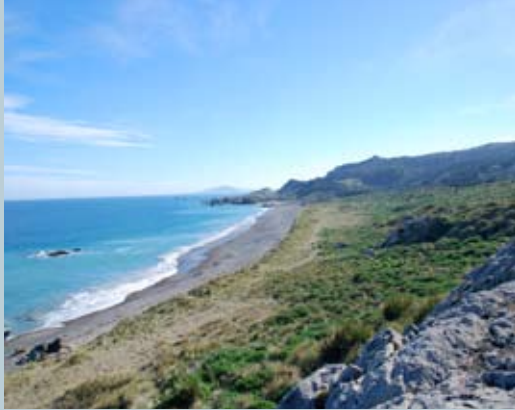
Beach at Howells Point (treated wastewater plume visible near shore all along beach)

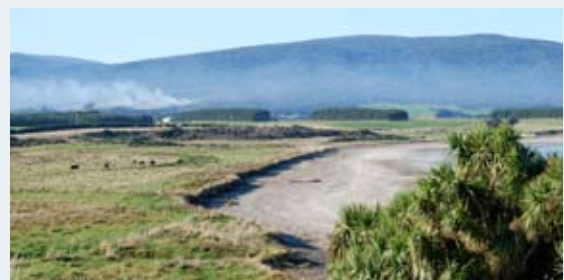
Pouahiri Estuary (centre), channelised and grazed to near the margin.

Issues	Monitoring	Management
<ul style="list-style-type: none"> <li>Landuse intensification.</li> <li>Grazing near margin.</li> <li>Channelised profile.</li> <li>Mouth constricts, low WQ.</li> <li>Weeds.</li> </ul>	<ul style="list-style-type: none"> <li>Map intensive landuse - 5 yearly.</li> <li>Habitat map estuary every 10 years.</li> </ul>	<ul style="list-style-type: none"> <li>Limit intensive landuse development</li> <li>Fence margins.</li> <li>Encourage margin profile shallowing and vegetation maintenance.</li> <li>Assess possibility of artificial mouth opening.</li> </ul>

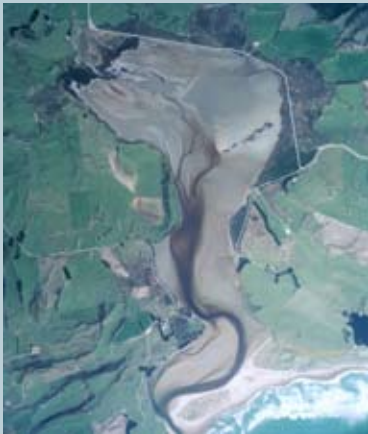
Haldane Estuary showing loss of saltmarsh with road development at top end.

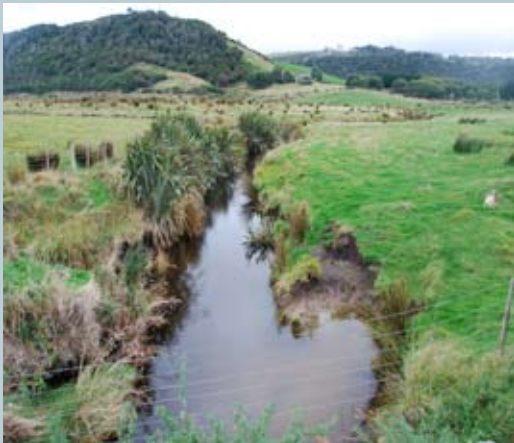
Cooks Creek Estuary - grazed unfenced margins.
