Waiau (Te Waewae) Lagoon 2012

Fine Scale Monitoring and Macrophyte Mapping

Prepared
for
Environment
Southland
August
2012

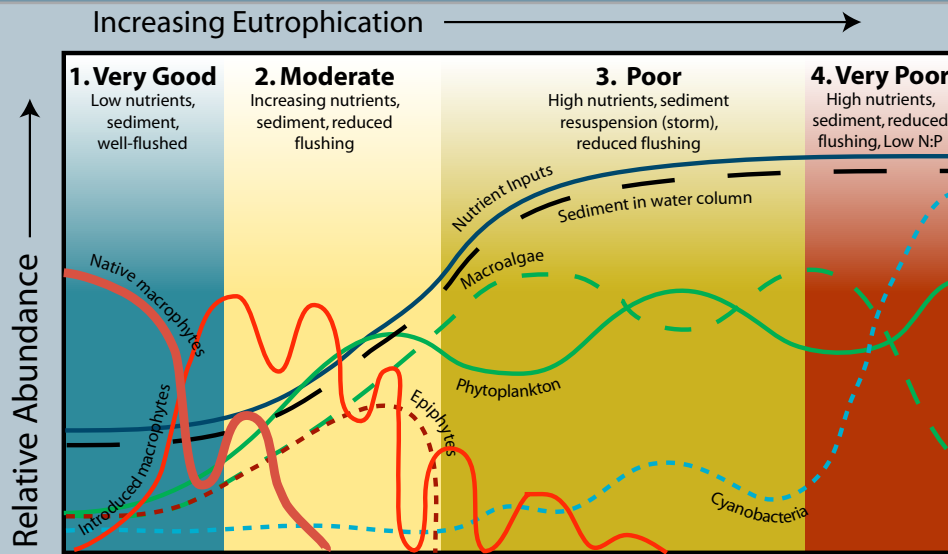
Figure 2. Tidal river mouth lagoon response to increasing eutrophication and other events.

Conceptual representation of response of aquatic vegetation to increased nutrients in coastal lagoons (modified from de Wit et al. 2001, Viaroli et al. 2004, Zaldivar et al. 2008 and information on NZ coastal lagoons - Mitchell 1971, Gibbs 1973, Gerbeaux and Ward 1991, Gibbs 2002, Edwards and Clayton 2002, Stevens and Robertson 2007 and 2007a, Ward 2008).

Eutrophication and sedimentation were highlighted as the greatest risks for the lagoon (Robertson and Stevens 2008). The likely pattern of increasing eutrophication and sedimentation that such lagoons follow, in response to increased nutrients (particularly nitrogen and phosphorus) and fine sediments, is presented in Figure 2.

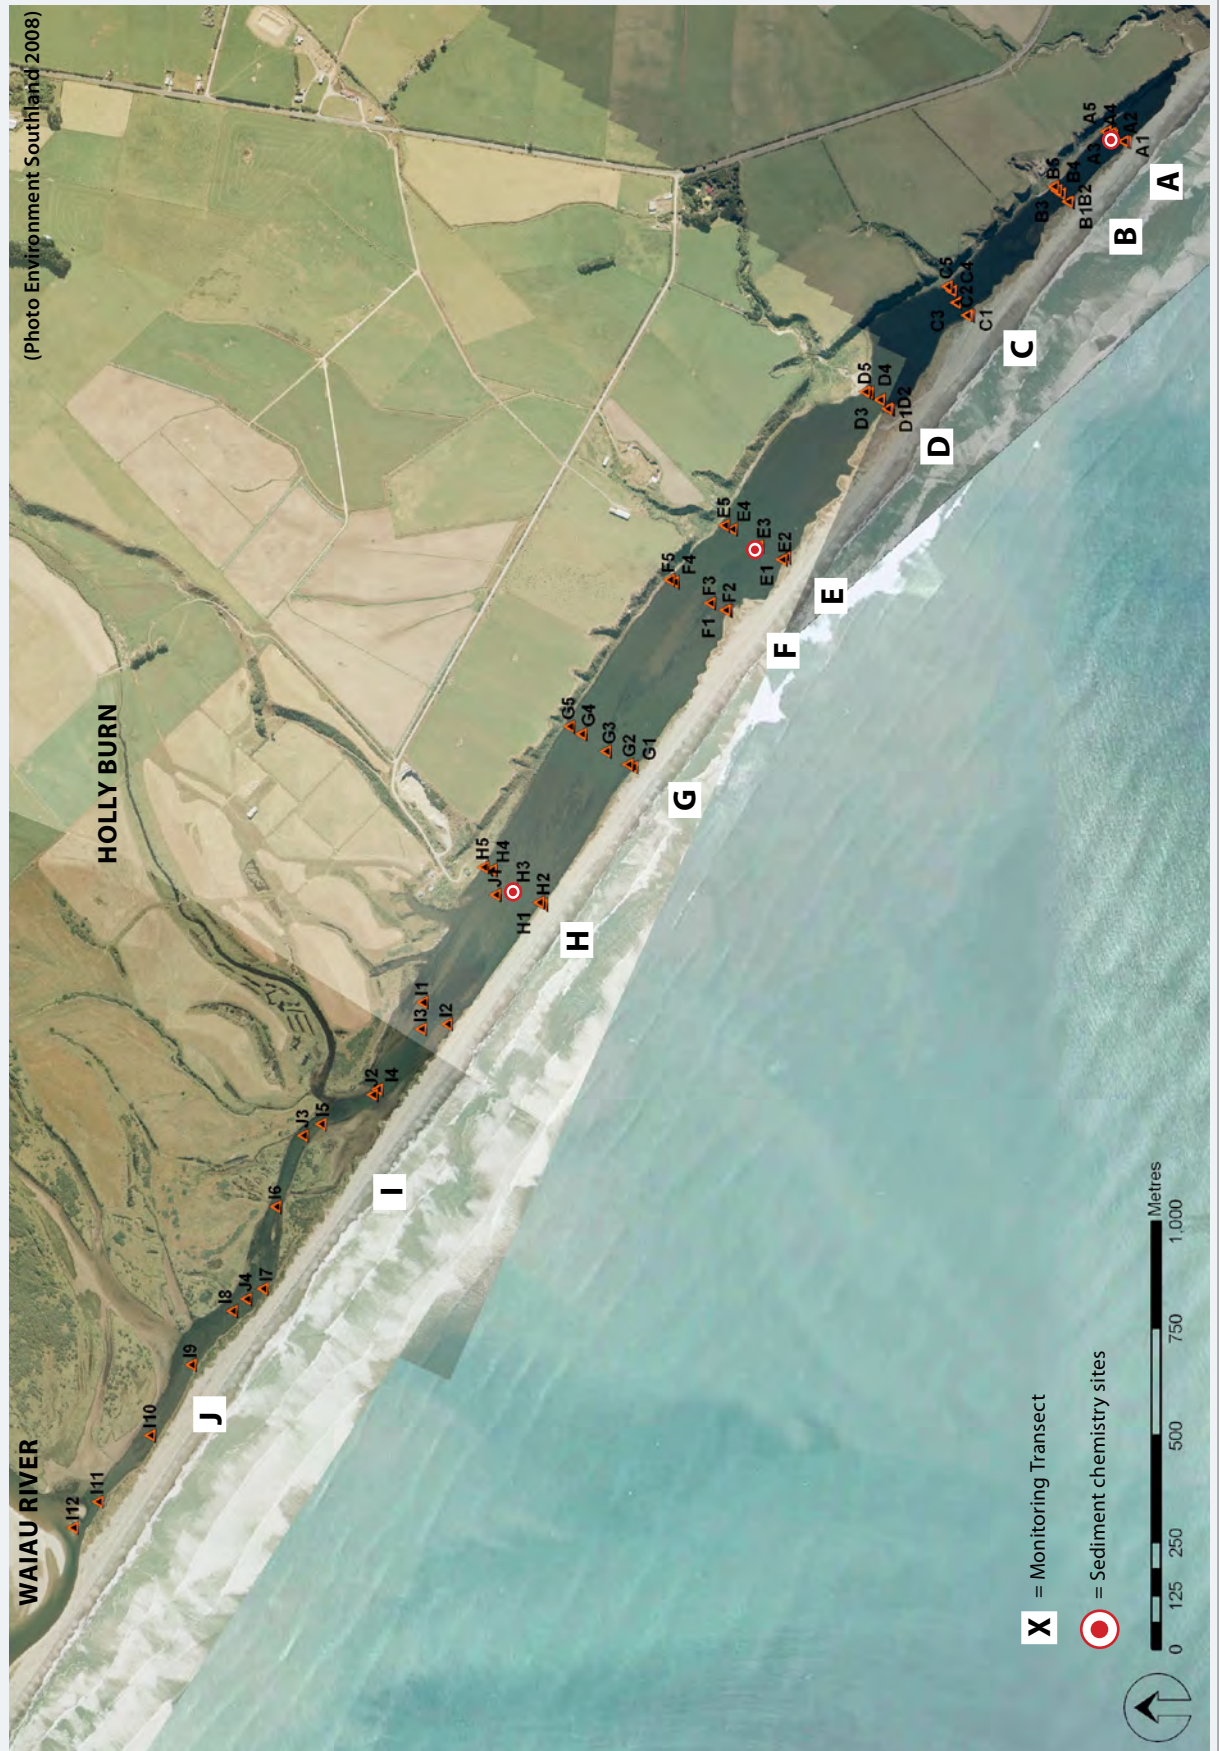
Figure 4. Location of sampling sites, Waiau/Te Waewae Lagoon, 24 January 2012.

Nine previously established transect sampling sites in Waiau/Te Waewae Lagoon (Robertson and Stevens 2009) are shown in Figure 4 covering a representative cross section of conditions throughout the estuary. They were visited by two scientists on 24 January 2012 when the lagoon was open to the sea. At each site, sampling was undertaken for key indicators of estuary condition as described below. The purpose was to collect information which, through repeat sampling, can be used as a rapid and robust method to indicate change within the estuary.

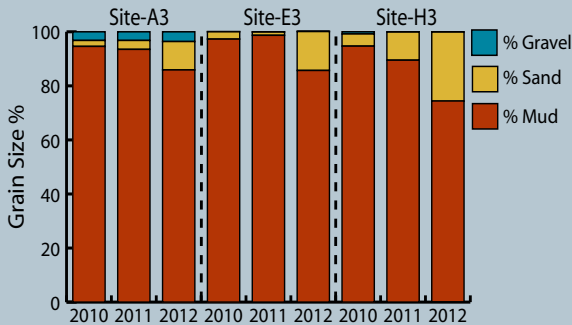
Figure 5. Grain size, at 3 subtidal sites (composite sample), Jan/Feb 2010-2012.

Grain Size: Analytical results from the three transects sampled, (A, E and H - Figure 5) show that the mud content is very high in the main estuary basin. This indicates that mud from the catchment is accumulating predominantly in the deeper reaches of the main lagoon, and indicating it is more at risk of sedimentation effects than the sandier more well-flushed western channel end. However, the results also indicate a substantial decline in mud content compared with previous years. The reason for this decline is currently unknown but one possible explanation is extensive wind driven re-suspension of fine sediment from the estuary bottom coupled with export from the lagoon following mouth closure just prior to sampling. Other possible explanations include catchment management actions to reduce fine sediment loads to streams, an abnormal annual river flow regime, and/or an increase in catchment gravel input loads. Overall, the findings indicate excessive deposition of fine-muds in Waiau/Te Waewae Estuary.

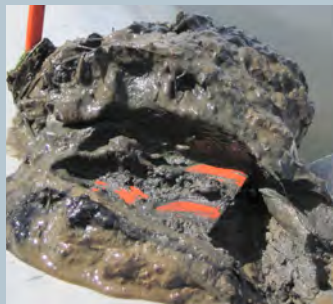
Sulphide-rich fine soft muds with shallow RPD - 2.5m depth.

Redox Potential Discontinuity (RPD). The depth of the RPD zone provides an indication of the level of sediment oxygenation. Like 2011, in 2012 the surface sediments within the lagoon were generally moderate to poorly oxygenated (RPD depth range >5cm to 1cm). Black sulphide-rich sediment was present near the surface under rotting macroalgae and macrophytes in localised areas (Figure 6), but this was not widespread. Such variable RPD values indicate the changeable conditions often experienced in tidal river estuaries where river flow is a major influence on estuary condition. As a result, the benthic community was likely to be transitional and dominated by organisms and plants tolerant of organic enrichment.

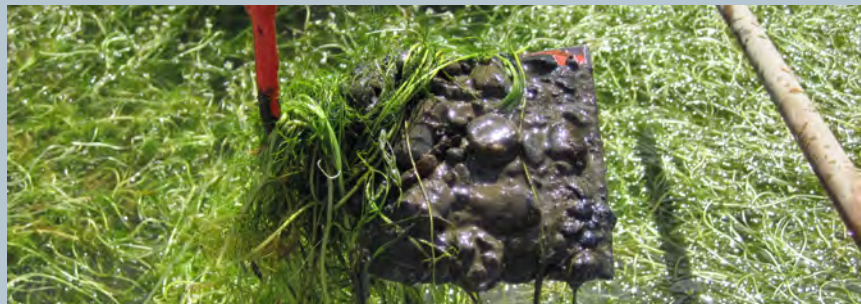
Poorly oxygenated cobble margins and moderately oxygenated muds in the middle estuary.

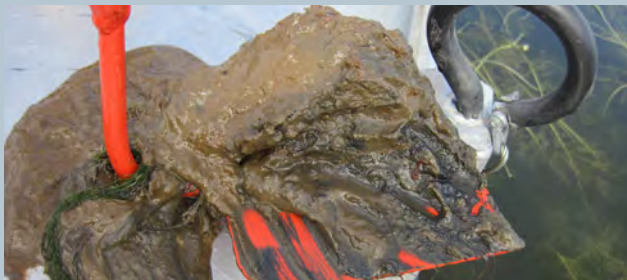
Clean oxygenated muds overlying sand and gravel at 1m depth.

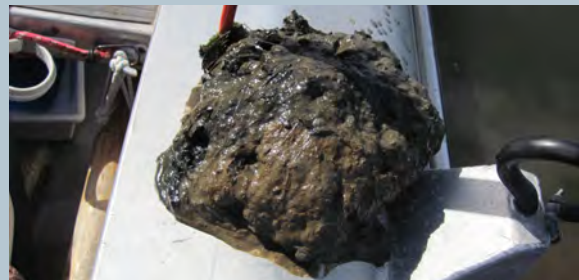
Anoxic sulphide rich sediment associated with decaying vegetation - 3m depth.

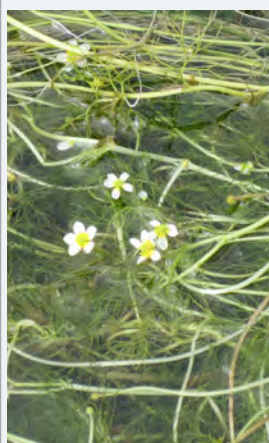
Ranunculus trichophyllus

R. trichophyllus (Water buttercup) is an introduced species common in freshwater and slightly saline waterbodies. Stems are up to 2m long, leaves are narrow and bright green. Flowers are white with a yellow centre. Found in patches in Waiau lagoon in shallow (<1m deep) water, with cover becoming extensive in 2011.

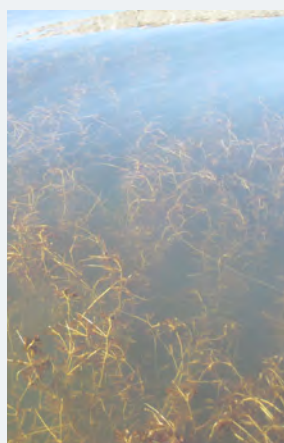
Potamogeton crispus

P. crispus is an introduced species that is tolerant of slightly brackish as well as freshwater. It can survive in low light and low temperatures, and prefers high nutrient water. It spreads mostly by means of vegetative buds (turions) that germinate in autumn. It forms dense mats of vegetation to the surface of the water. These mats inhibit the growth of native aquatics, and can interfere with boating and other water recreation. These plants germinate in autumn, grow vigorously in spring, and die off in the summer. The decaying plant matter can make the water extremely enriched and encourage nuisance algal mats near the sediment surface. Mainly found in the Waiau Lagoon in the 1-2m depth range.

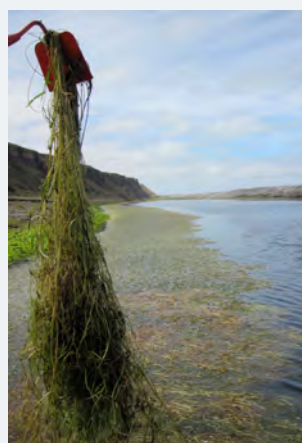
R. trichophyllus and *P. crispus* (1-2m long) at margin in east of the lagoon
