# Waiau Lagoon 2010

## Fine Scale Monitoring and Macrophyte Mapping

Prepared  
for  
**Environment  
Southland**  
July  
2010

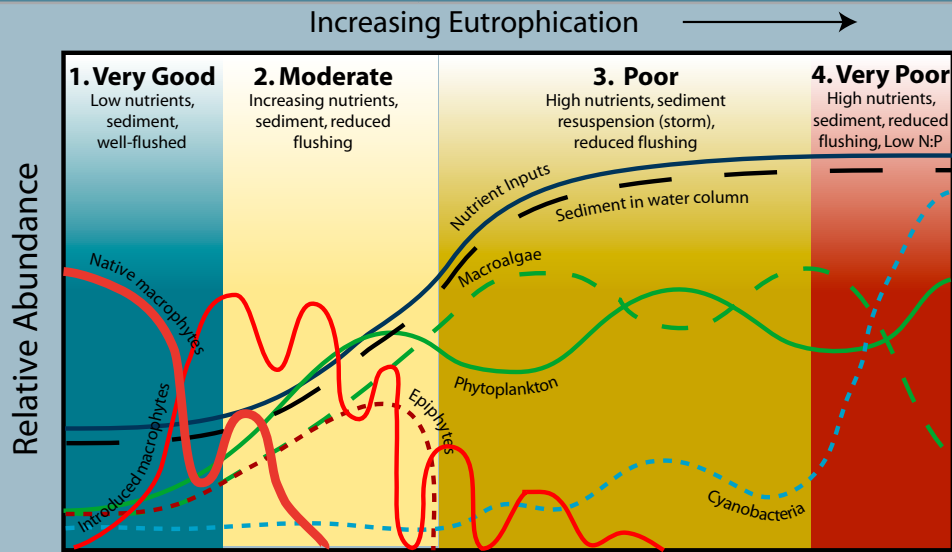
Figure 2. Tidal River Mouth Lagoon Response to Increasing Eutrophication and Other Events.

Conceptual representation of response of aquatic vegetation to increased nutrients in coastal lagoons (modified from de Wit et al. 2001, Viaroli et al. 2004, Zaldivar et al. 2008 and information on NZ coastal lagoons - Mitchell 1971, Gibbs 1973, Gerbeaux and Ward 1991, Gibbs 2002, Edwards and Clayton 2002, Stevens and Robertson 2007 and 2007a, Ward 2008).

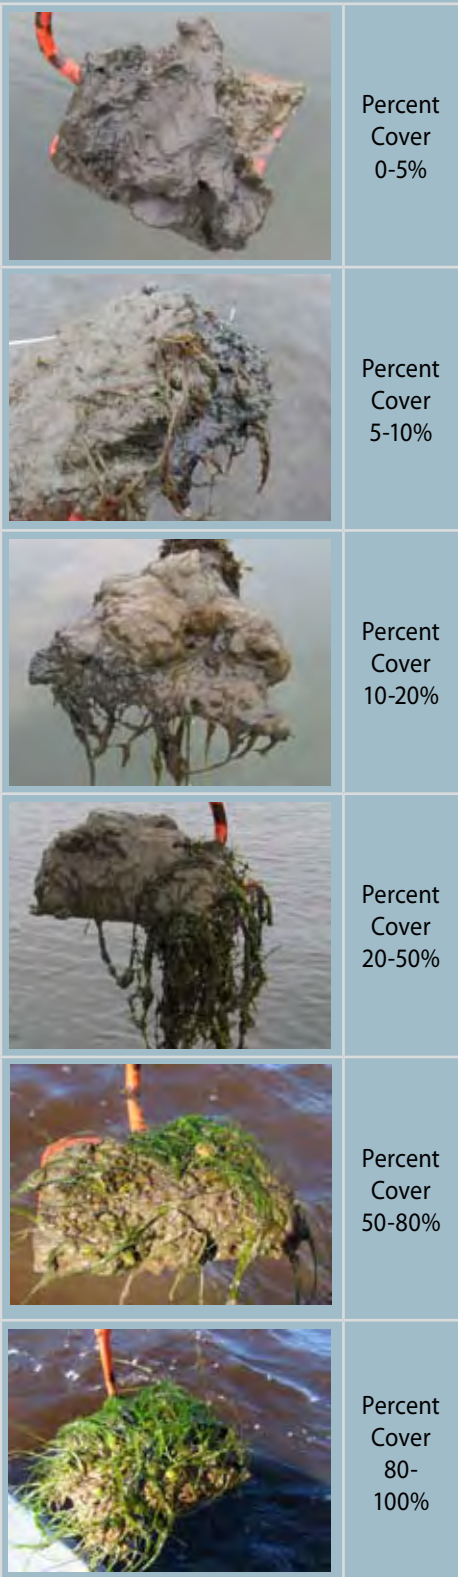
Figure 3. Percent cover categories for aquatic vegetation.

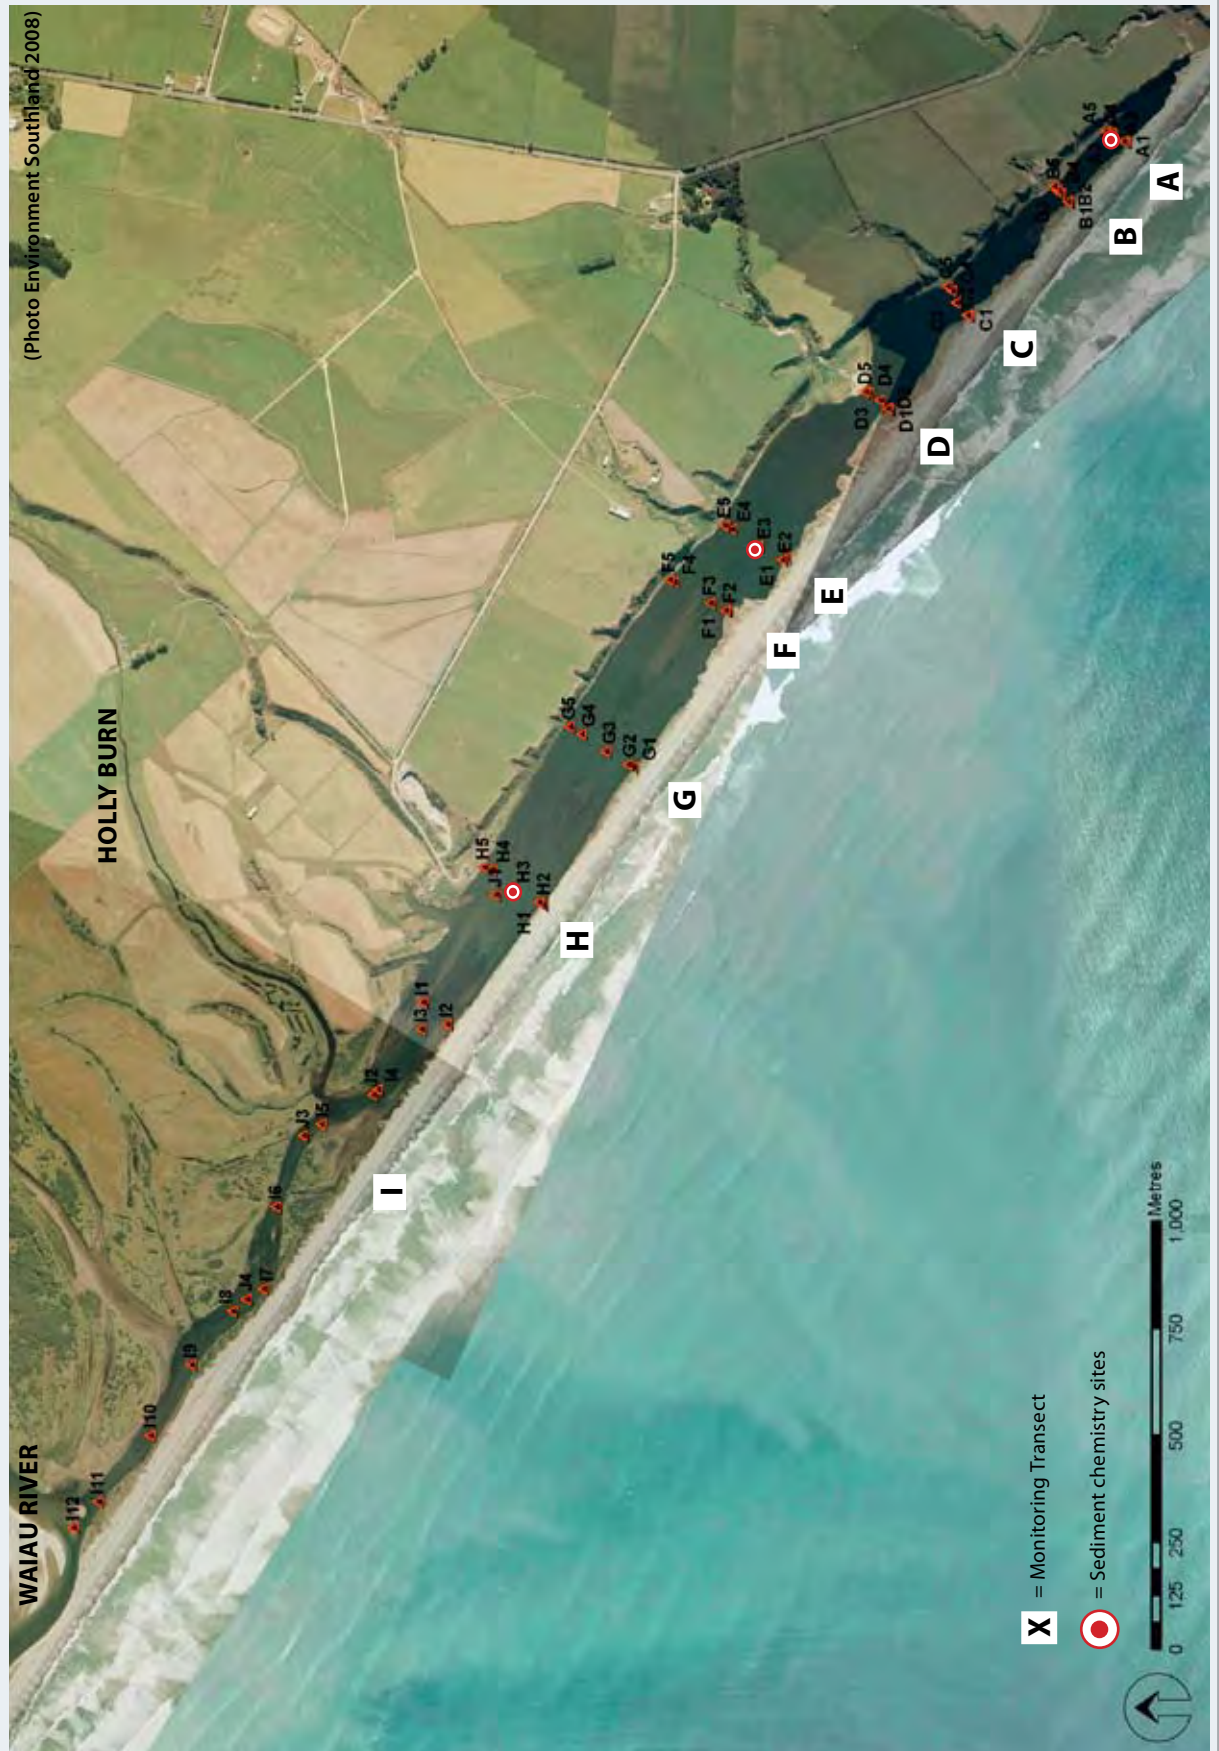
Figure 4. Location of sampling sites, Waiau Lagoon February 2010.

Nine previously established transect sampling sites in Waiau Estuary (Robertson and Stevens 2009) are shown in Figure 4. They provide a representative cross section of conditions throughout the estuary, and were visited by three scientists on 17 February 2010 when the lagoon was open to the sea. At each site, sampling was undertaken for key indicators of estuary condition as described below. The purpose was to collect information which, through repeat sampling, can be used as a rapid and robust method to indicate change within the estuary.

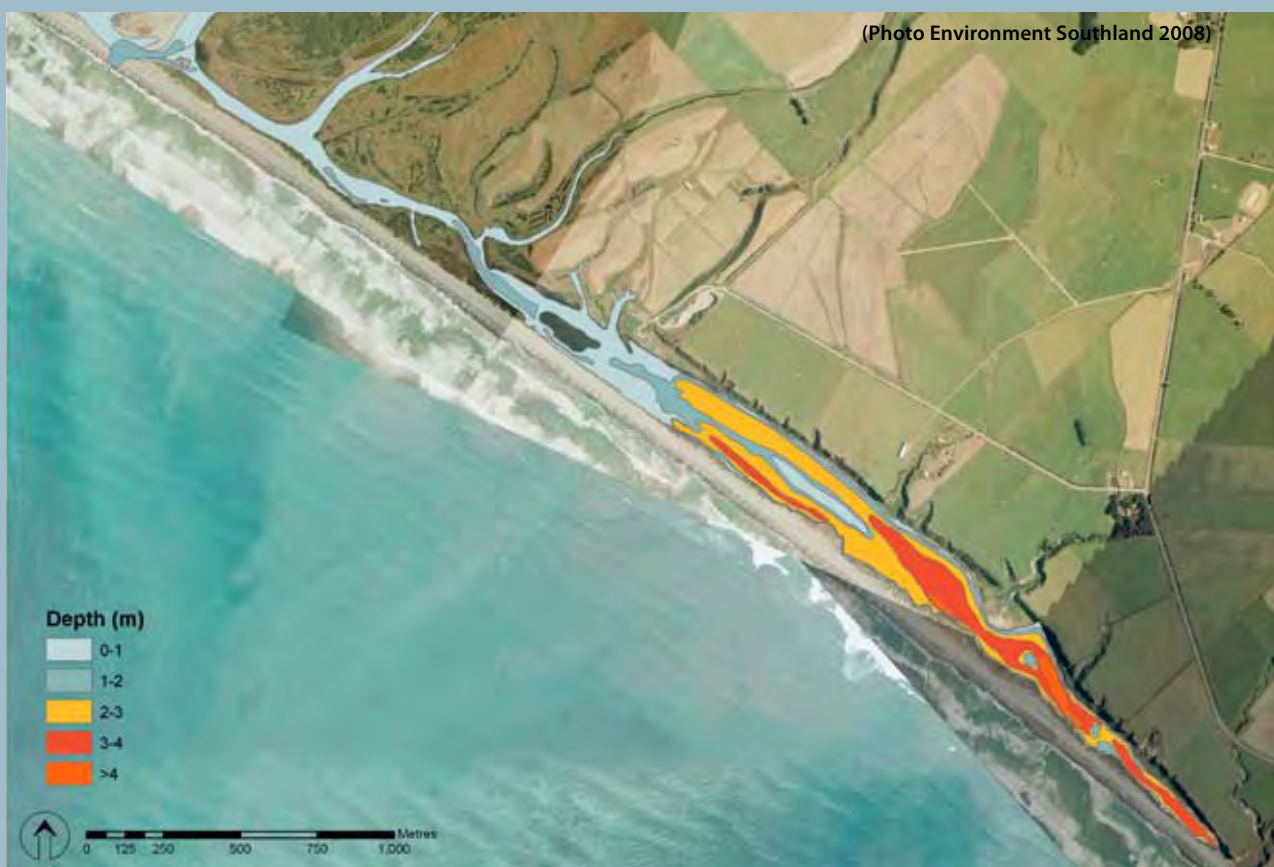
Figure 7. Approximate water depth Waiau Lagoon, 17 February 2010.

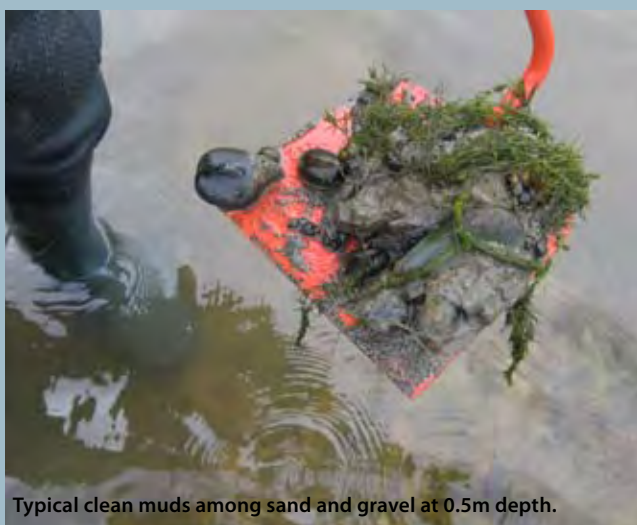
Typical clean muds among sand and gravel at 0.5m depth.

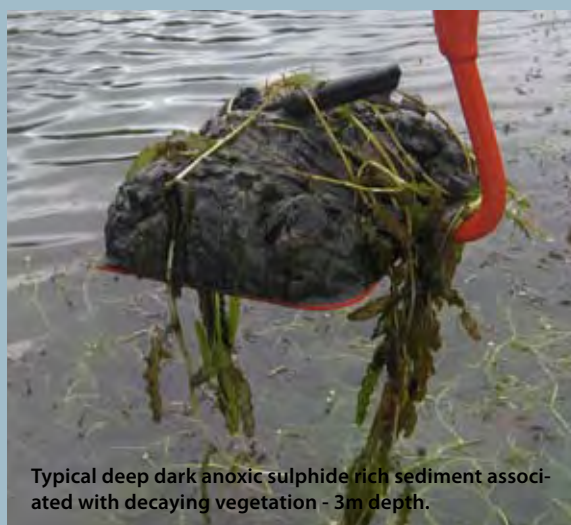
Typical deep dark anoxic sulphide rich sediment associated with decaying vegetation - 3m depth.

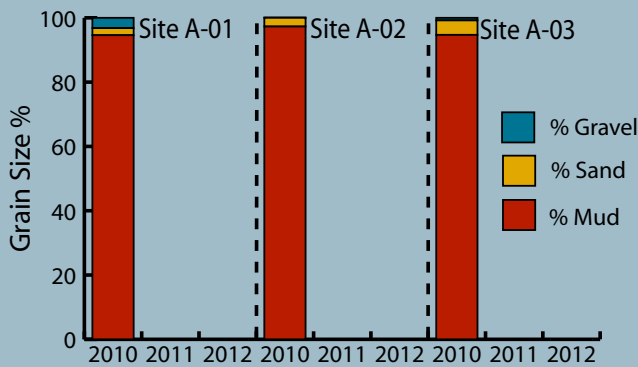
Figure 9. Grain size at 3 subtidal sites, Waiau Lagoon, 17 February 2010.

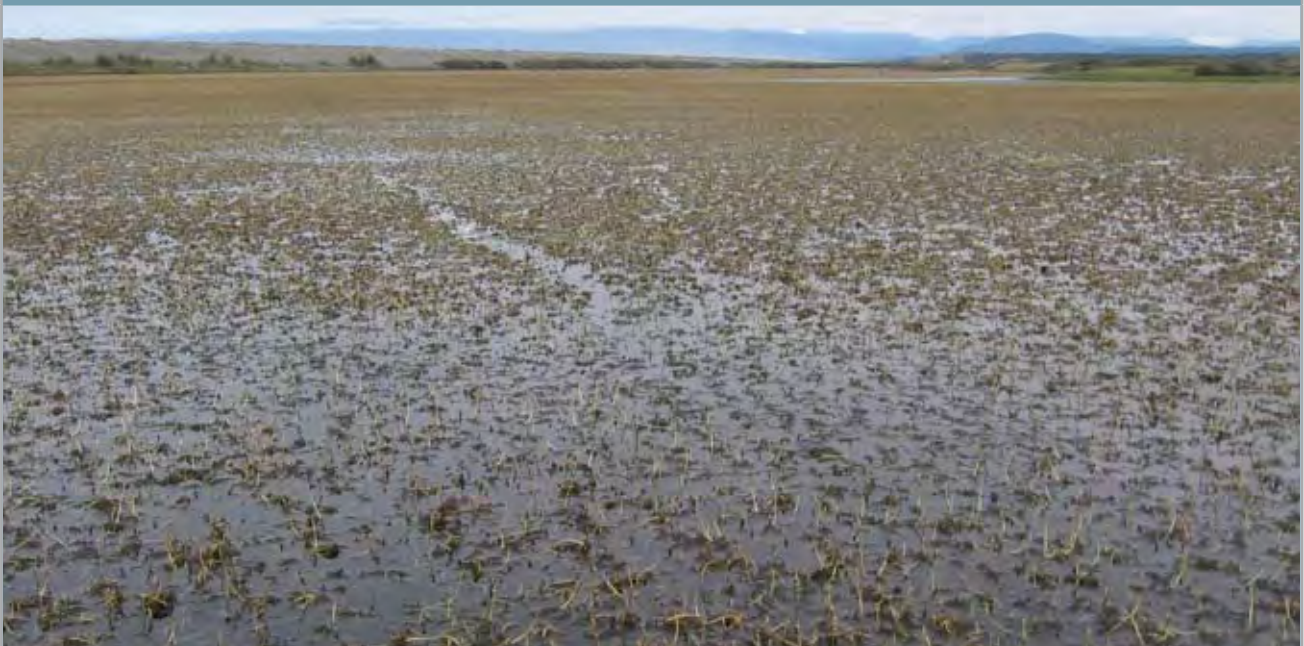
Figure 13. Waiau Lagoon - extensive choking growth of *Potamogeton crispus* just east of the Holly Burn mouth.

In order to establish baseline conditions, undertake fine scale monitoring (including macroalgal and macrophyte mapping) annually for the next 2-3 years, then every five years (next scheduled for February 2011). Broad scale habitat mapping is scheduled every 5 years (next due 2013). In order to assess water column trophic status, monthly water quality monitoring should be initiated. To assess the potential for excessive nutrients and sediment entering the lagoon and for reduced flushing, monitor the following key stressors: reduced flushing, catchment landuse, freshwater abstraction, mouth constriction, and changes to water level. In addition, sediment rate monitoring options should be initiated for the fine and easily disturbed sedimentation evident in the estuary east of the Holly Burn.

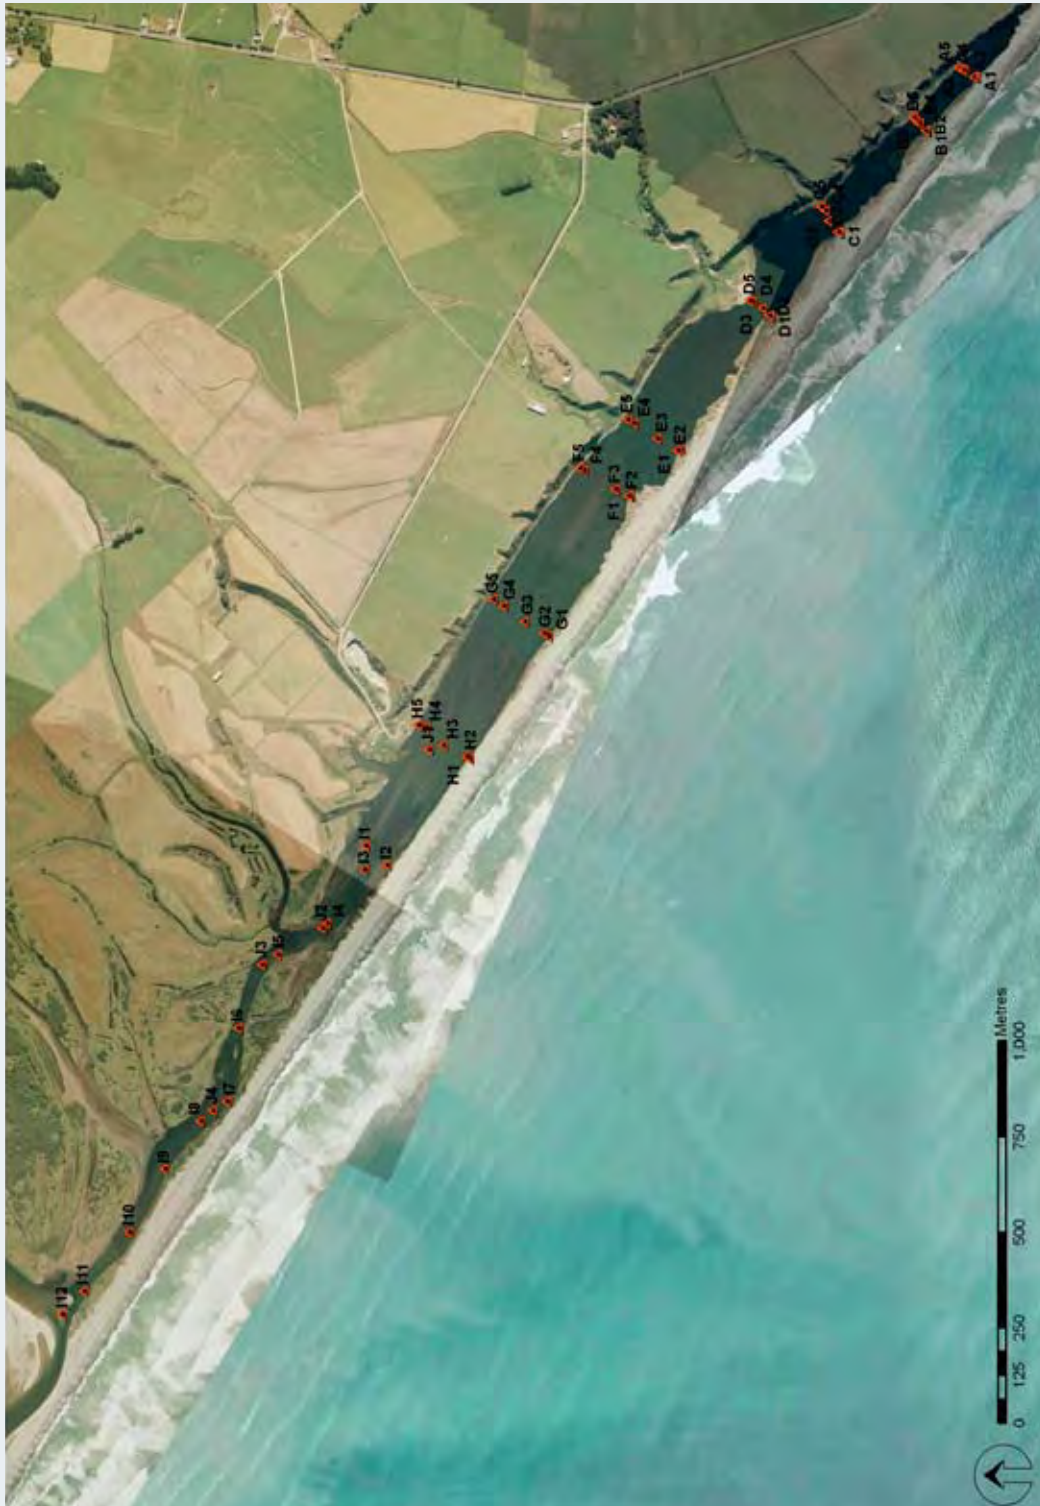
Map of Waiau Lagoon showing the location of sampling transects and sites.
