Waikawa Estuary

Broad Scale Habitat Mapping 2008/09

Environment
Southland

June
2009

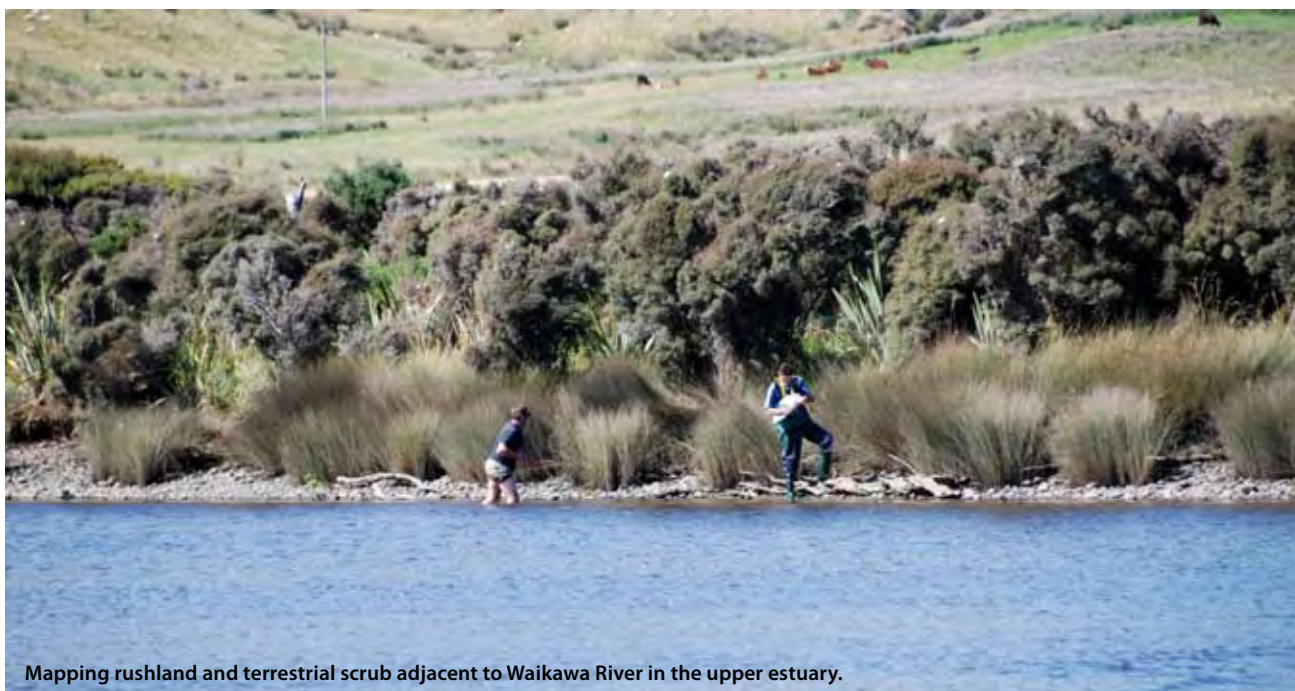
Mapping rushland and terrestrial scrub adjacent to Waikawa River in the upper estuary.

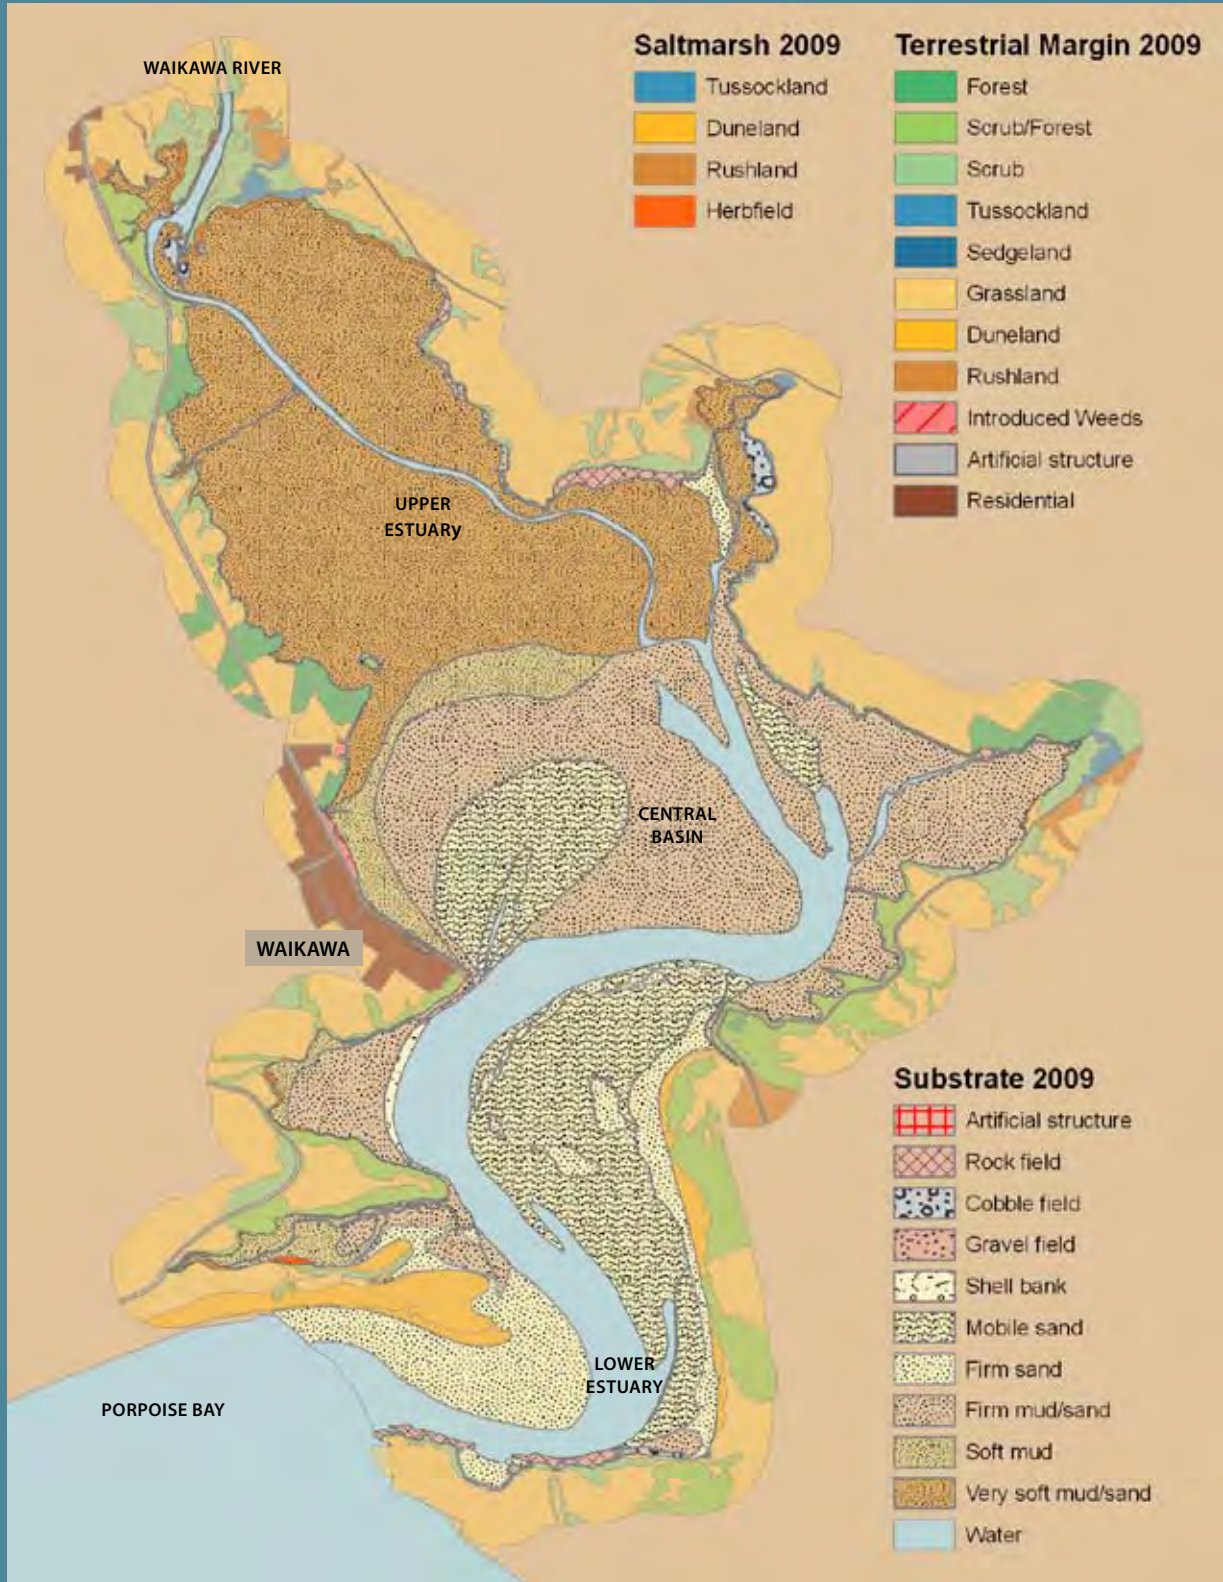
Summary map of the broad scale features of Waikawa Estuary, February 2009.

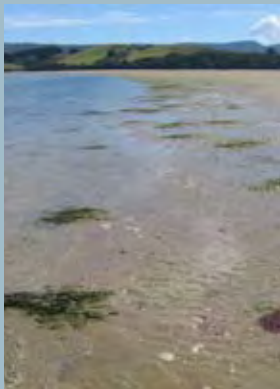
Figure 1. Summary of Habitat Features in Selected New Zealand Estuaries.

Waikawa is typical of New Zealand seawater dominated tidal lagoon estuaries in that it has a relatively small subtidal component (Figure 1), and almost completely drains on each tidal cycle, exposing extensive unvegetated tidal flats.

Particularly in the lower estuary the high rate of flushing mobilises sediments and keeps them well oxygenated and relatively free of fine muds.

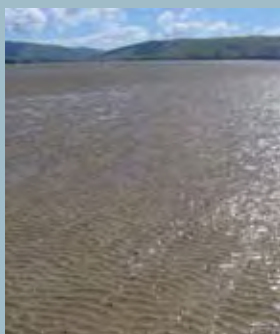
Figure 2. Map of Unvegetated Intertidal Flats - Waikawa Estuary, February 2009.

The broad scale substrate mapping results (Table 5, Figure 2) showed the intertidal area in the upper estuary was dominated by soft and very soft muds (239.8ha, 41.8%), while mobile sand and firm sand, and firm mud/sand (318ha, 55.5%) dominated the lower estuary and central basin. Clean sands were most common near the well flushed mouth of the estuary, while firm muddy sands in the central basin were very close to falling into the mobile sand classification. These extensive sand flats are expected to support a healthy sediment invertebrate community and provide extensive foraging areas for shorebirds.

The percent cover rating of soft mud placed the estuary in the "poor" category (>25% of the estuary is soft mud). Its presence detracts from human use of the estuary, contributes to decreased water clarity, and is commonly associated with reduced sediment oxygenation and biodiversity. However, there were few signs of excessive nutrient enrichment with low nuisance macroalgal growth in 2007 and 2008, a condition rating of "good".

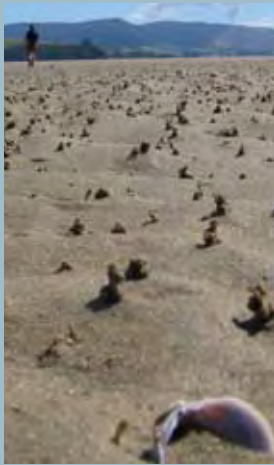
A significant change identified in 2009 was the migration of the transition point between the very soft muds of the upper estuary and the soft muds/firm muddy sands of the central basin approximately 80m towards the upper estuary. This was associated with an increase in the area of mobile sand (areas with large and obvious sand ripples) in the central basin, and particularly in the lower estuary. In the central basin, a reduction in mud was visually obvious near the fine scale and lower sediment monitoring sites.

The improvement in sediment conditions, while occurring in a relatively narrow band in the central basin, showed that water flows at the time of mapping were sufficient to turn over the top sediments, flushing fine particulate from coarser sands, and creating well oxygenated conditions. It demonstrated that there is a natural capacity for muddy parts of the estuary to return to being sandy again.

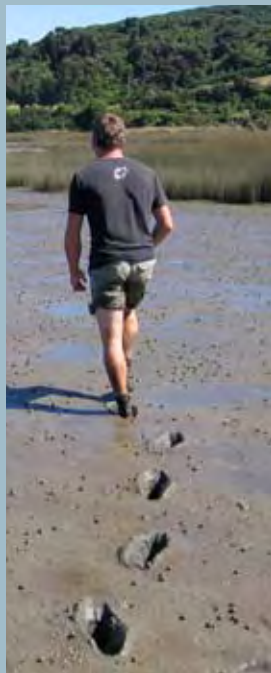
Figure 4. Sediment plate sites and mean change in sediment depth from 2007 baseline.

Sediment plate monitoring between February 2007 and 2009 has shown an overall trend of decreasing sediment levels (see sidebar Figure 4a), a condition rating of “very good”. However, the recently established sediment plates show expected localised variation - mean sediment depth decreased at all 3 sites in 2007-2008, but increased at the two upper sites in 2009 (Figure 4, Table 7, Appendix 4). As such, a longer monitoring interval is needed to determine the stability of the current trend.

If sediment is being exported from the estuary, which appears likely given the broad scale substrate results, a cumulative mean loss of between 2mm and 10mm in two years across the three sites represents a major change. This is in sharp contrast to the estimated average 3mm to 10mm per year increase in sedimentation in the upper estuary over the past 30 years, calculated from radio-isotope aging of sediment cores (Robertson and Stevens 2007).

Ongoing monitoring of the estuary will continue to track sediment changes, while it is recommended that catchment landuse changes and the recent flood history of Waikawa River be assessed for recent possible influences on sediment inputs.

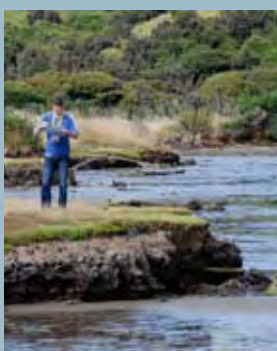
Figure 5. Map of Saltmarsh Vegetation Class - Waikawa Estuary, February 2009.

Overall, very little saltmarsh was present in the estuary (5.3ha, 0.8% - Table 4), providing a rating of “very low”. This is largely a reflection of previous losses, and the steep, often rocky, margins which surround much of the estuary and restrict the intertidal area suitable for saltmarsh growth (see top two sidebar photos).

Saltmarsh (Table 8) was dominated by rushland (jointed wire rush - 91%) and herbfield (7%). The most extensive areas of rushland were adjacent to gently sloping land near the Waikawa River (Figure 5). A common sequence (heading landwards from the unvegetated mudflats) was for a 5-10m wide strip of jointed wire rush to be present in very soft muds at the top of the intertidal area, before a transition to terrestrial ribbonwood scrub and grassland, often containing a variety of introduced weeds (e.g. gorse, blackberry) as sediments became elevated above the tidal reaches.

Elsewhere small pockets of rushland were located in sheltered arms along both sides of the estuary, with herbfields most common in the lower half of the estuary in firm sand/mud sediments. The herbfields were often elevated 0.5-1m above the estuary flats, particularly in the east, where they grew along a narrow strip of land periodically inundated by small waves and salt spray that prevented terrestrial grasses from establishing (see lower sidebar photo and Figure 5).

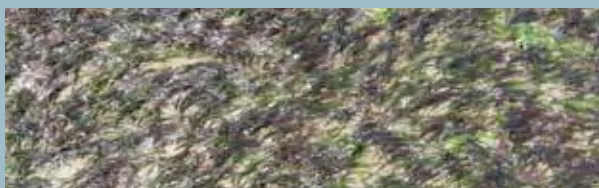
50-80% cover of seagrass.

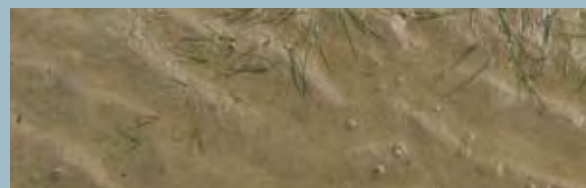
1-5% cover of seagrass in mobile sands.

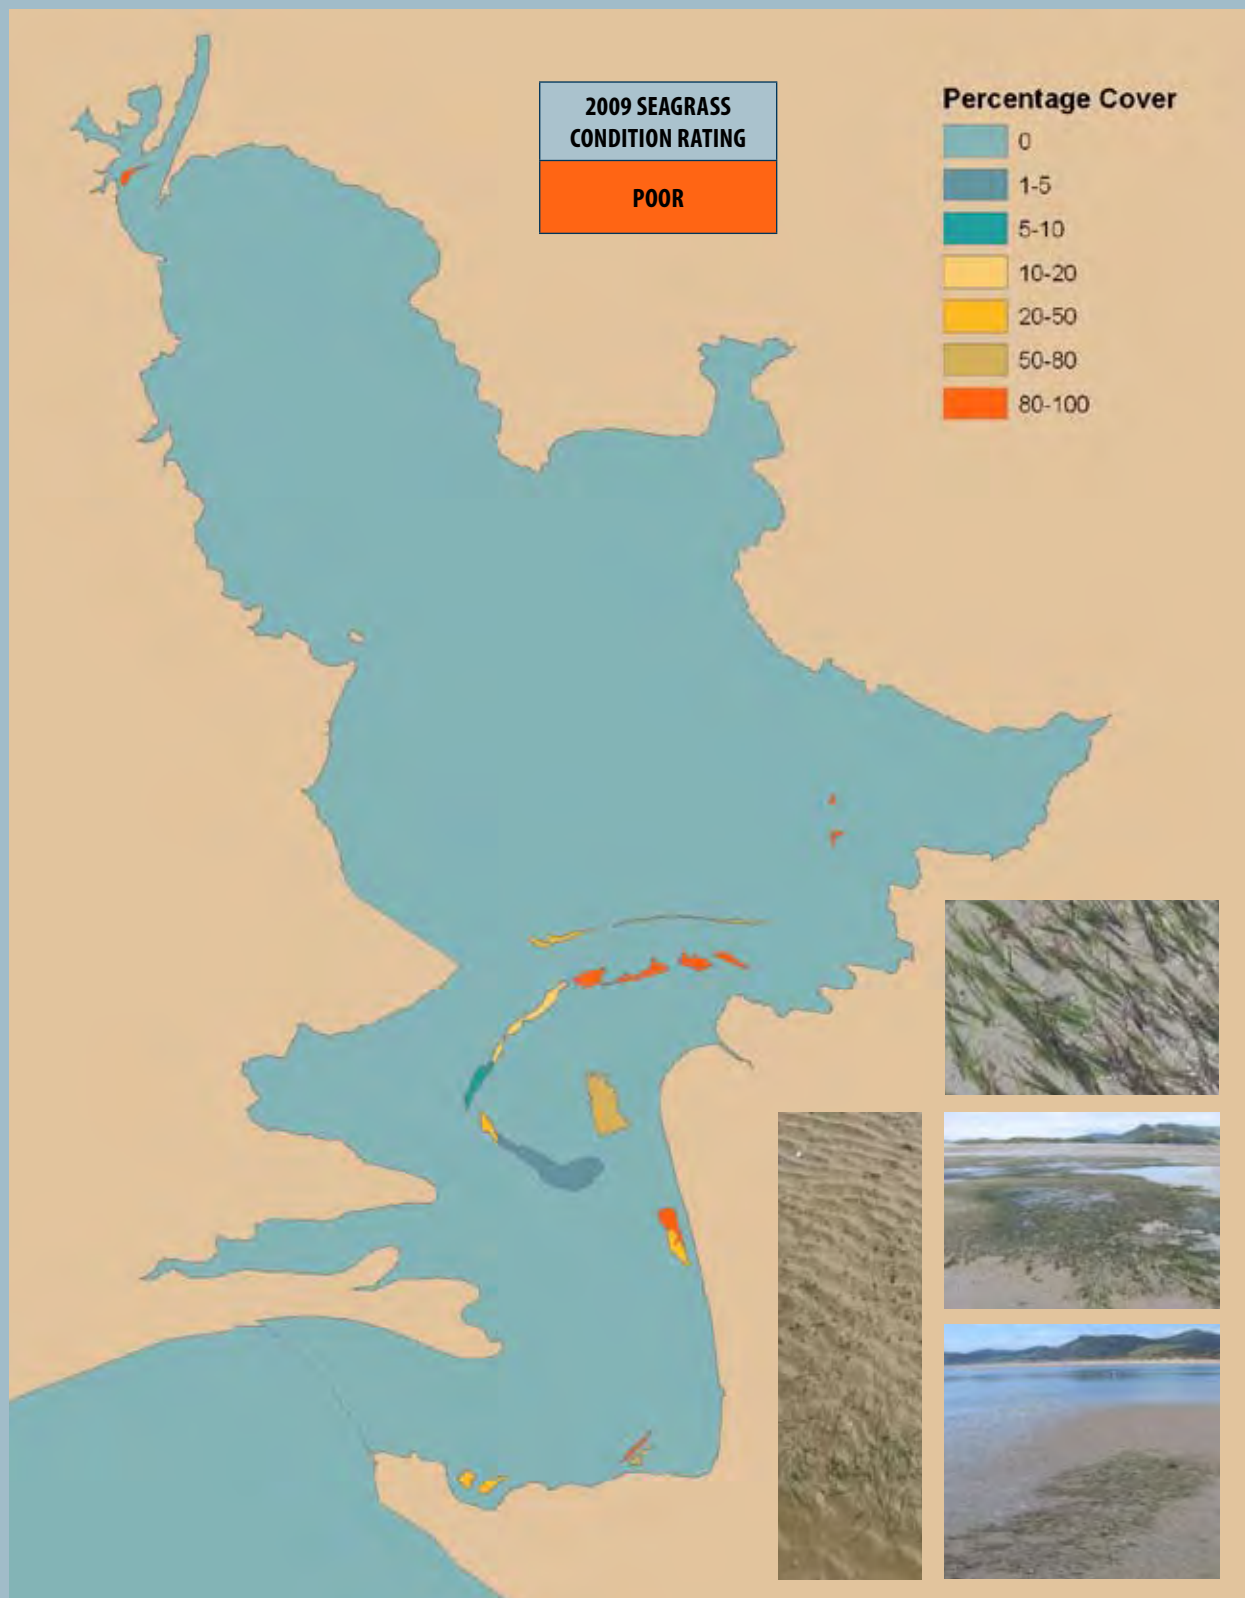
Figure 6. Map of Seagrass Percentage Cover - Waikawa Estuary, February 2009.

Table 9 and Figure 6 summarise the results of seagrass (*Zostera muelleri*) mapping within Waikawa Estuary. The "low" Seagrass Coefficient (SC) for the estuary (0.1), a condition rating of "poor", reflects that seagrasses were not widespread.

Seagrass was most common along the edge of the subtidal channel and in the firm mud/sands of the central basin and lower estuary, with cover mostly in the 50-100% range (Figure 6). In these well oxygenated areas flushed with relatively clear seawater the beds appeared healthy and relatively stable, with no significant changes observed between 2004 and 2009. Within the more mobile sands of the lower estuary, seagrass cover was sparse (e.g. 1-5% cover). Constant cycles of burial and exposure are likely to prevent dense beds from readily establishing in these areas.

No seagrass was present in the muddy upper estuary apart from a healthy bed of 80-100% cover in the subtidal reach of the Waikawa River where it enters the head of the estuary. As seagrass requires high light levels to grow, its absence from the muddy upper estuary is likely to relate to a combination of factors. Wave re-suspension of surface muds create turbid conditions that push seagrass growth towards shallow areas with higher light levels. These areas are subject to greater tidal exposures (and plant stress) and, in Waikawa Estuary, are associated with a shallow RPD layer (<1cm) and anoxic conditions close to the surface. Such conditions, present across the upper estuary, are generally unfavourable for seagrass growth.

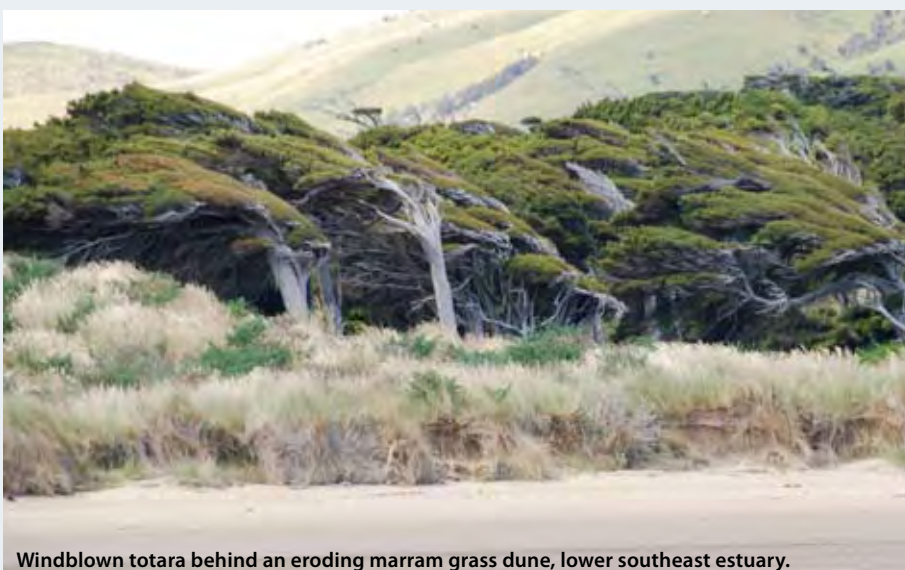
Windblown totara behind an eroding marram grass dune, lower southeast estuary.

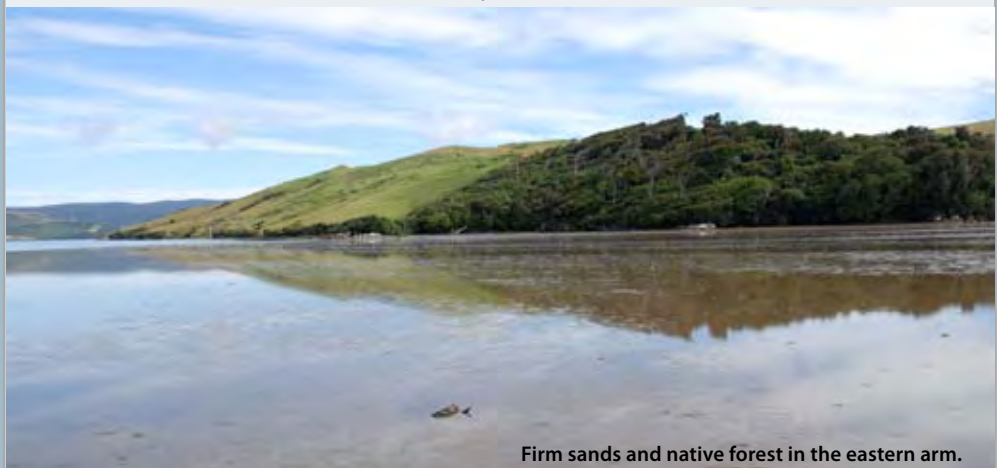
Firm sands and native forest in the eastern arm.
