# WAIKAWA ESTUARY: SEDIMENTATION RATE MONITORING SUMMARY, FEBRUARY 2013

Prepared by for Environment Southland by Leigh Stevens and Barry Robertson, Wriggle Coastal Management.

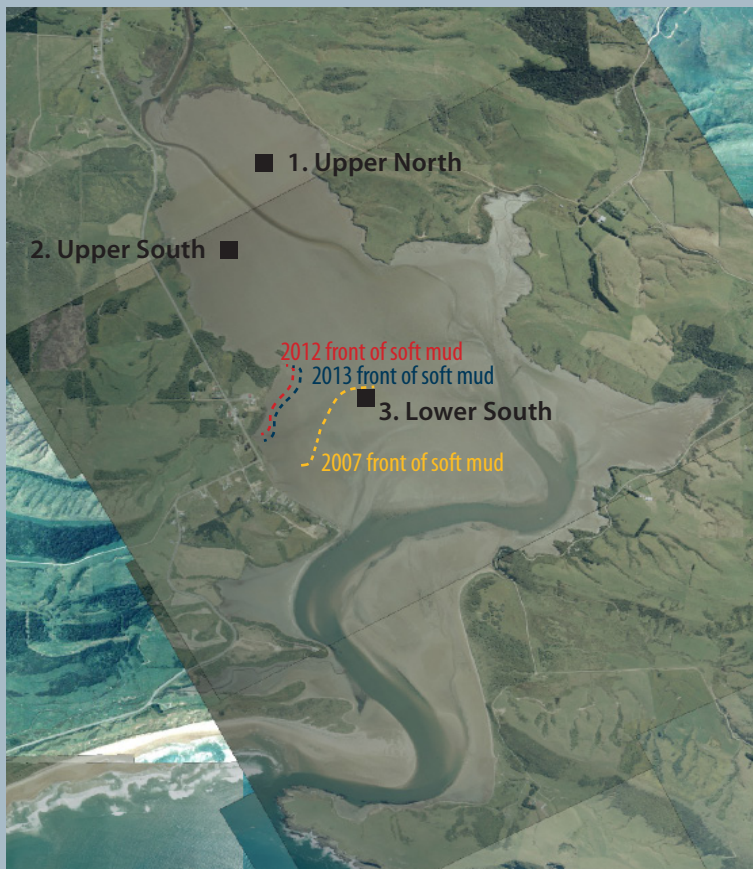
Figure 1. Location of sediment rate monitoring sites in Waikawa Estuary and the position of the soft mud front in the middle estuary.

The greatest mean annual decline in mud has been at the Lower South site. This site was established at the leading edge of soft mud in the middle estuary in 2007. Since then, the front of overlying surface mud has progressively moved up the estuary (Figure 1). In 2013, this trend has reversed slightly with soft mud depositing back over intertidal areas that had been getting sandier over the previous couple of years.

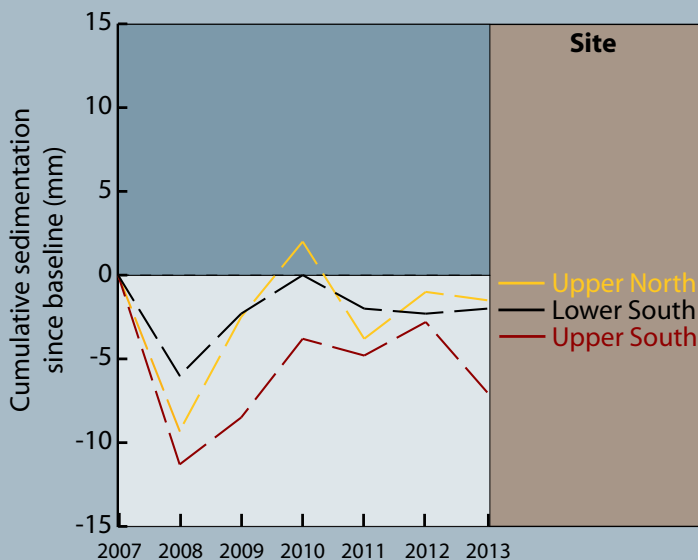
Figure 2. Cumulative change in sediment levels over buried plates in Waikawa Estuary, 2007 to 2013.

The mean annual rate of sedimentation indicates a slight overall loss of sediment at all sites since 2007 (-0.4mm/yr to -2.4mm/yr), a condition rating of "Very Low". This has been punctuated by variable increases and decreases within this period (Figure 2).

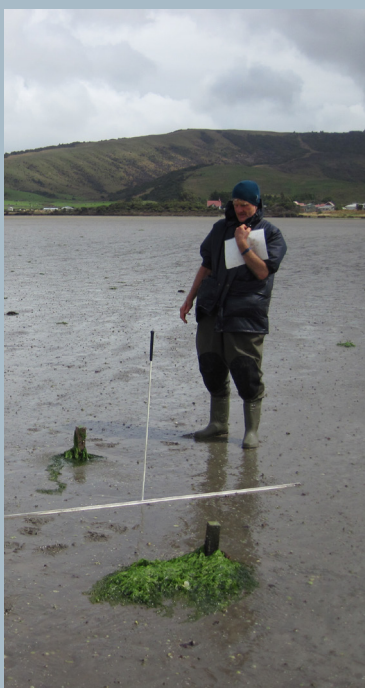
Despite the low mean annual deposition evident over the past 5 years, Waikawa Estuary remains excessively muddy (42% soft and very soft mud - Stevens and Robertson 2009), with the vast majority of the mud located in the extensive intertidal flats in the upper and middle estuary (see photo).

As such, ongoing management is needed to restrict future inputs to a level that the estuary can assimilate (i.e. mean areal sedimentation rate <1mm/yr). If this can be achieved, then the recently observed reduction of surface mud from the lower estuary is expected to continue.
