# Waimatuku Estuary 2012

## Fine Scale Monitoring and Macrophyte Mapping

Prepared  
for  
**Environment  
Southland**  
August  
2012

Leigh Stevens and Barry Robertson

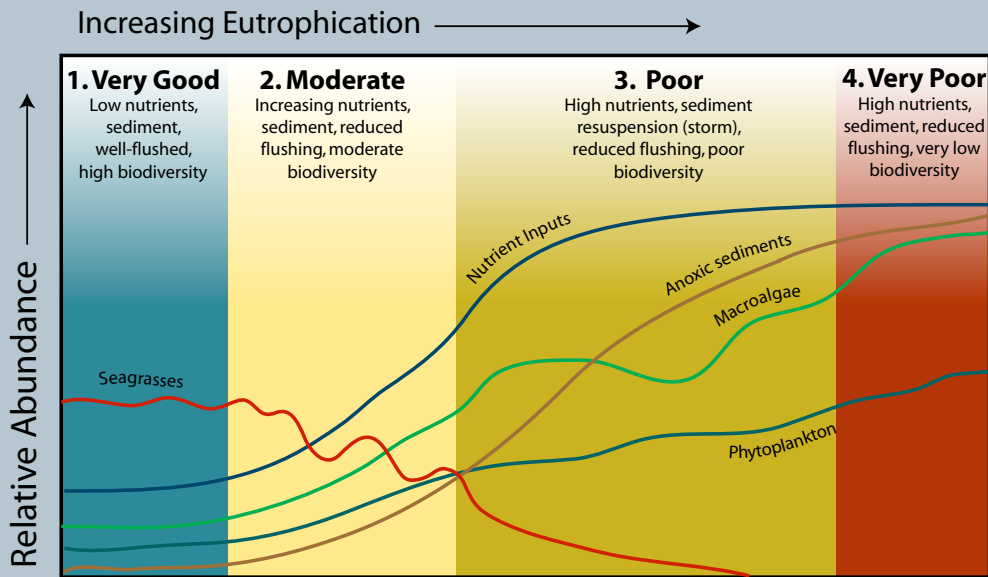
**Figure 2. Small tidal river mouth estuary - Response to increasing eutrophication.**

**Conceptual representation of estuary response to increased nutrients in tidal river mouth estuaries.**

**Stage 1.** In their pristine state, these small, narrow estuaries are adequately flushed with river and marine tidal waters. Nutrient and sediment inputs are low and their clear, shallow, waters are dominated by submerged macrophytes where sediments are stable (e.g. seagrass and *Ruppia*) and contain adequate nutrients. Nuisance macroalgae and phytoplankton growth is low. Sediment quality and biodiversity is high.

**Stage 2.** As nutrient and sediment levels increase, nuisance macroalgae (e.g. *Ulva*), and phytoplankton growth increases. Native macrophyte growth (e.g. seagrass and *Ruppia*), sediment oxygenation, and water clarity declines. Introduced, aggressive macrophytes can become dominant in the brackish upper estuary. The bed becomes muddier and a surface sulphide layer is common. If flushing is reduced due to freshwater abstraction or mouth constriction, the susceptibility to eutrophication is enhanced and biodiversity declines.

**Stage 3.** As nutrient inputs become elevated, native macrophytes are replaced with nuisance short-lived macroalgae and phytoplankton. Introduced macrophytes can also become dominant in upper estuary brackish areas. Water clarity is often low, muddy sediments are anoxic close to the surface and sulphide rich, and sediment macrofauna is dominated by high numbers of a few tolerant species only.

**Stage 4.** Nutrients in sediments and water continue at high concentrations, but a lowering of the N:P ratio results in nuisance cyanobacteria and toxic bloom events. Sediment macrofauna are often absent, but nuisance macroalgae and phytoplankton are still present. Water clarity is low and sediment quality poor with anoxic and sulphide-rich muds.

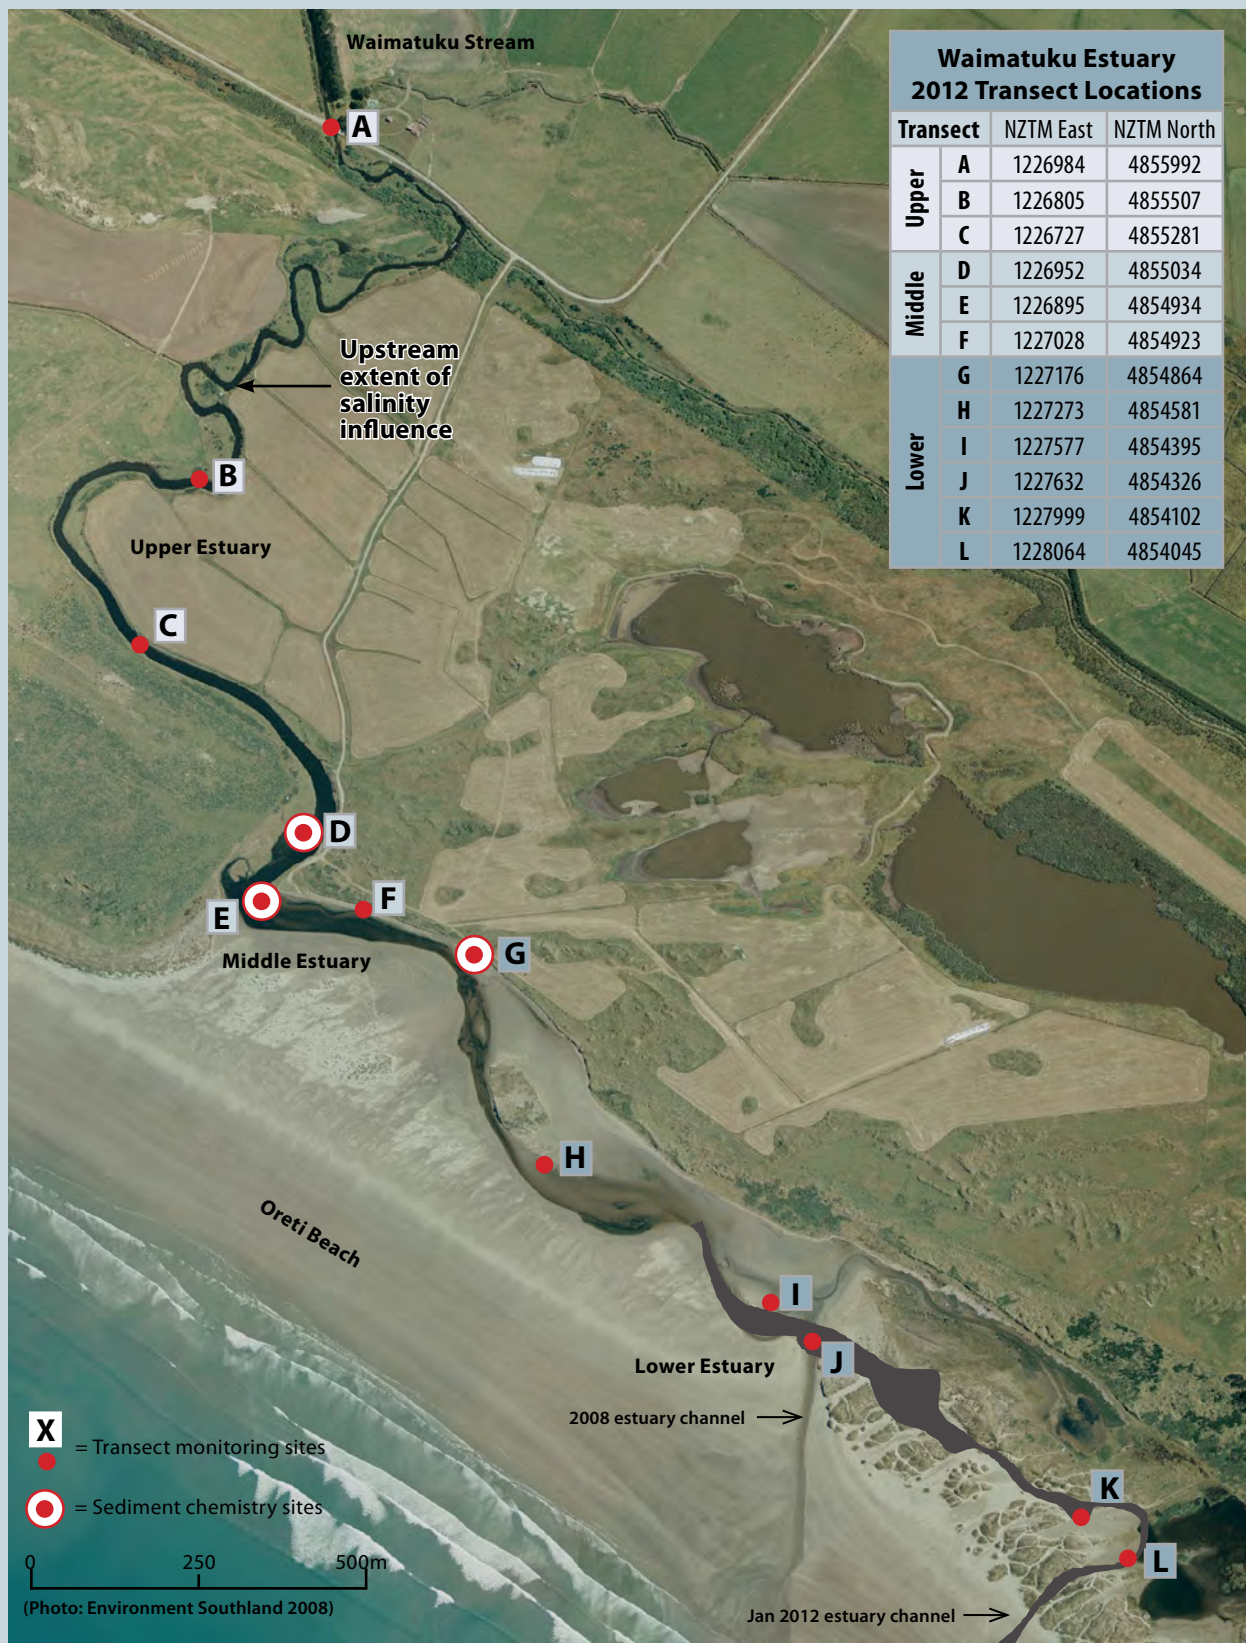
Figure 4. Sampling sites in the Waimatuku Estuary.

Ten previously established transect sampling sites, plus two new sites K and L, in Waimatuku Estuary (Figure 4, Robertson and Stevens 2009), representing the range of different conditions present throughout the estuary, were visited by two scientists on 22 January 2012 when the lagoon was open to the sea. At each site, sampling was undertaken for key indicators of estuary condition as described below. The purpose was to collect information which, through repeat sampling, can be used as a rapid and robust method to indicate change within the estuary.

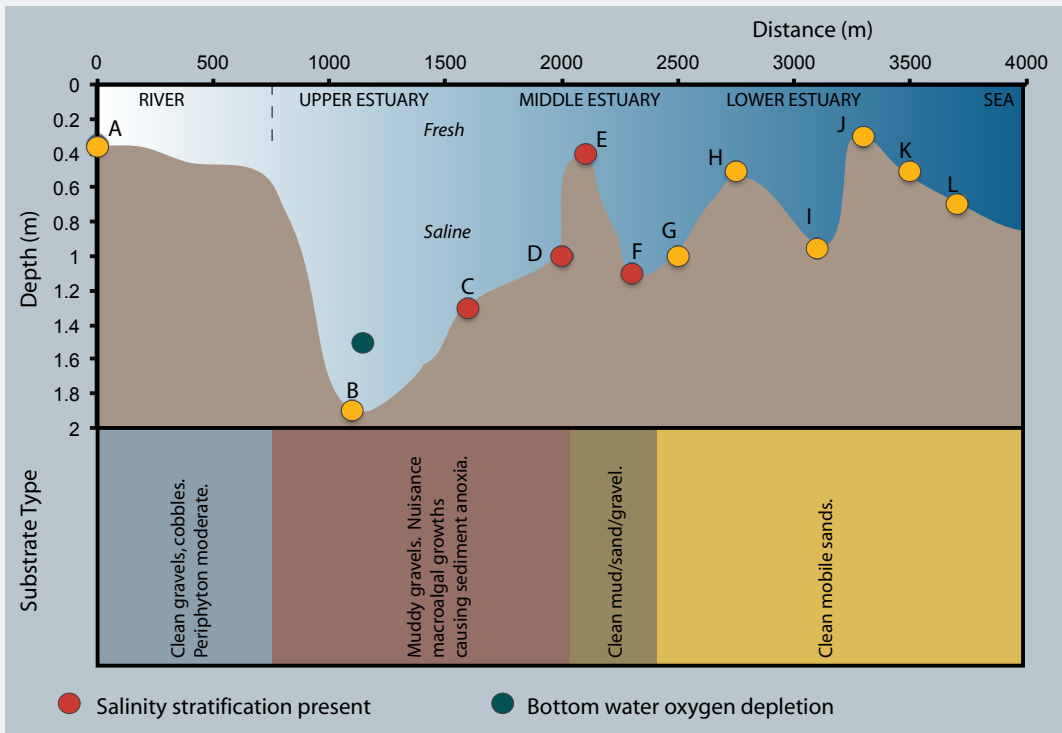
Figure 5. Longitudinal profile (river to sea) of maximum water depth (at low water) and substrate type, 22 February 2012.

**Sediment Type:** the substrate showed little change compared to the 2009-2011 period. It comprised predominantly clean gravels and cobbles in the lower Waimatuku Stream, clean muddy gravels in the upper estuary, muddy sands and gravels in the middle estuary, and clean mobile sands in the lower estuary (Figure 5).

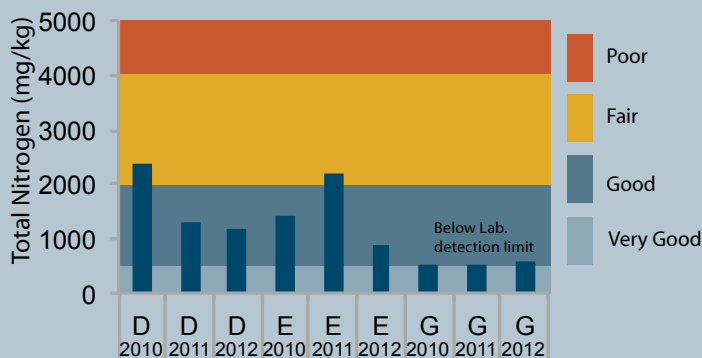
Figure 10. Total nitrogen at 3 subtidal sites (composite across transect), Feb. 2010, 2011 and Jan. 2012.

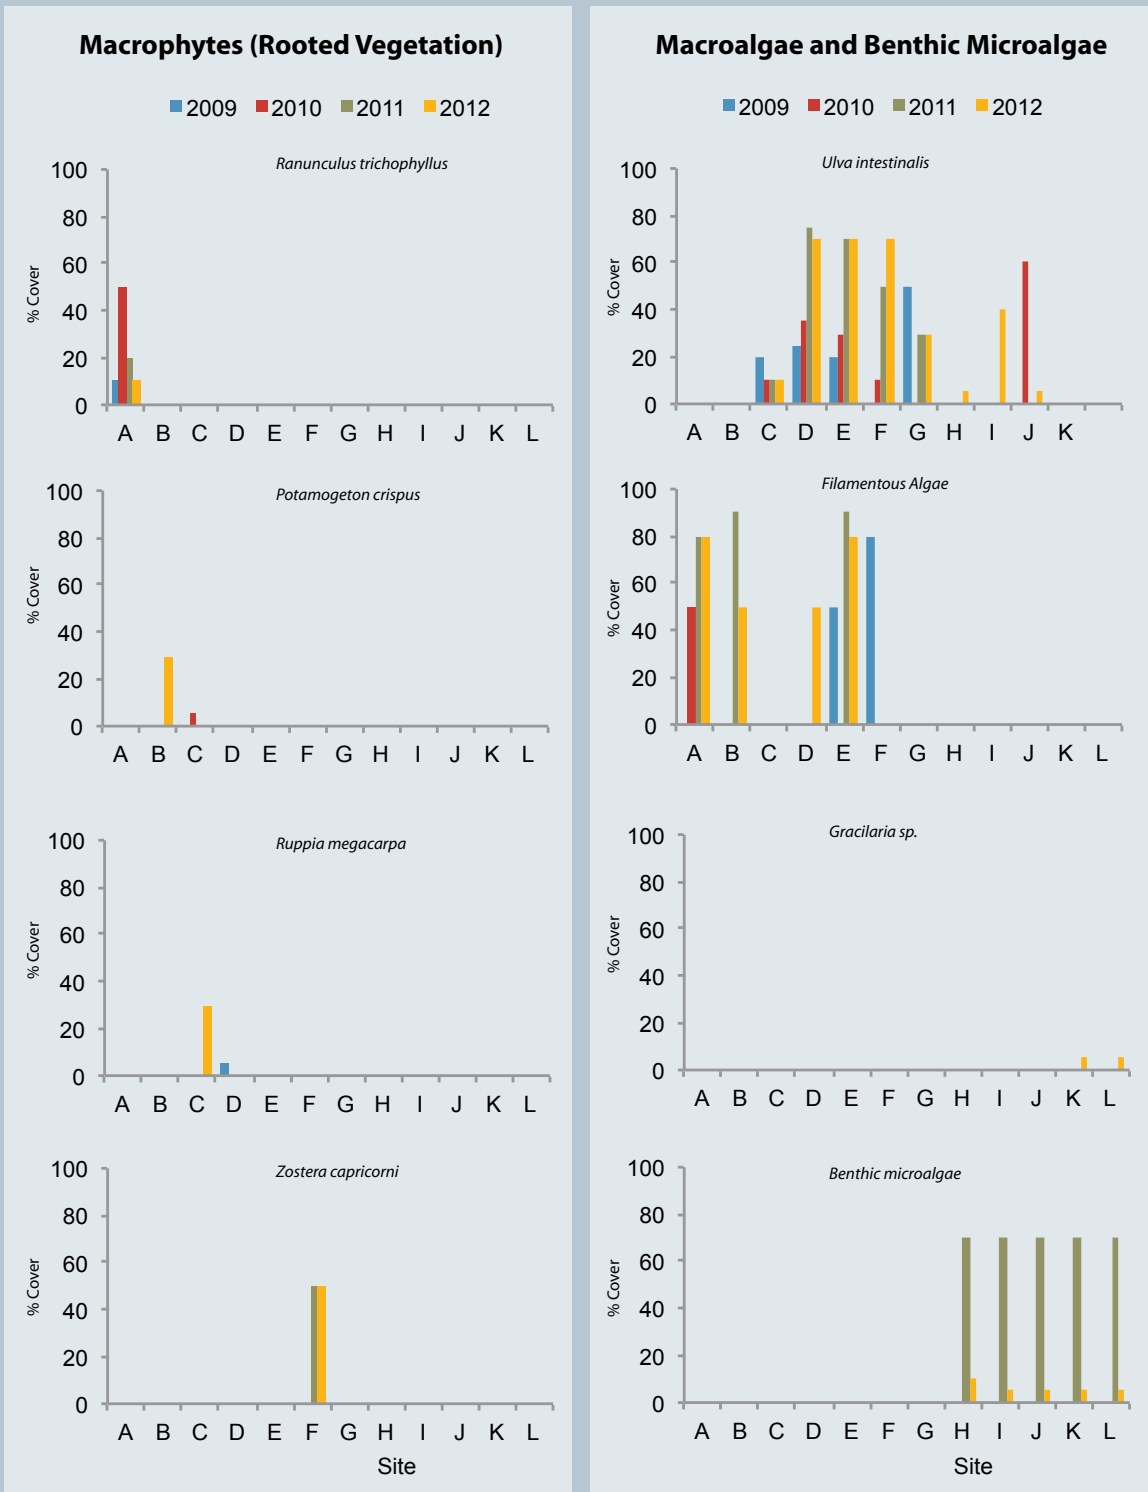
As in 2009, 2010 and 2011 the lower Waimatuku Stream and the upper Waimatuku Estuary supported growths of rooted aquatic macrophytes (Figure 11). *Ranunculus trichophyllus* (water buttercup Figure 12) was relatively abundant in the clear, 0-0.5m deep, flowing freshwater of the lower Waimatuku Stream Site A, growing in 1-2m long strands in the clean gravel bed, while *Mimulus guttatus* (monkey musk) was common along the margins.

Figure 11. Percent cover of aquatic vegetation at 12 Waimatuku estuary transects 2009-2012.

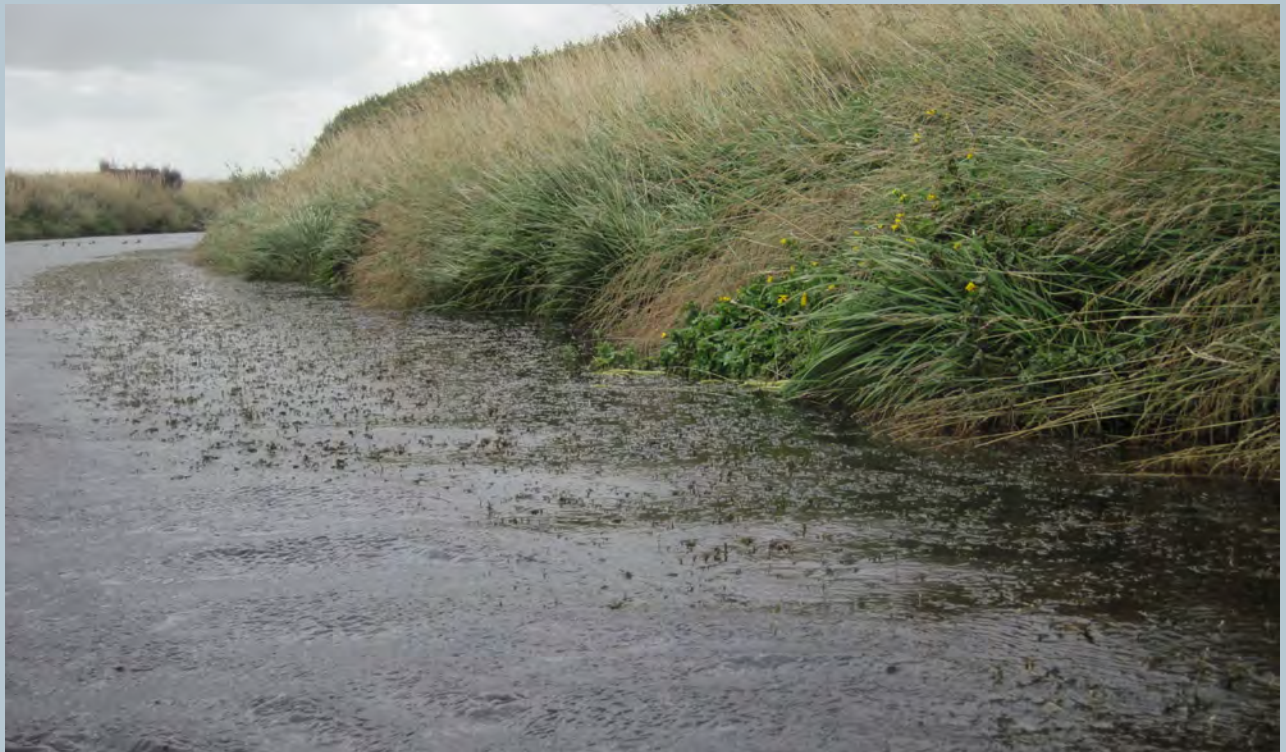
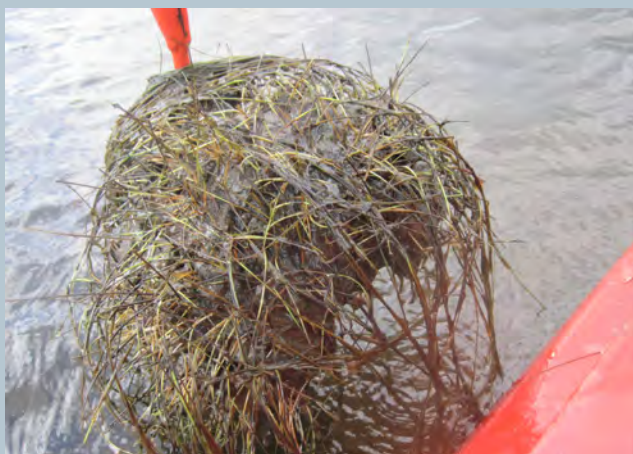
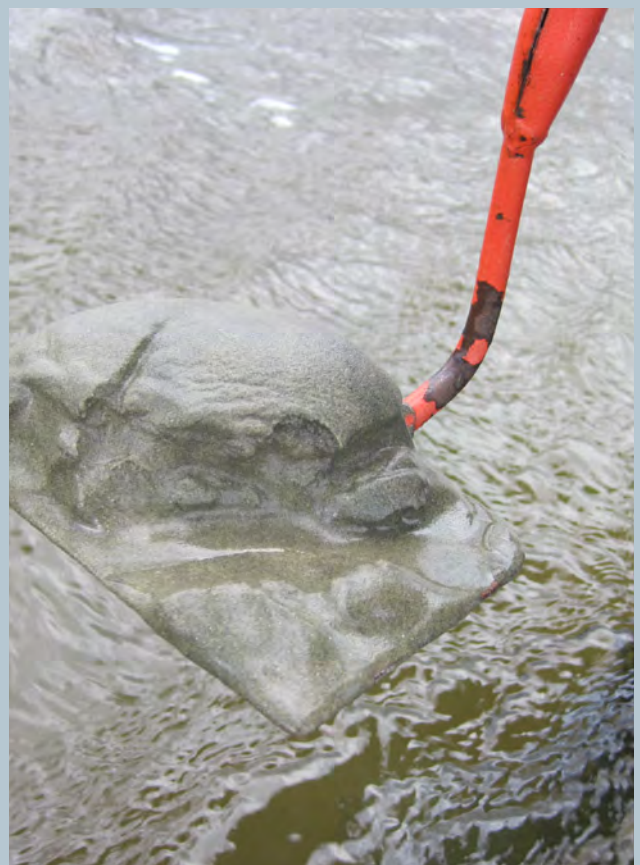
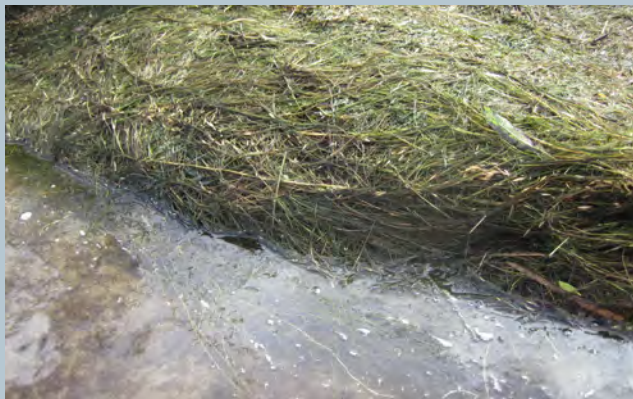
***Potamogeton crispus* (Curly pondweed)** is an introduced species that is tolerant of slightly brackish as well as freshwater. It can survive in low light and low temperatures, and prefers high nutrient water. It spreads mostly by means of vegetative buds (turions) that germinate in autumn, grow vigorously in spring, and die off in the summer. The decaying plant matter can make the water extremely enriched, encourage nuisance algal mats near the sediment surface, inhibit the growth of native aquatics, and can interfere with boating and other water recreation. These plants germinate in autumn, grow vigorously in spring, and die off in the summer.

Figure 13. Examples of thick *Potamogeton crispus* beds in upper estuary (top), *Ruppia megacarpa* from the upper estuary (left), and benthic microalgae on sands (right) in the lower Waimatuku Estuary, 22 February 2012.

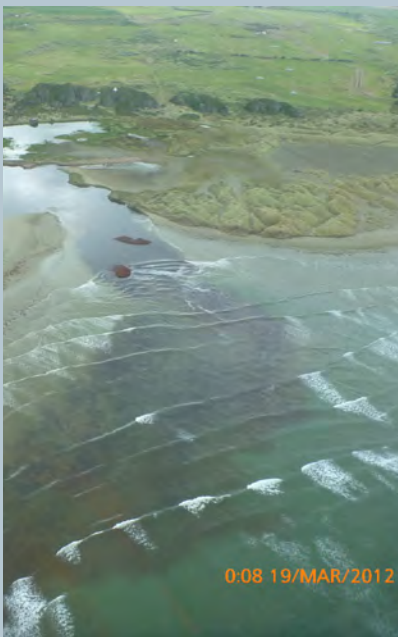
Figure 14. Coastal algal bloom at the mouth of Waimatuku Estuary, March 2012. Photo ES.

Intertidal and subtidal flats in the lower estuary supported a thick benthic microalgal growth not evident in 2010. The water also had a noticeable green stain in 2011 and 2012. These conditions place the estuary in a Stage 2 “moderate” state (Figure 15). Consequently, the native seagrass community in the upper estuary is at risk of being degraded and lost. Macroinvertebrates, fish, birdlife, and human use of the estuary is all likely to be adversely impacted.

At present, eutrophication symptoms are minimised by the short residence time of water within the estuary. This is maintained by the mouth remaining open to the sea which minimises the build up of nutrients. Despite this however, eutrophication symptoms have been evident every year since the estuary was monitored in 2008, with the 2011 results showing eutrophication symptoms increase very quickly and persist following even short duration estuary mouth constriction. If mouth migration continues to constrict flows, the estuary quality is likely to deteriorate quickly. Notwithstanding, discharges of elevated nutrient loads to the coast from the Waimatuku, plus Jacobs River and New River estuaries, may also be contributing to the presence of coastal algal blooms nearby at Oreti Beach, as evident in Figure 14.

These results highlight the priority need to manage nutrient inputs from the catchment. Saltmarsh and terrestrial margin habitat is also modified and scarce, so maintaining these in good condition will help provide important filtering and uptake of sediment and nutrients, and help other important parts of the ecosystem to thrive.

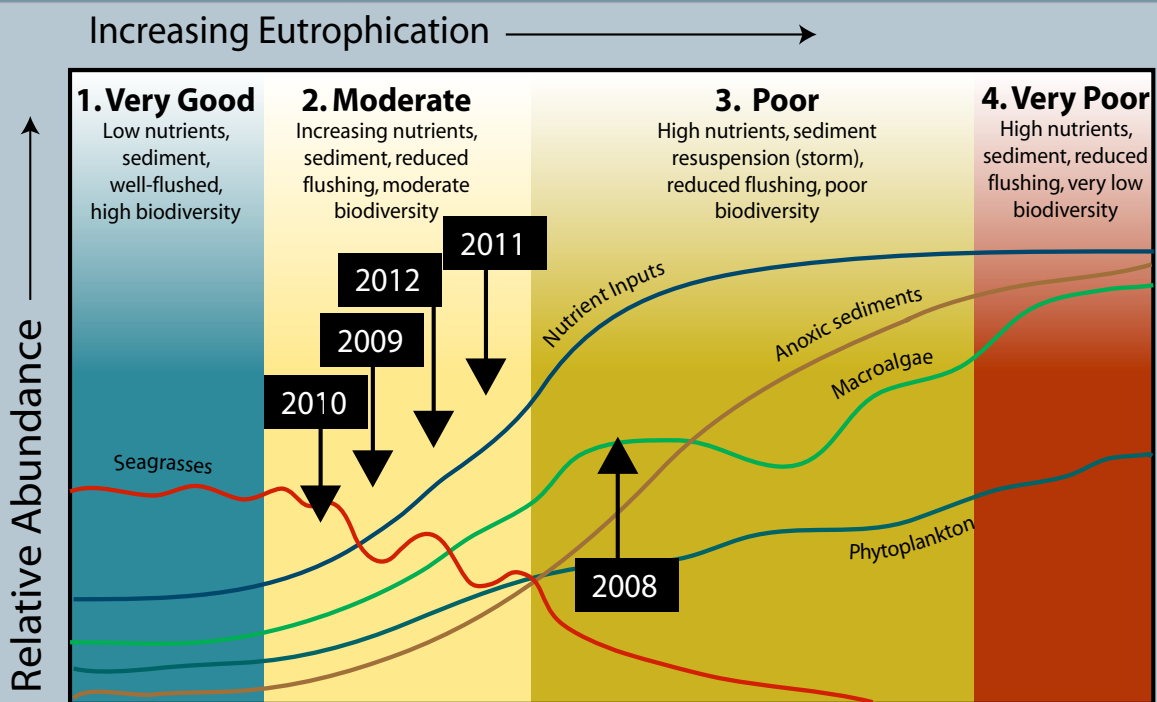
Figure 15. Waimatuku Estuary - condition rating and trophic state, 2008, 2009, 2010, 2011 and 2012.

Conceptual representation of estuary response to increased nutrients in tidal river mouth estuaries.
