Waimatuku Estuary 2010

Fine Scale Monitoring and Macrophyte Mapping

Prepared
for
Environment
Southland
July
2010

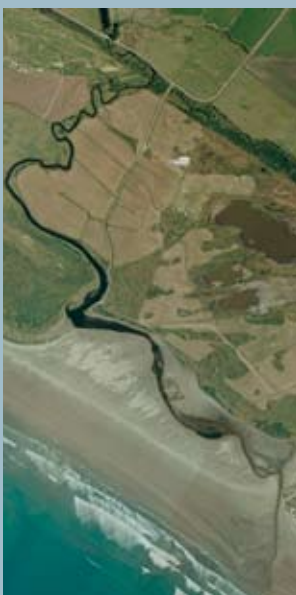
Figure 1. Waimatuku Estuary.

Waimatuku Estuary is a small (20ha at high tide), mainly open, shallow, "tidal river mouth" estuary separated from the sea by a barrier beach (Figures 1 and 4). It is fed by the Waimatuku Stream and drains to the sea through an entrance that is artificially opened a couple of times per year. Where it flows across the beach berm and discharges to the sea, it cuts through modified duneland dominated by marram grass.

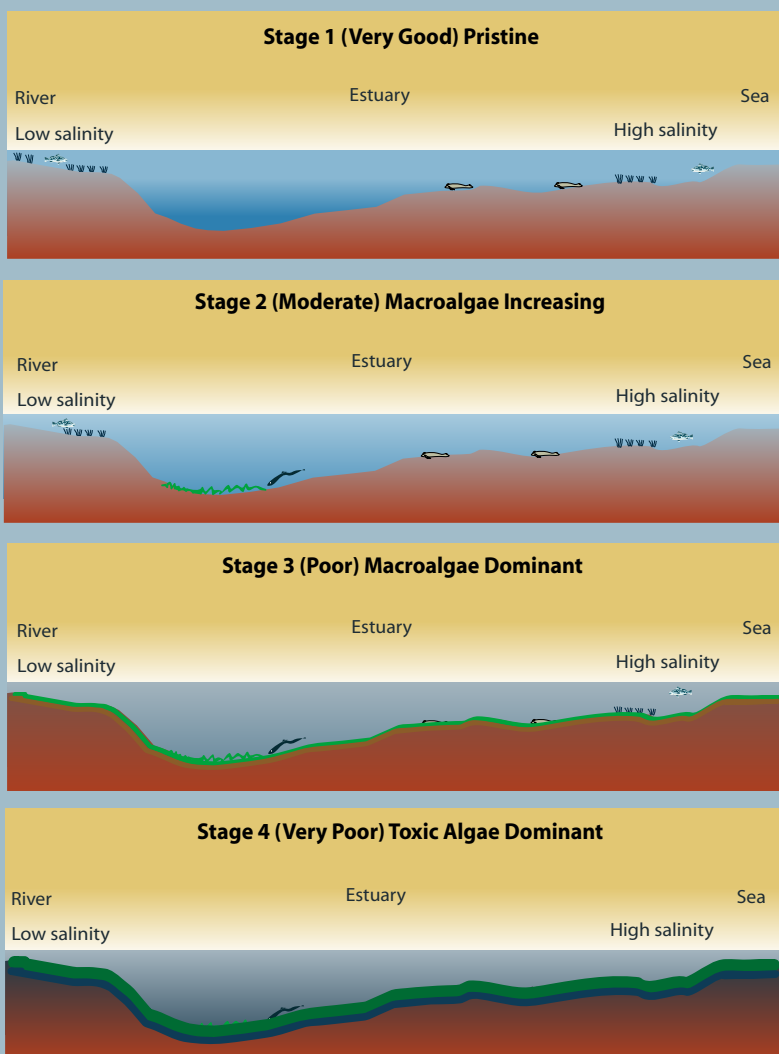
Figure 2. Small Tidal River Mouth Estuary - Response to Increasing Eutrophication.

Conceptual representation of estuary response to increased nutrients in tidal river mouth estuaries.

Stage 1. In their pristine state, these small, narrow estuaries are adequately flushed with river and marine tidal waters. Nutrient and sediment inputs are low and their clear, shallow, waters are dominated by submerged macrophytes where sediments are stable (e.g. seagrass and *Ruppia*) and contain adequate nutrients. Nuisance macroalgae and phytoplankton growth is low. Sediment quality and biodiversity is high.

Stage 2. As nutrient and sediment levels increase, nuisance macroalgae (e.g. *Enteromorpha*), and phytoplankton growth increases. Native macrophyte growth (e.g. seagrass and *Ruppia*), sediment oxygenation and water clarity declines. Introduced, aggressive macrophytes can become dominant in the brackish upper estuary. The bed becomes muddier and a surface sulphide layer is common. If flushing is reduced due to freshwater abstraction or mouth constriction, the susceptibility to eutrophication is enhanced and biodiversity declines.

Stage 3. As nutrient inputs become elevated, native macrophytes are replaced with nuisance short-lived macroalgae and phytoplankton. Introduced macrophytes can also become dominant in upper estuary brackish areas. Water clarity is often low, muddy sediments are anoxic close to the surface and sulphide rich, and sediment macrofauna is dominated by high numbers of a few tolerant species only.

Stage 4. Nutrients in sediments and water continue at high concentrations, but a lowering of the N:P ratio results in nuisance cyanobacteria and toxic bloom events. Sediment macrofauna are often absent, but nuisance macroalgae and phytoplankton are still present. Water clarity is low and sediment quality poor with anoxic and sulphide-rich muds.

The major threat to the estuary is increased eutrophication due to elevated nutrient inputs coupled with variable entrance constrictions and restricted flushing (reflecting the combined influence of river flows and sea state). The likely pattern of increasing eutrophication that these types of estuary follow in response to increased nutrients (particularly nitrogen) is presented in Figure 2.

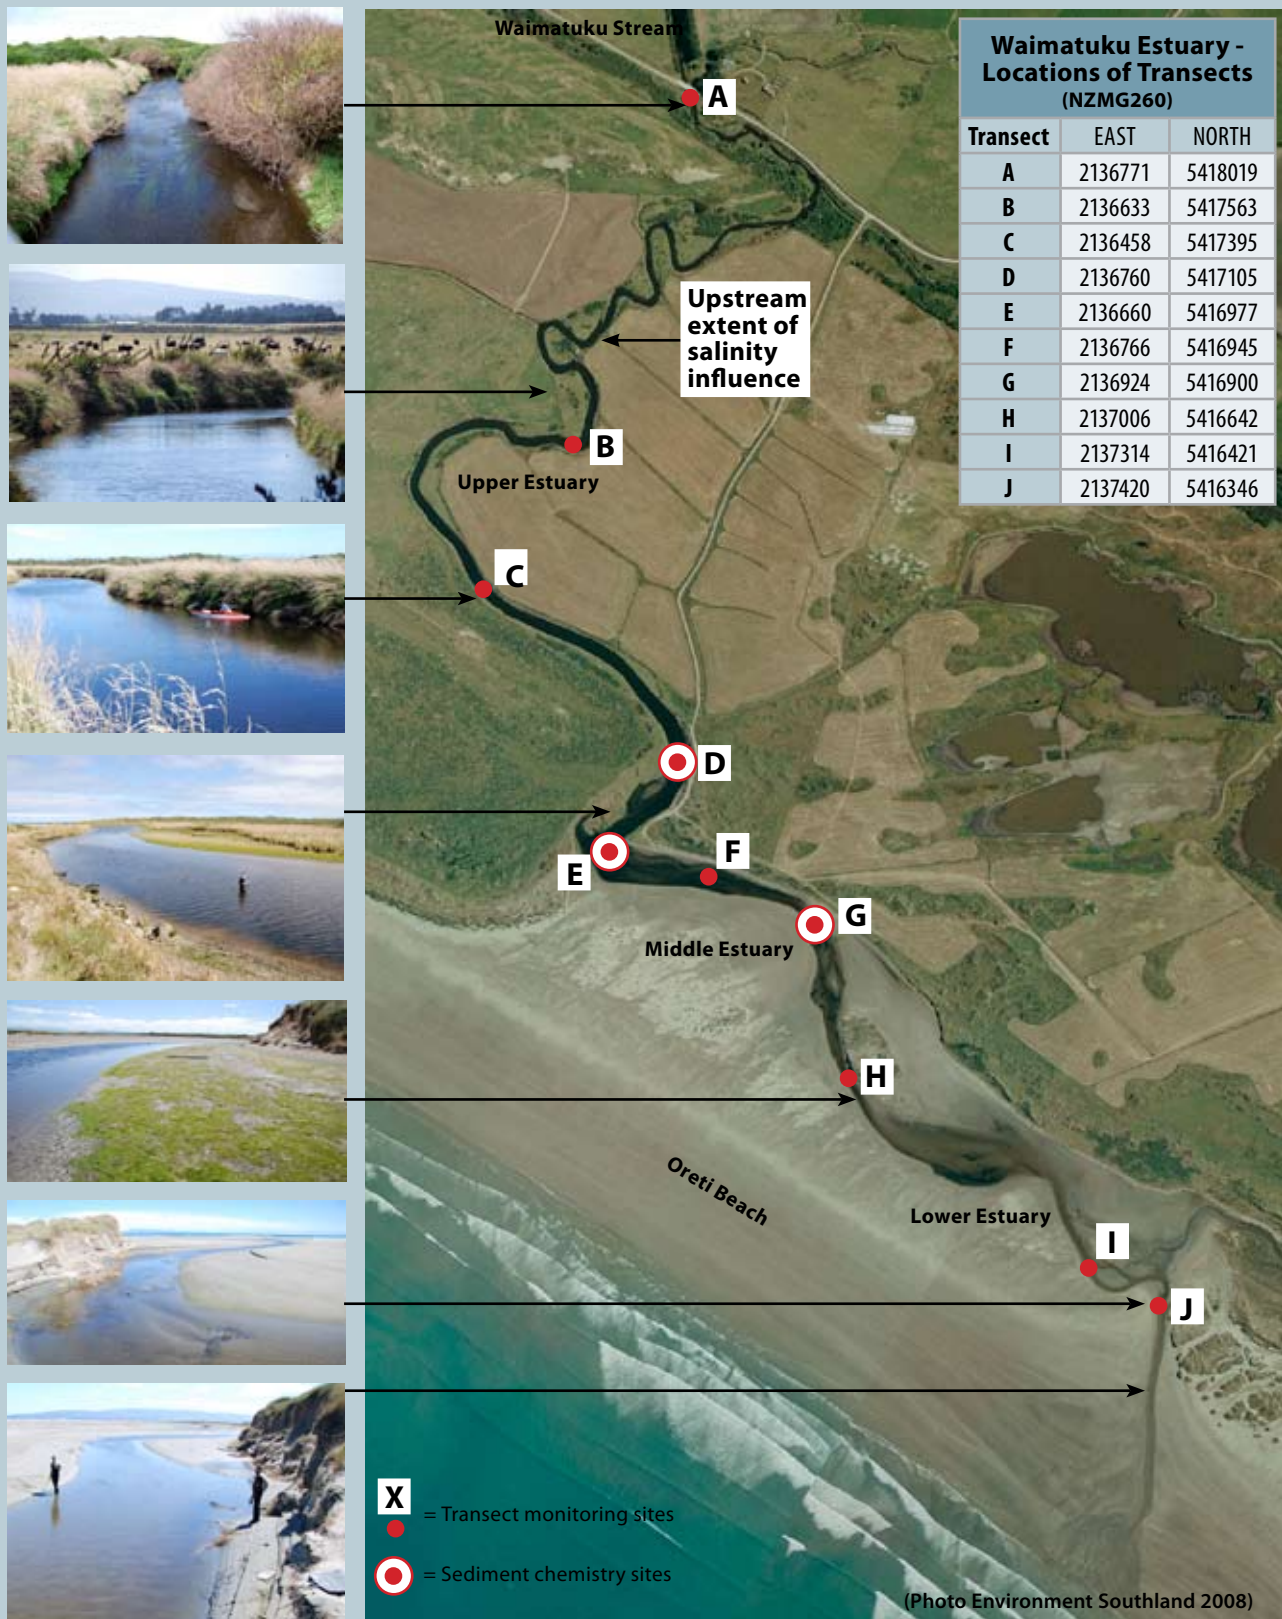
Figure 4. Sampling sites in the Waimatuku Estuary.

Ten previously established transect sampling sites in Waimatuku Estuary (Robertson and Stevens 2009, Figure 4), representing the range of different conditions present throughout the estuary, were visited by two scientists on 17 and 18 February 2010 when the lagoon was open to the sea. At each site, sampling was undertaken for key indicators of estuary condition as described below. The purpose was to collect information which, through repeat sampling, can be used as a rapid and robust method to indicate change within the estuary.

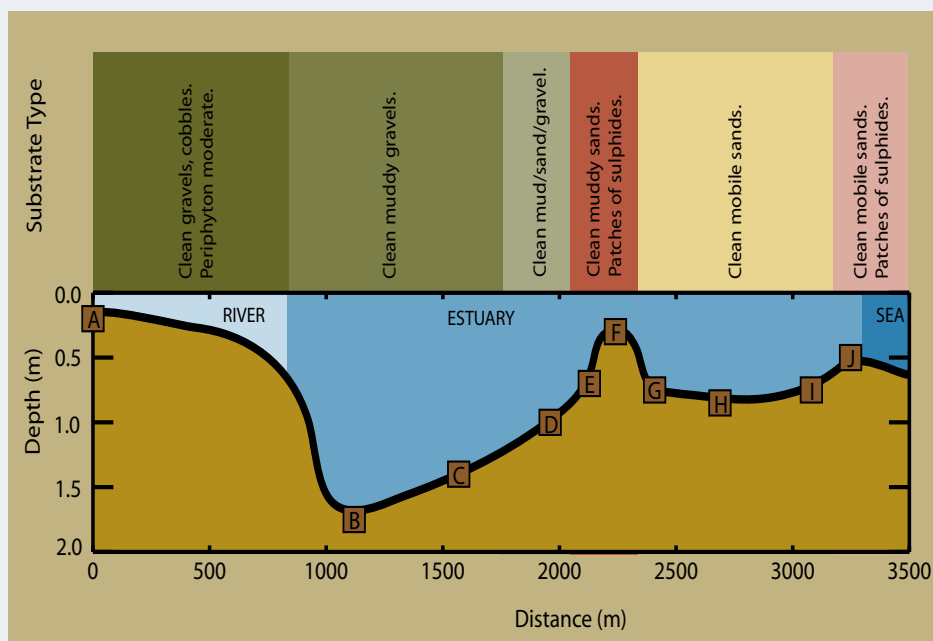
Figure 6. Longitudinal profile (river to sea) of maximum water depth (at low water) and sediment type, 18 February 2010.

There was little change in the water depth and level measured in February 2009 compared to February 2010. In 2010, the estuary was open to the sea with the low tide water depth predominantly <1.5m, and the deepest area (~2m) at Transect B (Figures 6 and 7). At high water the lagoon water level was approximately 0.5m deeper in the lower and mid estuary, with little change in the freshwater dominated upper estuary.

The substrate also showed little change compared to 2009. It comprised predominantly clean gravels and cobbles in the lower Waimatuku Stream, clean muddy gravels in the upper estuary, muddy sands and gravels in the middle estuary, and clean mobile sands in the lower estuary (Figure 6). Anoxic, sulphide rich sediments common in 2009 in the middle estuary around sites E and F, as well as in patches near the mouth, were much less common in February 2010. The depth to the redox potential discontinuity was >5cm throughout the majority of the estuary, a condition rating of "good".

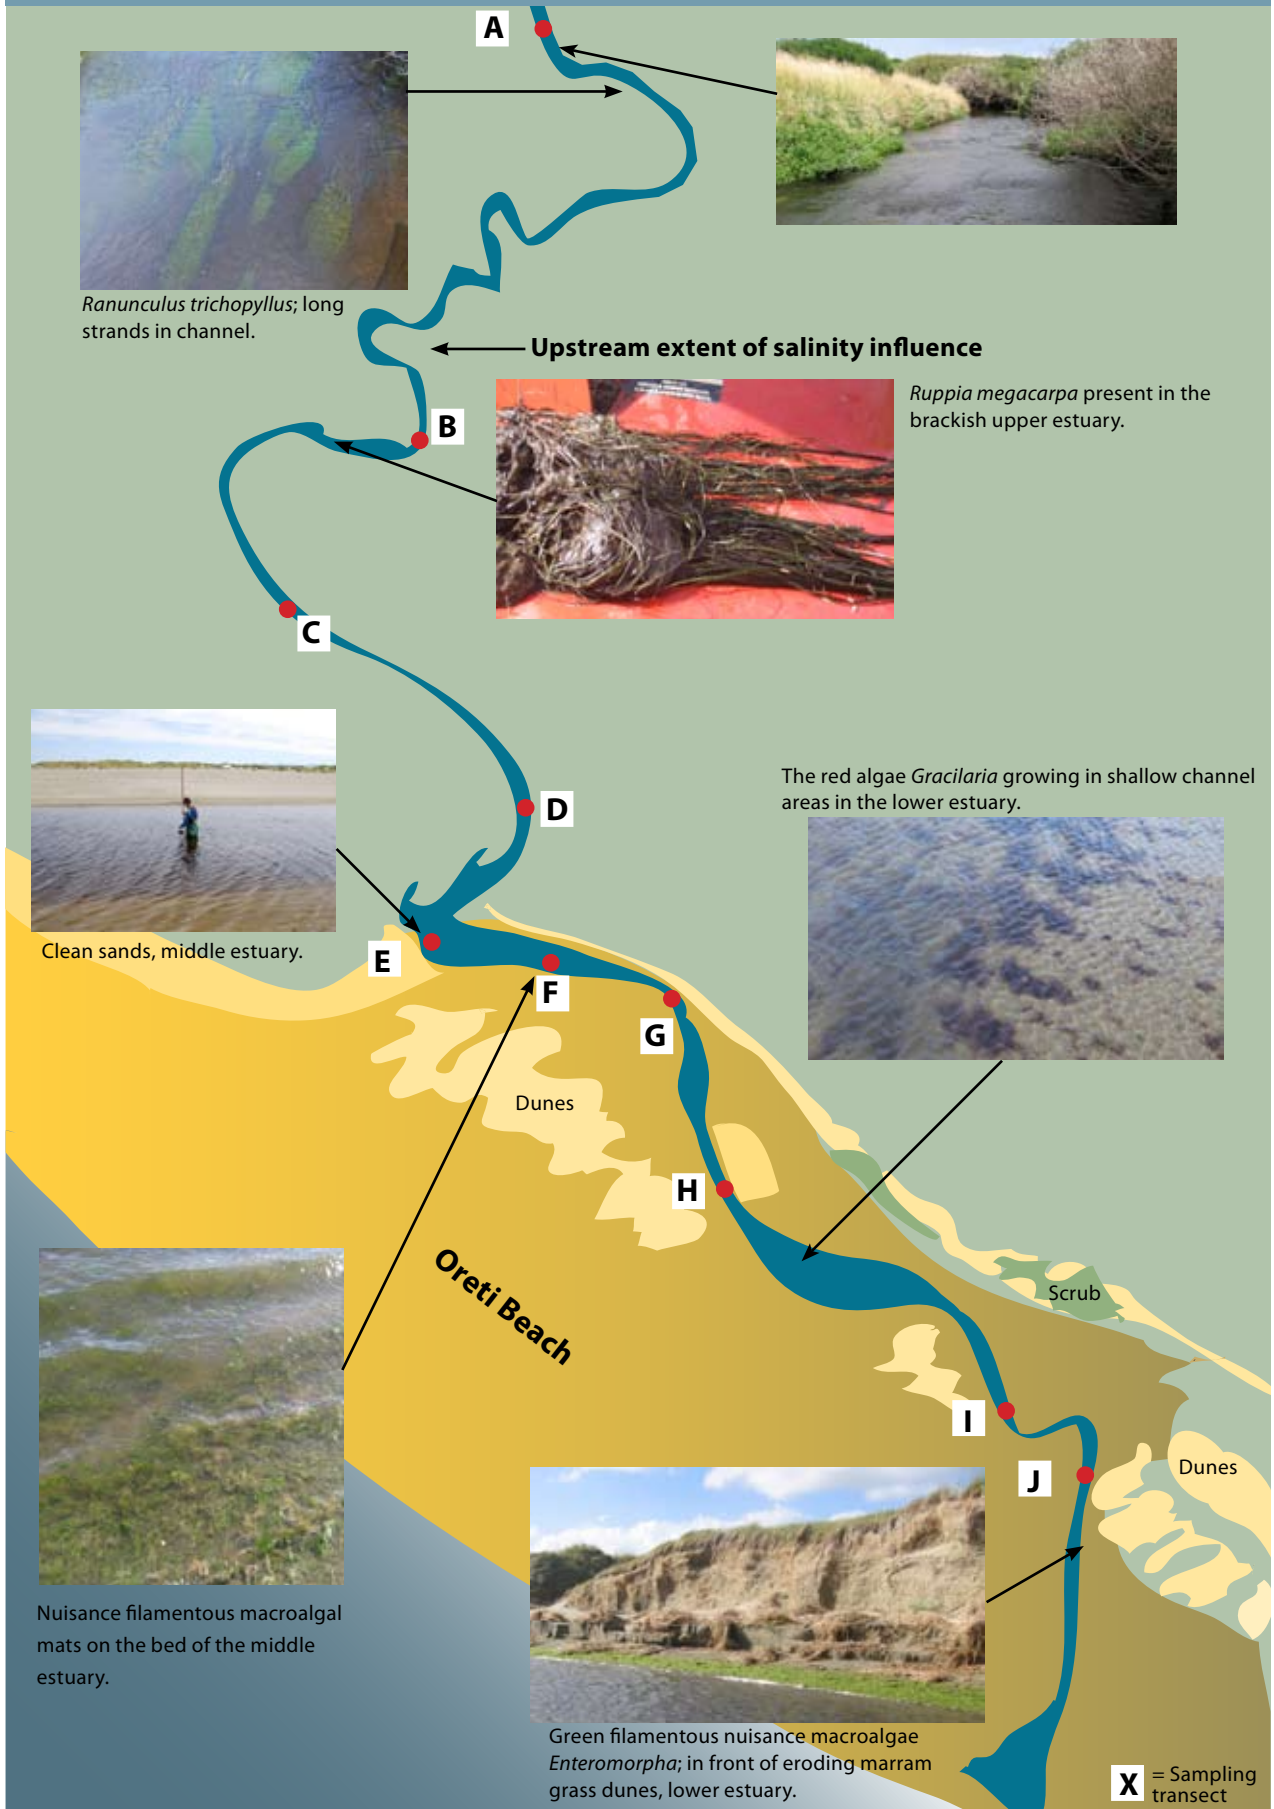
Figure 7. Location of dominant macrophytes and macroalgae, Waimatuku Estuary, 18 February 2010.

As in 2009, the lower Waimatuku Stream and the upper Waimatuku Estuary supported growths of rooted aquatic macrophytes. *Ranunculus trichophyllus* (water buttercup) was relatively abundant in the clear, 0-0.5m deep, flowing freshwater of the lower Waimatuku Stream section, growing in 1-2m long strands in the clean gravel bed, while *Mimulus guttatus* (monkey musk) was common along the margins.

In the brackish upper estuary, the native *Ruppia megacarpa* (horse's mane weed) and introduced *Potamogeton crispus* (pondweed) were the dominant rooted plants. *Ruppia* was present throughout the upper estuary as occasional dense patches in the 0-1m depth range. *Potamogeton* was present at similar depths, but restricted to patches in the upper reaches of the upper estuary.

The nuisance filamentous green macroalgae *Enteromorpha* was also common throughout the estuary. Dense mats were present among *Ruppia* beds in the brackish upper estuary, almost certainly restricting its growth through smothering, and reducing water and sediment quality.

Enteromorpha was also present in mats on the intertidal flats in the middle estuary, and on the bed of the estuary wherever the current was not too strong. These macroalgal mats, when present in high densities, were contributing to black, anoxic, sulphide-rich surface sediments.

The lower estuary was relatively clean of all vegetation except for a thin film of micro-algae on the intertidal sediment surface, and occasional patches of *Gracilaria* and *Enteromorpha* in the low tide channel near the estuary mouth.

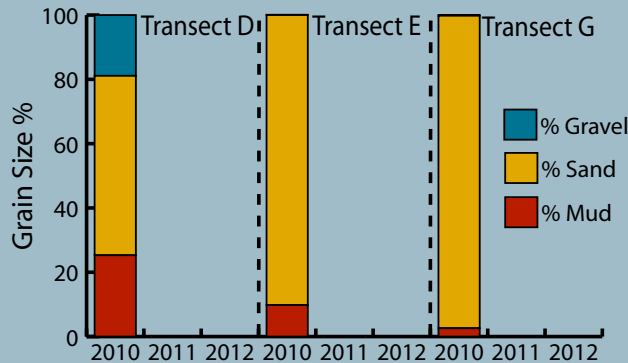
Figure 8. Grain size, at 3 subtidal sites (composite across transect), February 2010.

Grain size measurements indicate the muddiness of a particular site. Because of greater relative surface area, muds are generally associated with higher organic content and nutrient concentrations than sands and gravels. Thus muddier areas generally act as a sink concentrating these catchment inputs. Results from the 3 transects sampled (Figure 8) show muds from the catchment accumulate predominantly in the deeper reaches of the upper estuary, indicating it is more at risk of sediment eutrophication effects than the better flushed middle and lower estuary which are much sandier.
