Waimatuku Estuary 2011

Fine Scale Monitoring and Macrophyte Mapping

Prepared
for
**Environment
Southland**
July
2011

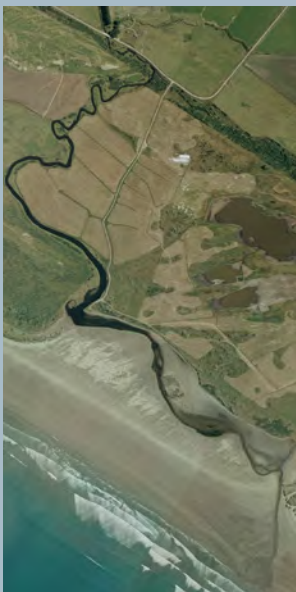
Figure 1. Waimatuku Estuary.

Waimatuku Estuary is a small (20ha at high tide), shallow, "tidal river mouth" estuary that drains to the sea through a sand dominated barrier beach and modified marram grass duneland (Figures 1 and 4). The estuary mouth periodically constricts naturally reducing flushing, and is artificially opened a couple of times per year.

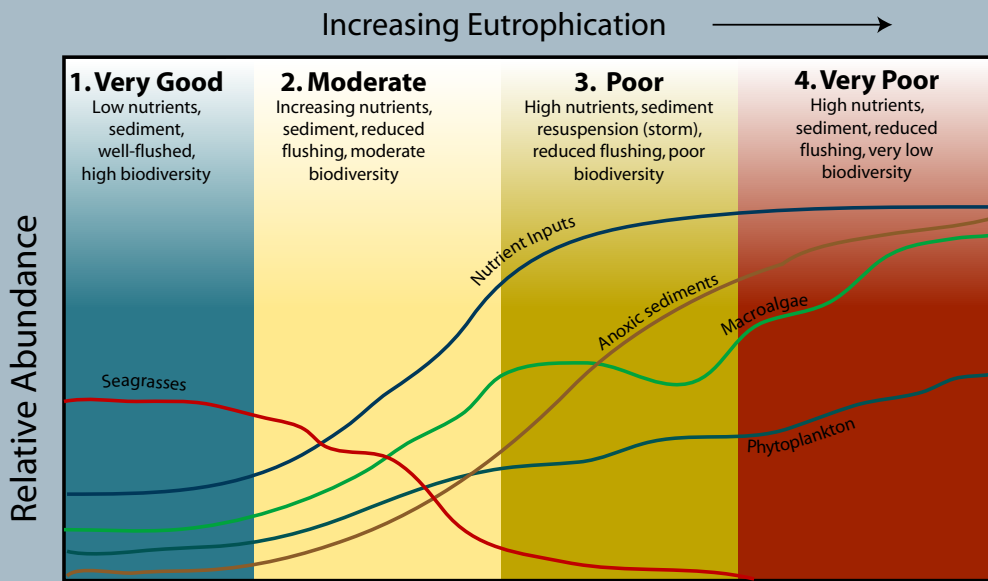
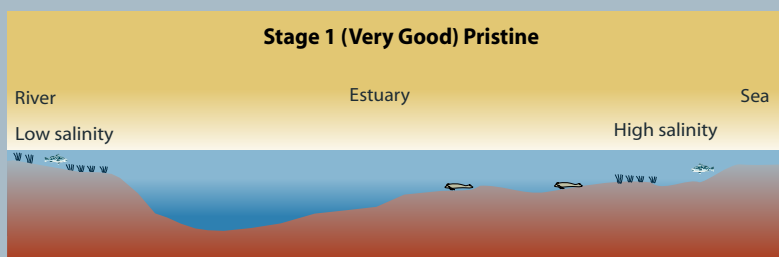
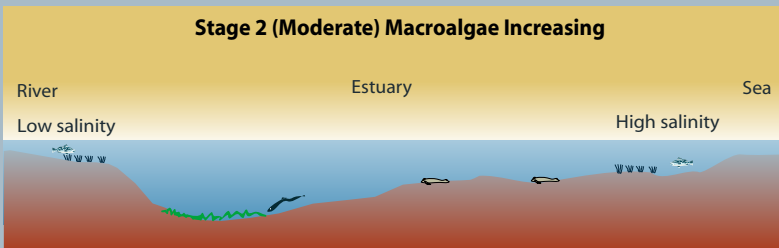
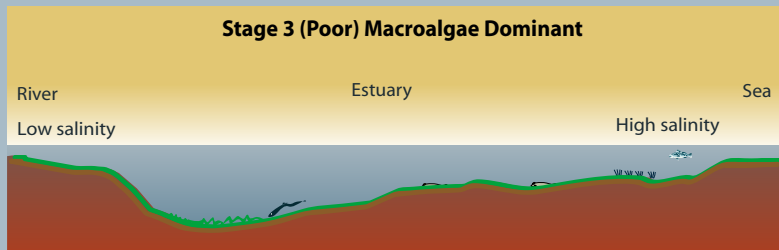
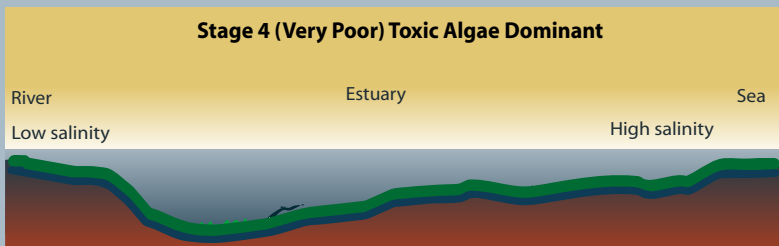
Figure 2. Small tidal river mouth estuary - Response to increasing eutrophication.

Conceptual representation of estuary response to increased nutrients in tidal river mouth estuaries.

Stage 1. In their pristine state, these small, narrow estuaries are adequately flushed with river and marine tidal waters. Nutrient and sediment inputs are low and their clear, shallow, waters are dominated by submerged macrophytes where sediments are stable (e.g. seagrass and *Ruppia*) and contain adequate nutrients. Nuisance macroalgae and phytoplankton growth is low. Sediment quality and biodiversity is high.

Stage 2. As nutrient and sediment levels increase, nuisance macroalgae (e.g. *Enteromorpha*), and phytoplankton growth increases. Native macrophyte growth (e.g. seagrass and *Ruppia*), sediment oxygenation, and water clarity declines. Introduced, aggressive macrophytes can become dominant in the brackish upper estuary. The bed becomes muddier and a surface sulphide layer is common. If flushing is reduced due to freshwater abstraction or mouth constriction, the susceptibility to eutrophication is enhanced and biodiversity declines.

Stage 3. As nutrient inputs become elevated, native macrophytes are replaced with nuisance short-lived macroalgae and phytoplankton. Introduced macrophytes can also become dominant in upper estuary brackish areas. Water clarity is often low, muddy sediments are anoxic close to the surface and sulphide rich, and sediment macrofauna is dominated by high numbers of a few tolerant species only.

Stage 4. Nutrients in sediments and water continue at high concentrations, but a lowering of the N:P ratio results in nuisance cyanobacteria and toxic bloom events. Sediment macrofauna are often absent, but nuisance macroalgae and phytoplankton are still present. Water clarity is low and sediment quality poor with anoxic and sulphide-rich muds.

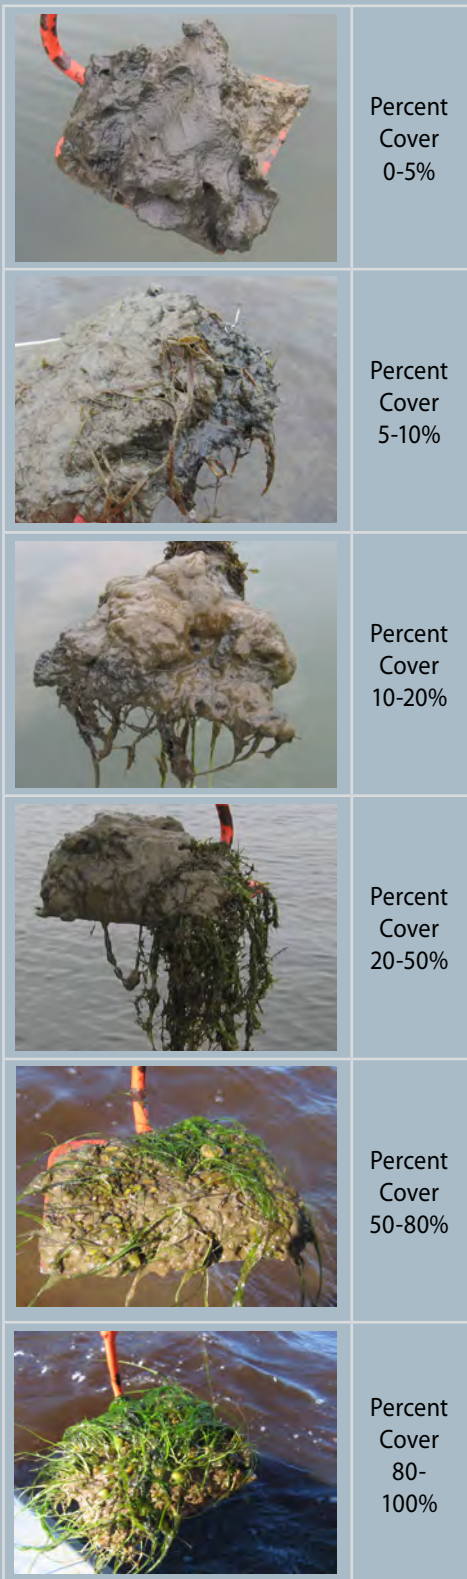
Figure 3. Percent cover categories for aquatic vegetation.

- The taxa, height, percentage cover, and life stage of aquatic vegetation (Figure 3 gives examples of percentage cover estimates for macrophytes).
- The sediment type and depth to the blackened sulphide rich layer (Redox Potential Discontinuity layer - RPD).

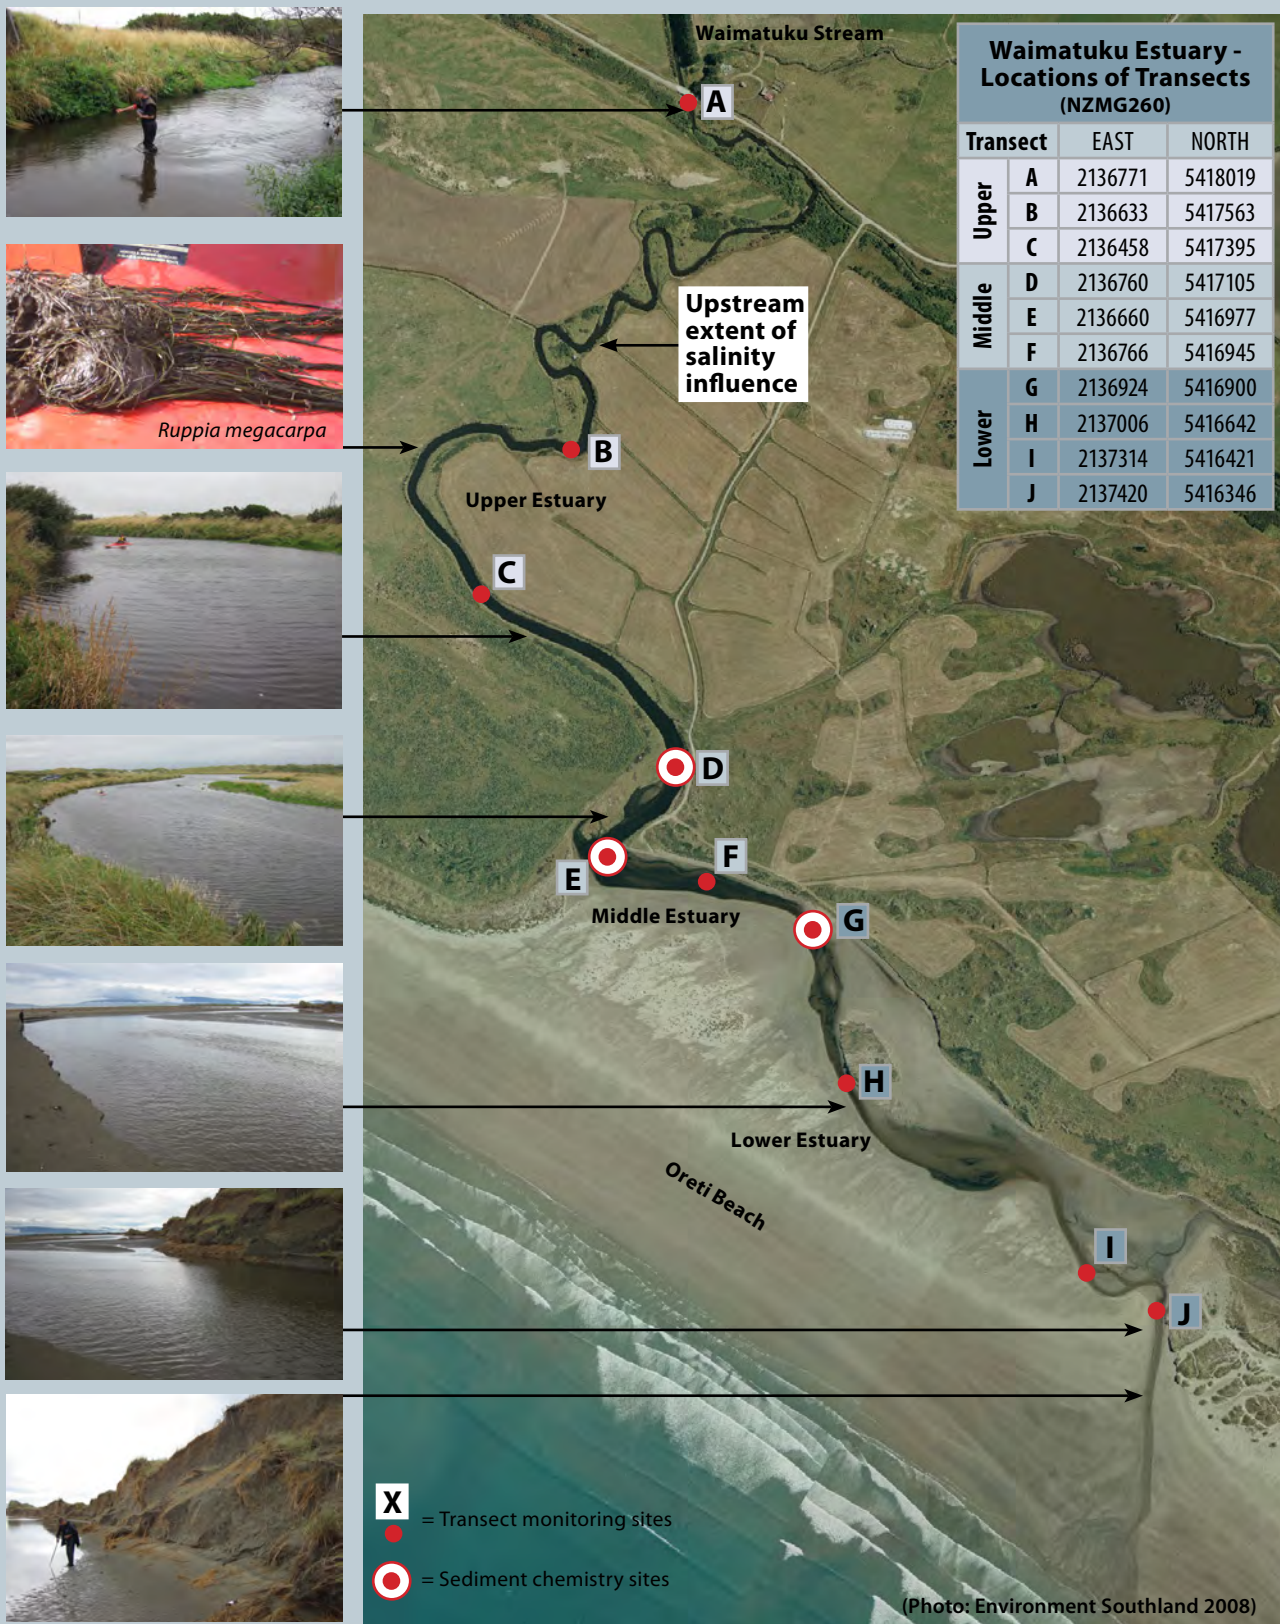
Figure 4. Sampling sites in the Waimatuku Estuary.

Ten previously established transect sampling sites in Waimatuku Estuary (Figure 4, Robertson and Stevens 2009), representing the range of different conditions present throughout the estuary, were visited by two scientists on 21 February 2011 when the lagoon was open to the sea. At each site, sampling was undertaken for key indicators of estuary condition as described below. The purpose was to collect information which, through repeat sampling, can be used as a rapid and robust method to indicate change within the estuary.

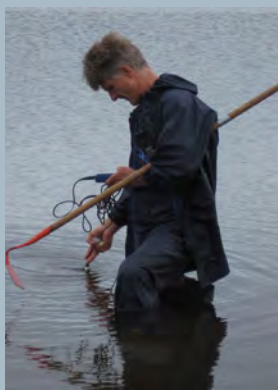
Measuring water quality, Site E, Waimatuku Estuary.

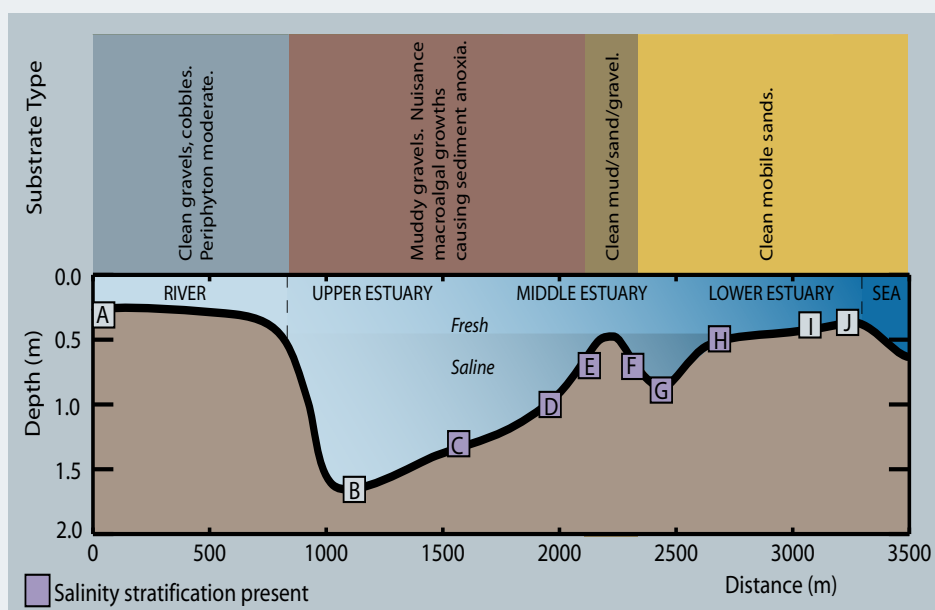
Figure 6. Longitudinal profile (river to sea) of maximum water depth (at low water) and substrate type, 21 February 2011.

The substrate showed little change compared to 2009 or 2010. It comprised predominantly clean gravels and cobbles in the lower Waimatuku Stream, clean muddy gravels in the upper estuary, muddy sands and gravels in the middle estuary (with increased gravel presence in 2011), and clean mobile sands in the lower estuary (Figure 6). Sediment RPD depth was >5cm in the lower estuary, a condition rating of “good”, but with a “poor-fair” rating at sites B, C, D and E. The anoxic, sulphide-rich sediments at these sites, were similar to those observed in 2008 and 2009.

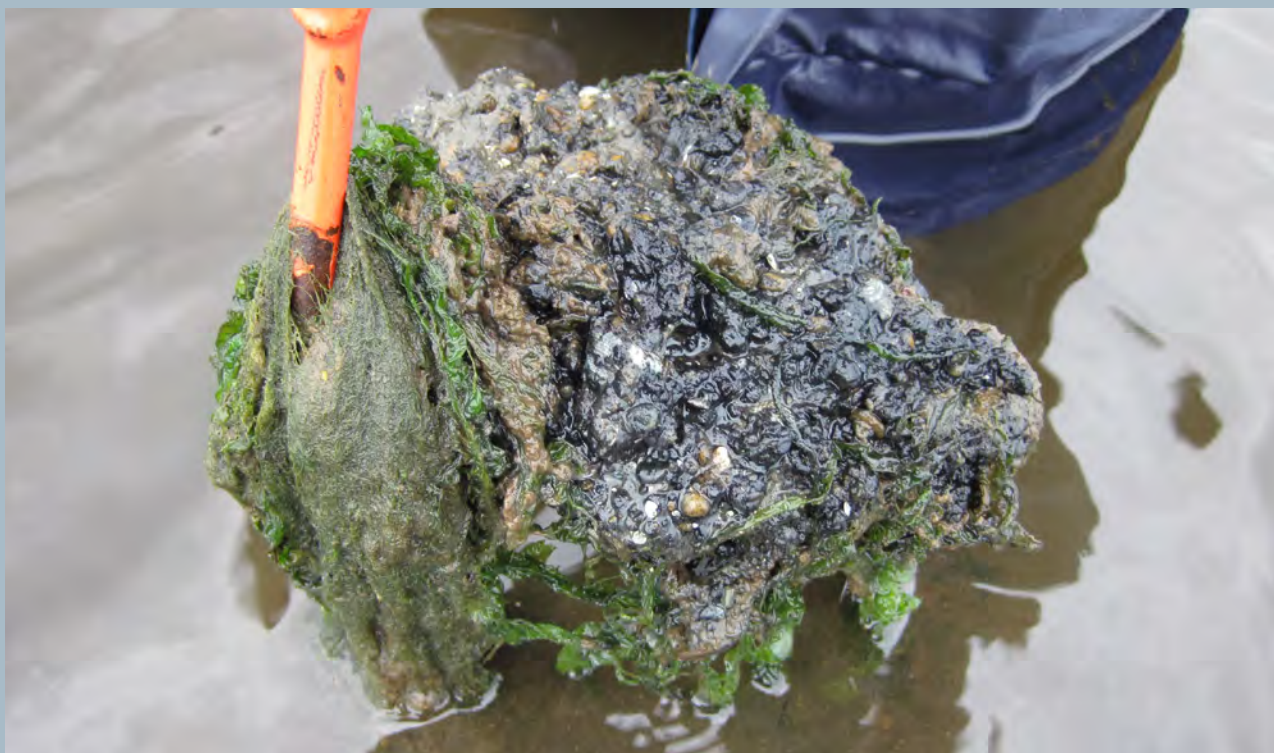
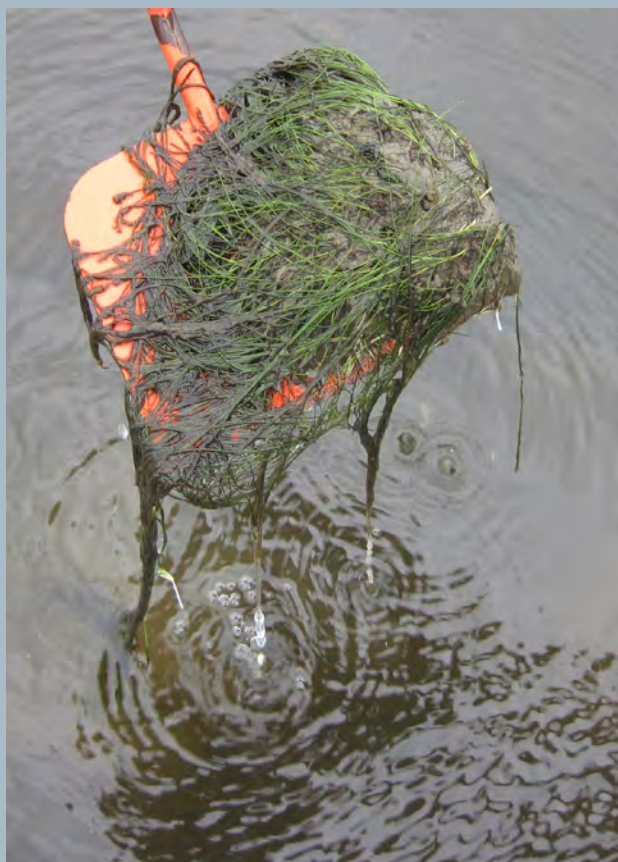
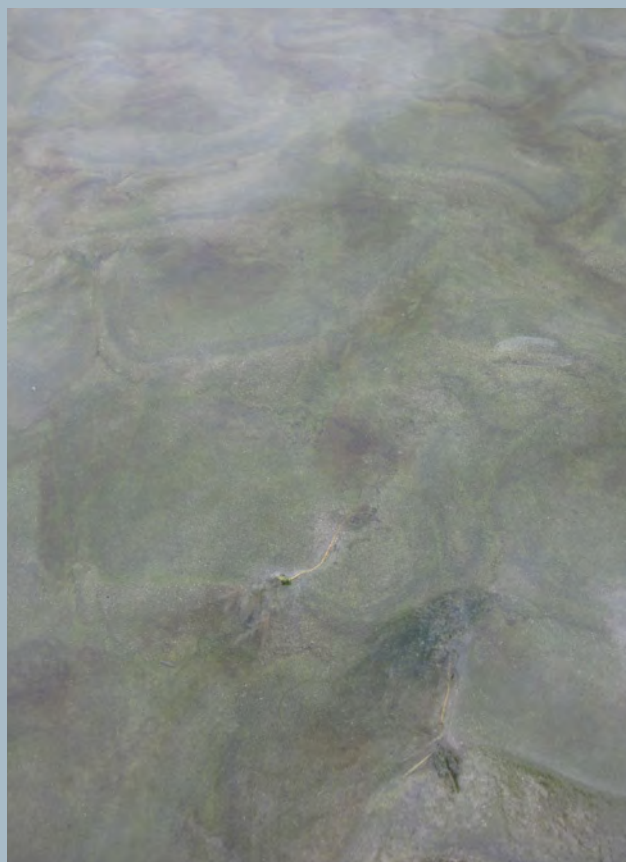
Figure 7. Examples of thick *Ulva intestinalis* and filamentous algae overlying anoxic sediments from site E (top), filamentous algae covering *Ruppia megacarpa* from the upper estuary (left), and benthic microalgae on sands (right) in the lower Waimatuku Estuary, 21 February 2011.

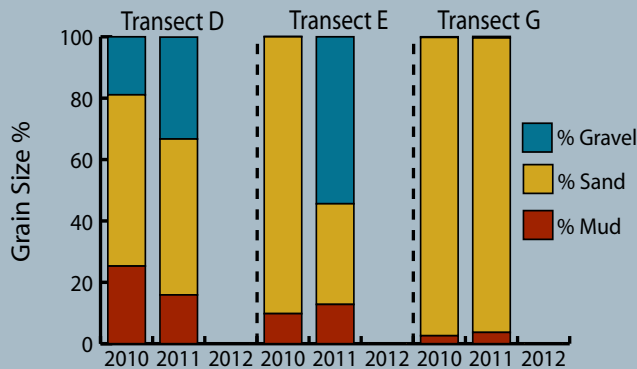
Figure 8. Grain size, at 3 subtidal sites (composite across transect), February 2010, 2011.

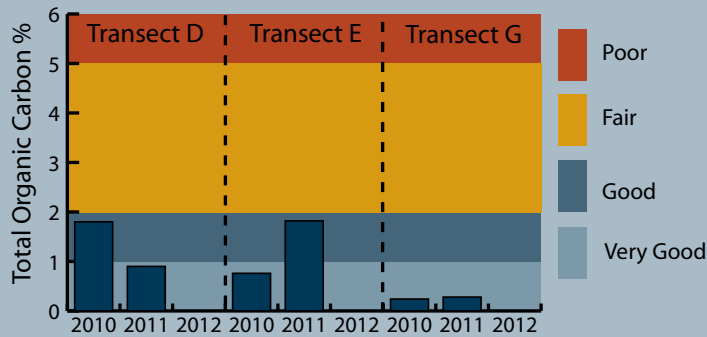
Figure 9. Total organic carbon at 3 subtidal sites (composite across transect), February 2010, 2011.

The indicator of organic enrichment (TOC) in 2011 was at low concentrations (<2%) at all sites (Figure 9) and met the "good" to "very good" condition ratings.

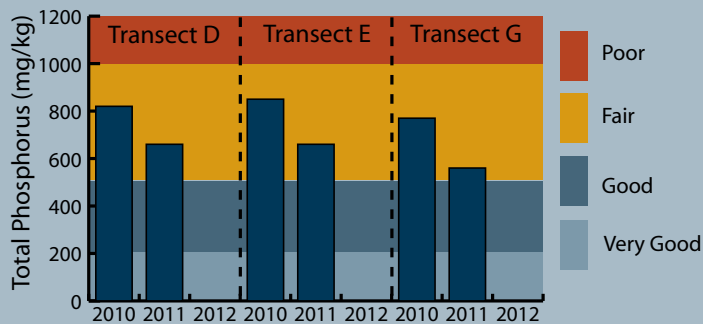
Figure 10. Total phosphorus at 3 subtidal sites (composite across transect), February 2010, 2011.

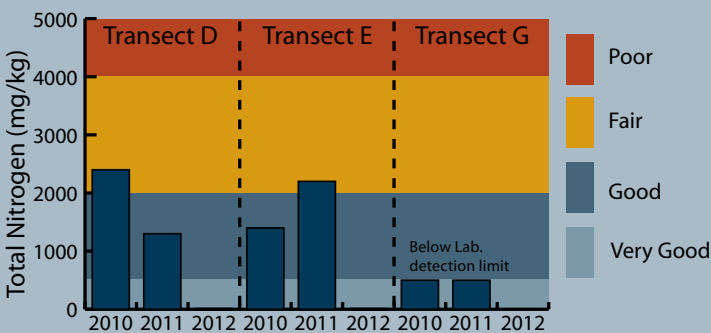
Figure 11. Total nitrogen at 3 subtidal sites (composite across transect), February 2010, 2011.

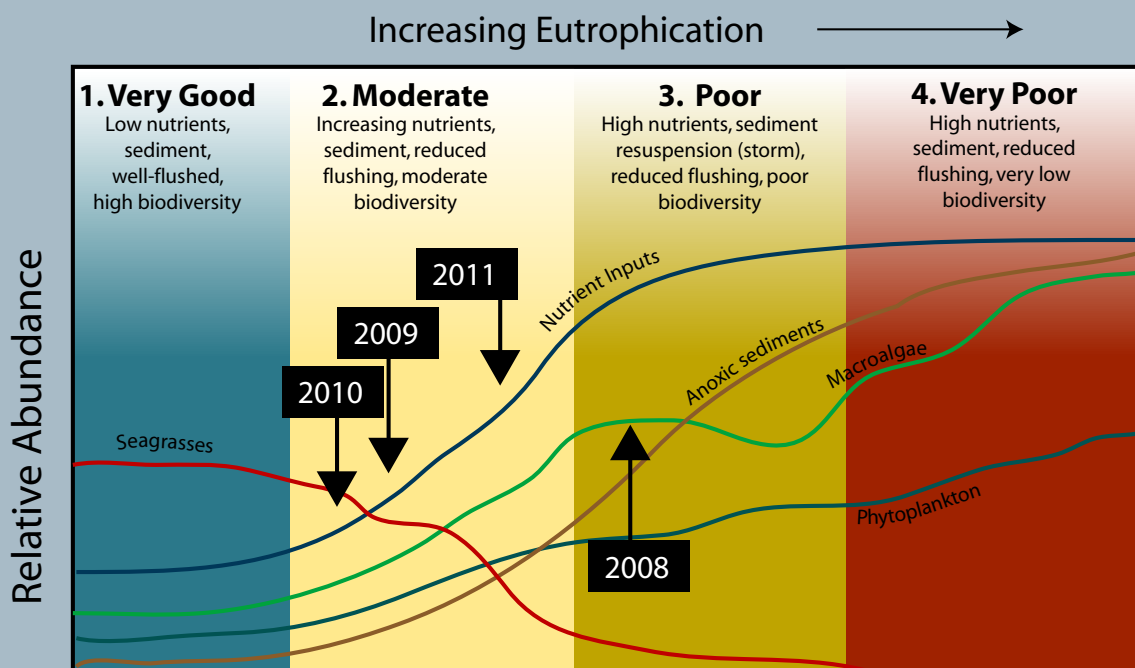
Figure 12. Waimatuku Estuary - condition rating and trophic state, 2008, 2009, 2010 and 2011.

The 2011 results confirm the presence of excessive blooms of nuisance macroalgae concentrated in the middle and lower estuary, while the middle/upper estuary had relatively poor sediment conditions (shallow RPD, high nutrients, nuisance macroalgae, elevated mud concentrations), particularly in areas where salinity stratification was present. Intertidal and subtidal flats in the lower estuary supported a thick benthic microalgal growth not evident in 2010. These conditions place the estuary in a Stage 2 “moderate” state (Figure 12). Consequently, the native seagrass community in the upper estuary is at risk of being degraded and lost. Macroinvertebrates, fish, birdlife, and human use of the estuary is all likely to be adversely impacted.

Conceptual representation of estuary response to increased nutrients in tidal river mouth estuaries.

These results highlight the priority need to manage nutrient inputs from the catchment. Saltmarsh and terrestrial margin habitat is also modified and scarce, so maintaining these in good condition will help provide important filtering and uptake of sediment and nutrients, and help other important parts of the ecosystem to thrive. Pathogens, the other key issue facing the estuary, are currently being addressed as part of Environment Southland’s state of the environment monitoring programme.
