Investigation of cracking soils: Heddon Bush, January 2018.
Michael Killick, Technical Specialist (Soils and Groundwater Quantity)

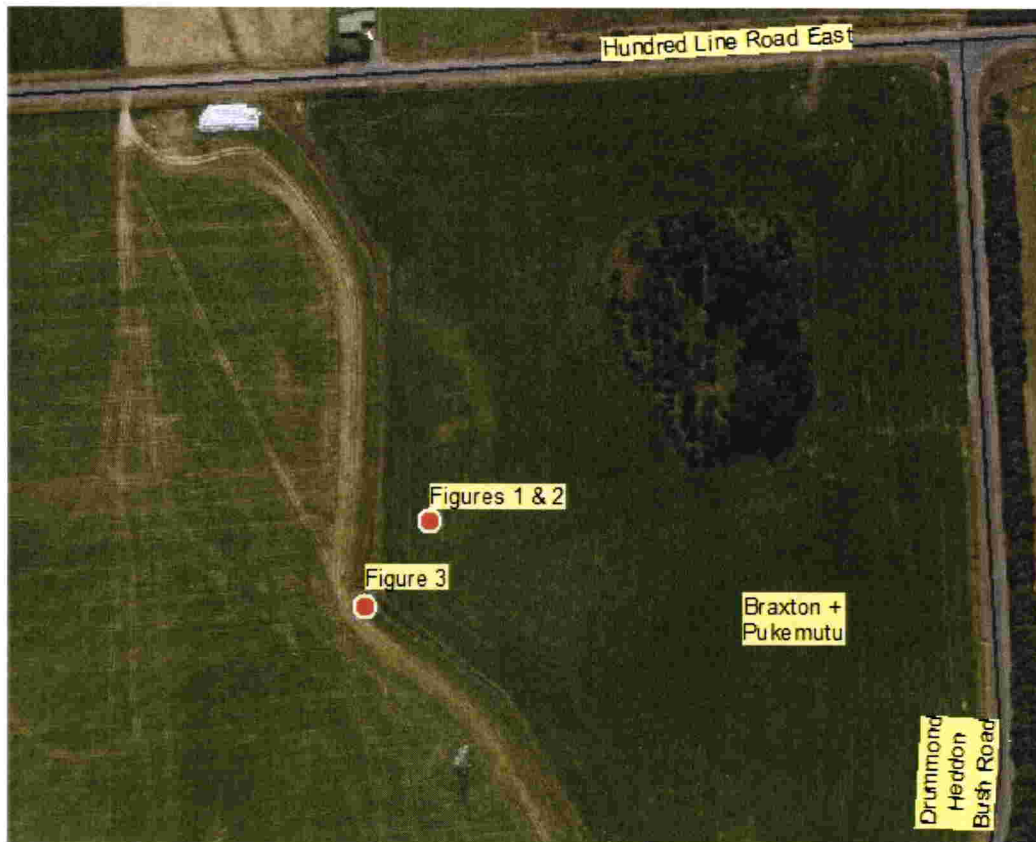
Figure 4. Site 1 locations.

A shallow hole (~15cm deep) at the site showed the soil was friable with many small to medium well-formed peds. A creek on the west side of the paddock which is a small tributary of Middle Creek was dry at the culvert where the bed was a metre or so below ground level. Site 1 was described by Abe as wet in winter with areas of standing water, the effects of which could still be observed in the dry conditions of our visit (re-sowing with new pasture had been prevented in one place due to previous muddy conditions). See figures 1-5.

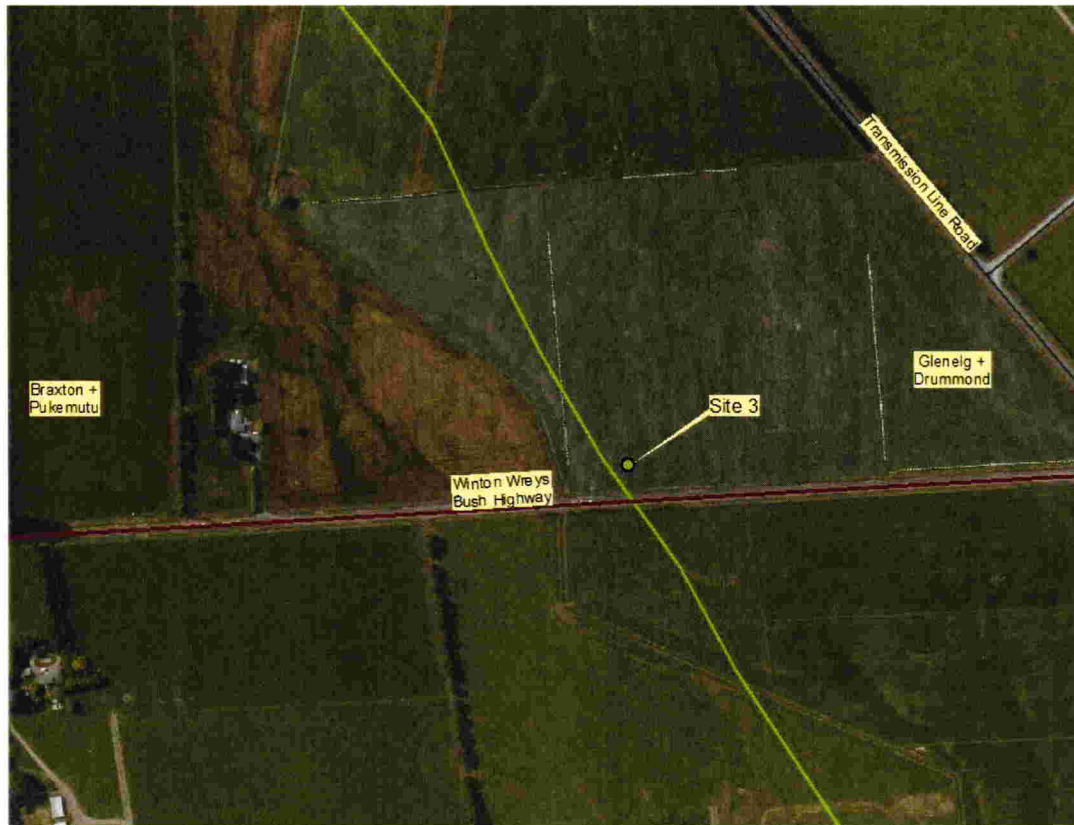
Figure 7. Site 3 location.

We walked a transect of approximately 50m at a third site ('Site 3', Figure 7) mapped as Glenelg + Drummond soils (close to the boundary of Braxton + Pukemutu soils). Cracks in this soil were observed at a density of at least one in the region of each stride i.e. $1/m^2$. The cracks were smaller than at Site 1, 2-4mm wide and less than 100mm long (see Figure 6). A hole dug to about 15cm depth at this site brought up two large stones (~90mm) and a number of small stones. A steel ruler was inserted easily into a crack to a depth of ~20cm, but could be inserted with similar ease to similar depth in soil without cracks at the site. (The depth of the cracks could not otherwise be ascertained as it was not visible from the surface and the soil structure and cracks collapsed easily with digging.)
